RADIOLOGIC AND ENGINEERING ASSESSMENT

DOE ID NO.: GJ-05828-MR
ADDRESS: 140 MIRIAM AVENUE

AUGUST 1985

BENDIX FIELD ENGINEERING CORPORATION
P.O. Box 1569
Grand Junction, Colorado 81502

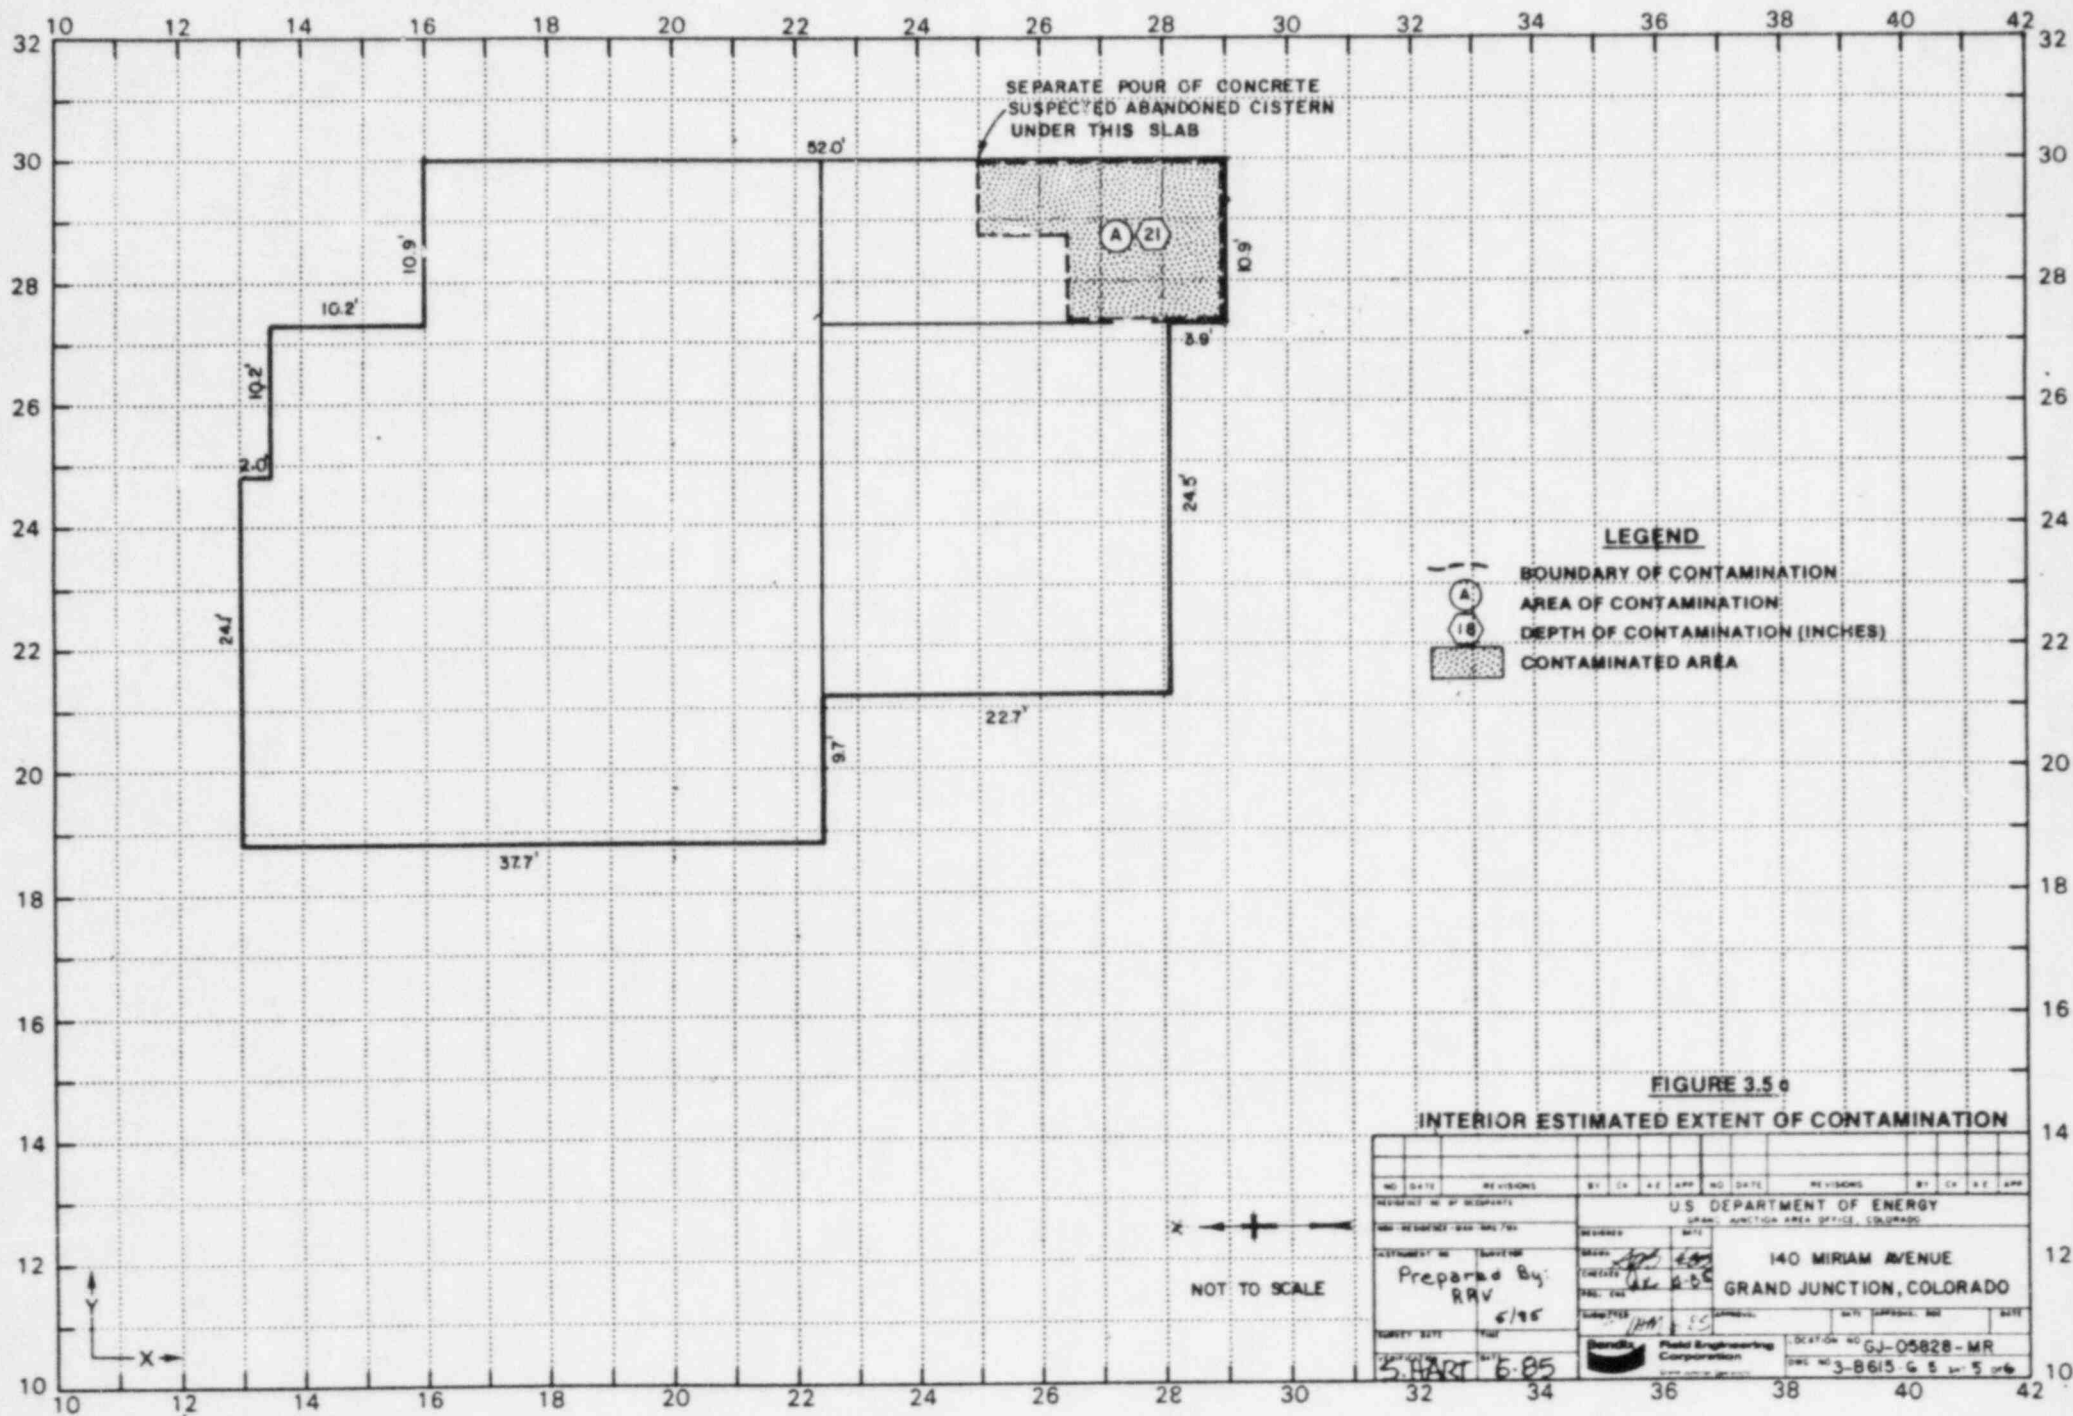
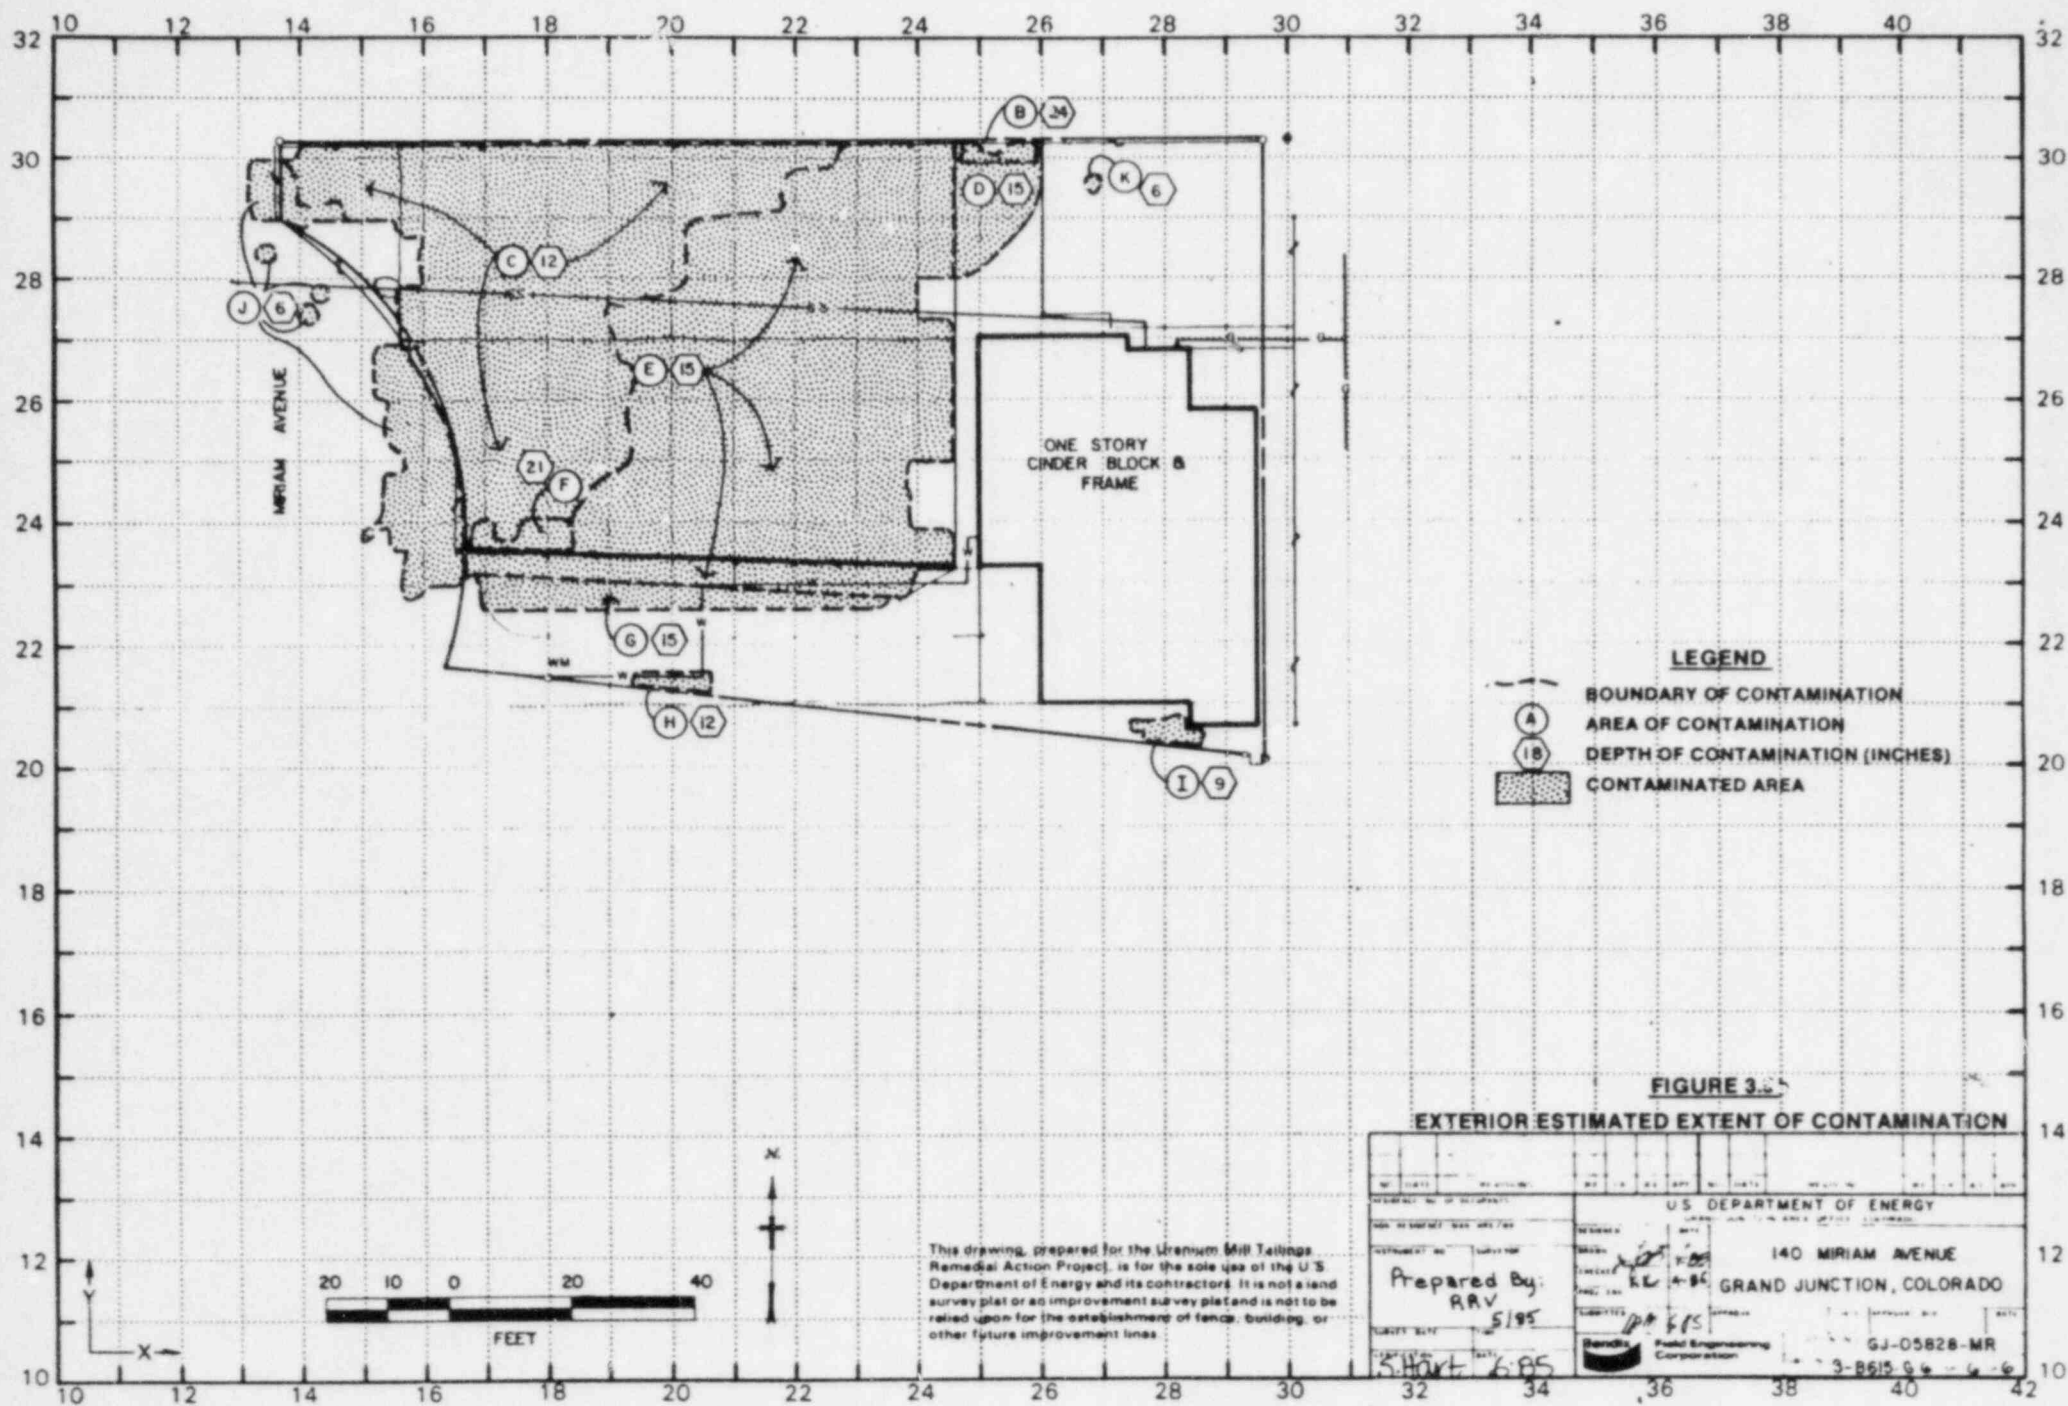
Appendix Figures 3.5a and 3.5b shows identified areas and estimated depths of contamination on this property, based on assessments of all measurements taken. As noted in these figures, areas recommended for remedial action that contain identified residual radioactive materials are:

Concerning questions 1 through 3. A new exterior estimated extent of contamination map has been generated, to correct errors made on the depths of contamination at Locations 4, 7, 8, 14, 16, and 17.

The recommended remedial action for this property, DOE ID No. GJ-05828-MR, includes select removal of all areas identified as containing radioactive material (as discussed in Section 3.5 and shown in Appendix Figure 3.5b) and transport of removed material to the disposal site.

- 1) That remedial action be completed within one year;
- 2) That remedial action work be done after October 1, 1985, because of the garden;
- 3) That the existing concrete driveway be replaced with a new 8' wide concrete driveway; and
- 4) That the contamination in Area H be replaced with roadbase.

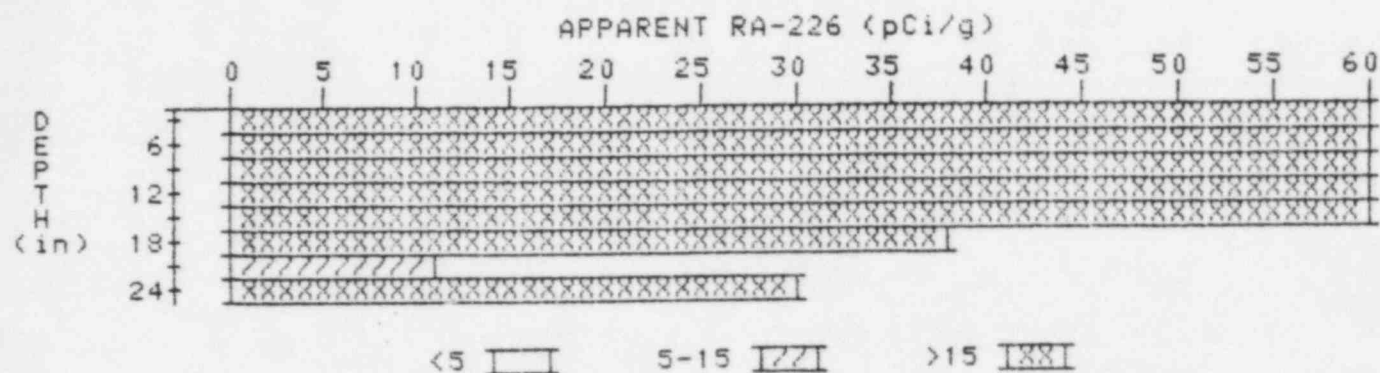
HOLE NUMBER: 1

There were visible signs indicating two separate pours of concrete in the storage and laundry room. The older pour showing the elevated readings.

Two boreholes were augered adjacent to the south wall of the building, also footing/foundation data was collected. The later information led the Bendix team leader to suspect an abandoned cistern located in that area.

Depth (in)	Apparent Radium-226 (pCi/g) Undeconvolved	Apparent Radium-226 (pCi/g) Deconvolved
3	75.0	75.0
6	111.4	161.2
9	119.8	152.0
12	110.1	143.9
15	81.4	79.3
18	53.9	38.3
21	35.2	11.4
24	29.9	29.9

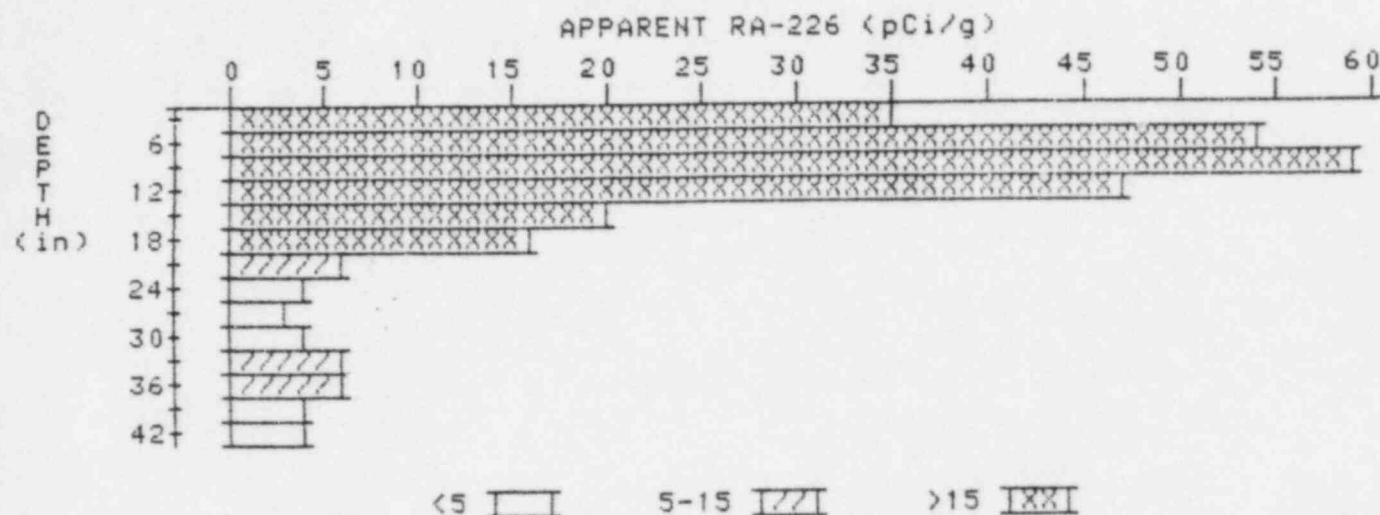
PROPERTY NUMBER: GJ-05829-MR
HOLE NUMBER: 10
LOCATION: 168237

Depth (in)	Apparent Radium-226 (pCi/g) Undeconvolved	Apparent Radium-226 (pCi/g) Deconvolved
3	34.8	34.8
6	42.9	54.5
9	44.5	58.9
12	38.0	47.1
15	26.4	20.4
18	18.2	15.9
21	11.3	5.8
24	7.5	4.1
27	5.6	3.1
30	5.1	4.0
33	5.2	5.7
36	5.0	5.7
39	4.4	3.5
42	4.3	4.3

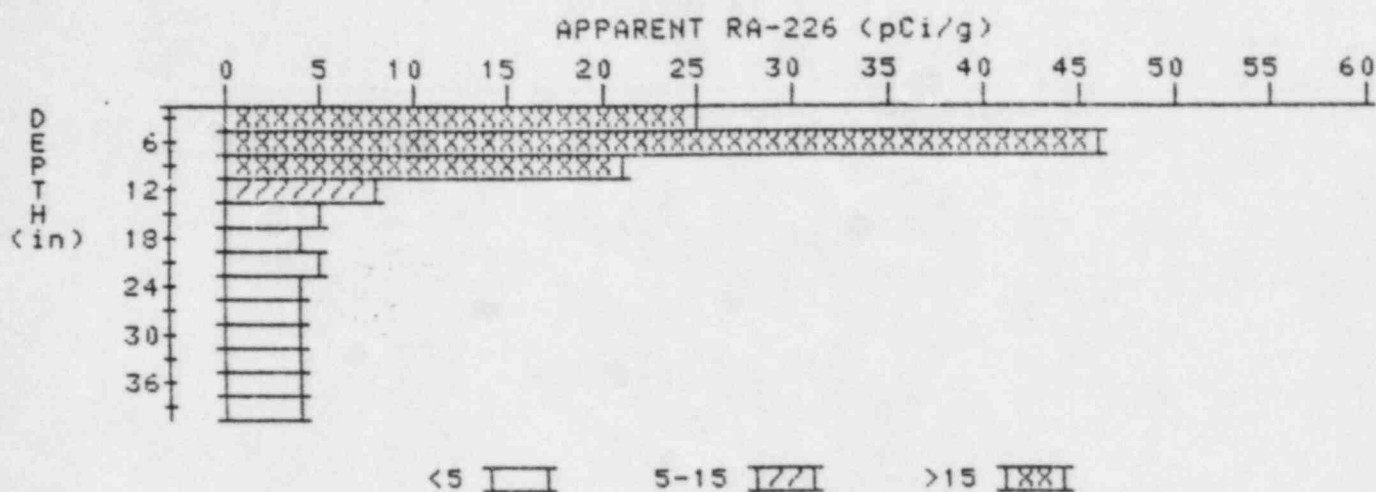
PROPERTY NUMBER: GJ-05828-MR
HOLE NUMBER: 20
LOCATION: 217232

Depth (in)	Apparent Radium-226 (pCi/g) Undeconvolved	Apparent Radium-226 (pCi/g) Deconvolved
3	25.3	25.3
6	27.9	45.5
9	20.6	20.6
12	13.3	8.5
15	8.7	4.6
18	6.4	4.3
21	5.3	4.6
24	4.6	3.9
27	4.3	4.1
30	4.1	3.7
33	4.1	4.3
36	4.0	3.6
39	4.1	4.1
