RADIOLOGIC AND ENGINEERING ASSESSMENT

DOE ID NO.: GJ-00590-MR
ADDRESS: 1827 NORTH 21ST STREET

AUGUST 1985

BENDIX FIELD ENGINEERING CORPORATION
P.O. Box 1569
Grand Junction, Colorado 81502

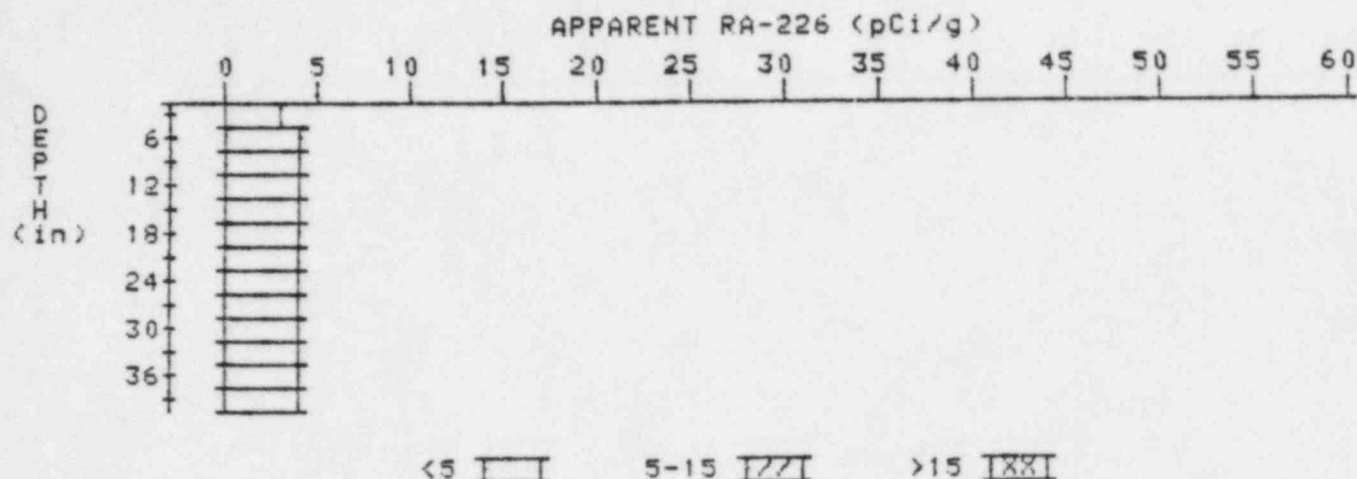
HOLE NUMBER: 7

Depth (in)	Apparent Radium-226 (pCi/g) Undeconvolved	Apparent Radium-226 (pCi/g) Deconvolved
3	3.0	3.0
6	3.4	3.8
9	3.6	3.8
12	3.7	3.9
15	3.7	3.7
18	3.7	3.7
21	3.7	3.7
24	3.7	3.5
27	3.8	3.8
30	3.9	3.9
33	4.0	4.2
36	4.0	3.8
39	4.1	4.1

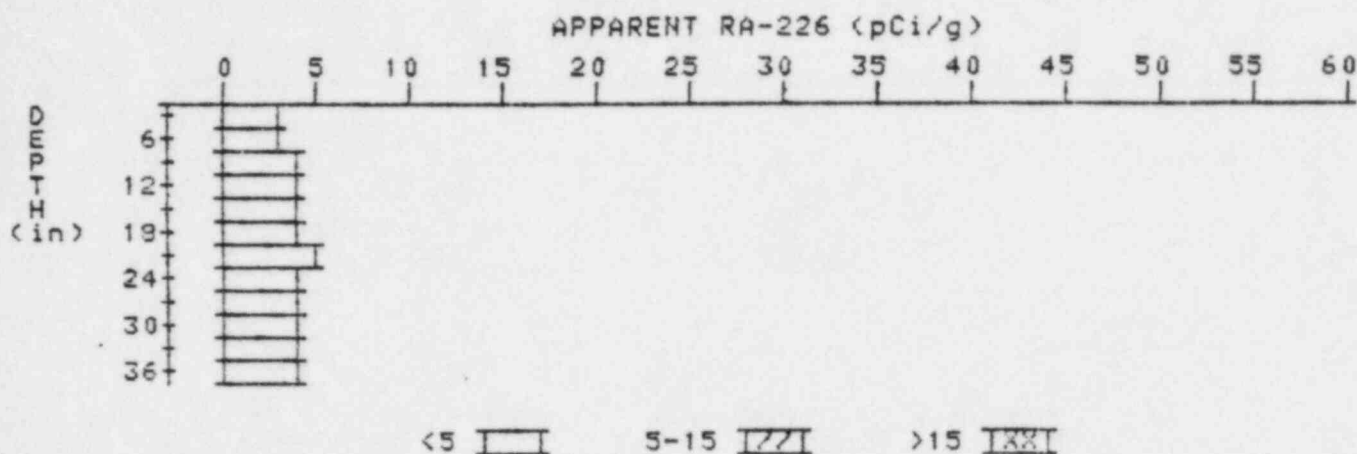
HOLE NUMBER: 8

Depth (in)	Apparent Radium-226 (pCi/g) Undeconvolved	Apparent Radium-226 (pCi/g) Deconvolved
3	2.9	2.9
6	3.3	3.5
9	3.6	4.0
12	3.7	3.9
15	3.7	3.5
18	3.8	3.6
21	4.0	4.5
24	3.9	3.5
27	4.0	4.0
30	4.1	4.3
33	4.1	4.5
36	3.9	3.9

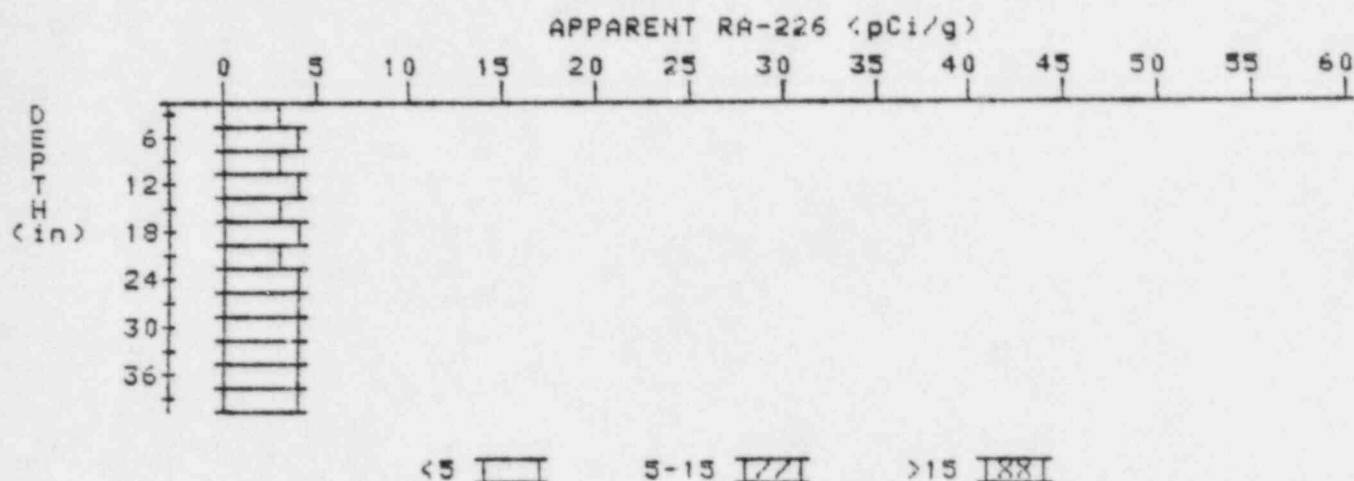
PROPERTY NUMBER: GJ-00590-MR
HOLE NUMBER: 13
LOCATION: 169221

Depth (in)	Apparent Radium-226 (pCi/g) Undeconvolved	Apparent Radium-226 (pCi/g) Deconvolved
3	2.8	2.8
6	3.2	3.6
9	3.4	3.2
12	3.7	4.2
15	3.7	3.3
18	3.9	4.4
21	3.9	3.4
24	3.9	4.1
27	3.9	3.9
30	3.9	3.9
33	3.9	3.9
36	3.9	3.9
39	3.9	3.9

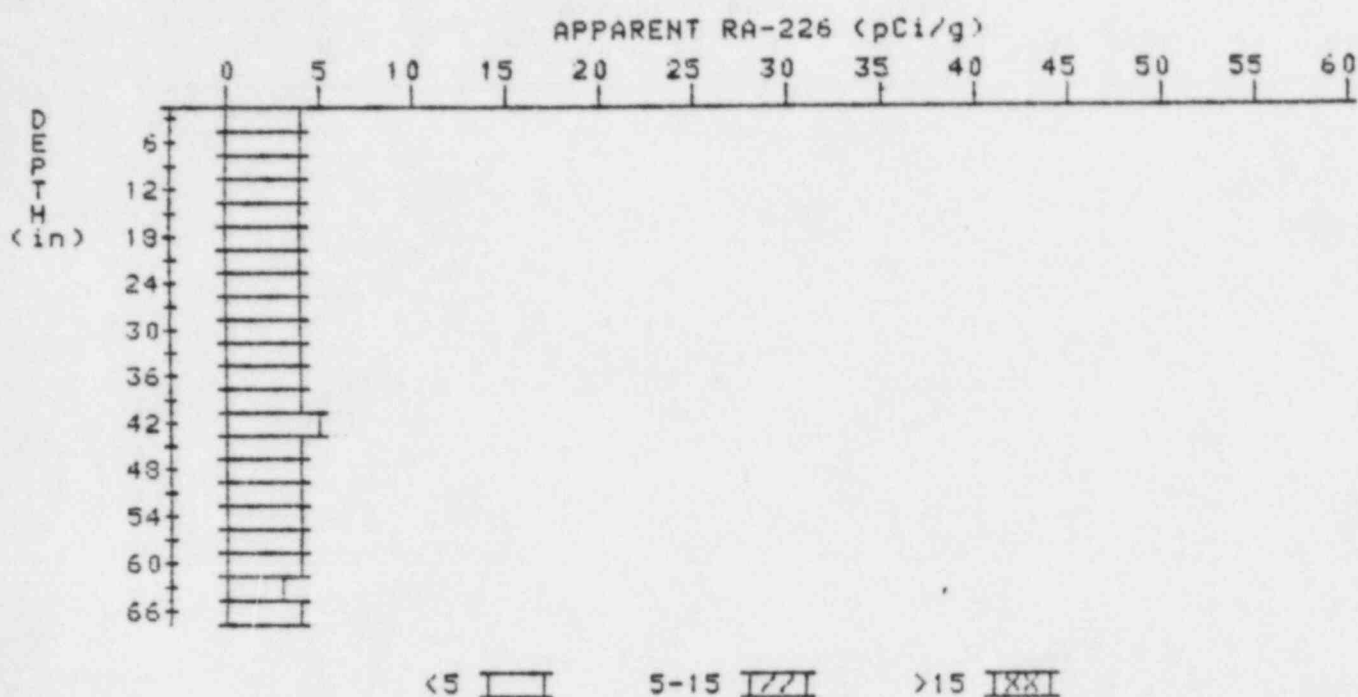
PROPERTY NUMBER: GJ-00590-MR
HOLE NUMBER: 14
LOCATION: 169271

Depth (in)	Apparent Radium-226 (pCi/g) Undeconvolved	Apparent Radium-226 (pCi/g) Deconvolved
3	3.5	3.5
6	3.8	4.2
9	3.9	4.1
12	3.9	3.9
15	3.9	3.9
18	3.9	3.7
21	4.0	4.2
24	4.0	3.8
27	4.1	4.3
30	4.1	4.3
33	4.0	3.6
36	4.1	4.1
39	4.2	4.2
42	4.3	4.8
45	4.1	3.7
48	4.1	4.1

51	4.1	3.9
54	4.2	4.4
57	4.2	4.4
60	4.1	4.1
63	4.0	3.5
66	4.2	4.2

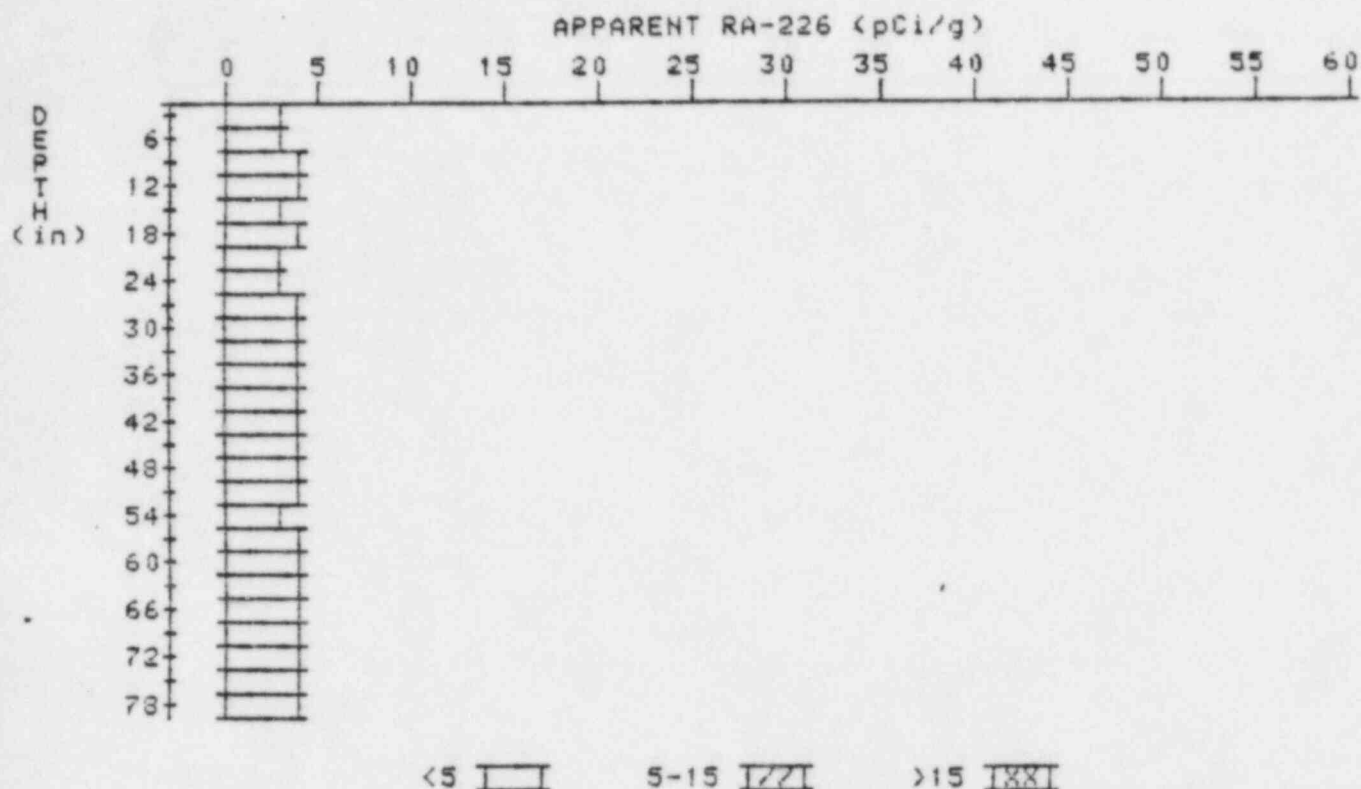
HOLE NUMBER: 16

Depth (in)	Apparent Radium-226 (pCi/g) Undeconvolved	Apparent Radium-226 (pCi/g) Deconvolved
3	2.9	2.9
6	3.1	2.9
9	3.4	3.8
12	3.5	3.7
15	3.5	3.1
18	3.7	4.2
21	3.6	3.4
24	3.6	3.4
27	3.7	3.9
30	3.7	3.5
33	3.8	4.2
36	3.7	3.5
39	3.7	3.7

42	3.7	3.7
45	3.7	3.5
48	3.8	3.3
51	3.9	4.3
54	3.8	3.4
57	3.9	4.3
60	3.8	3.6
63	3.8	3.6
66	3.9	4.3
69	3.8	3.6
72	3.8	3.6
75	3.9	4.3
78	3.8	3.6

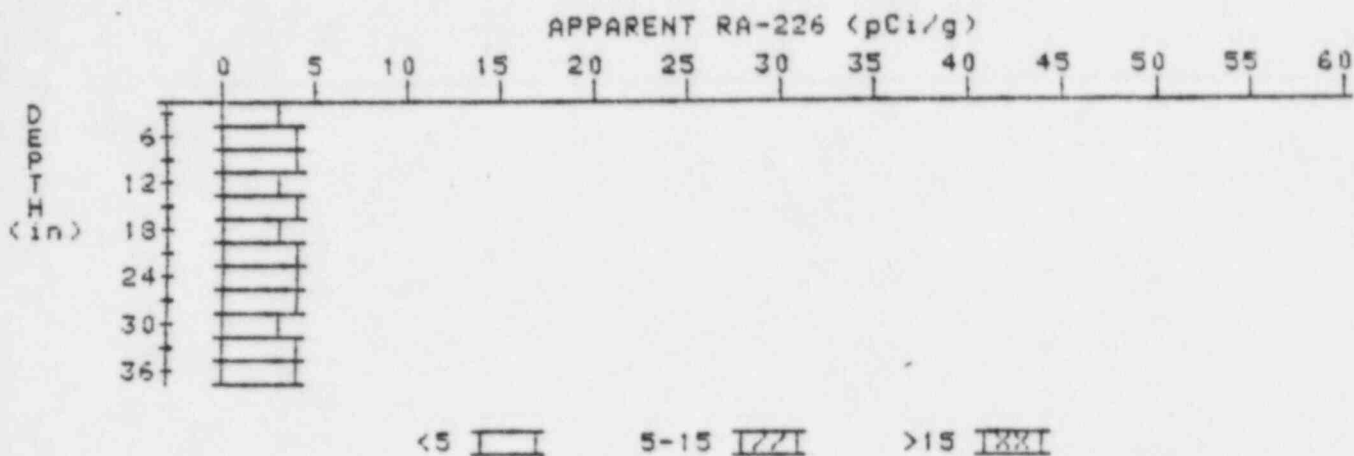
PROPERTY NUMBER: GJ-00590-MR
HOLE NUMBER: 17
LOCATION: 192221

Depth (in)	Apparent Radium-226 (pCi/g) Undeconvolved	Apparent Radium-226 (pCi/g) Deconvolved
3	3.0	3.0
6	3.4	3.3
9	3.6	4.0
12	3.6	3.4
15	3.7	4.1
18	3.6	3.2
21	3.7	3.7
24	3.8	4.0
27	3.8	4.0
30	3.7	3.2
33	3.9	4.4
36	3.8	3.8

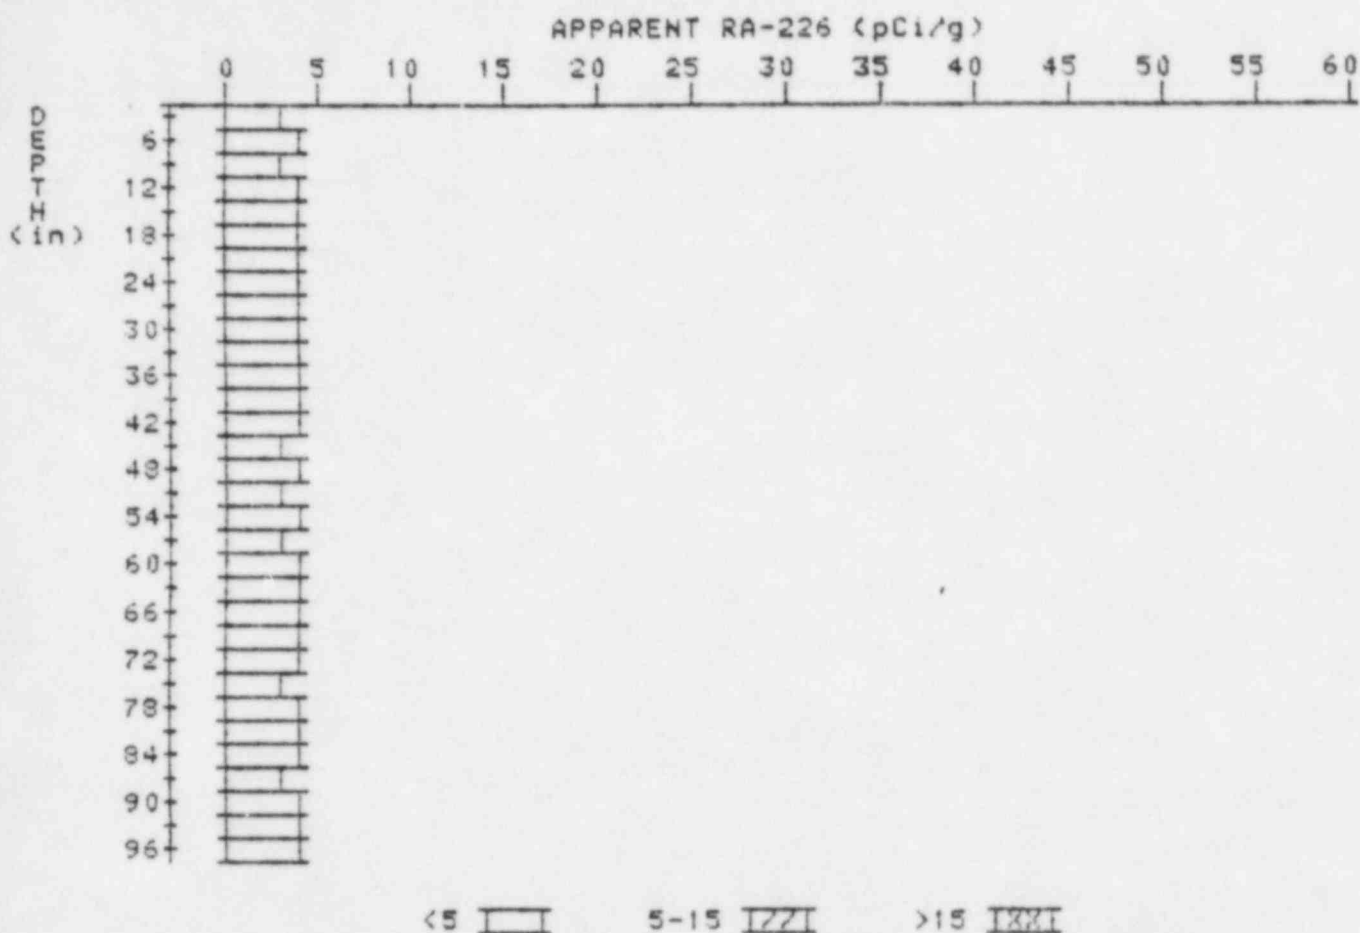
HOLE NUMBER: 18

Depth (in)	Apparent Radium-226 (pCi/g) Undeconvolved	Apparent Radium-226 (pCi/g) Deconvolved
3	2.9	2.9
6	3.4	4.1
9	3.5	3.3
12	3.7	4.1
15	3.7	3.7
18	3.7	3.5
21	3.8	4.0
24	3.8	3.8
27	3.8	3.8

30	3.8	3.6
33	3.9	4.3
36	3.8	3.6
39	3.8	3.8
42	3.8	4.0
45	3.7	3.3
48	3.8	4.2
51	3.7	3.3
54	3.8	4.2
57	3.7	3.3
60	3.8	4.2
63	3.7	3.5
66	3.7	3.7
69	3.7	3.7
72	3.7	3.9
75	3.6	3.2
78	3.7	3.9
81	3.7	3.5
84	3.8	4.2
87	3.7	3.3
90	3.8	4.0
93	3.8	3.8
96	3.8	3.8
