RADIOLOGIC AND ENGINEERING ASSESSMENT

DOE ID NO.: GJ-06775-RS
ADDRESS: 1840 NORTH 18TH STREET

AUGUST 1985

URANIUM MILL TAILINGS REMEDIAL ACTION PROJECT OFFICE

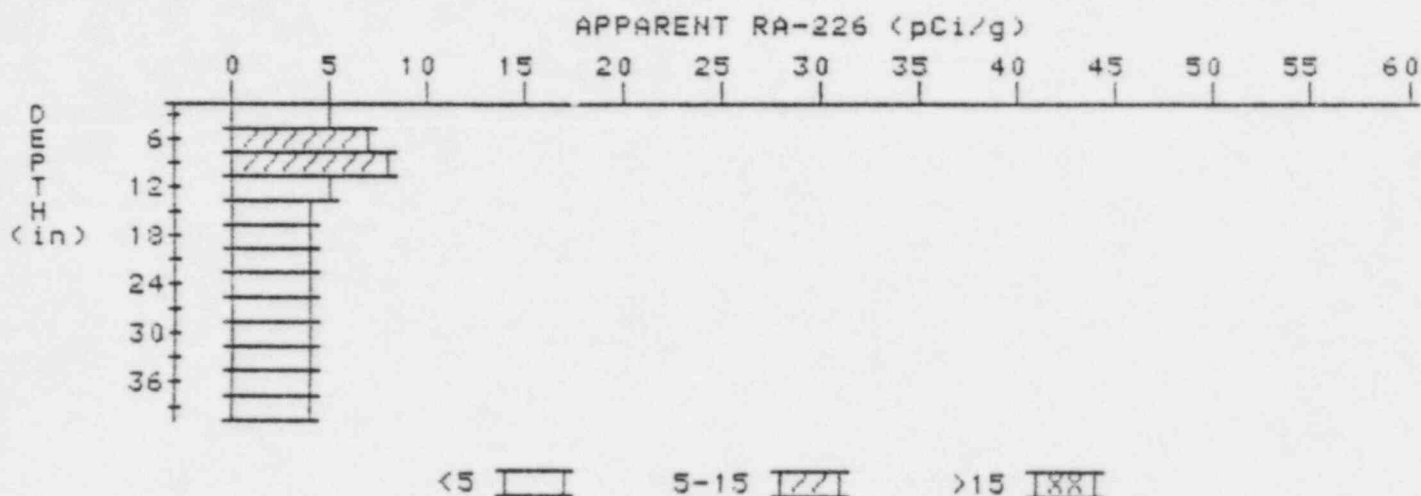
HOLE NUMBER: 10

Loc #	Grid Location	Depth (in.)	Meas. Type	In Situ Ra-226 (pCi/g)		Chem Ra-226 (pCi/g)	Comments
				Tot. Ct	Spectr.		
8	167267	00	DS	4.5		*	Lilac bush in north yard
		06	DS	1.5		*	
9	173183	00	DS	1.3		*	Along west fence
10	175278	00	DS	3.6		*	North yard DC = 12 inches Based on the deconvolution graph
		03	TC	4.5		*	
		06	TC	5.6		*	
		09	TC	5.9		*	
		12	TC	5.2		*	
		15	TC	4.7		*	
		18	TC	4.4		*	
		21	TC	4.2		*	
		24	TC	4.1		*	
		27	TC	4.1		*	
		30	TC	4.1		*	
		33	TC	4.1		*	
		36	TC	4.1		*	
		39	TC	4.0		*	
11	179215	00	DS	1.9		*	West foundation DC = 0 inches
		03	TC	3.0		*	
		06	TC	3.3		*	
		09	TC	3.5		*	
		12	TC	3.7		*	
		15	TC	3.7		*	
		18	TC	3.8		*	
		21	TC	3.9		*	
		24	TC	3.9		*	
		27	TC	3.8		*	
		30	TC	3.9		*	
		33	TC	3.9		*	
		36	TC	4.0		*	
		39	TC	4.0		*	
		42	TC	4.0		*	
		45	TC	4.1		*	
		48	TC	4.1		*	
		51	TC	4.0		*	
		54	TC	4.0		*	
		57	TC	4.1		*	
		60	TC	4.0		*	
		63	TC	3.9		*
