RADIOLOGIC AND ENGINEERING ASSESSMENT

DOE ID NO.: GJ-02961-RS  
ADDRESS: 1445 WALNUT AVENUE

AUGUST 1985

BENDIX FIELD ENGINEERING CORPORATION  
P.O. Box 1569  
Grand Junction, Colorado 81502

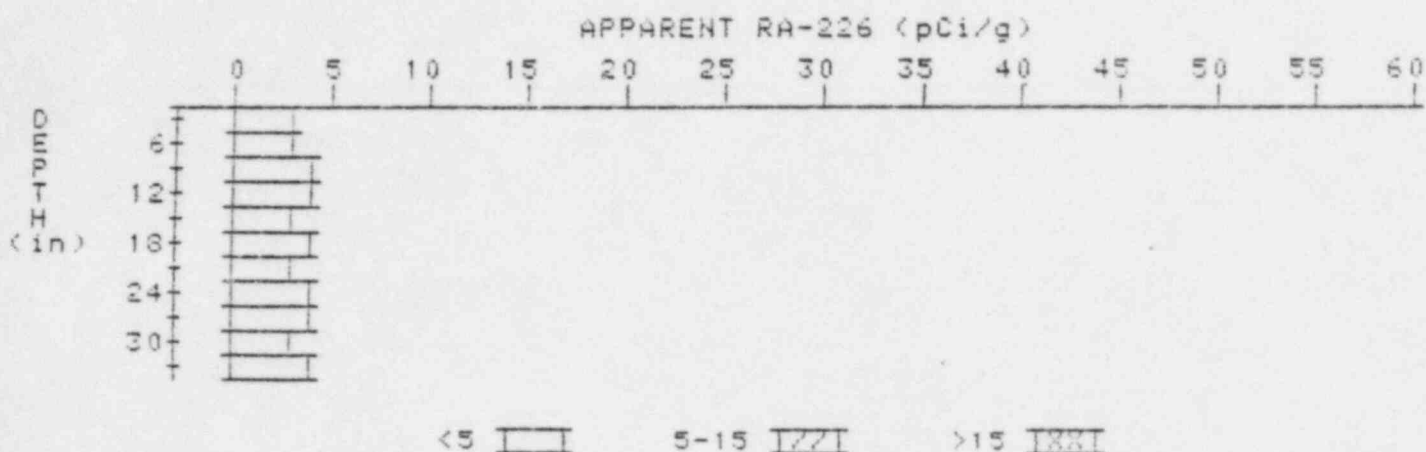
HOLE NUMBER: 2

Depth (in)	Apparent Radium-226 (pCi/g) Undeconvolved	Apparent Radium-226 (pCi/g) Deconvolved
3	2.9	2.9
6	3.2	3.2
9	3.5	4.0
12	3.5	3.5
15	3.5	3.3
18	3.6	4.0
21	3.5	3.3
24	3.5	3.5
27	3.5	3.7
30	3.4	3.0
33	3.5	3.5

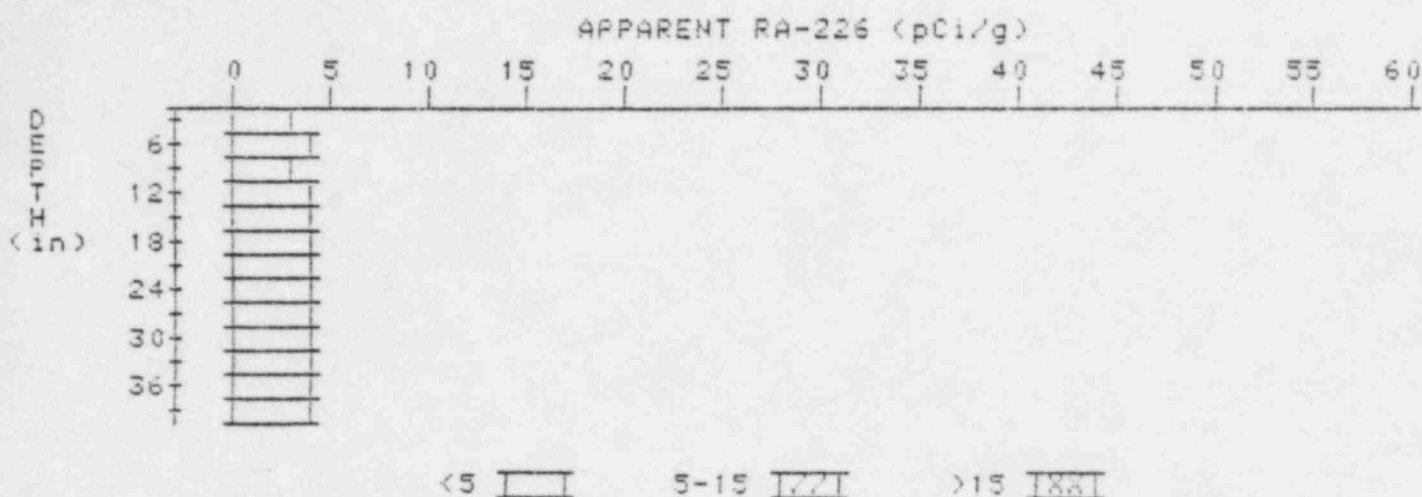
HOLE NUMBER: 3

Depth (in)	Apparent Radium-226 (pCi/g) Undeconvolved	Apparent Radium-226 (pCi/g) Deconvolved
3	3.1	3.1
6	3.4	3.8
9	3.5	3.3
12	3.7	3.9
15	3.8	3.8
18	3.9	3.9
21	4.0	4.2
24	4.0	4.2
27	3.9	3.9
30	3.8	3.6
33	3.8	4.0
36	3.7	3.8
39	3.7	3.7

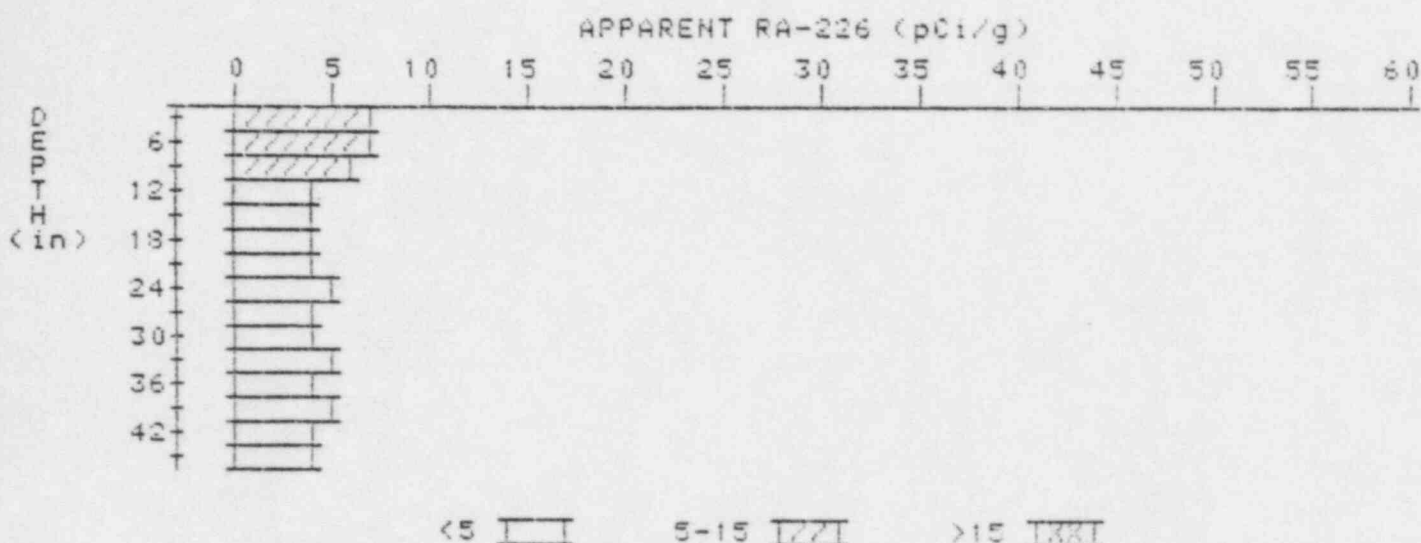
HOLE NUMBER: 7

Depth (in)	Apparent Radium-226 (pCi/g) Undeconvolved	Apparent Radium-226 (pCi/g) Deconvolved
3	6.6	6.6
6	6.2	6.6
9	5.6	5.8
12	4.9	4.4
15	4.5	4.1
18	4.3	4.1
21	4.2	3.8
24	4.3	4.7
27	4.2	3.8
30	4.3	4.3
33	4.4	4.8
36	4.3	4.1
39	4.3	4.7
42	4.1	3.9
45	4.0	4.0

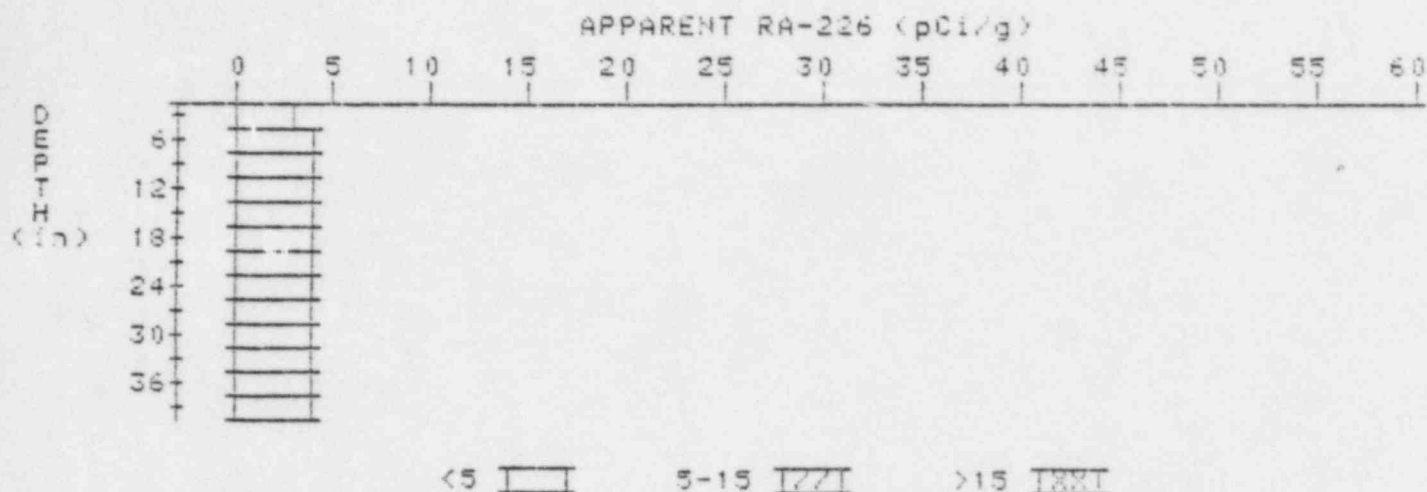
HOLE NUMBER: 12

Depth (in)	Apparent Radium-226 (pCi/g) Undeconvolved	Apparent Radium-226 (pCi/g) Deconvolved
3	3.1	3.1
6	3.5	3.9
9	3.7	4.1
12	3.7	3.7
15	3.7	3.7
18	3.7	3.7
21	3.7	3.7
24	3.7	3.5
27	3.8	4.0
30	3.8	3.8
33	3.8	4.0
36	3.7	3.5
39	3.7	3.7
