RADIOLOGIC AND ENGINEERING ASSESSMENT

DOE ID NO.: GJ-11549-MR
ADDRESS: 2860 BUNTING AVENUE

AUGUST 1985

BENDIX FIELD ENGINEERING CORPORATION
P.O. Box 1569
Grand Junction, Colorado 81502

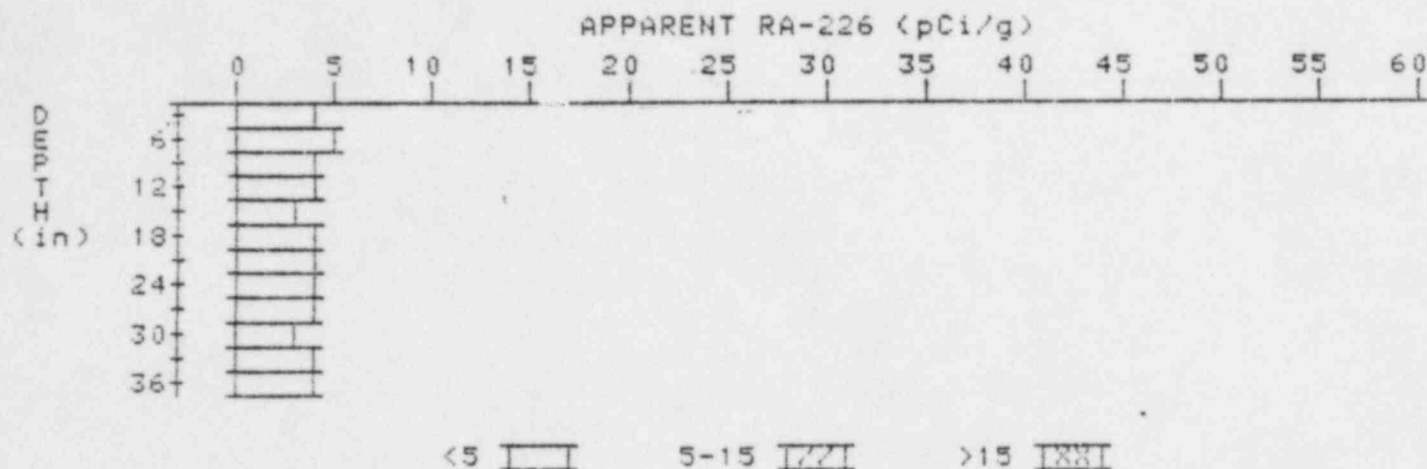
PROPERTY NUMBER: GJ-11549-MR
HOLE NUMBER: 6
LOCATION: 139218

Depth (in)	Apparent Radium-226 (pCi/g) Undeconvolved	Apparent Radium-226 (pCi/g) Deconvolved
3	3.7	3.7
6	4.0	4.7
9	3.9	4.1
12	3.7	3.7
15	3.5	3.1
18	3.5	3.5
21	3.5	3.5
24	3.5	3.5
27	3.5	3.5
30	3.5	3.3
33	3.6	3.8
36	3.6	3.6

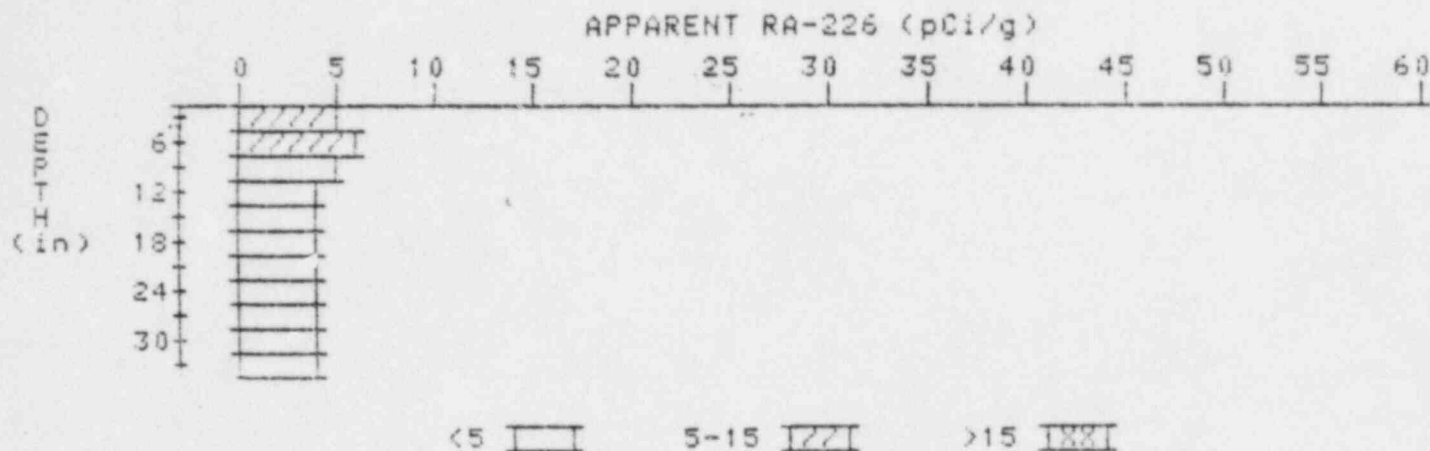
PROPERTY NUMBER: GJ-11549-MR
HOLE NUMBER: 7
LOCATION: 142185

Depth (in)	Apparent Radium-226 (pCi/g) Undeconvolved	Apparent Radium-226 (pCi/g) Deconvolved
3	5.3	5.3
6	5.2	5.9
9	4.7	4.5
12	4.3	3.8
15	4.2	4.2
18	4.1	3.9
21	4.1	4.3
24	4.0	3.8
27	4.0	4.0
30	4.0	4.2
33	3.9	3.9

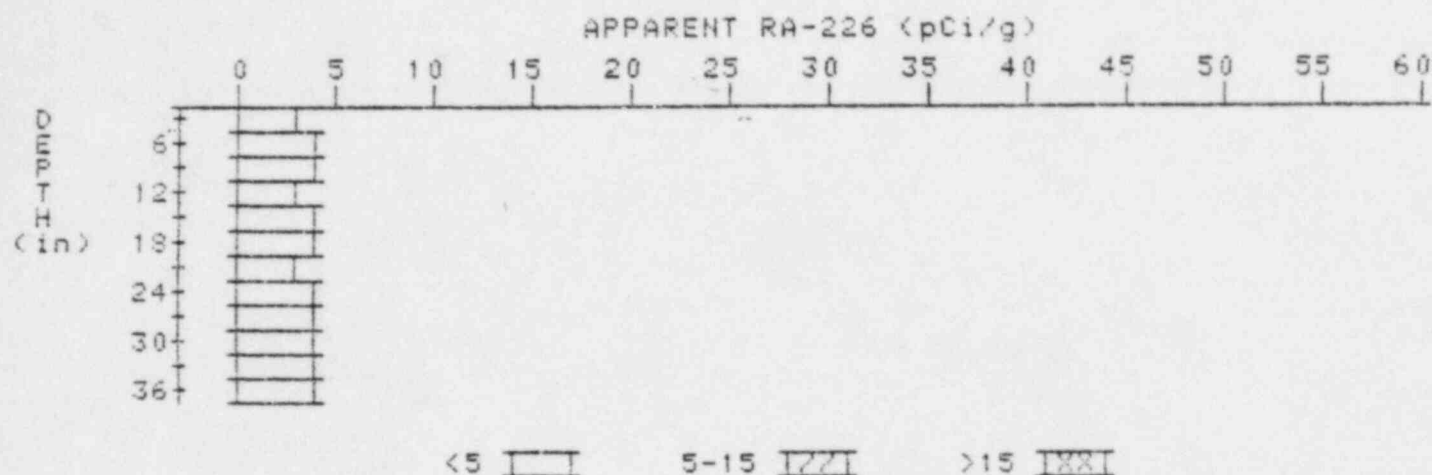
HOLE NUMBER: 11

Depth (in)	Apparent Radium-226 (pCi/g) Undeconvolved	Apparent Radium-226 (pCi/g) Deconvolved
3	3.4	3.4
6	3.7	4.4
9	3.6	3.6
12	3.5	3.3
15	3.5	3.5
18	3.5	3.5
21	3.5	3.3
24	3.6	3.3
27	3.6	3.6
30	3.6	3.6
33	3.6	3.6
36	3.6	3.6

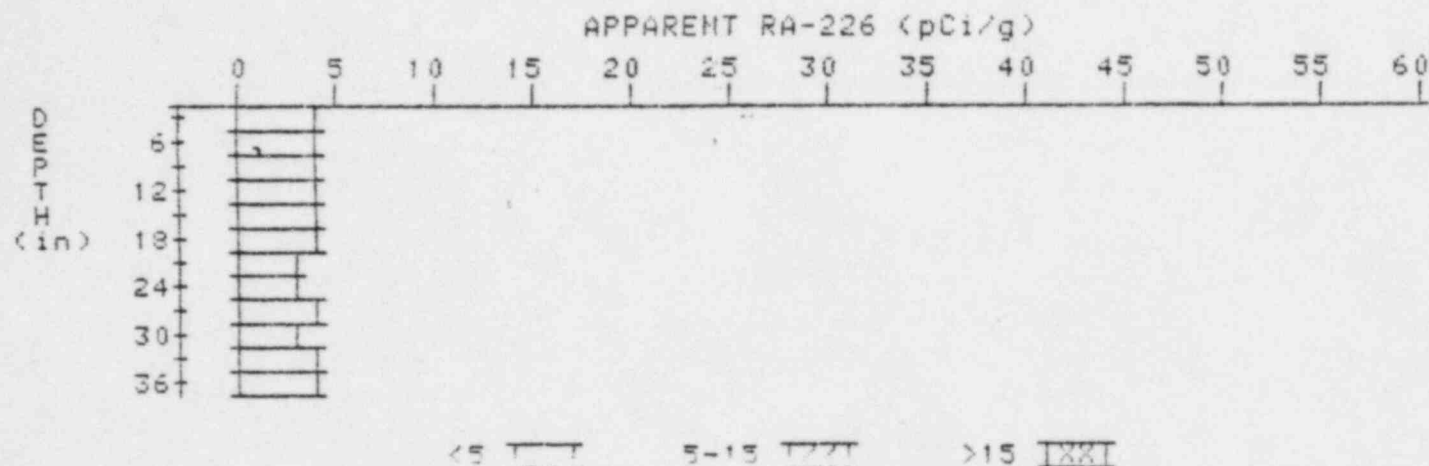
HOLE NUMBER: 13

Depth (in)	Apparent Radium-226 (pCi/g)	Apparent Radium-226 (pCi/g)
	Undeconvolved	Deconvolved
3	3.9	3.9
6	3.9	3.9
9	3.9	4.1
12	3.8	3.8
15	3.7	3.5
18	3.7	3.9
21	3.6	3.4
24	3.6	3.4
27	3.7	4.1
30	3.6	3.4
33	3.6	3.6
36	3.6	3.6

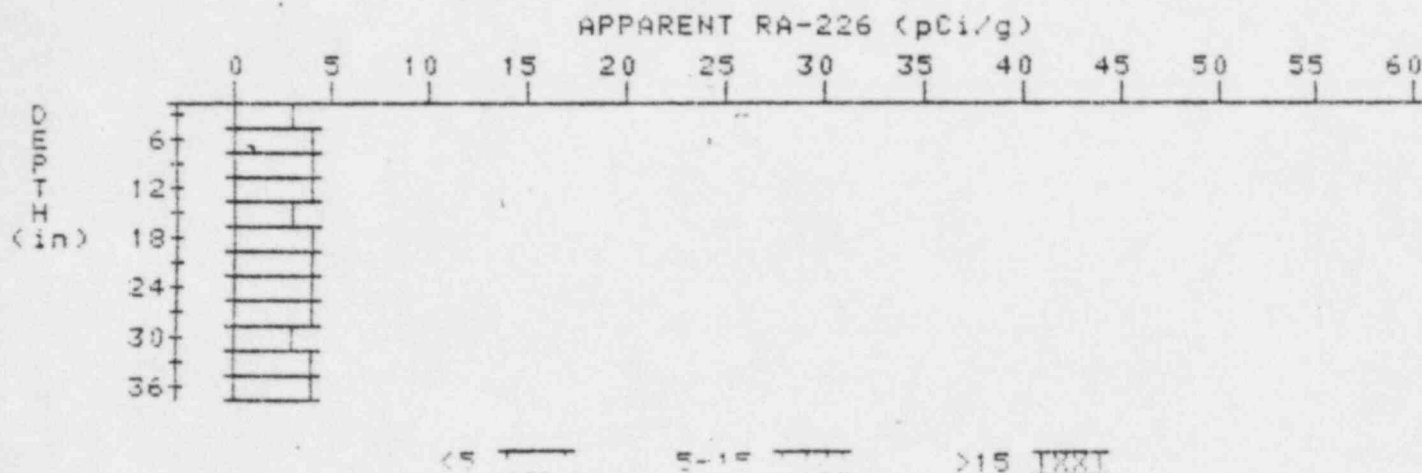
PROPERTY NUMBER: GJ-11549-MR
HOLE NUMBER: 14
LOCATION: 170200

Depth (in)	Apparent Radium-226 (pCi/g) Undeconvolved	Apparent Radium-226 (pCi/g) Deconvolved
3	3.0	3.0
6	3.5	4.2
9	3.6	3.6
12	3.7	4.1
15	3.6	3.2
18	3.7	3.9
21	3.7	3.7
24	3.7	3.7
27	3.7	3.9
30	3.6	3.4
33	3.6	3.8
36	3.5	3.5
