RADIOLOGIC AND ENGINEERING ASSESSMENT

DOE ID NO.: GJ-01007-RS
ADDRESS: 2512 TEXAS AVENUE

AUGUST 1985

BENDIX FIELD ENGINEERING CORPORATION
F.O. Box 1569
Grand Junction, Colorado 81502

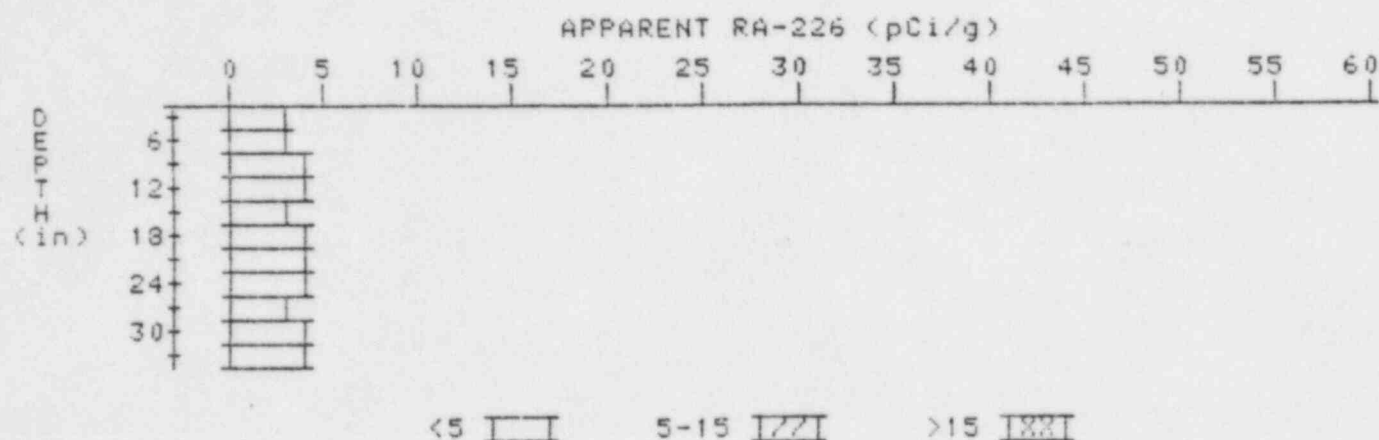
HOLE NUMBER: 4

LOCATION: 170230

Depth (in)	Apparent Radium-226 (pCi/g) Undeconvolved	Apparent Radium-226 (pCi/g) Deconvolved
3	3.3	3.3
6	3.4	3.2
9	3.6	4.0
12	3.6	3.8
15	3.5	3.3
18	3.5	3.5
21	3.5	3.5
24	3.5	3.7
27	3.4	3.0
30	3.5	3.5
33	3.6	3.6

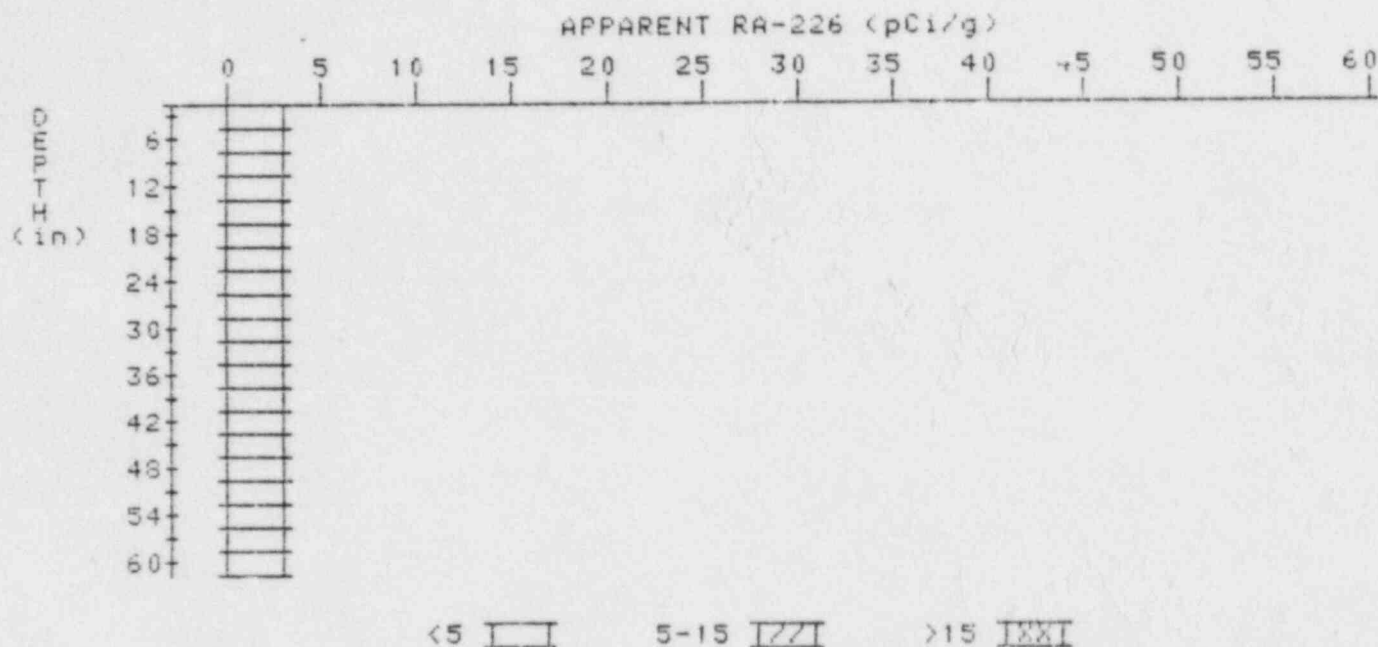
HOLE NUMBER: 5

LOCATION: 191220

Depth (in)	Apparent Radium-226 (pCi/g) Undeconvolved	Apparent Radium-226 (pCi/g) Deconvolved
3	2.7	2.7
6	2.9	3.1
9	3.0	3.2
12	3.0	3.0
15	3.0	3.0
18	3.0	3.0
21	3.0	3.0
24	3.0	3.2
27	2.9	2.5
30	3.0	3.2
33	3.0	3.2
36	2.9	2.5
39	3.0	3.4
42	2.9	2.7
45	2.9	2.7
48	3.0	3.4
51	2.9	2.9
54	2.8	2.6

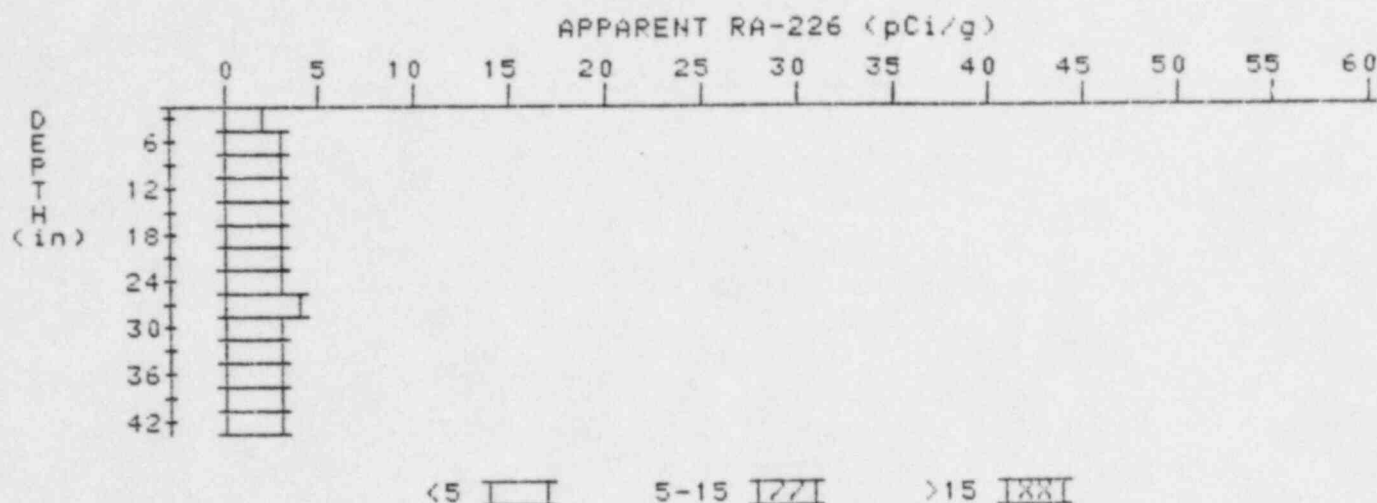
PROPERTY NUMBER: GJ-01007-RS
HOLE NUMBER: 11
LOCATION: 220214

Depth (in)	Apparent Radium-226 (pCi/g) Undeconvolved	Apparent Radium-226 (pCi/g) Deconvolved
3	2.4	2.4
6	2.7	2.7
9	3.0	3.4
12	3.1	3.5
15	3.0	2.6
18	3.1	3.3
21	3.1	3.1
24	3.1	2.9
27	3.2	3.6
30	3.1	2.7
33	3.2	3.4
36	3.2	3.4
39	3.1	2.9
42	3.1	3.1

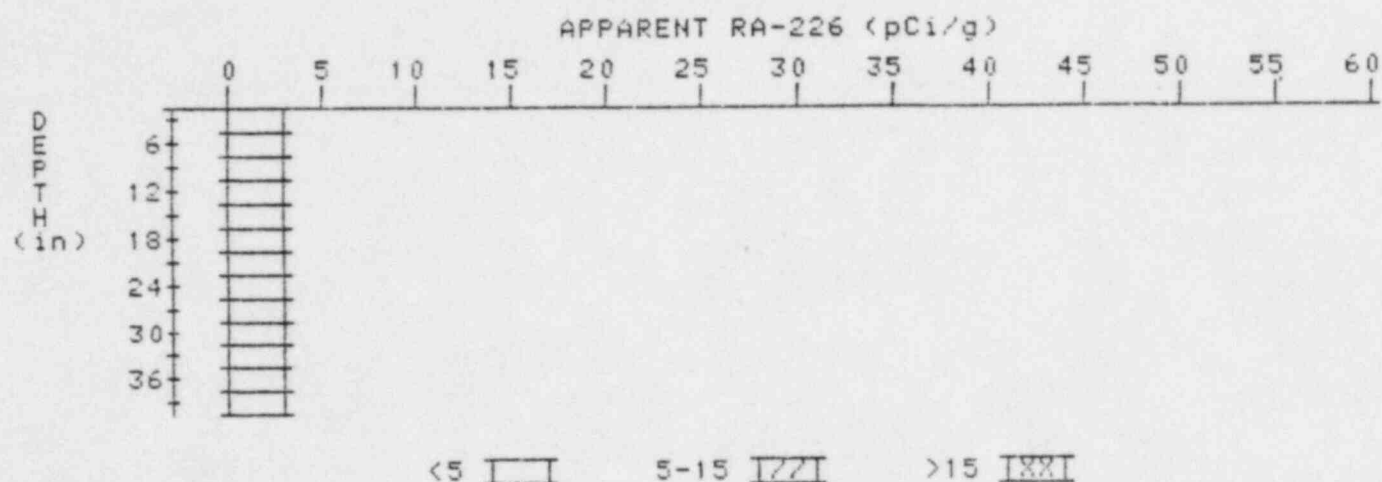
PROPERTY NUMBER: GJ-01007-RS
HOLE NUMBER: 16
LOCATION: 235265

Depth (in)	Apparent Radium-226 (pCi/g) Undeconvolved	Apparent Radium-226 (pCi/g) Deconvolved
3	2.8	2.8
6	2.9	2.9
9	3.0	3.0
12	3.1	3.3
15	3.1	3.1
18	3.1	3.1
21	3.1	3.1
24	3.1	3.1
27	3.1	3.1
30	3.1	3.1
33	3.1	3.1
36	3.1	3.3
39	3.0	3.0

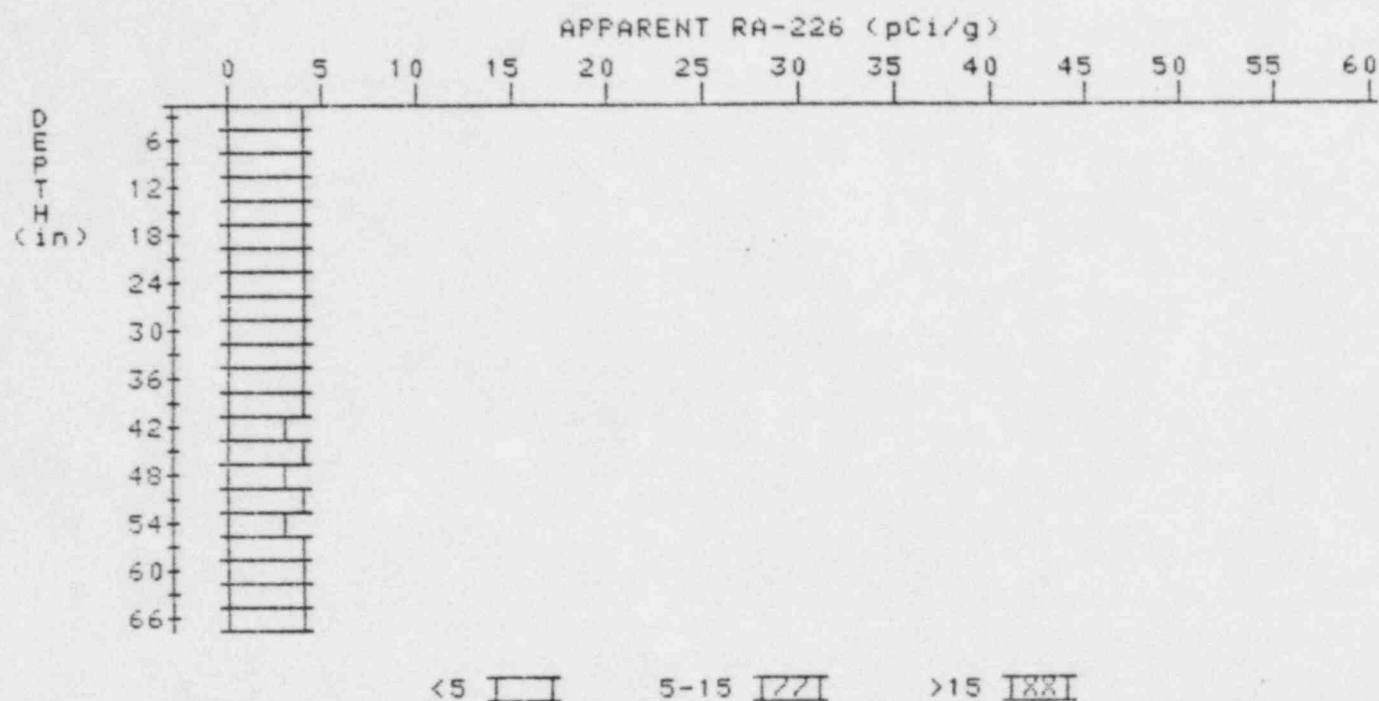
HOLE NUMBER: 19

Loc #	Grid Location	Depth (in.)	Meas. Type	In Situ Ra-226 (pCi/g)		Chem Ra-226 (pCi/g)	Comments
				Tot. Ct	Spectr.		
19	242220	00	DS	1.4		*	Water line
		03	TC	3.5		*	South foundation
		06	TC	3.8		*	
		09	TC	3.9		*	DC = 0 inches
		12	TC	4.0		*	
		15	TC	3.9		*	
		18	TC	3.9		*	
		21	TC	3.9		*	
		24	TC	4.0		*	
		27	TC	3.9		*	
		30	TC	3.9		*	
		33	TC	3.8		*	
		36	TC	3.8		*	
		39	TC	3.7		*	
		42	TC	3.7		*	
		45	TC	3.9		*	
		48	TC	3.8		*	
		51	TC	3.9		*	
		54	TC	3.8		*	
		57	TC	3.9		*	
		60	TC	3.9		*	
		63	TC	4.1		*	
		66	TC	4.2		*

LOCATION: 242220

Depth (in)	Apparent Radium-226 (pCi/g) Undeconvolved	Apparent Radium-226 (pCi/g) Deconvolved
3	3.5	3.5
6	3.8	4.2
9	3.9	3.9
12	4.0	4.4
15	3.9	3.7
18	3.9	3.9
21	3.9	3.7
24	4.0	4.4
27	3.9	3.7
30	3.9	4.1
33	3.8	3.6
36	3.8	4.0
39	3.7	3.5
42	3.7	3.3
45	3.9	4.4
48	3.8	3.4
