ACCIDENT SEQUENCE PRECURSOR PROGRAM EVENT ANALYSIS

LER Number: 293/90-013
 Event Description: Scram with RCIC failure; feedwater, HPCI, and RHR problems
 Event Date: September 2, 1990
 Plant: Pilgrim

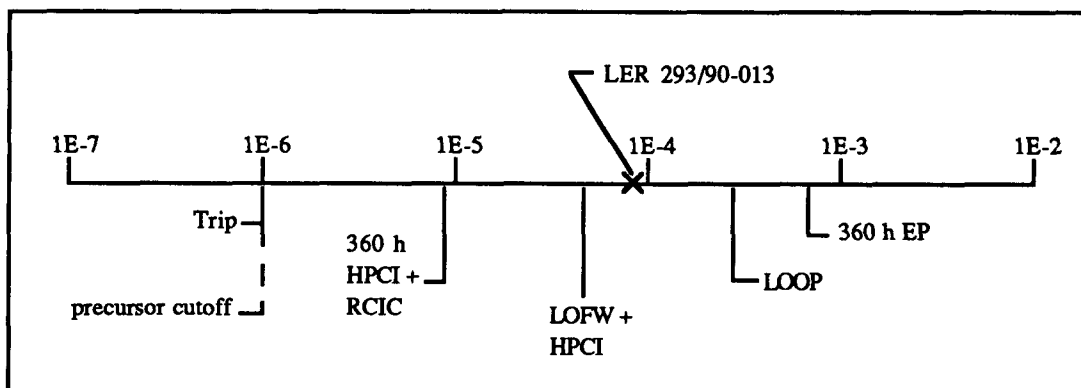
The conditional core damage probability estimated for this event is 8.4×10^{-5} . The relative significance of this event compared to other postulated events at Pilgrim is shown below:
