TOLEDO EDISON COMPANY
DAVIS-BESSE NUCLEAR POWER STATION
COURSE OF ACTION REPORT

SEPTEMBER 9, 1985

September 9, 1985

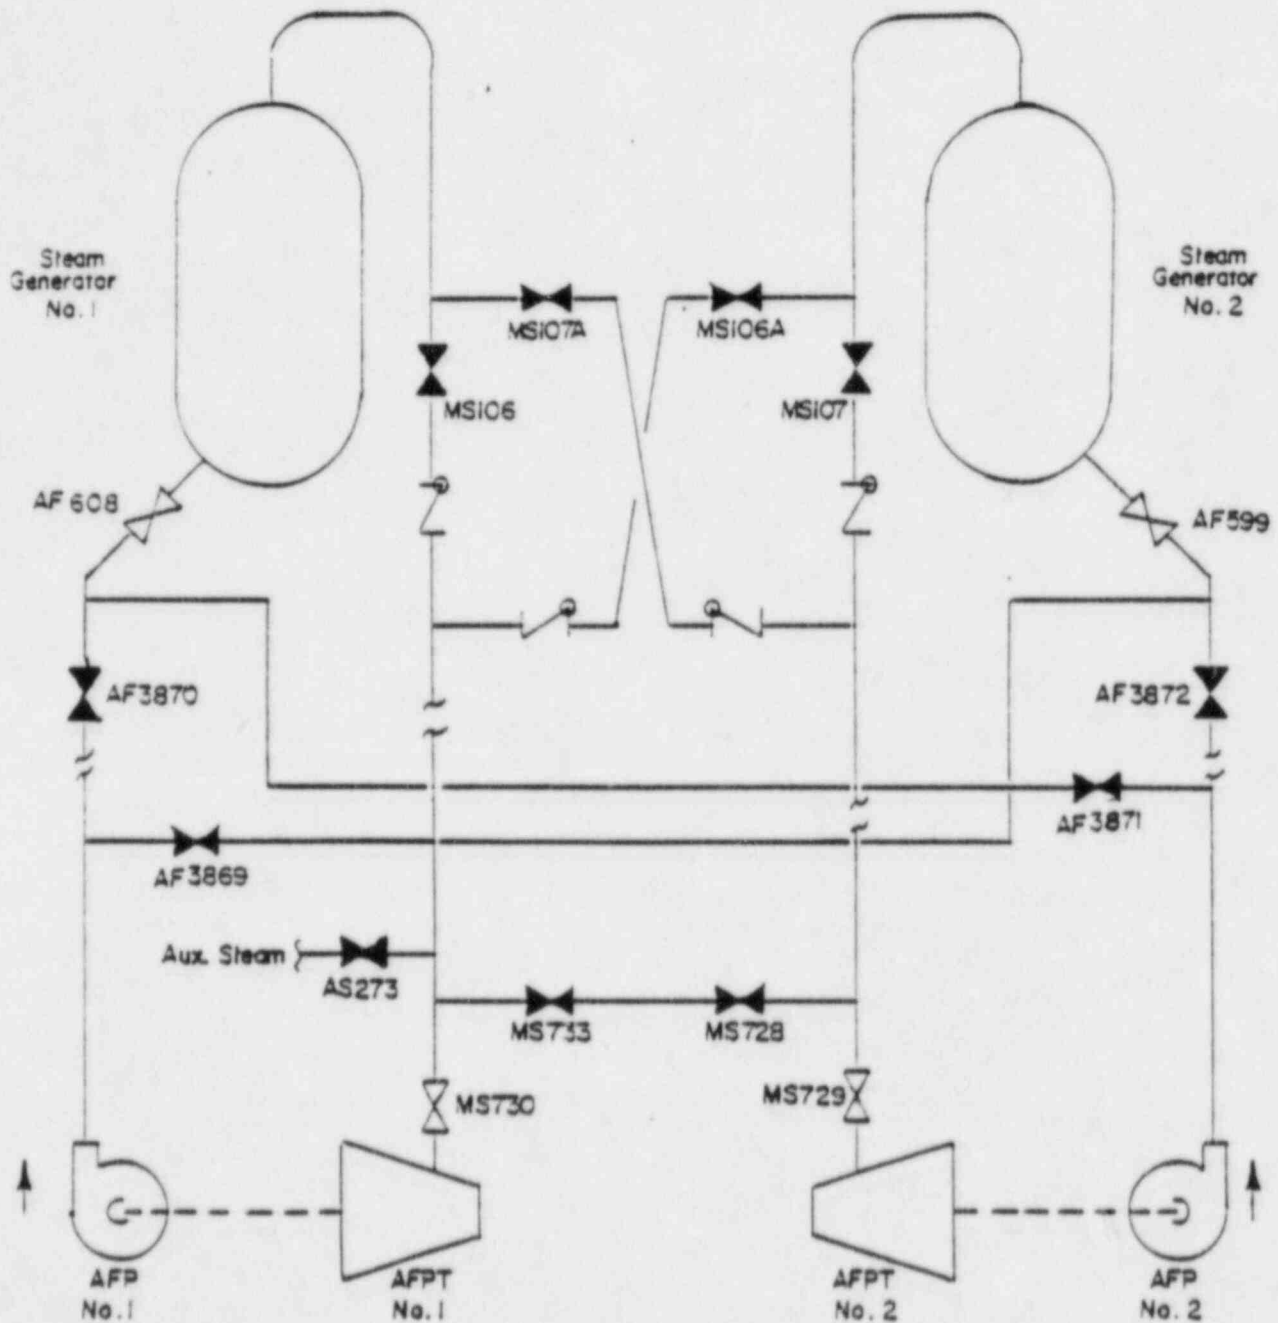
Figure 1

SCHEMATIC REPRESENTATION OF
AUXILIARY FEED PUMP TURBINE STEAM PIPING SYSTEM

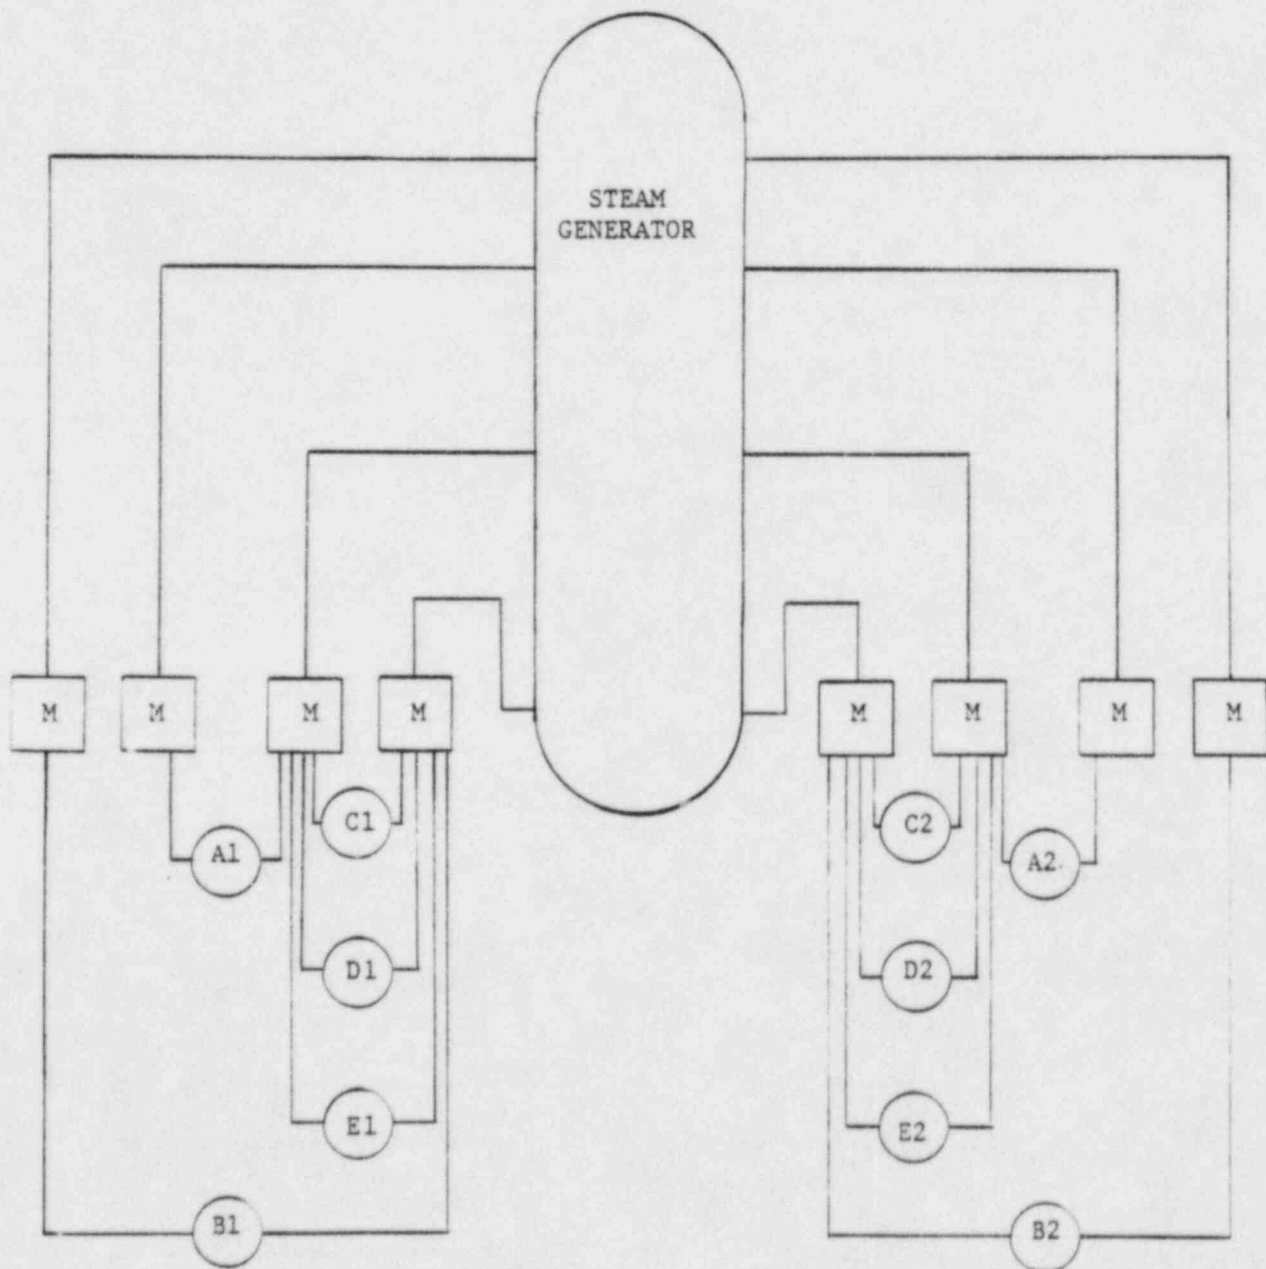
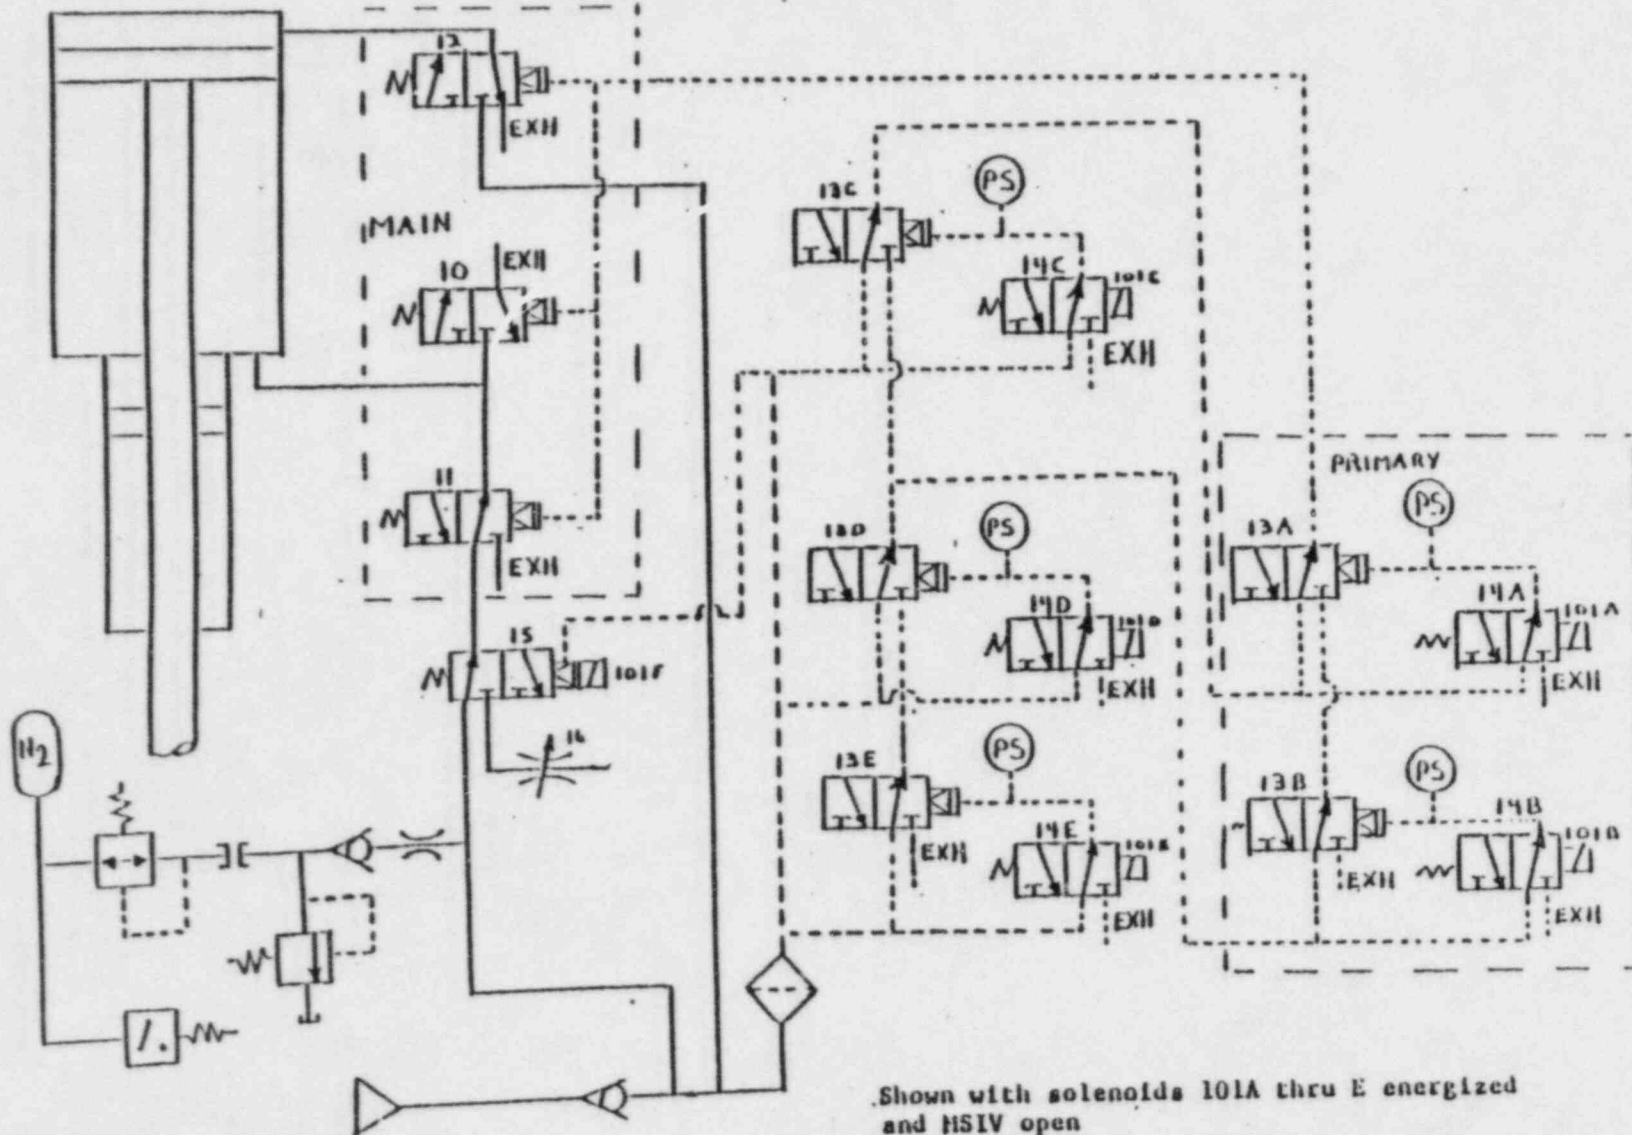
Figure 2

The MSIVs are air operated, balanced-disk stop valves. A spring actuator is provided for rapid closure of the valves. The valves are held open by air operators. A nitrogen accumulator is provided for each valve in case of loss of plant air. The MSIVs are controlled using solenoid valves and pneumatic pilot valves which are configured as shown in attached Figure 2.

HSIV CONTROL AIR DIAGRAM

Shown with solenoids 101A thru E energized
and HSIV open

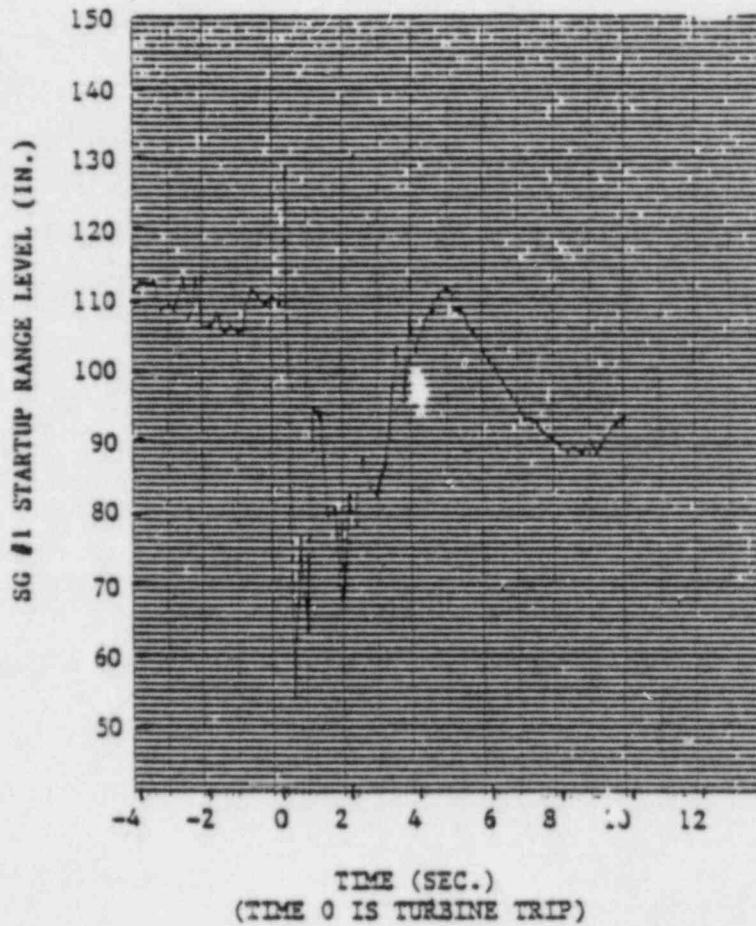
Figure 4

A review of past pre-operational testing at Davis-Besse has revealed oscillations in indicated startup range level following a turbine stop valve closure. Only one occasion was encountered when such data was recorded with high enough frequency to exhibit drastic oscillations in level transmitter output. This data was taken for a turbine trip from 75% full power and was logged every 200 milliseconds. The data showed that level transmitter output can change by as much as 60 inches following a turbine trip (see attached Figures 4 and 5). It is noted that this behavior is

DATA FROM 75% TURBINE TRIP TEST (TP 800.14)

APRIL 2, 1978 (DELOG INTERVAL 0.2 SEC.)

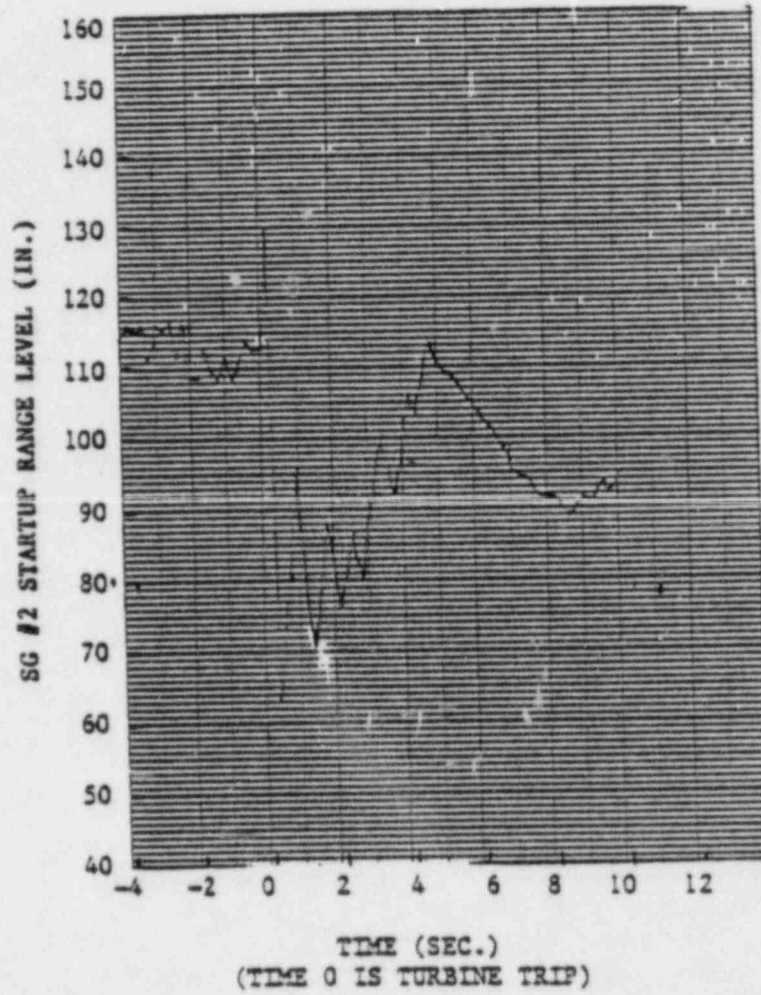
Figure 5

DATA FROM 75% TURBINE TRIP TEST

(TP 800.14) APRIL 2, 1978 (DELOG INTERVAL 0.2 SEC.)

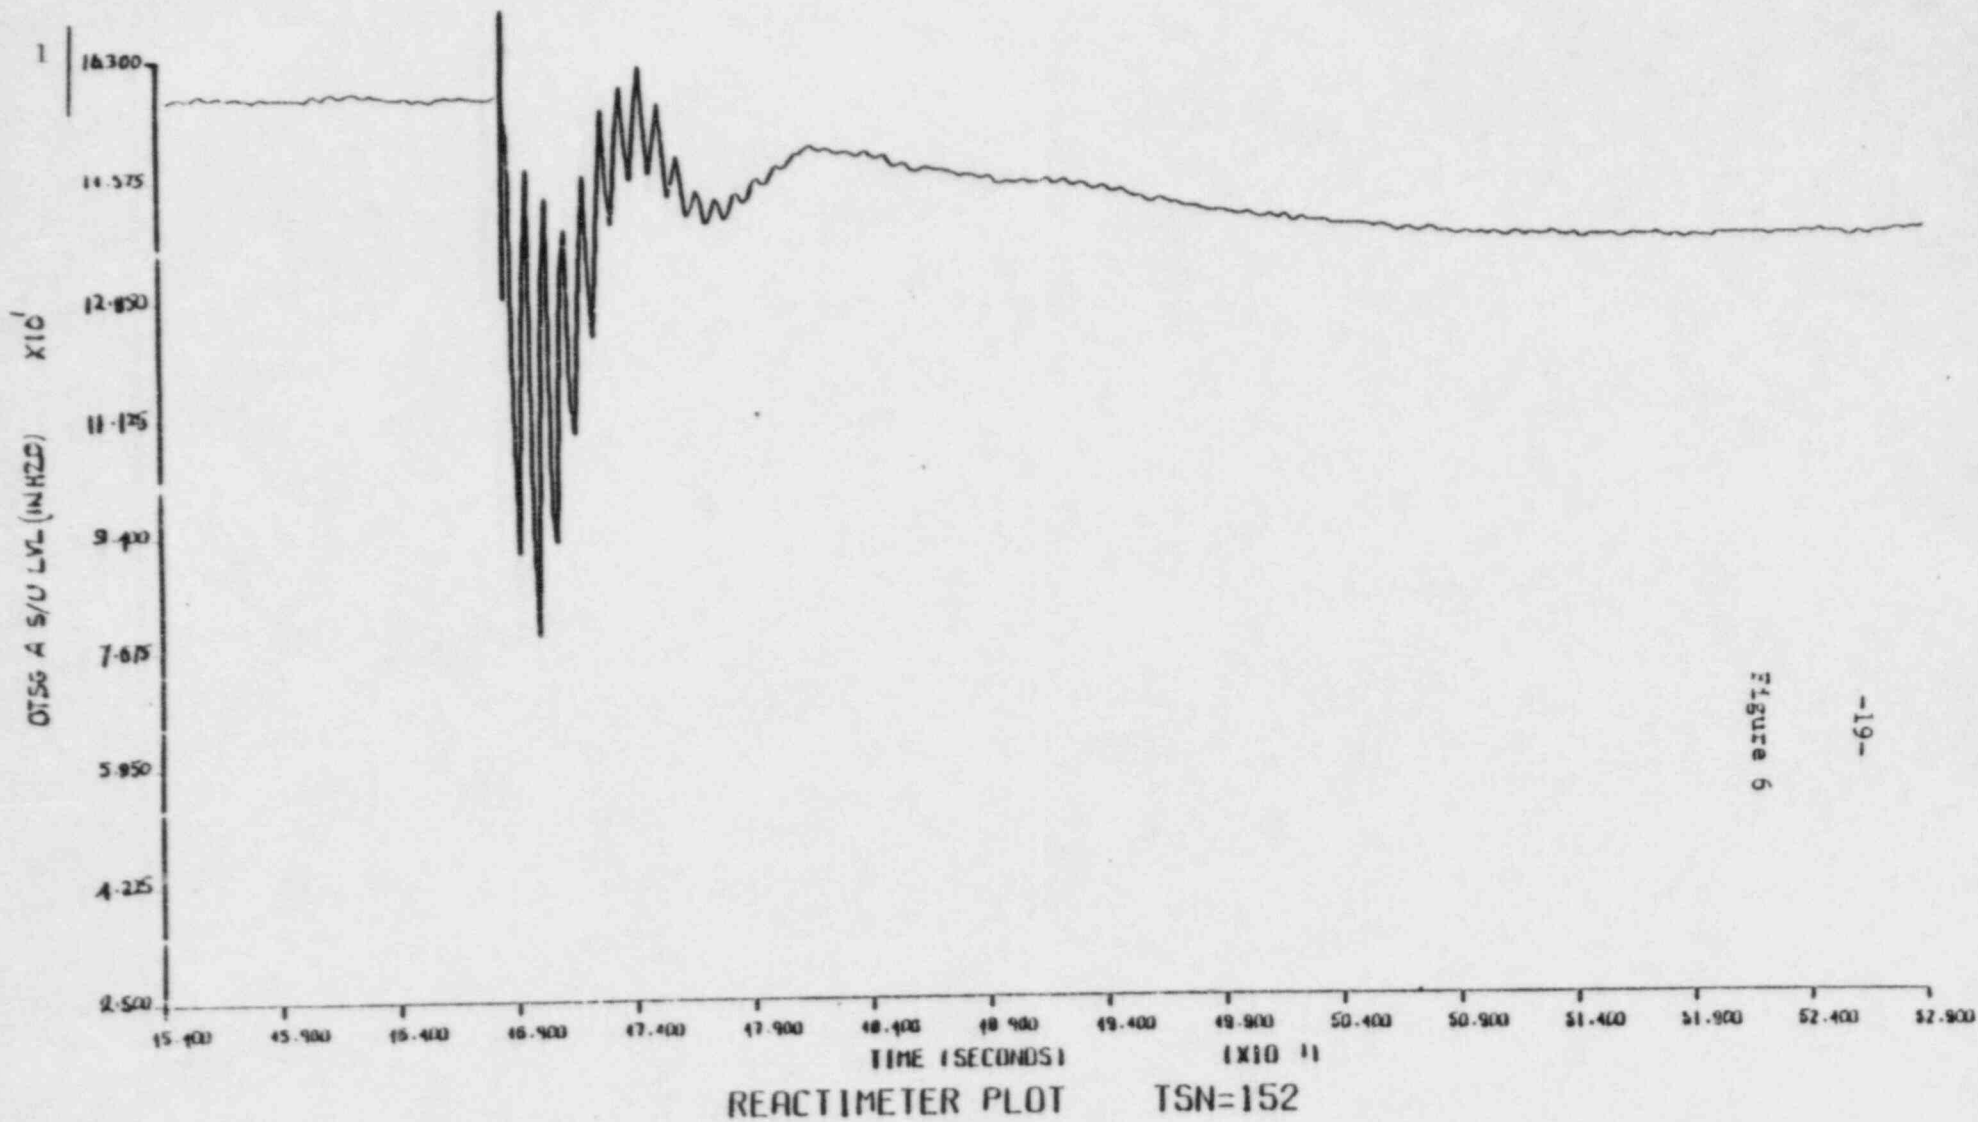
FIGURE - 6

A review of transient reports from three other units all reveal oscillatory behavior in the level transmitter output following reactor/turbine trips apparently due to pressure oscillations in the steam line following valve closure. This behavior is evident from the attached Figures 6 through 9. It is concluded from the above review that significant fluctuations in level transmitter output are expected to occur following a turbine trip or load rejection. These fluctuations can, therefore, result in spurious actions by control systems (e.g., SFRCS) which sense such oscillatory behavior. The frequency and magnitude of these oscillations has the potential of resulting in several momentary trips of the protection system.

STEAM GENERATOR STARTUP RANGE
LEVEL XMITTER RESPONSE
TURBINE TRIP TEST

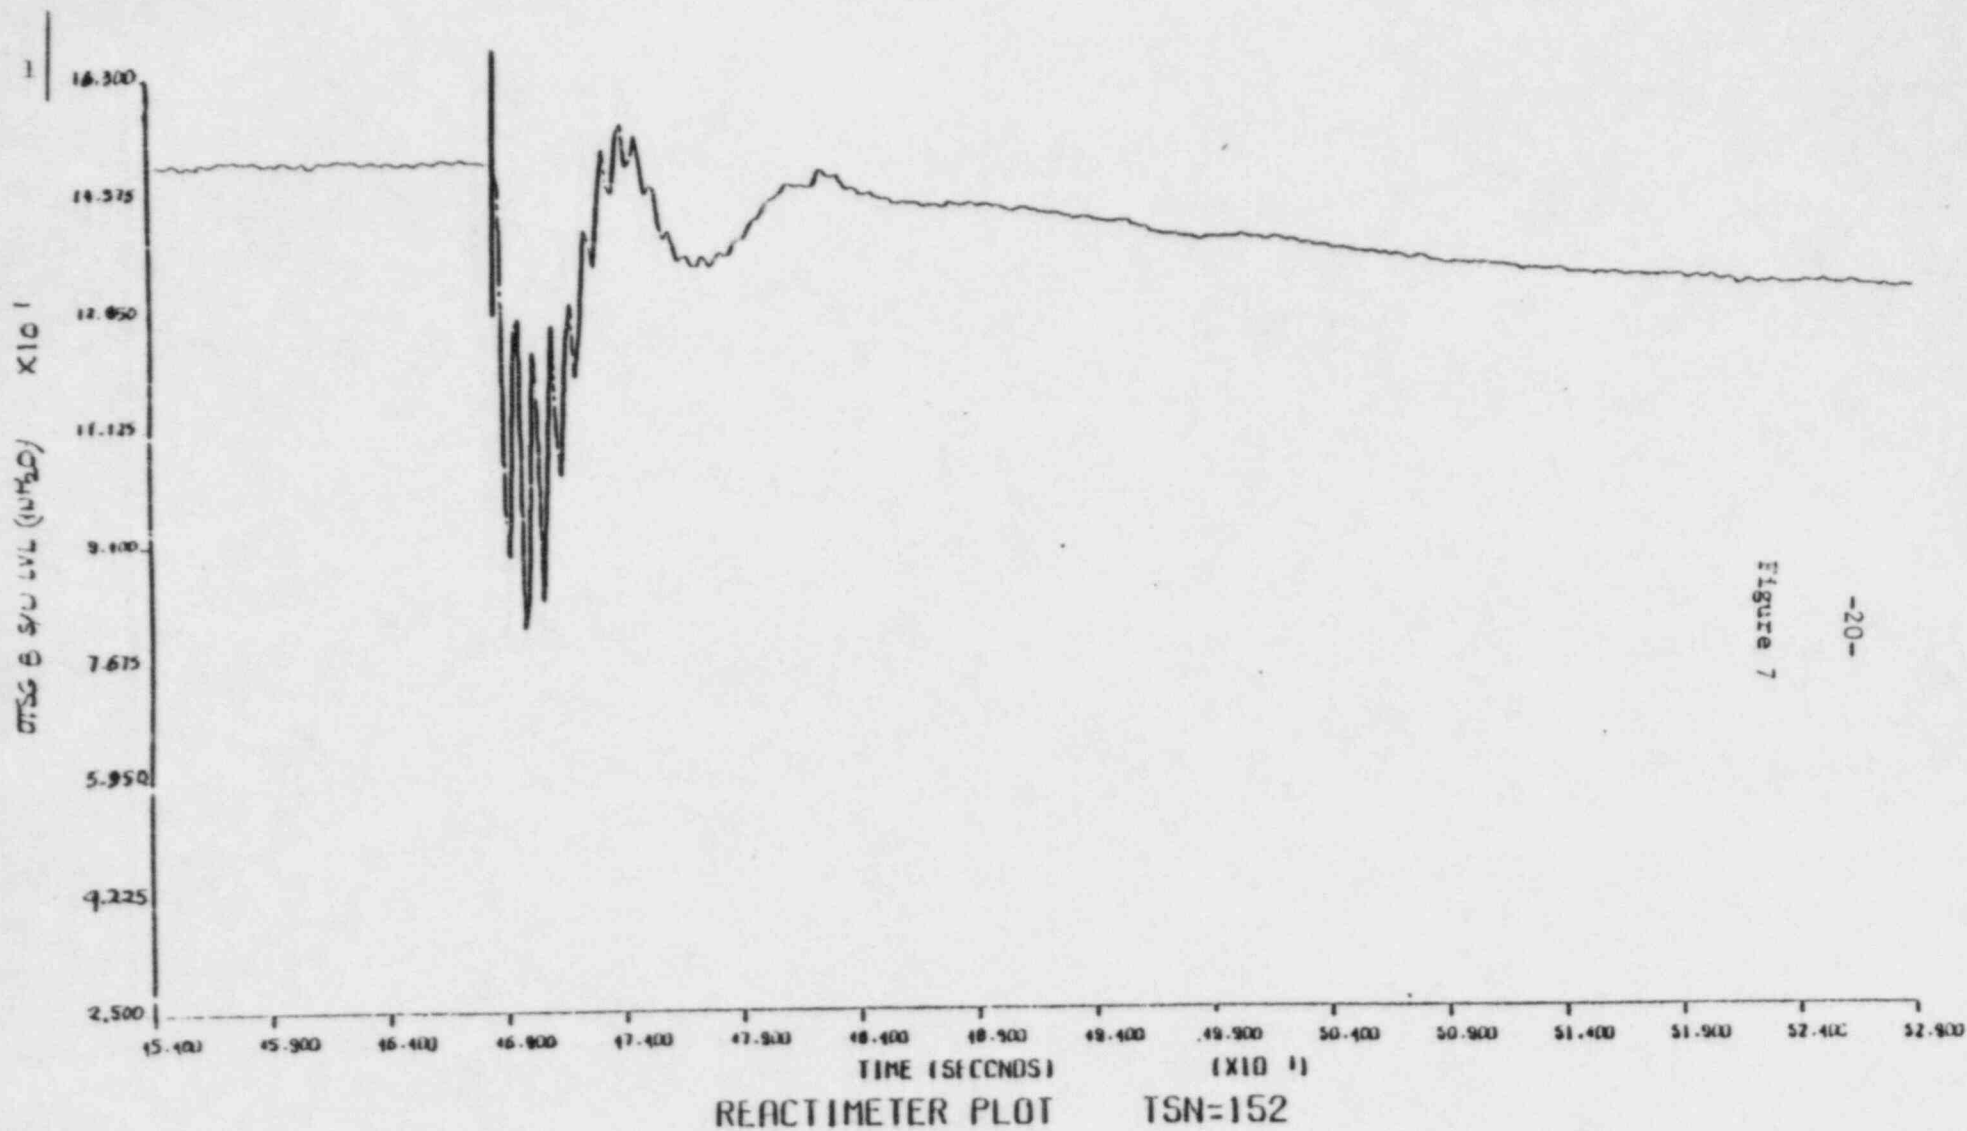
Figure 7

FIGURE -7
STEAM GENERATOR STARTUP
RANGE LEVEL XMITTER
RESPONSE TO
TURBINE TRIP TEST

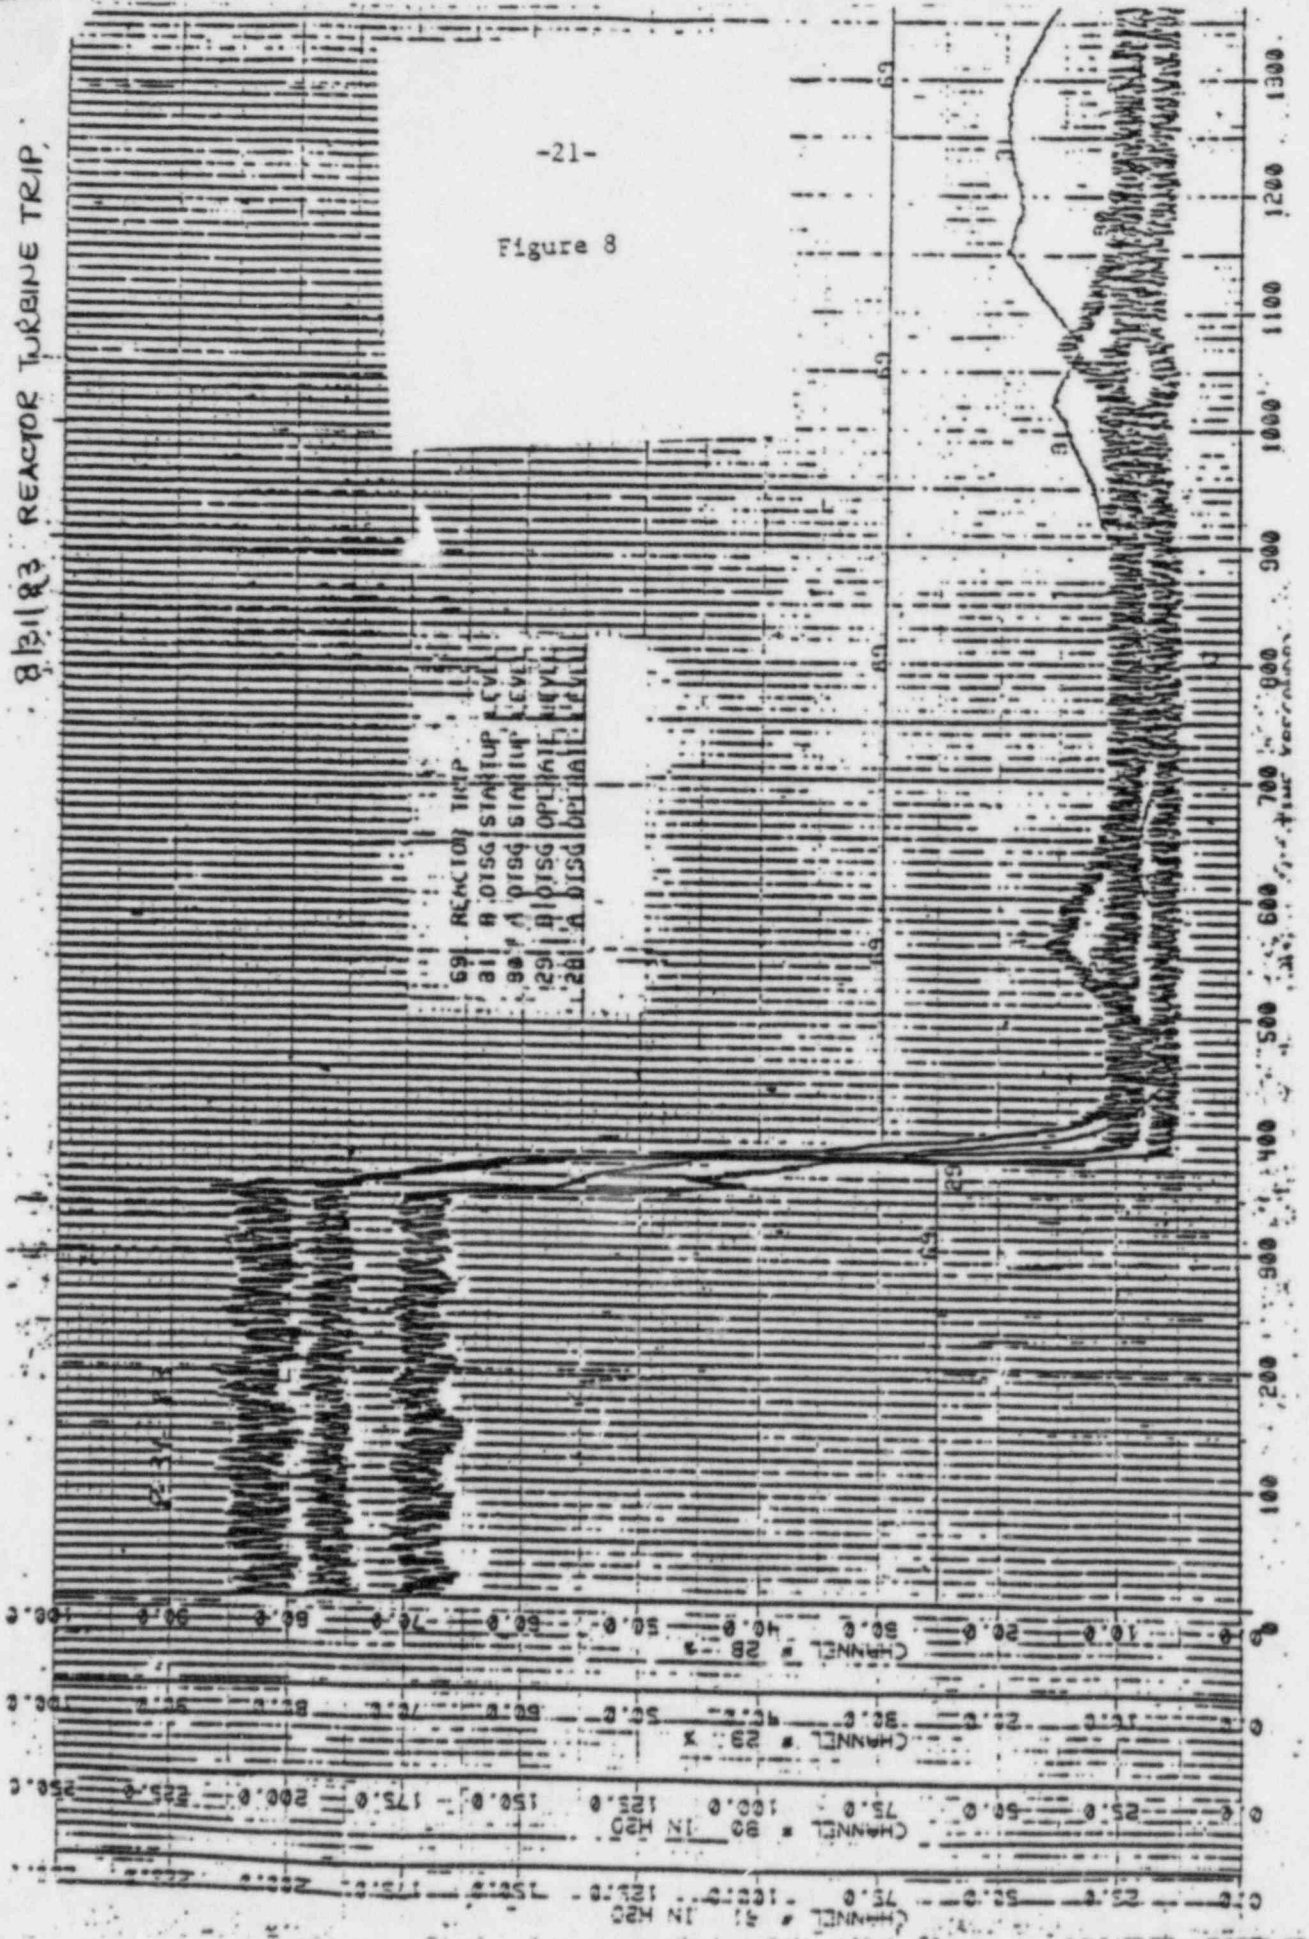
Figure 8

4/26/84 REACTOR TURBINE TRIP

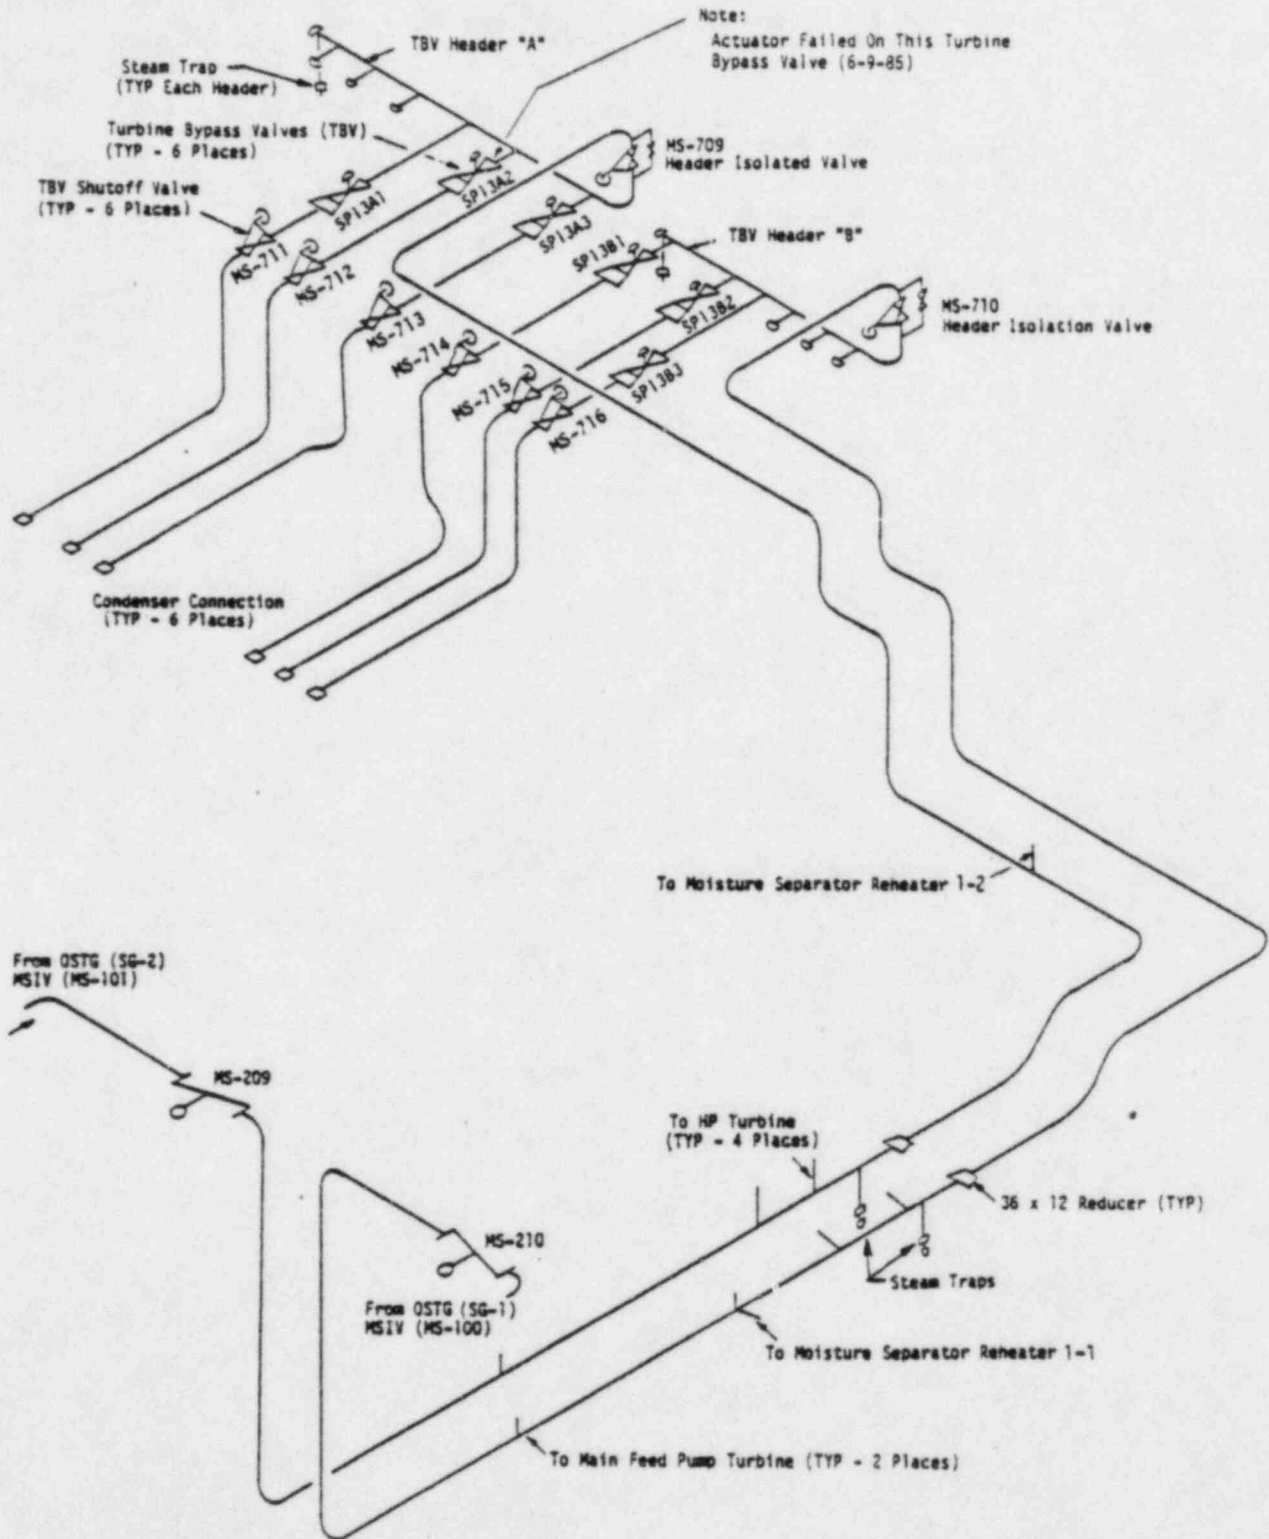
FIGURE 2

Condenser Nozzle
 *** Denotes Turbine Bypass Valve
 Whose Actuator Failed 6-9-85

DAVIS-BESSIE
MAIN STEAM PIPING AND TURBINE BYPASS VALVES
SIMPLIFIED SCHEMATIC

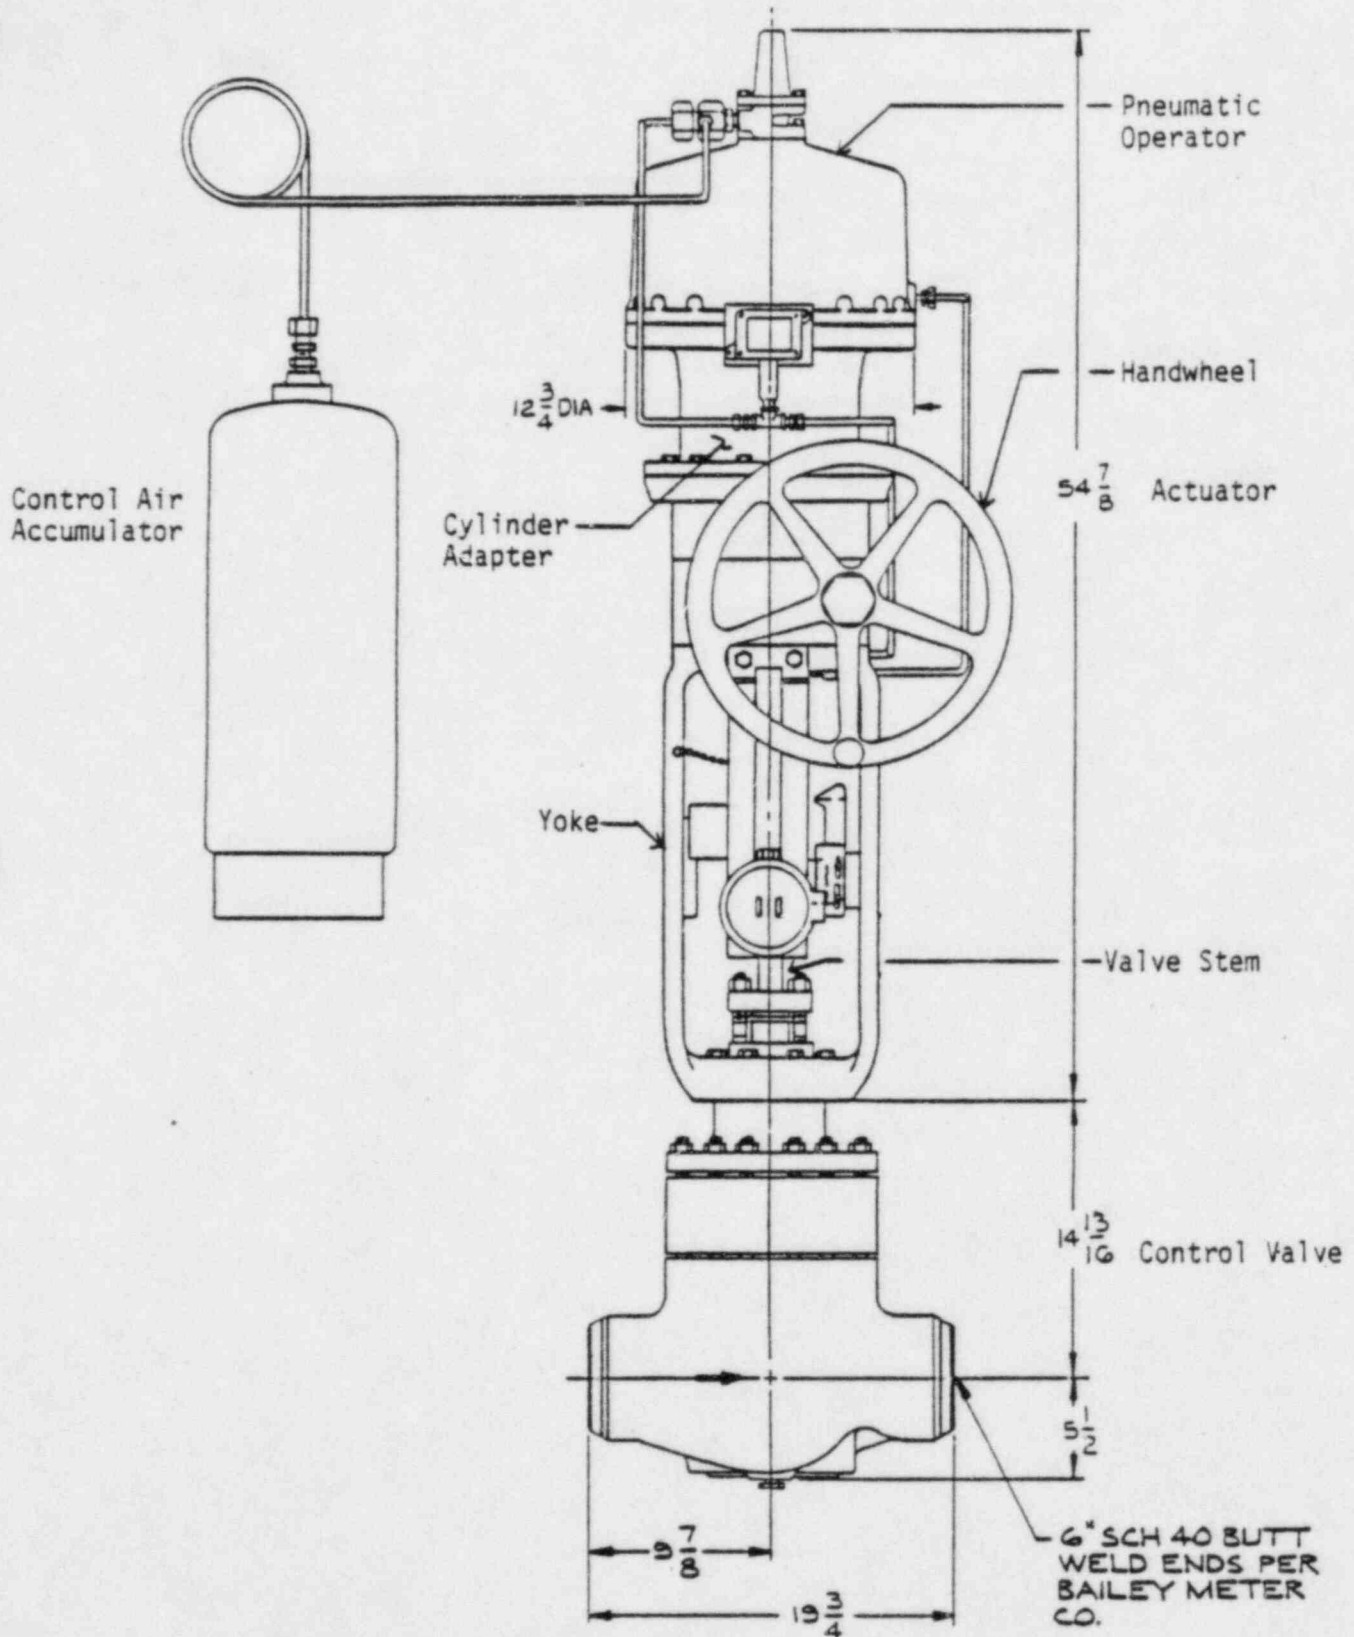
FIGURE 4

The turbine bypass valves are Fisher Controls Company 6-inch valves; Type VFJ454BX Style C060WX (see Figures 4 and 5). They are ANSI 600-S valves rated for a maximum shutoff pressure of 1065 psia at 600°F. They are single port, cage-guided globe valves with an internal pilot valve to assist in positive shutoff against full

DAVIS-BESSE TURBINE BYPASS VALVE AND ACTUATOR

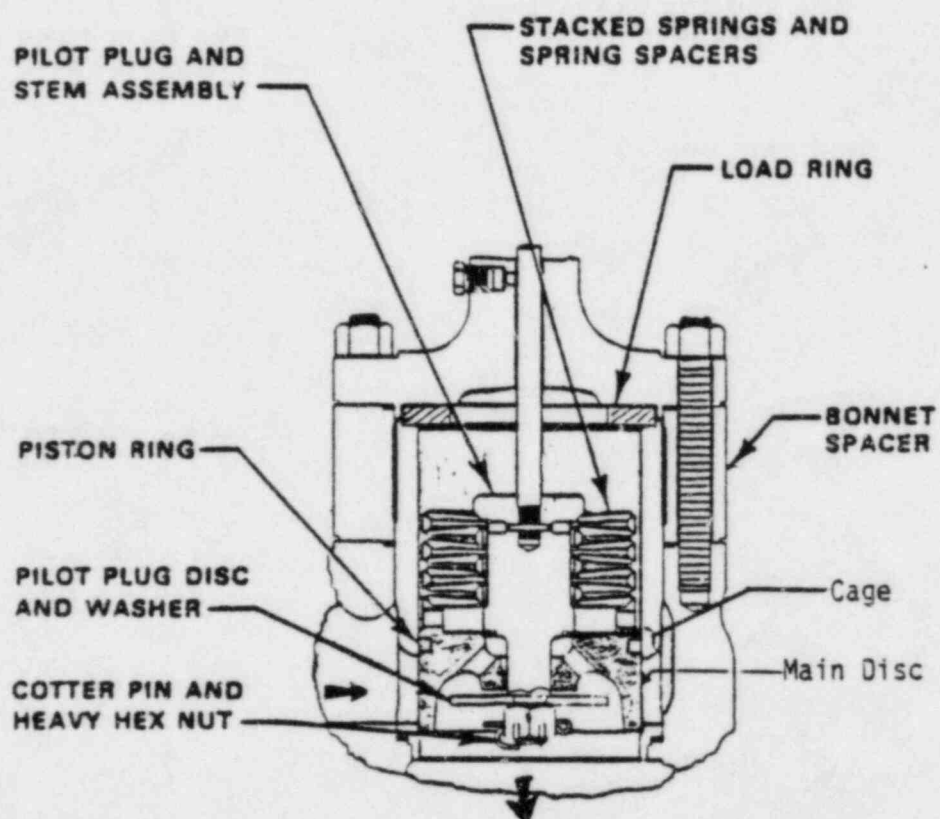
FIGURE 5
DAVIS-BESSE TURBINE BYPASS VALVE INTERNALS

DETAIL OF 8-INCH DESIGN EAP BODY WITH CLOSED
BELLEVILLE SPRING VALVE PLUG ASSEMBLY
