TOLEDO EDISON COMPANY
DAVIS-BESSE NUCLEAR POWER STATION
COURSE OF ACTION REPORT

SEPTEMBER 9, 1985

September 9, 1985

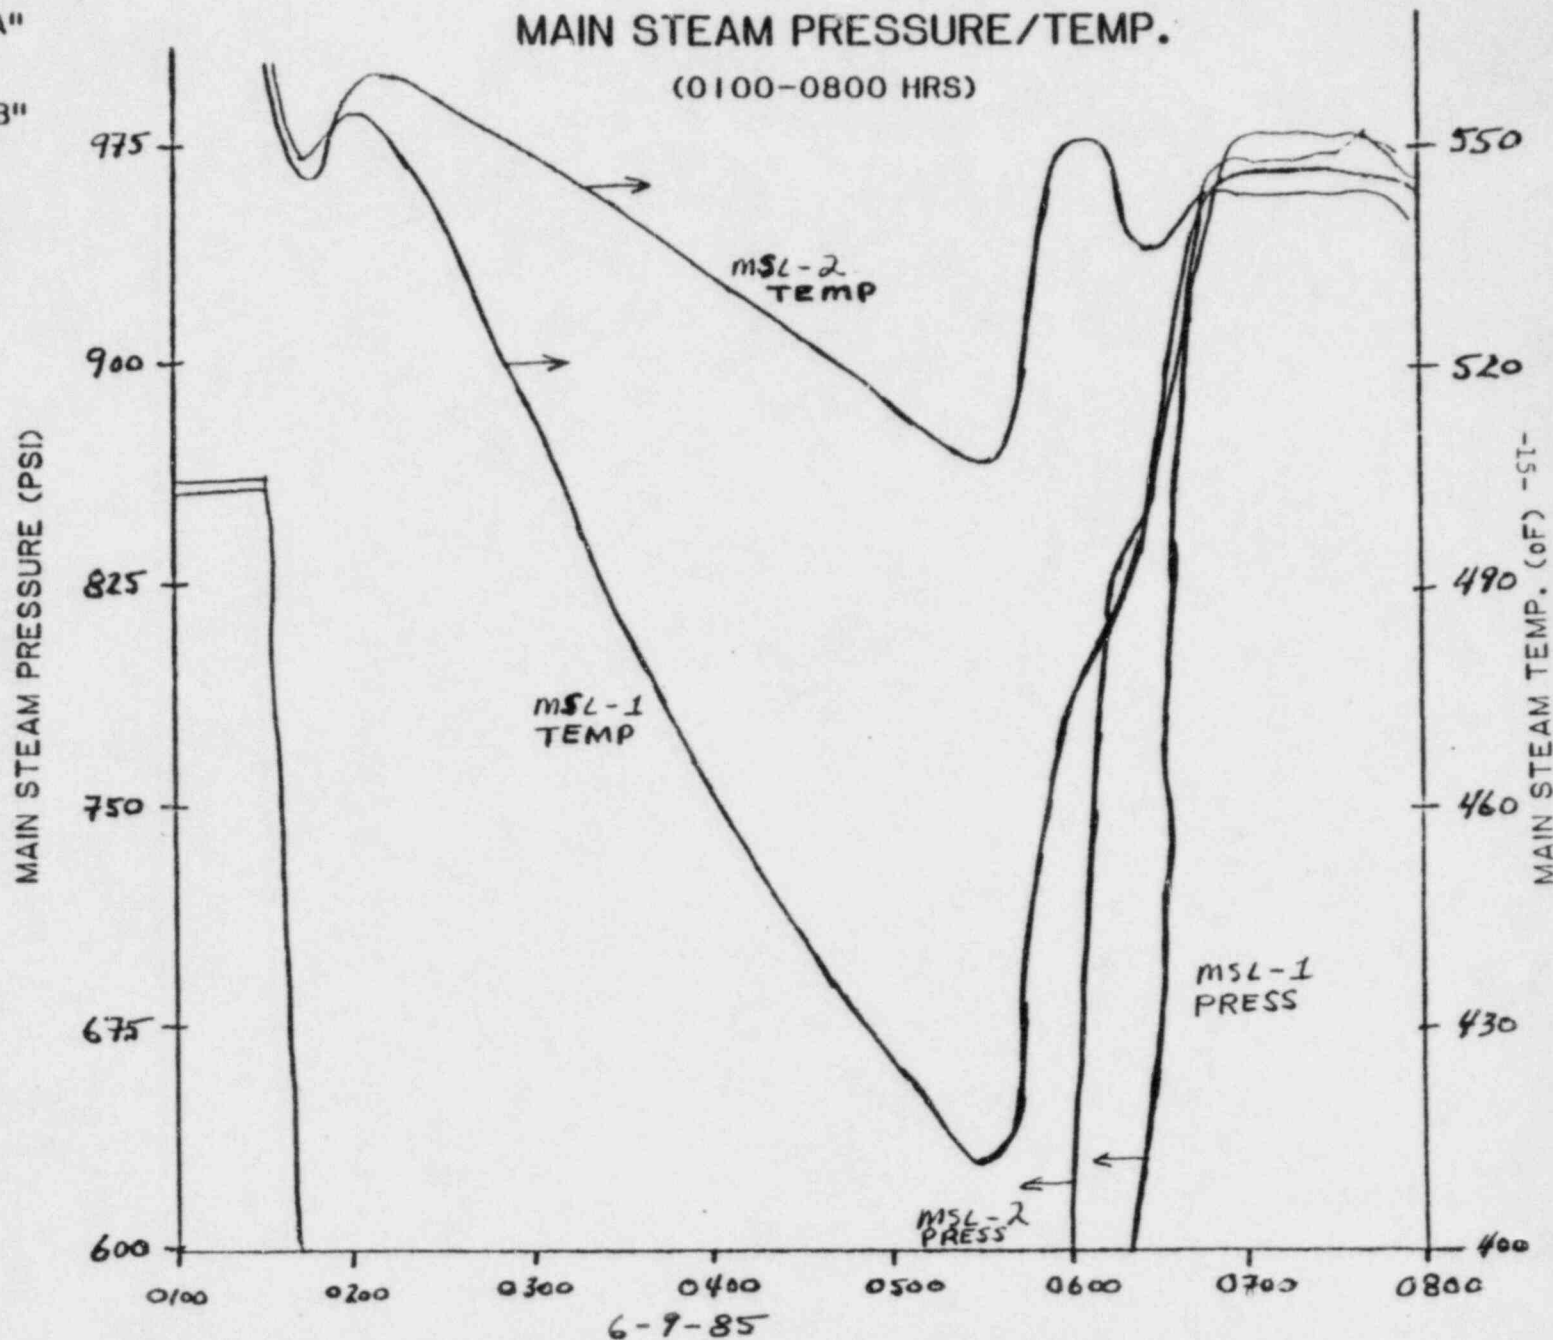
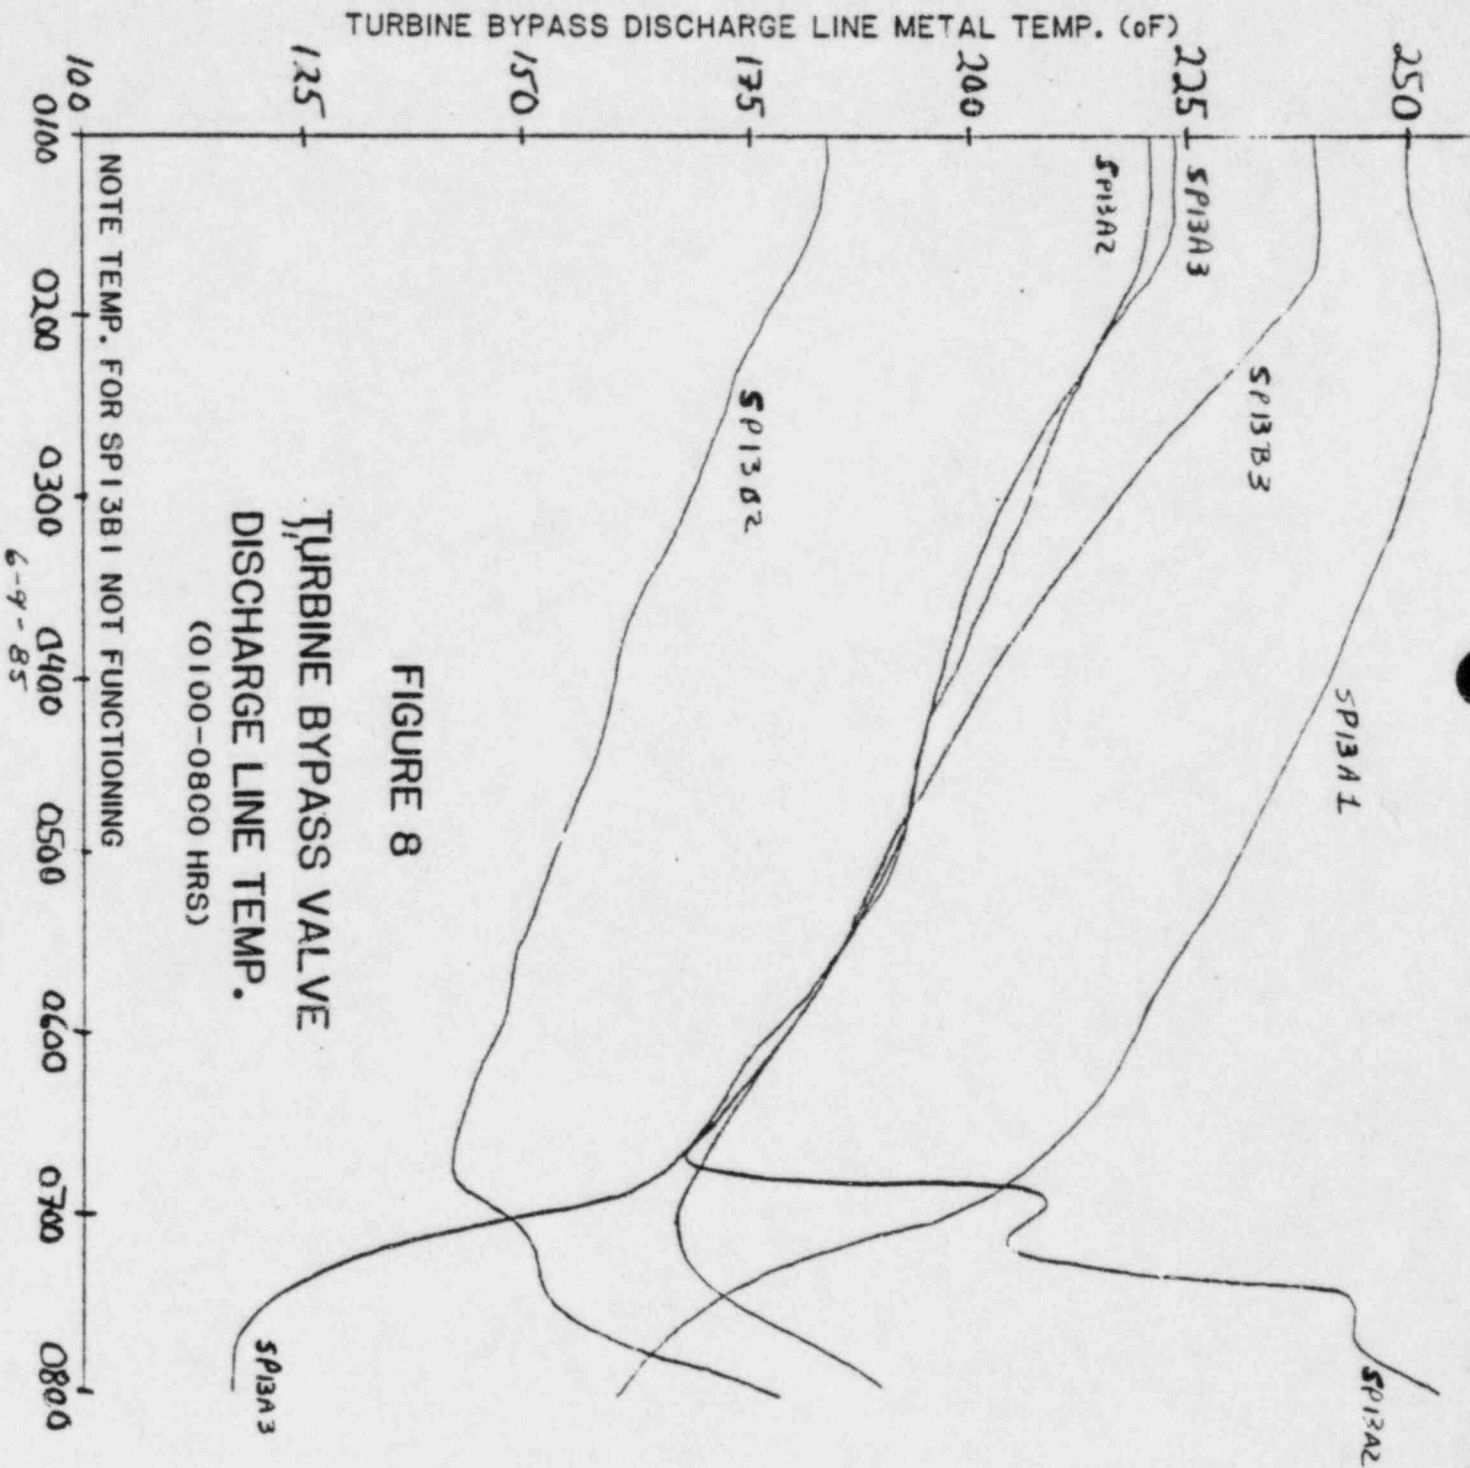
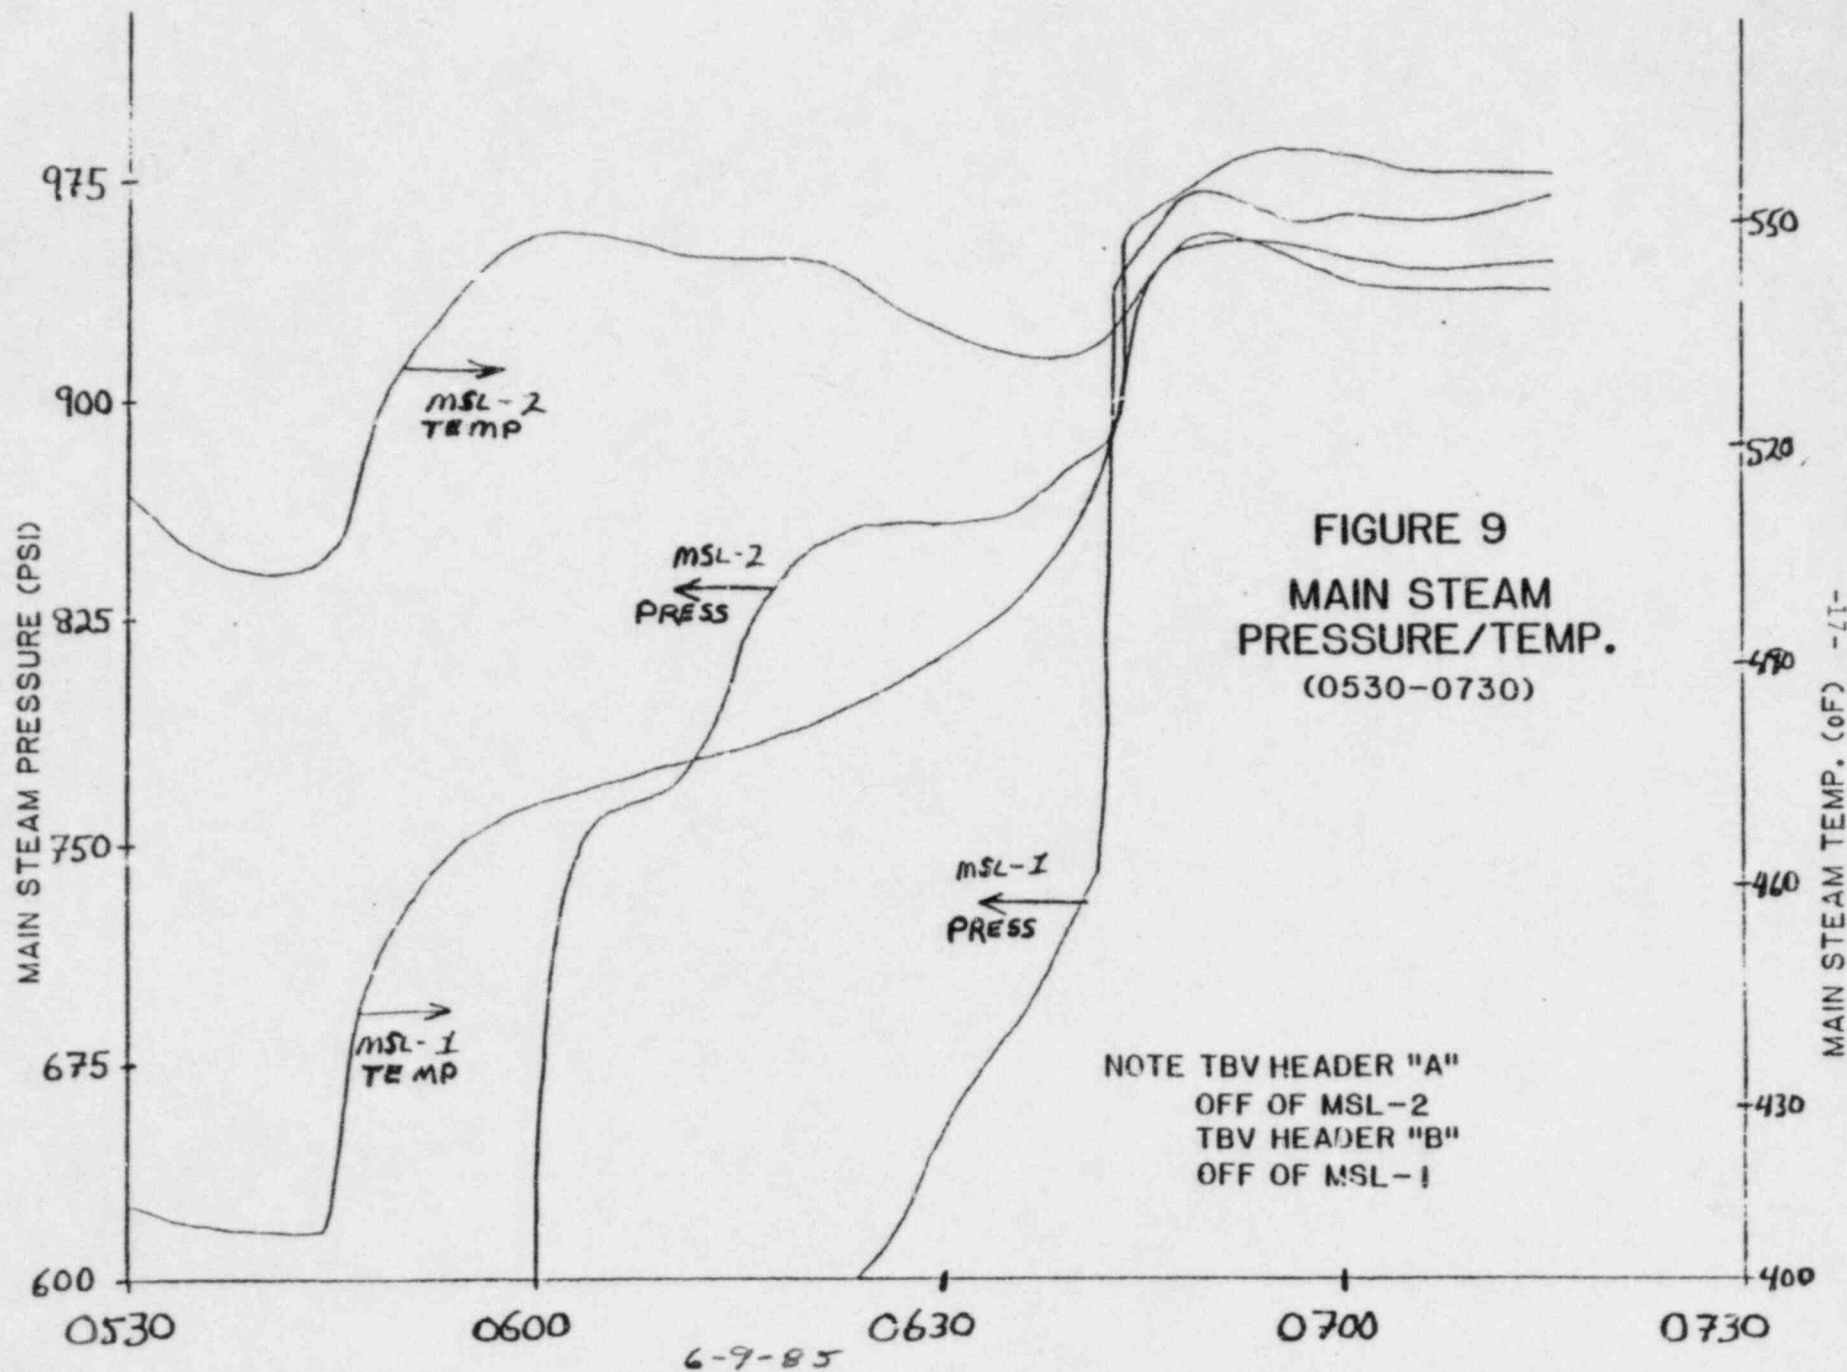
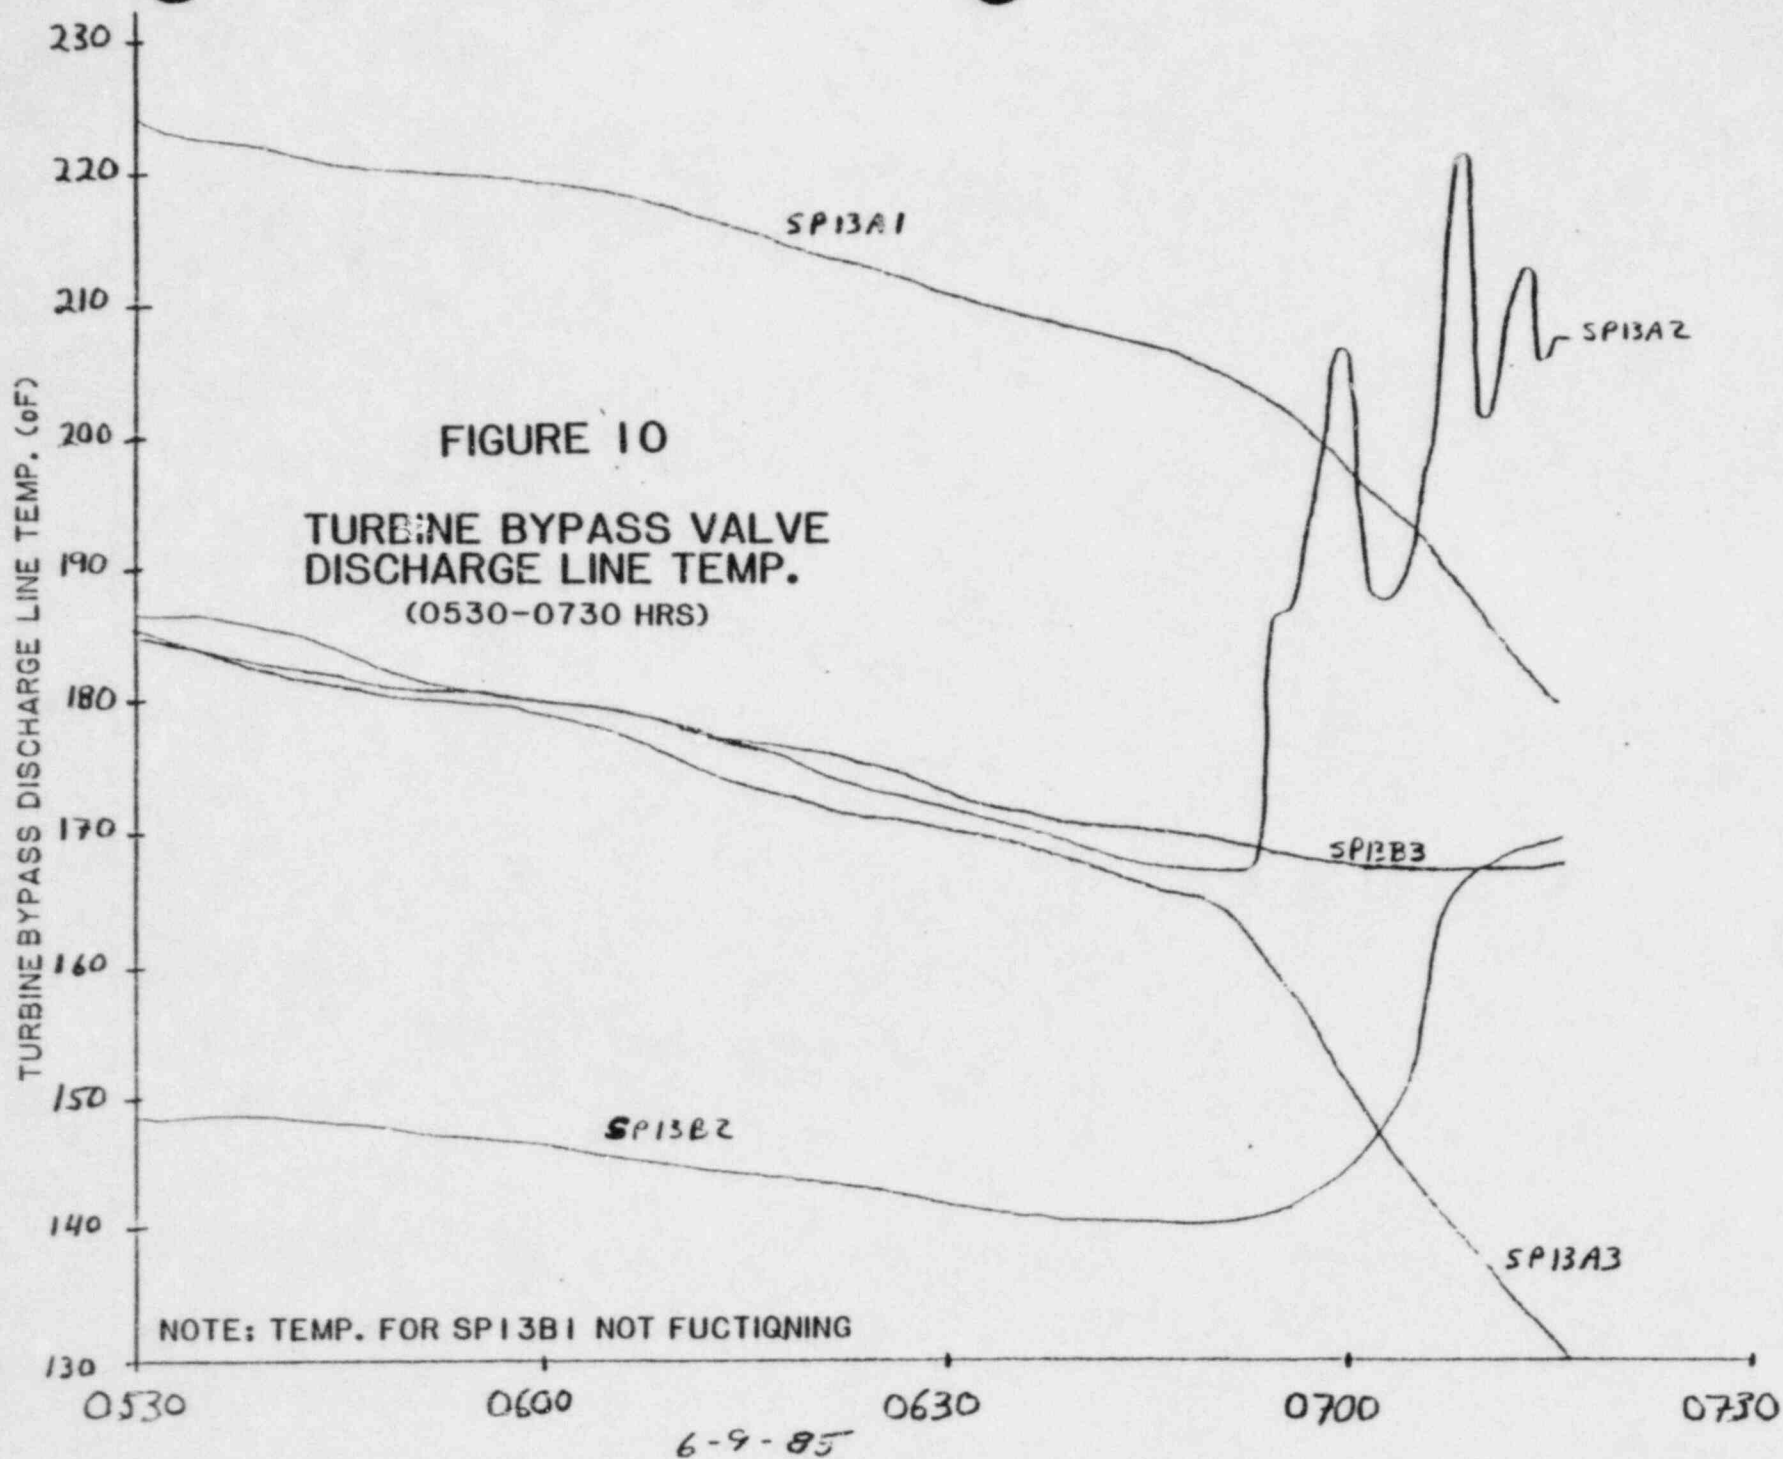
FIGURE 7

Plant instrument data for mainsteam pressure and temperature, and for turbine bypass valve discharge piping metal temperature, prior to the valve actuator failure, are shown in Figures 7 through 10.

MAIN STEAM PRESSURE/TEMP.
