Re: **St. Lucie Units 1 and 2**  
**Docket Nos. 50-335 and 50-389**  
**Special Report on Reactor Coolant Pump Anti-Reverse Rotation Device**

**SPECIAL REPORT FOR ST. LUCIE UNITS 1 and 2**  
**REACTOR COOLANT PUMP ANTI-REVERSE ROTATION DEVICE**

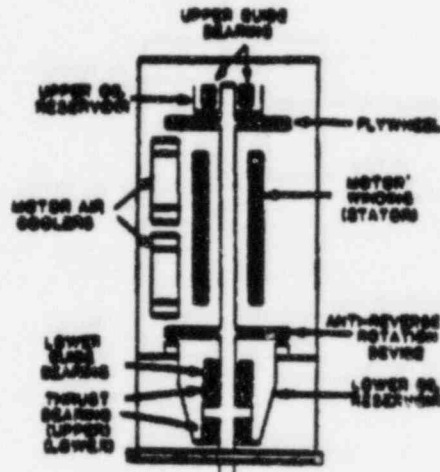
# RCP MOTOR

During the startup and coastdown of the motor, the molybdenum-disulfide tip absorbs the impacts between the pin and the ramps. All of the damaged ARRD pins had significant damage to, or no molybdenum-disulfide tips left. This allowed metal-to-metal contact between the ARRD pins and the ramps causing the ARRD pins to "mushroom" out. Continued impacting of the ARRD pins caused sufficient deformation such that the pins stuck in their holes.

After a discussion with Siemen-Allis Engineering, a two part approach to solve the problem was agreed upon. The 72 new replacement pins were alternately exchanged with the existing ARRD pins. In addition, half of the pins were modified. The bottom outer edge of the ARRD pins were machined to a steeper angle (see figure - 2). It was felt that this taper would reduce the "mushrooming" of the pins.
