NEDC-31115
CLASS II
NOVEMBER 1985

**EVALUATION OF THE LOW CARBON
TYPE 316 STAINLESS STEEL
RECIRCULATION OUTLET SAFE ENDS AT
PEACH BOTTOM UNIT 3**

T. L. Chapman
J. P. Clark
D. E. Delwiche
R. M. Horn

NUCLEAR ENERGY BUSINESS OPERATIONS • GENERAL ELECTRIC COMPANY
SAN JOSE, CALIFORNIA 95125

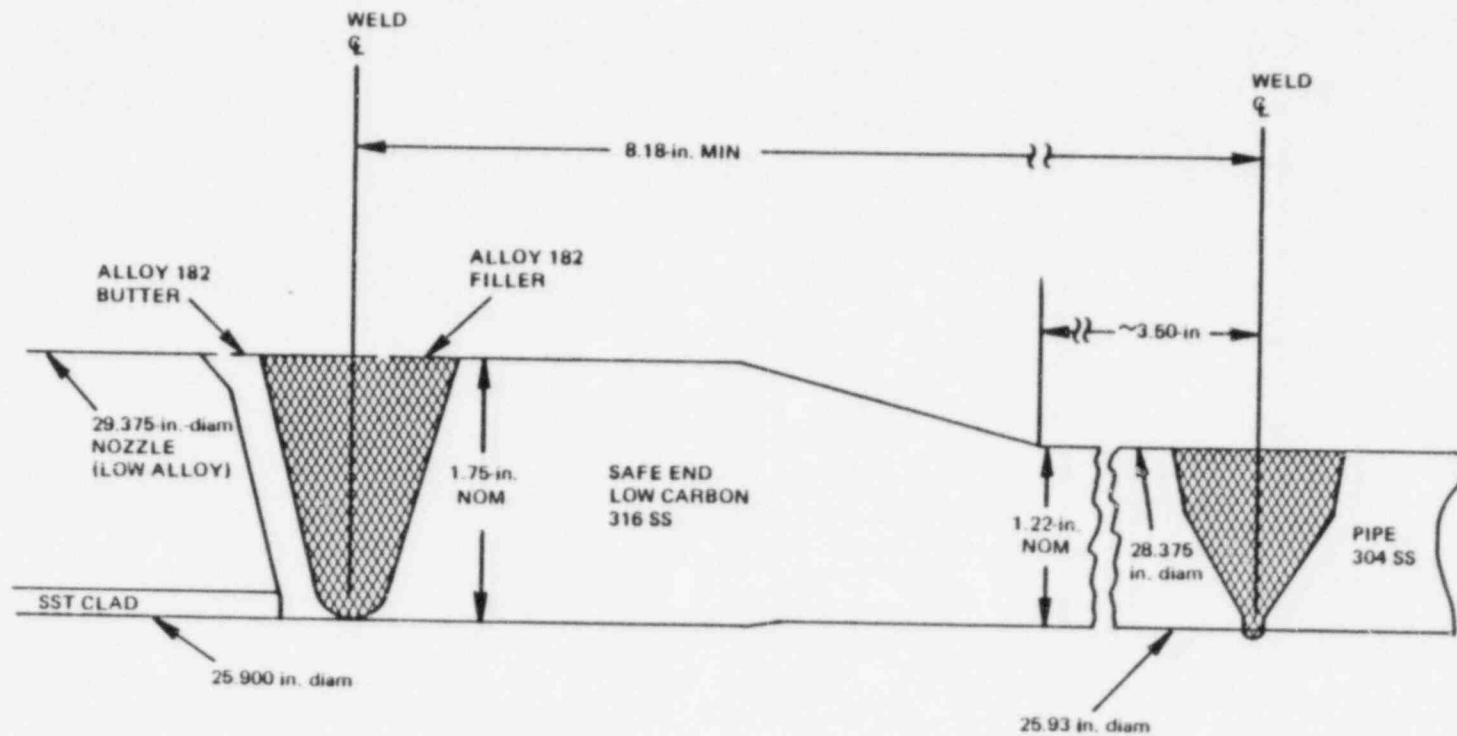
Figure 3-1. Peach Bottom-3 Recirculation Outlet Safe End Configuration

The indications were known to be at or near the fusion line but field experience had shown that cracks in large diameter pipes would frequently occur there. This information - combined with the construction radiographic evidence also displayed in Figure 3-2 that showed the inside to be ground smooth eliminating geometric reflectors at those locations - left little doubt that the safe ends were cracked.

Figure 3-2. Schematic of Ultrasonic and Radiographic Records for Peach Bottom-3 Outlet Safe End to Pipe Weld 2-BS-2; (a) UT crack indications around circumference; (b) construction radiographic interpretation around circumference

The recirculation outlet safe end to pipe weld 2-B-2 was selected for obtaining the core sample. This selection was based on both UT and construction Radiographic (RT) data. The construction radiographs showed that there had been considerable grinding on the inside surface as indicated in Figure 3-2. This was important since it was felt that cold work as a result of the grinding was the only potential method of crack initiation in this uncreviced joint. According to the radiographs weld 2-BS-2 had an area where all of the root and counterbore had been removed. This corresponded to an area indicated by UT to have a relatively long and deep crack indication on the safe end side of the weld. The layout of the UT indications for weld 2-BS-2 is also shown in Figure 3-2 and, for reference, the core sample centerline is noted. (The method of selecting the core sample location is described later in this section.)

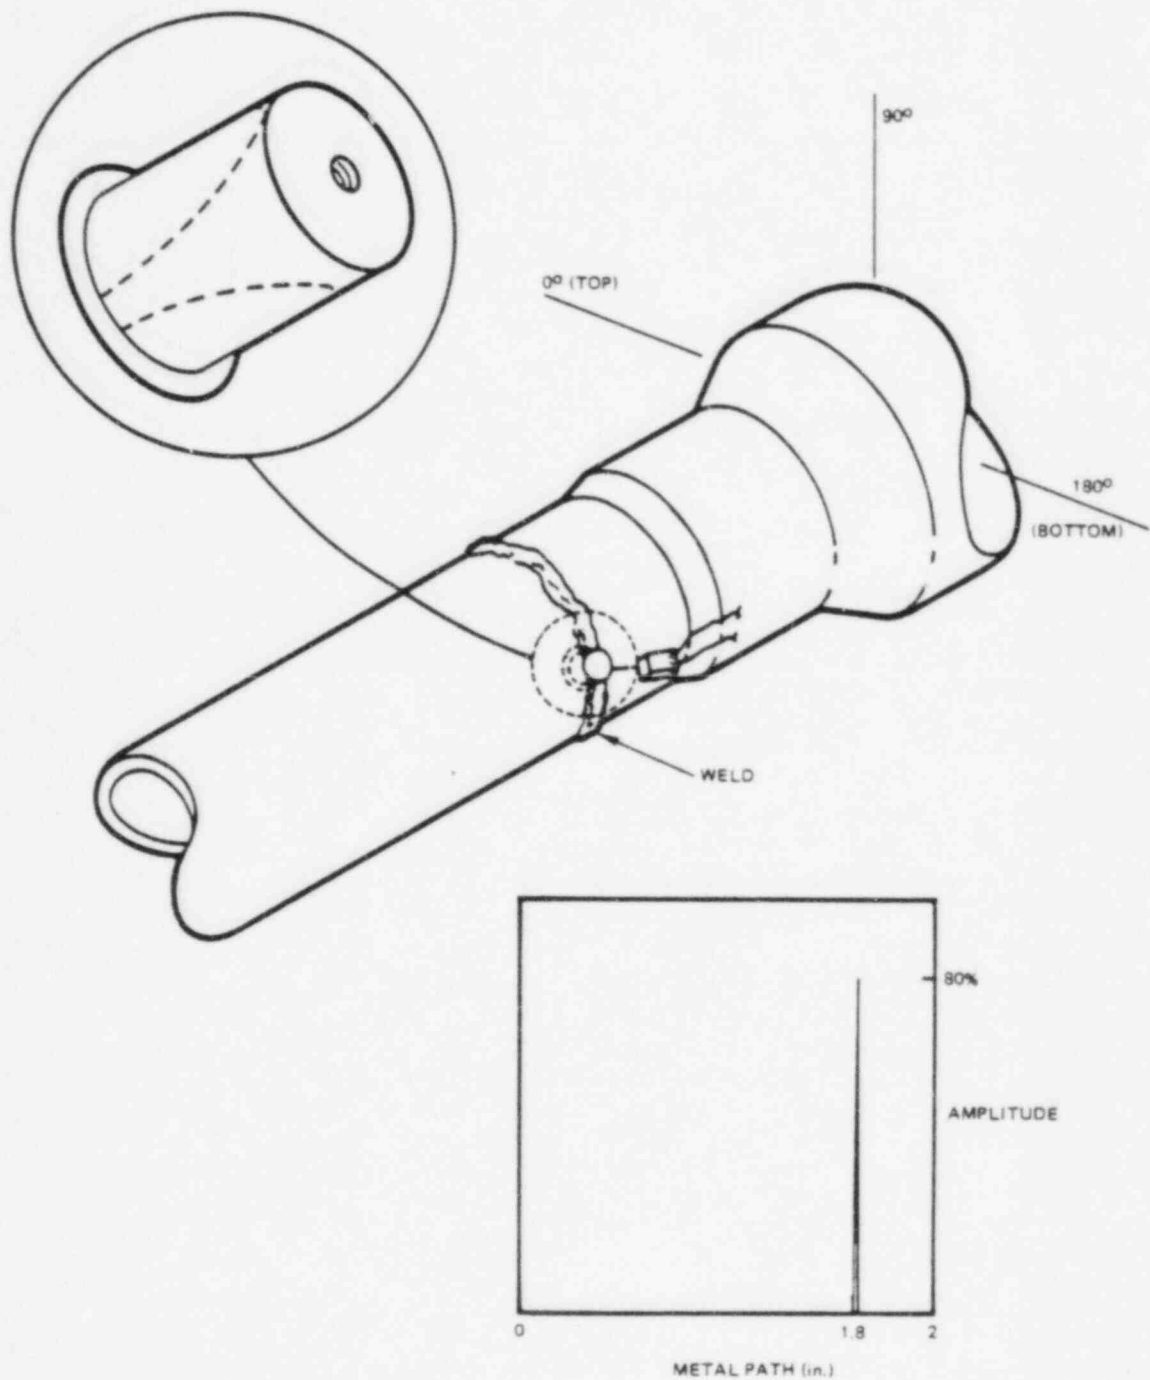
Figure 3-6. Schematic Showing Technique for Core Sample Location and Accompanying UT Signal for I.D. Crack

To assure that the sample was located to contain a representative portion of the entire crack indication, and to finalize the exact location with respect to the weld centerline, additional UT examinations were performed. These included 45° shear wave and 45° refracted L-wave examinations. Using this data, the precise azimuth location and an O.D. weld centerline reference point were marked by the UT personnel performing the examination. The location selected was the 47 inch azimuth (looking clockwise toward vessel centerline). This was about the midpoint of the crack indication on the safe end side at a location showing confirmed IGSCC signals on the I.D. and a measured crack tip at 50% through-wall.

Extreme care was taken in locating the precise position for the core sample that was to be removed. A UT transducer was placed on the safe end and aimed directly at the indication. While this indication was being observed on the instrumentation, the centerline of the weld was marked with a punch directly in front of the transducer. This arrangement is shown in Figure 3-6. Next, cross-section layouts and UT data plots were prepared to determine the axial position of the core sample cutter. The primary objective was to include both the initiation and the through-wall crack tip points in the 316 side of the joint. A second objective was to include the root pass and some of the pipe side crack indications. It was decided to locate the center of

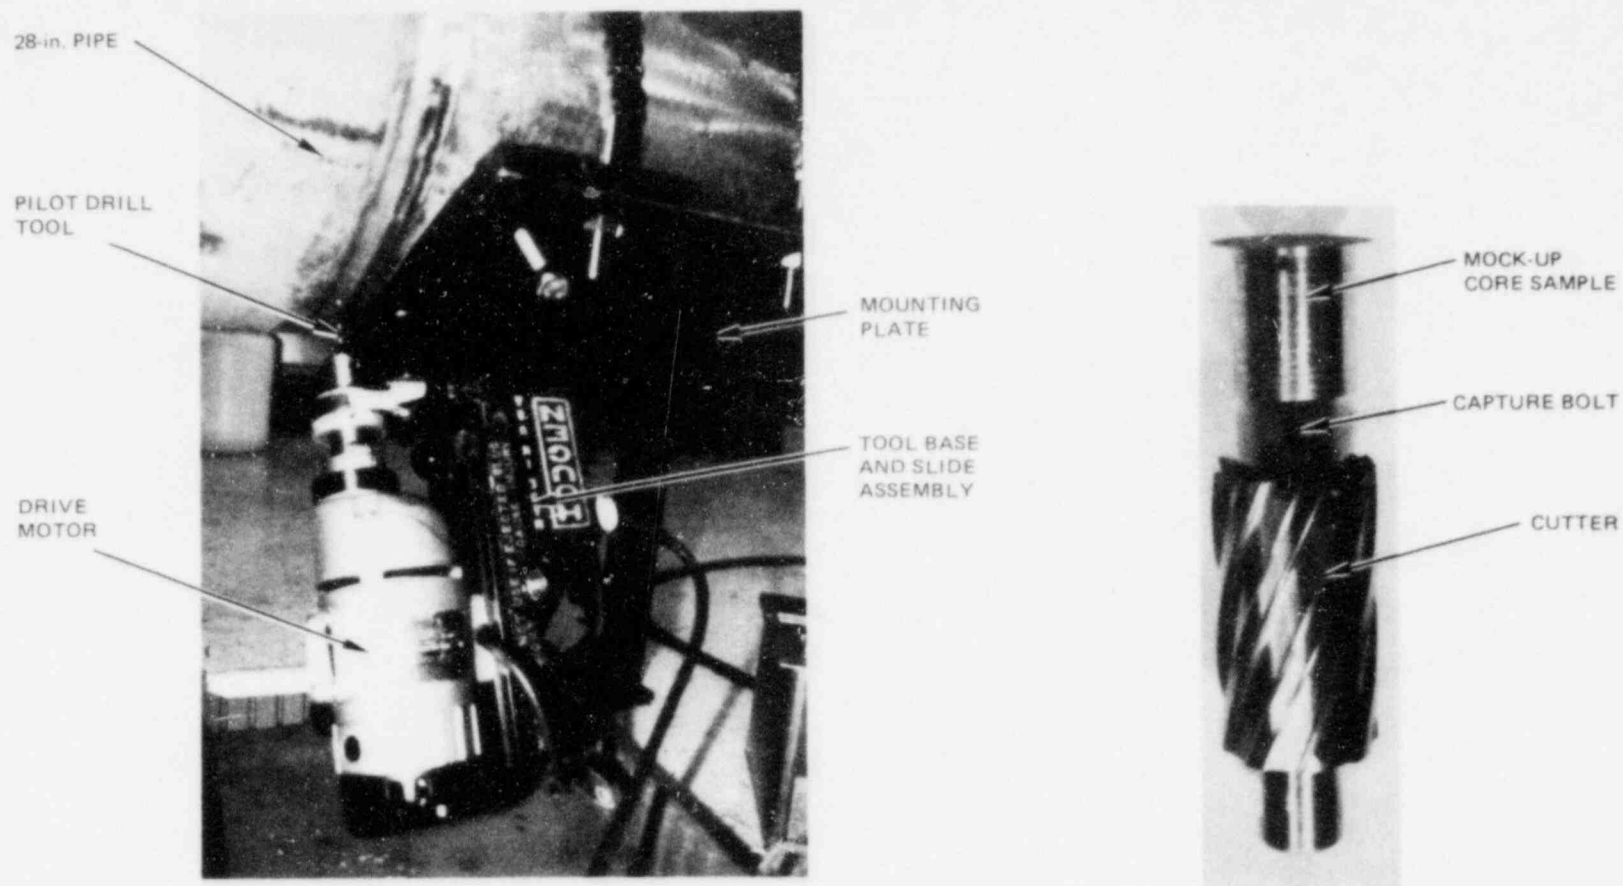
The tool was set-up and functionally tested in the GE San Jose facilities. All tests were performed using a spray coolant of de-ionized water. The tool performed very successfully, and high quality cuts could readily be made through a pipe butt weld. On-site, additional mockups were performed under full access restrictions to train craft labor crews and formally qualify the sample removal procedure.

a) TOOLING INSTALLED ON MOCK-UP
AND DRILLING PILOT HOLE

b) CORE SAMPLE CUTTER AND
CAPTURE BOLT ARRANGEMENT

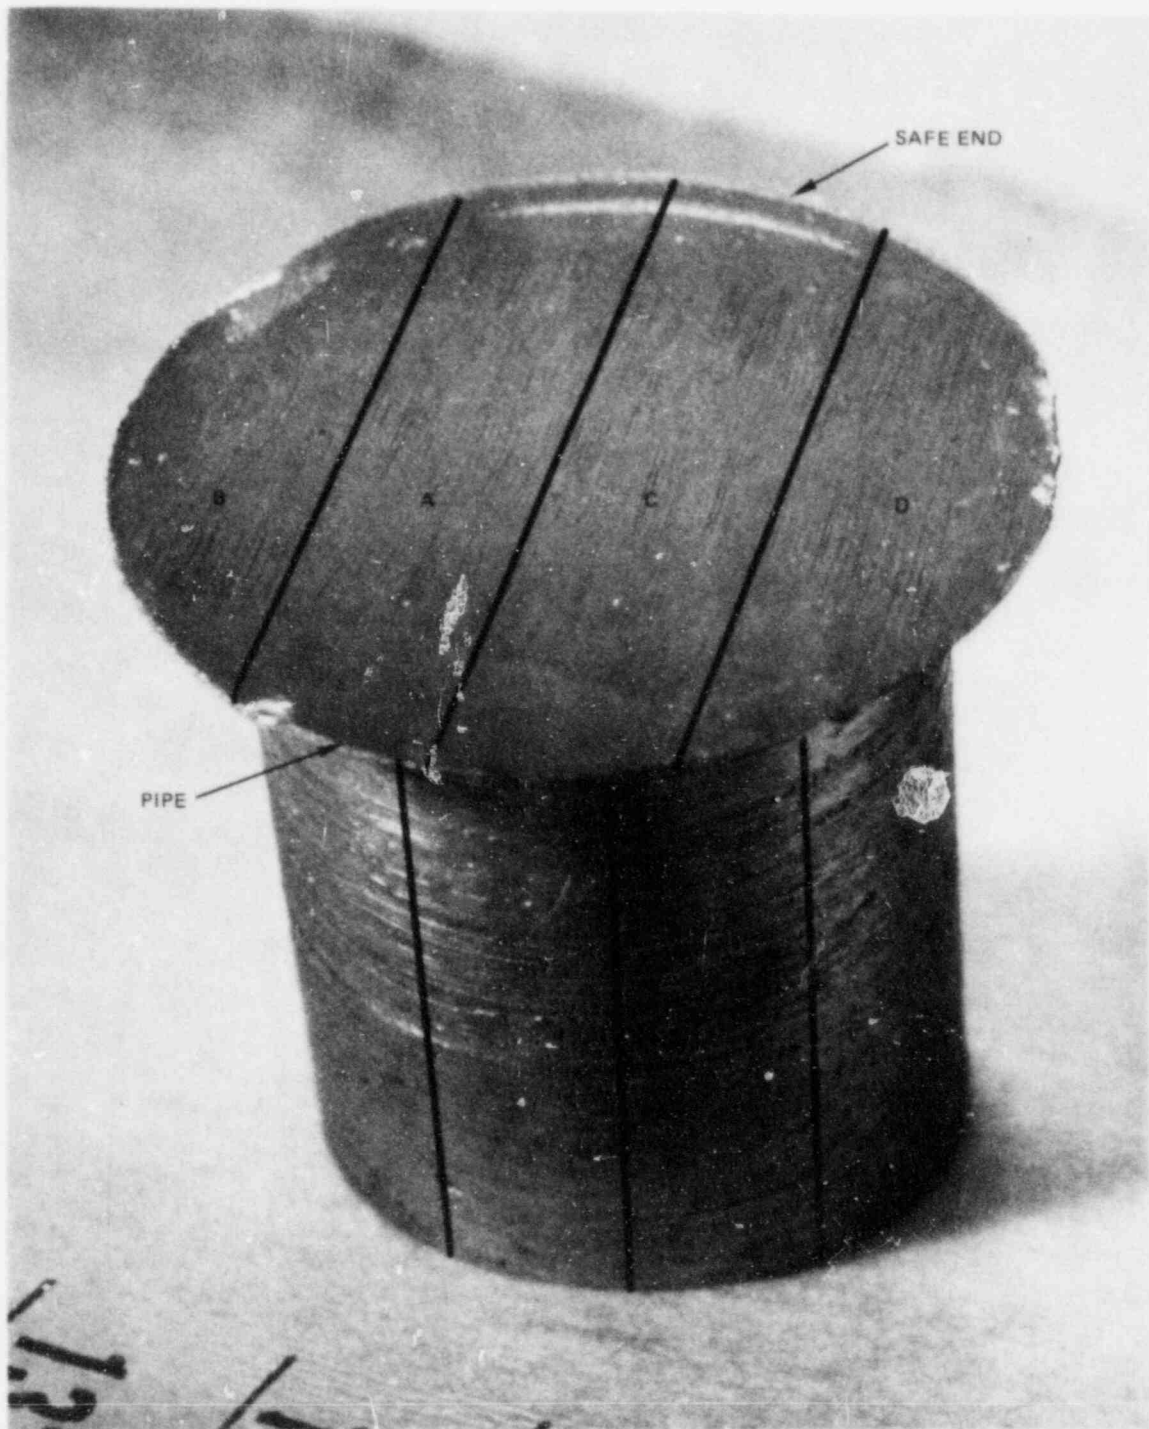
Figure 5-3. Core Sample Cutting Plan (all samples A, B C and D were mounted for optical microscopy with no cracking found in any section)

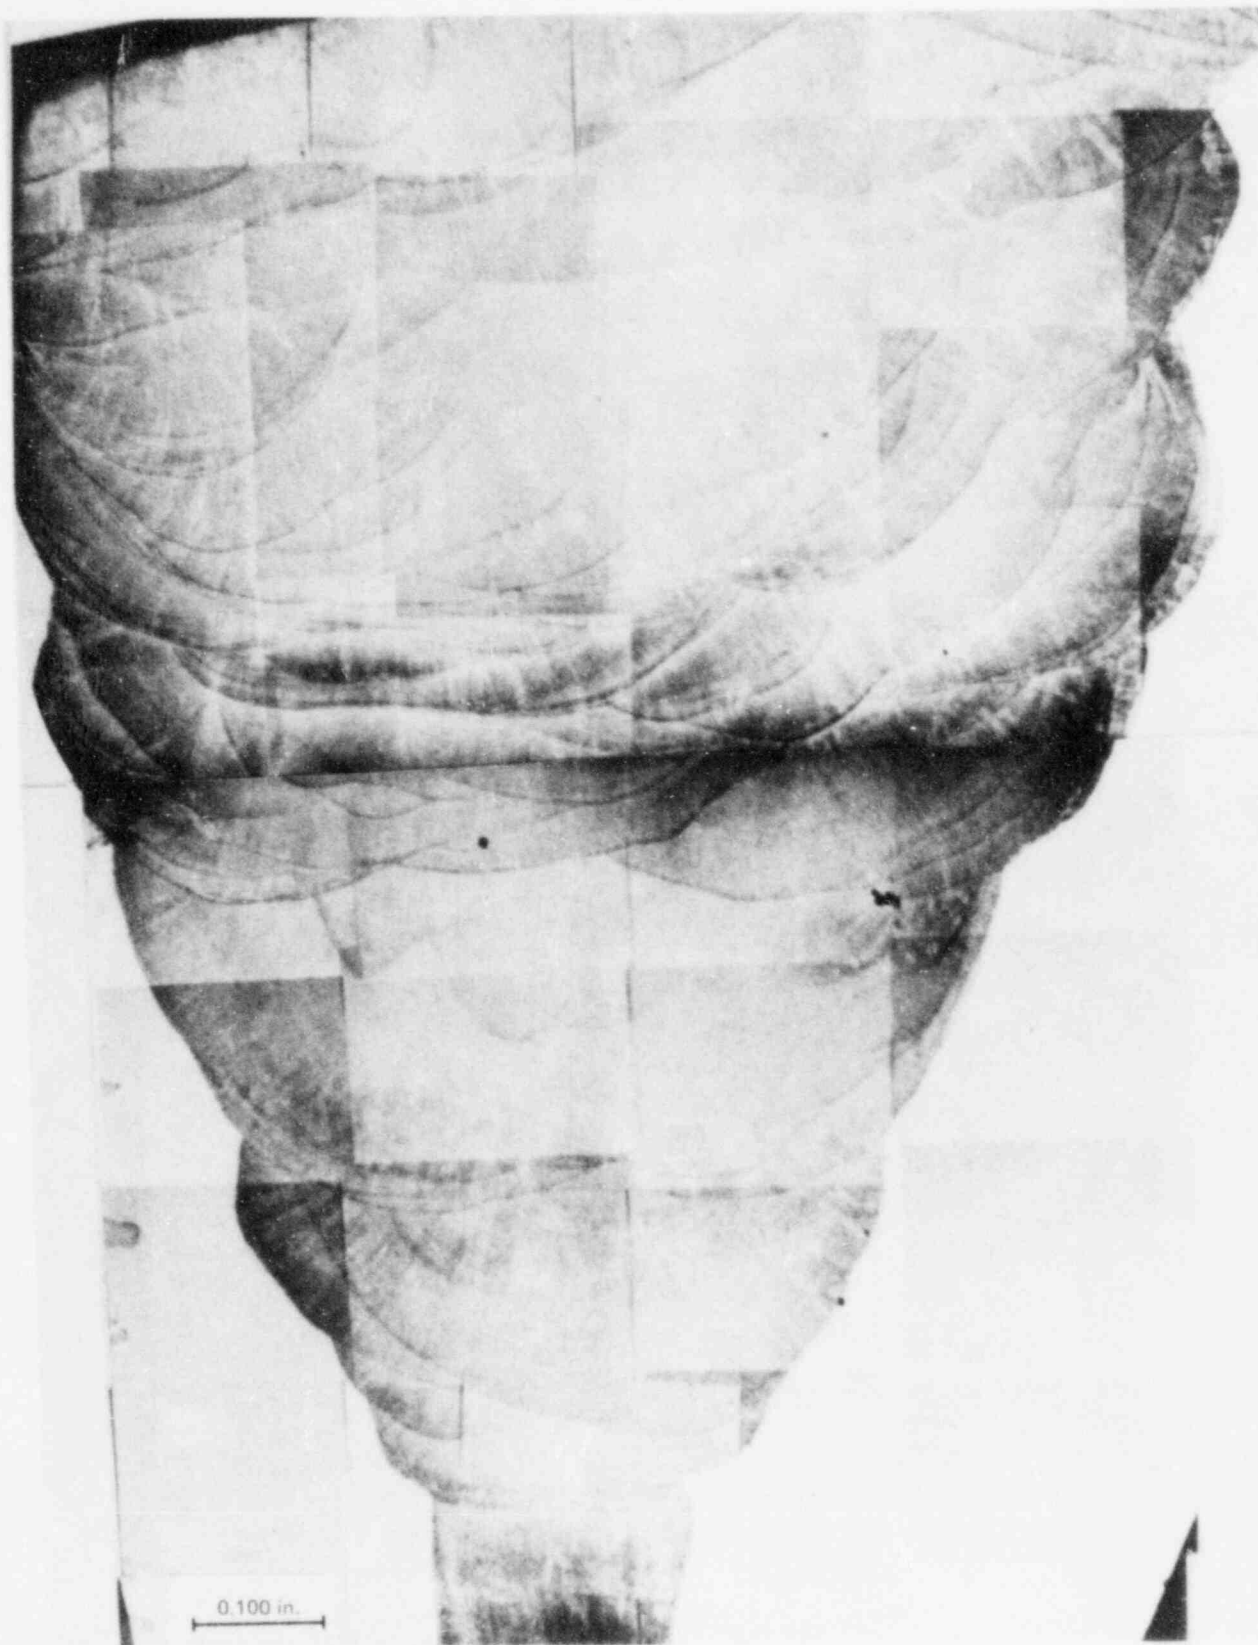
A cylindrical core sample, approximately 1-inch in diameter was removed from the safe end to pipe weld 2-BS-2 of the 28-inch recirculation outlet nozzle N1B to confirm the nature of UT indications. The sample was removed from a location near the center of the largest and deepest UT crack indication. (The depth was estimated to be 50% wall at this location.) The circumferential location of the core sample (Figure 3-2) also coincided with a location of heavy weld root grinding, as determined by the construction radiographs for the weld.

Figure 5-4. Cross Section Photomicrograph of 2-BS-2 Safe End to Pipe Weld Core Sample

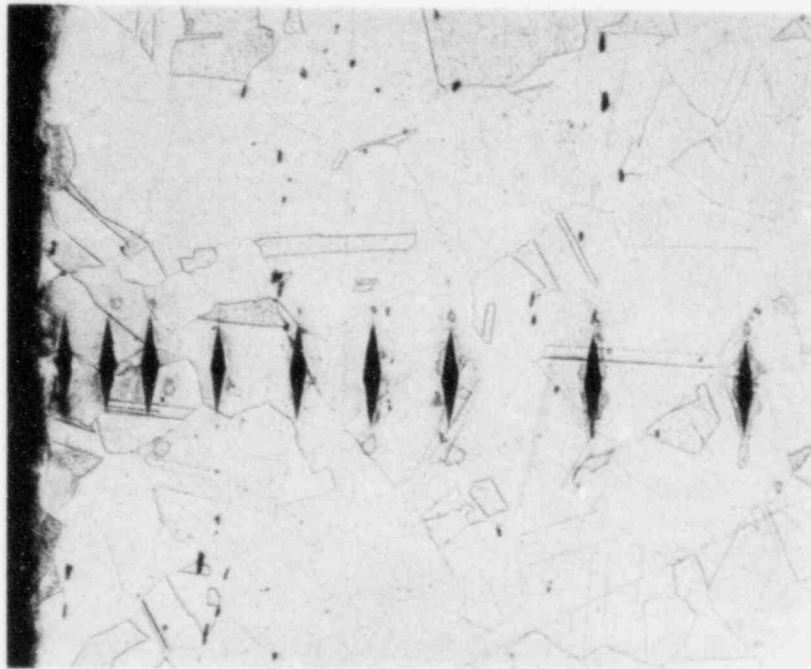
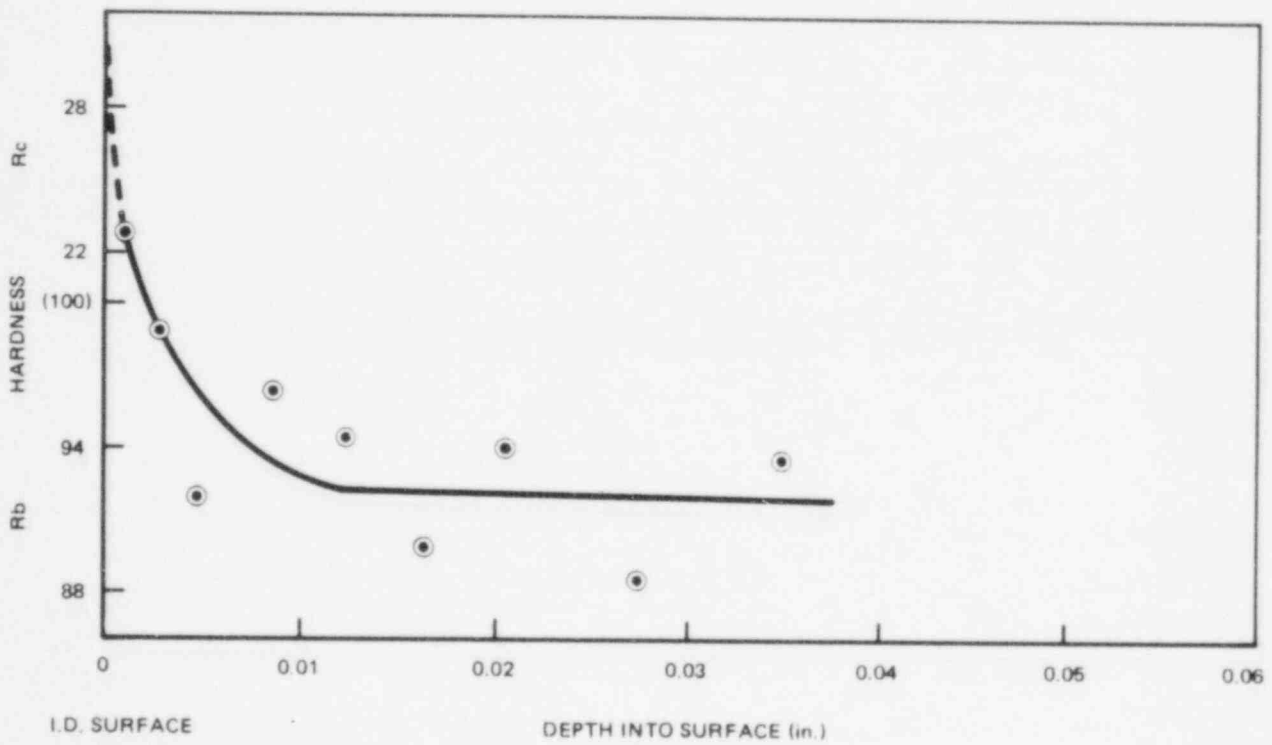
Figure 5-9. Photomicrograph and Plot of Hardness Traverse of Safe End Surface to Evaluate Cold Work

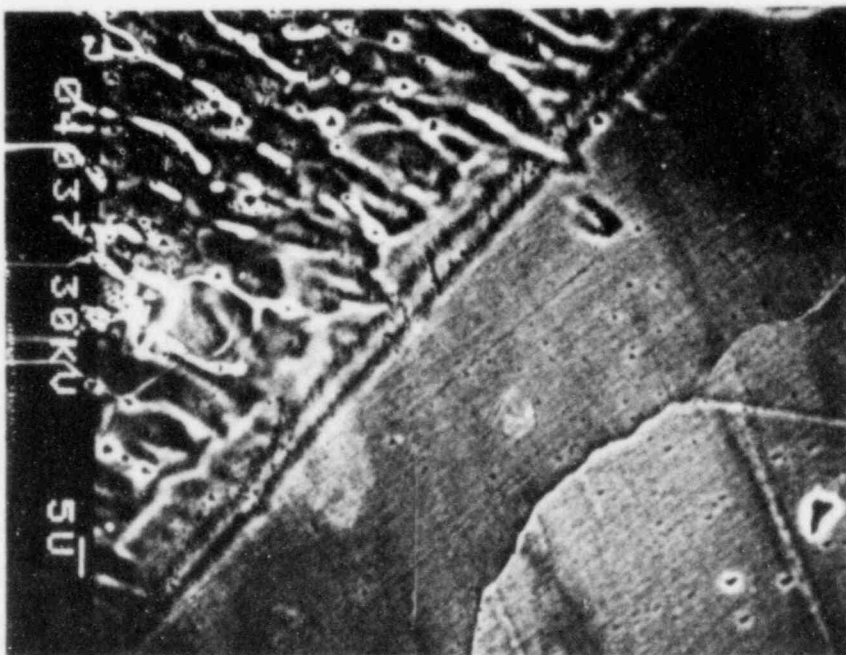
Figure 5-12. High Magnification SEM View of the 316L/308 Weld Interface
(Note the Abrupt Microstructural Change and Lack of
Transition Zone at the Interface)

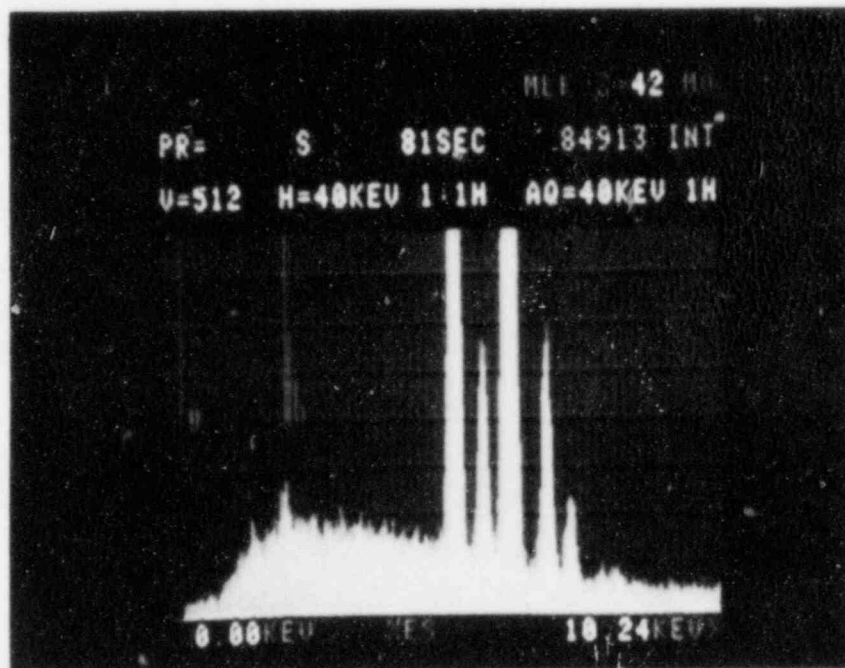
A linearly decreasing gradient of diffused Mo was observed in the weld metal when moving from the 316L fusion line towards the pipe side fusion line. In addition, there was an enrichment of Mo in the ferritic phase of the weld. The enrichment gradient from the 316L fusion line to the 304 fusion line was linear, suggestive of mechanical mixing. Figure 5-12 is a photo of the 316L weld interface boundary and Figure 5-13 is a SEM photo of the Mo enriched ferritic phase within the austenitic matrix. Figure 5-14 is an energy scan made on the SEM with the energy dispersive X-ray detection equipment providing confirmation of Mo enrichment in the light second phase regions of Figure 5-13.

Figure 5-14. Dispersive X-ray Energy Scan Confirming the Mo Enrichment in the Light Second Phase

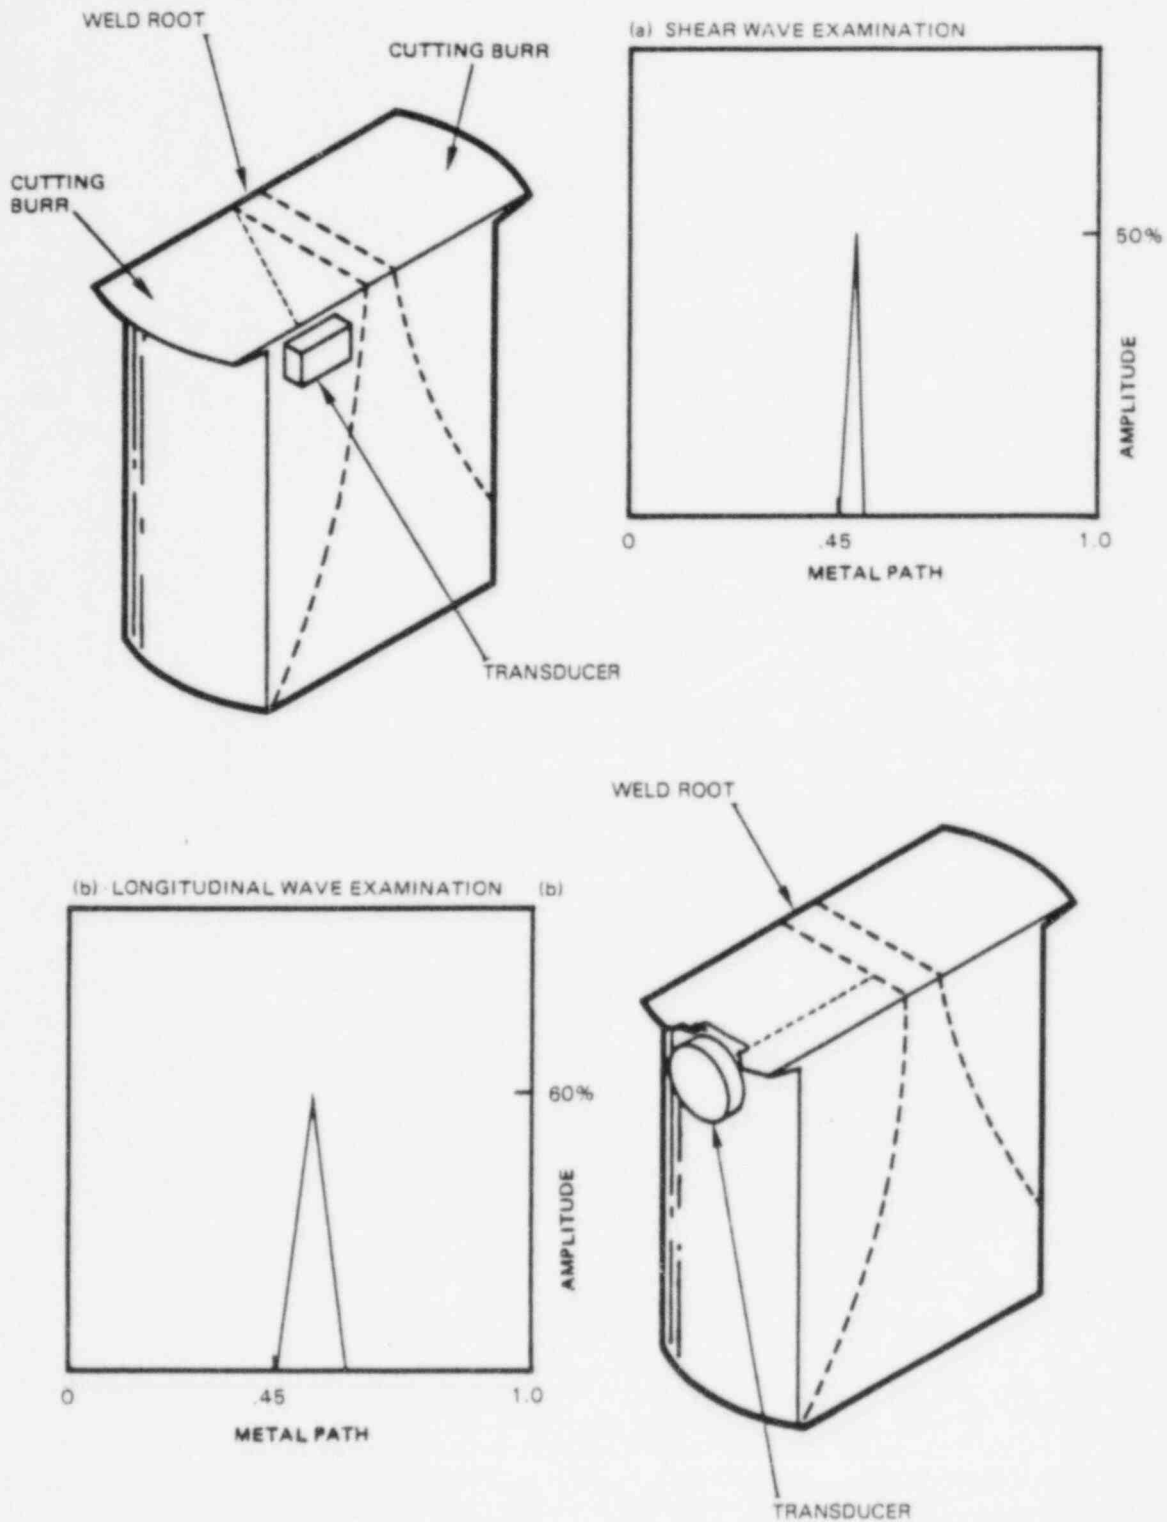
Additional UT was also performed on the metallographic slices. First a straight beam (0° longitudinal) was directed from the safe end side of the sample, such that the sound beam was perpendicular to the weld root. A direct reflection was obtained from the fusion line. Secondly a 45° shear wave was aimed from the face of the sample towards the weld root such that it intercepted the fusion line at the opposite face of the sample thus forming a corner trap. Again a direct reflection was obtained from the fusion line area. In both of these experiments calibration of the UT instrument was performed utilizing a 1/16 inch diameter side drilled hole at a depth of 1/2 inch in a stainless steel block. The reflection from this hole was set at 100% of full screen height. The resultant reflections from the fusion line were 50% of full screen height at a metal path of 0.4 inch in the case of the shear wave and 60% of full screen height at a metal path of 0.5 inch in the case of the straight beam. This arrangement is shown in Figure 6-1. These experiments clearly show that the source(s) of the reflections are still contained in the metallographic sample and are somehow related to the fusion line at the weld root. The only aspect noted to be unusual in this case is the long (1/8 inch), vertical side walls of the root.* The indication that was detected with refracted longitudinal waves in the field and thought to be due to diffraction at a crack tip is now believed to be related to small slag stringers with associated lack of fusion located near mid wall in the weldment. Records

Figure 6-1. Schematic of Location and Signal from UT of the 316L Safe End Metallographic Sample

A special UT procedure is needed to discriminate IGSCC from Peach Bottom-3 weld type indications. This would require mockups with vertical root welds and with IGSCC located near the root. Samples from the field might also be helpful when and if they are available. Such a study could be funded by the BWR Owners Group through EPRI. Certainly the objective of such a program would have to be to understand the source of the reflections and the qualification of discriminating techniques or methods.

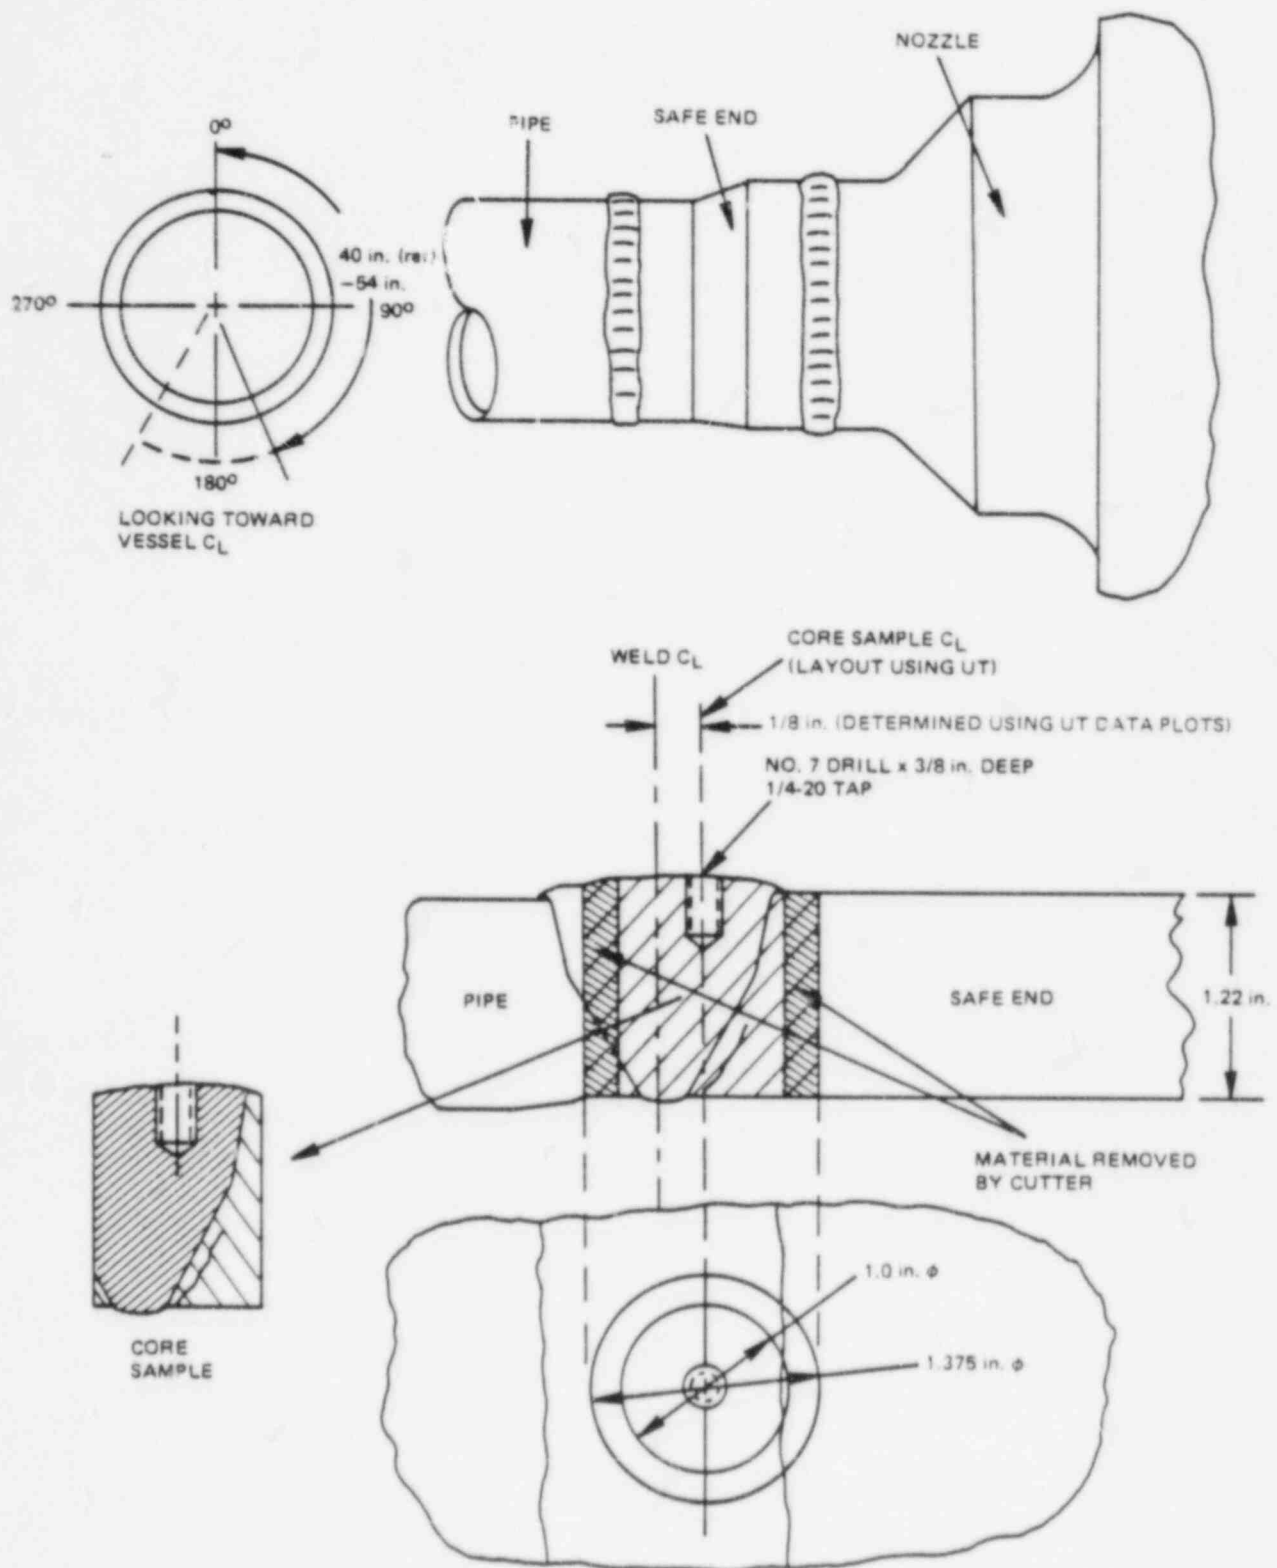
Figure 1

A cylindrical core sample, approximately 1 inch in diameter will be removed from the safe end side of the safe end-to-pipe weld 2-BS-2 of the 28 inch recirculation outlet nozzle N1B. The sample will be removed as shown in Figure 1.

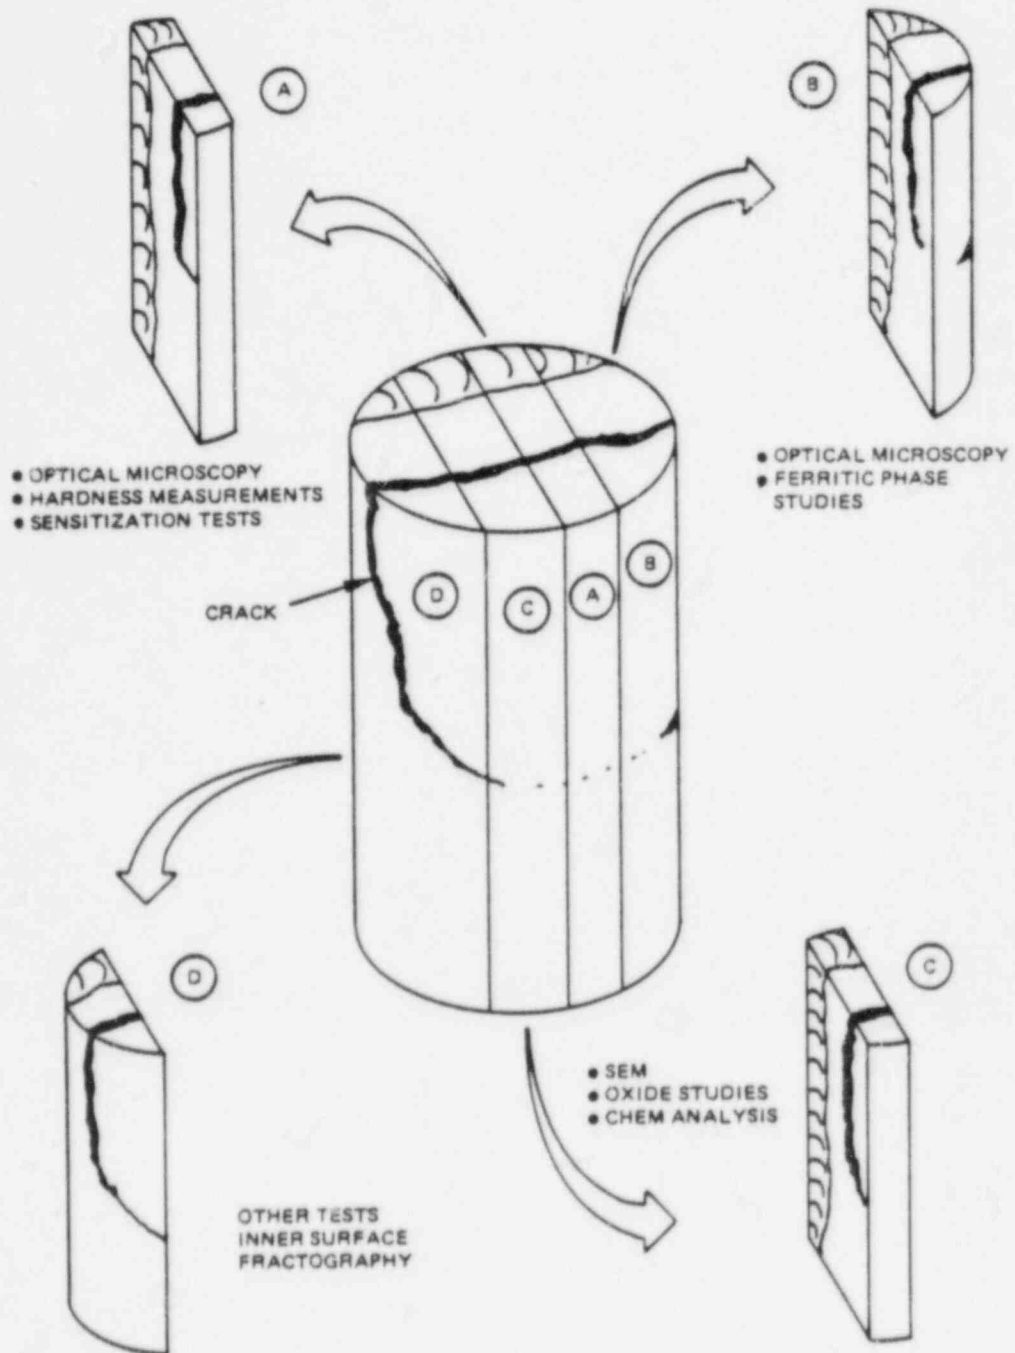
- A. Visual exam of core sample inner surface. Examine, and photograph macroscopic evidence of weld root grinding.
- B. Map the fracture plane in the core sample. Identify and document the crack on both the inner surface and the cylindrical side of the core. (Note: Do not penetrant examine [PT] or use any material other than deionized water on the sample, so as to avoid masking of possible contaminants on the fracture surface.)
- C. Prepare the cutting map and prepare sections for the tests identified below. (See Figure 2.)

Figure 2. Suggested Cutting Plan for Core Sample

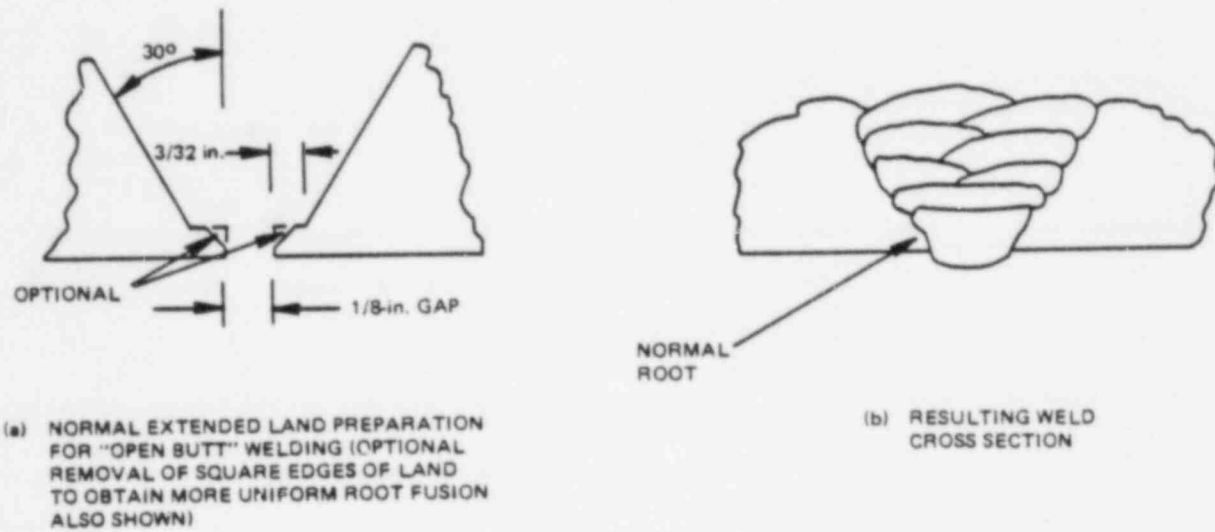
Figure B-1. Normal Weld Preparation and Weld Cross-Section

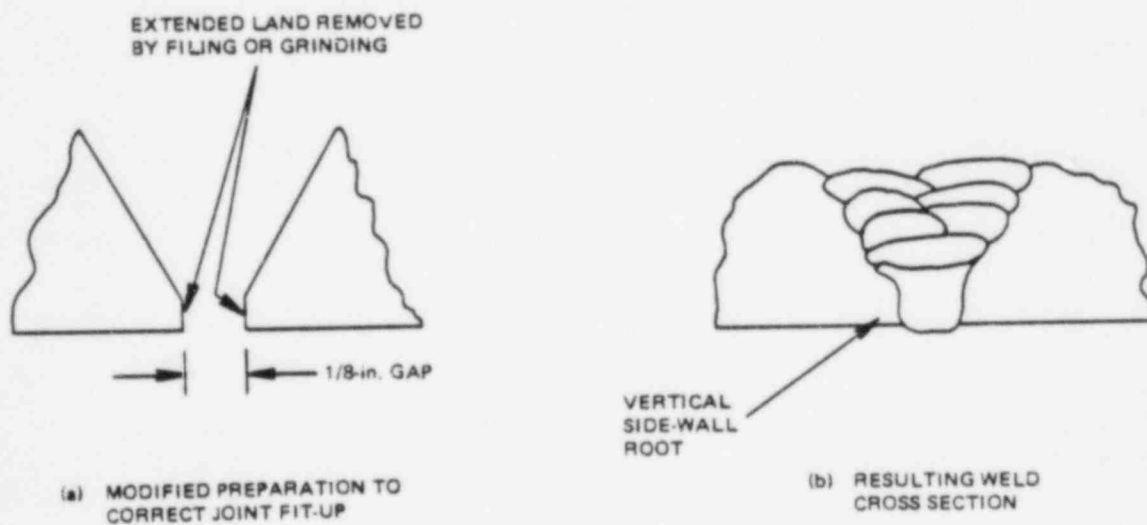
Realizing the difficulty of accurately templating and machining such a large spool piece, the need to modify the weld preparations in the field would not be unexpected. Such a modification would most likely be performed by hand grinding or filing the extended lands as shown in Figure B-2(a). In this case, the cross-section shown in Figure B-2(b) could result, which is similar to that found in the core sample.

Field construction records are insufficient to show whether this actually occurred, but the practice was commonly used to help obtain the 1/8 inch minimum gap specified in the "open-butt" welding procedures. This weld prep modification could have been made anywhere on the 28-inch piping, but the closure weld spools would be the most probable locations requiring such a field modification. Based on this, the observed root cross-section and anomalous UT crack indication are not considered typical of the other 28-inch piping in the system.

Figure B-2. Modified Weld Preparation and Cross-Section
