UNITED STATES
NUCLEAR REGULATORY COMMISSION

AEOD/E97-01

SUBJECT: "REVIEW OF INDUSTRY EFFORTS TO MANAGE PRESSURIZED
WATER REACTOR FEEDWATER NOZZLE, PIPING, AND FEEDRING
CRACKING AND WALL THINNING," NUREG/CR-6456
(INEL 96/0089)

Review of Industry Efforts To Manage Pressurized Water Reactor Feedwater Nozzle, Piping, and Feedring Cracking and Wall Thinning

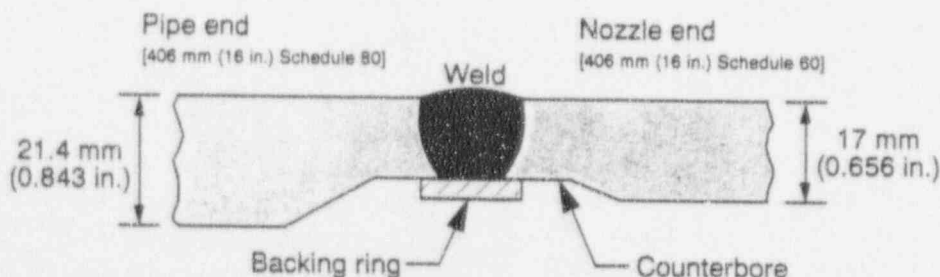
sign and the codes of construction, the weld and its inspection varies from plant to plant. The geometric discontinuity at the junction of the nozzle and the pipe causes stress concentration and has been the location for many of the cracking incidents. As shown in Figure 15, a counterbore at the inside diameter, and a backing ring for the weld were originally used. In many cases the cracked component was replaced in kind with the same design, which, as discussed in Section 6, has led to a second, and in some cases, a third replacement. Consequently, redesigns of the configuration have been proposed to reduce the damaging effects of the piping discontinuity. These redesigns are discussed in Sections 6 and 9.

Figure 15. Typical PWR feedwater nozzle-to-pipe weld with a counterbore.

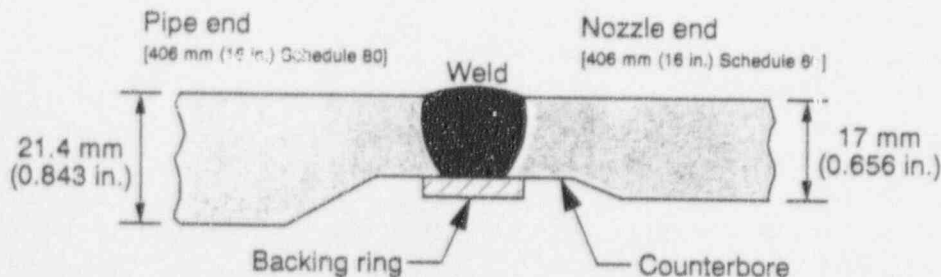
sign and the codes of construction, the weld and its inspection varies from plant to plant. The geometric discontinuity at the junction of the nozzle and the pipe causes stress concentration and has been the location for many of the cracking incidents. As shown in Figure 15, a counterbore at the inside diameter, and a backing ring for the weld were originally used. In many cases the cracked component was replaced in kind with the same design, which, as discussed in Section 6, has led to a second, and in some cases, a third replacement. Consequently, redesigns of the configuration have been proposed to reduce the damaging effects of the piping discontinuity. These redesigns are discussed in Sections 6 and 9.

**Figure 15.** Typical PWR feedwater nozzle-to-pipe weld with a counterbore.

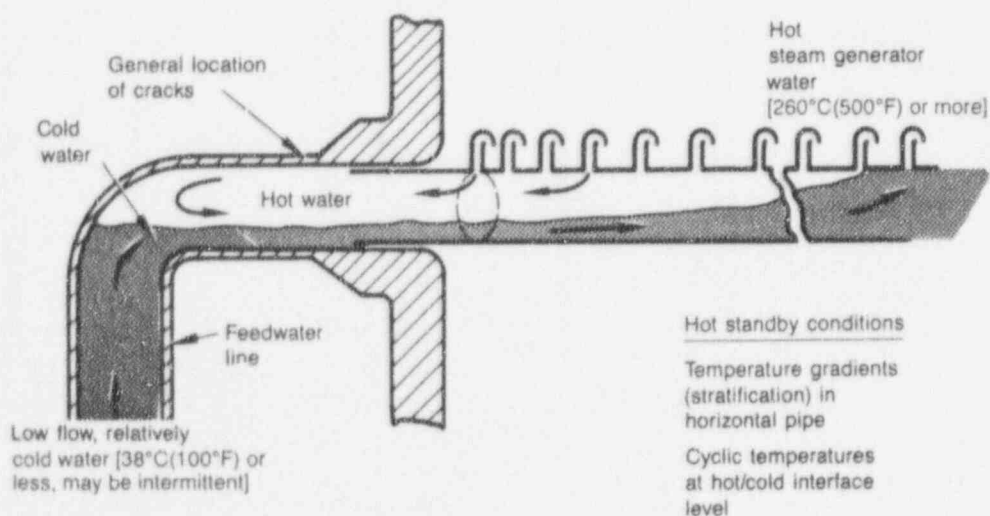
Figure 19 shows such a low-flow condition during hot standby. The upper portion of the pipe fills with hot steam or water from the steam generator while the bottom portion is filled with relatively cold auxiliary feedwater. The figure also shows the general location of fatigue cracks produced by thermal stratification. The height of the interface layer between cold and hot coolants in the pipe depends on the auxiliary feedwater flow rate, the temperature difference between the coolants, and the piping layout. The height increases as the auxiliary feedwater flow rate increases, and it fluctuates as the flow rate is increased and decreased to maintain the steam generator water level. While the steam dumps are cycling open and closed, there is a corresponding on and off cycling of the auxiliary feedwater. When the auxiliary feedwater flow rate is increased above a threshold flow rate, the cross section of the horizontal piping connected to the nozzle becomes completely filled with cold feedwater, and thermal stratification is no longer present. The threshold flow rate depends on the same parameters on which the height of the interface layer depends. Therefore, the threshold flow rates are different at different plants. For example, the threshold flow rate at the Diablo Canyon plants is about 757 ℓ/min (200 gpm). The threshold flow rate is higher,

Figure 19. Flow stratification in PWR feedwater nozzle during low flow conditions (USNRC 1980).

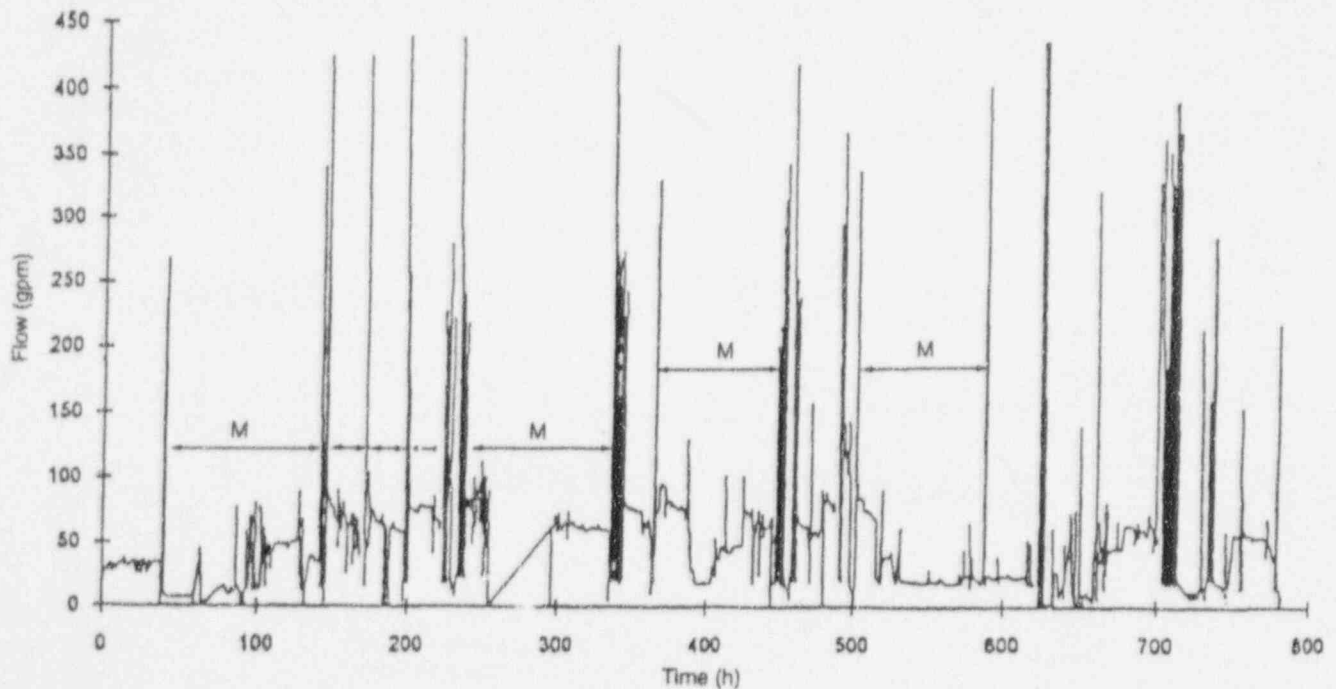
Figure 20. Auxiliary feedwater flow for Sequoyah Unit 1 showing automatic and manual controls (Cofie et al. 1994). Copyright American Society for Mechanical Engineers; reprinted with permission.

80 gpm). However, automatic auxiliary feedwater control resulted in large flow cycles from 0 to 757-1514 l/min (200-400 gpm) at frequencies of about 2 cycles/h. Though the automatic control accounted for only 13% of the total time, severe fluctuations in the flow rates occurred during automatic control that caused significant fatigue damage. Figure 21 shows typical periods of automatic and manual feedwater flows at Sequoyah Unit 2 (Shvarts et al. 1994). Obviously, the time of automatic auxiliary feedwater use is important for fatigue crack growth.

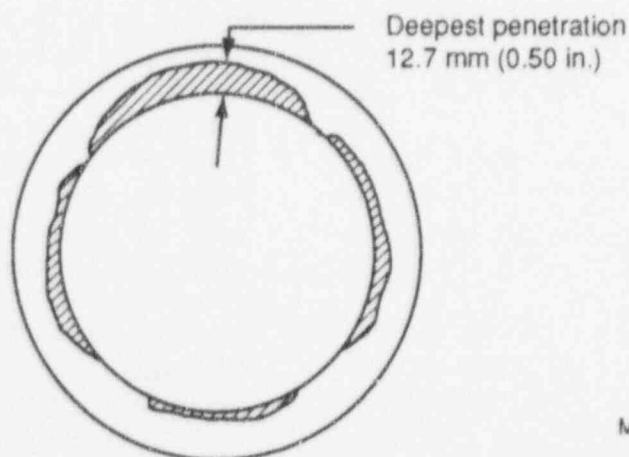
(a) Crack profile in degraded feedwater piping.

(b) Crack location in the D.C. Cook nozzle (USNRC 1980).

Figure 22. Typical fatigue crack orientation at feedwater nozzle counterbore.

entrant corner of the counterbore at the upstream end, not in the weld or heat-affected-zone. However, the major cracks in a few units initiated away from the counterbore. For example, in San Onofre Unit 1 (a 3-loop Westinghouse plant), the major crack [2.54-mm (0.1-in.) deep] initiated in the weld whereas in Palisades (a Combustion Engineering plant), the major crack [4.3-mm (0.17-in.) deep] initiated near the weld in the heat-affected zone (Consumers Power 1979). At Kewaunee (a 2-loop Westinghouse plant) a crack initiated in the piping at the weld interface. Examinations of the weld areas found tool marks and machining grooves in the counterbore region. The through-wall cracks occurred at the top of the pipe, though many other cracks were found at the 3 and 9 o'clock positions. The fracture surfaces of the through-wall cracks showed striations, typical of fatigue crack growth, and the presence of corrosion products. Table 3 summarizes the extent of damage at the 18 PWR plants where cracking was discovered during the inspections performed in response to the Bulletin.

The cracking was attributed primarily to thermal fatigue caused by thermal stratification and striping in the nozzle region and concentrated at the stress raiser at the counterbore. Corrosion fatigue apparently played a secondary role in the cracking. Some of the cracks initiated at pits on the inside surface, and corrosion products have been found on crack surfaces. Although oxygen is thought to be a factor in accelerating the fatigue, it is not considered to be the primary factor.

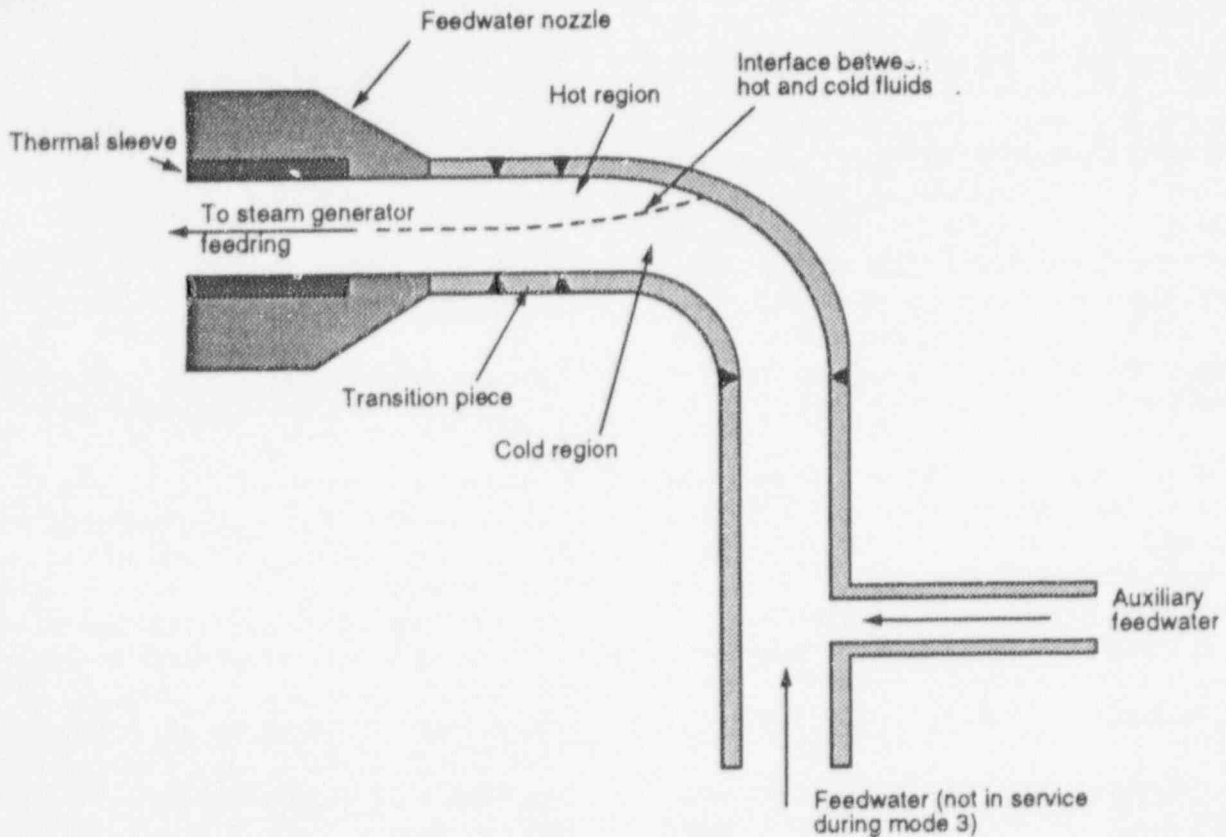
The auxiliary feedwater piping at the Sequoyah plants connects to the main feedwater piping inside the containments on Loops 2 and 3 at a vertical rise of the piping upstream of the elbow at the steam generator feedwater nozzle, as shown in Figure 25, but outside the containments on loops 1 and 4. Each connection consists of an expander [102 to 152 mm (4 to 6 in.)] and a tee fitting [405 x 406 x 152 mm (16 x 16 x 6 in.)] containing a thermal sleeve; these details are not shown in Figure 25.

Figure 25. Stratified flows during operation of auxiliary feedwater system (TVA 1992a).

During periods of auxiliary feedwater operation, the flow partially fills the horizontal portion of the nozzle region, leading to the stratified fluid condition shown in Figure 25. The cold auxiliary feedwater [about 20 to 38°C (70 to 100°F)] fills the lower portion of the horizontal portion of the feedwater line and nozzle, and hot fluid [about 286°C (547°F)] from the steam generator fills the upper portion. When the auxiliary feedwater flow is terminated, the nozzle region temperature returns to the hot condition, and then when flow is reinitiated, the stratified condition is reestablished. This on-off auxiliary feedwater operation leads to cyclic thermal stratification. Figure 29 shows typical auxiliary feedwater flow rates with the auxiliary feedwater cycling on and off during automatic operation.

mode of operation, the auxiliary feedwater flows at about 760 l/min and fills the lower half of the feedwater piping cross section as shown in Figure 25. The pipe wall inside surface, near the interface, is probably subject to high-cycle fatigue damage caused by thermal striping.

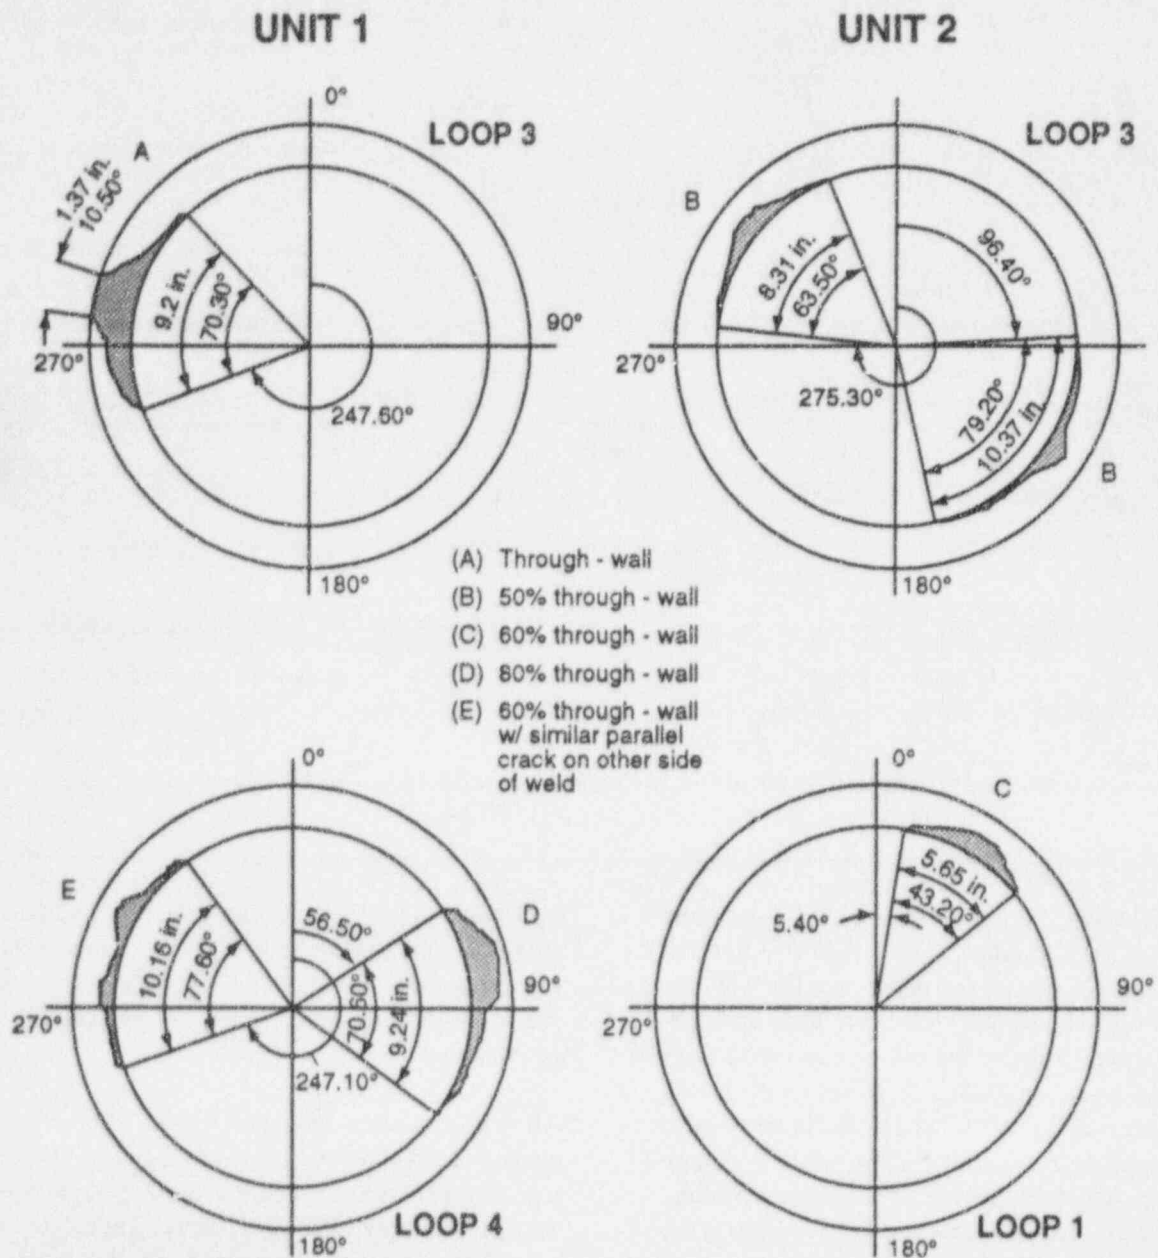
Figure 27 shows the extent and orientation of some of the primary cracks (TVA 1992a). Although only one of the cracks had penetrated the wall, the other five cracks shown were 50 to 80% through-wall. Figure 18 shows the primary and secondary cracking at the 270-degree location of Steam Generator 3 at Unit 1. The cracks on the Unit 1 steam generators were at the 90- and 270-degree locations, which indicates that the elevation of the hot and cold fluid interface might have been at the horizontal centerline of the pipe during periods of auxiliary feedwater operation. Thermal striping at the interface may have caused crack initiation, and the cracks were then propagated by cyclic thermal stratification. The crack locations on Unit 2 are more difficult to explain. The cracks on Steam Generator 3 at Unit 2 were rotated approximately 30 degrees clockwise from the 90-to-270-degree line, and the crack on Steam Generator 1 at Unit 2 was located near the top of the pipe. Two possible

explanations for these asymmetric crack profiles are (a) the elbow may be in a plane inclined to the vertical plane instead of in the vertical plane, or (b) the counterbore may have an asymmetric geometry.

Figure 27. Extent and orientation of primary cracks in feedwater nozzle-to-transition field weld at Sequoyah Units 1 and 2 found in 1992 (TVA 1992a).

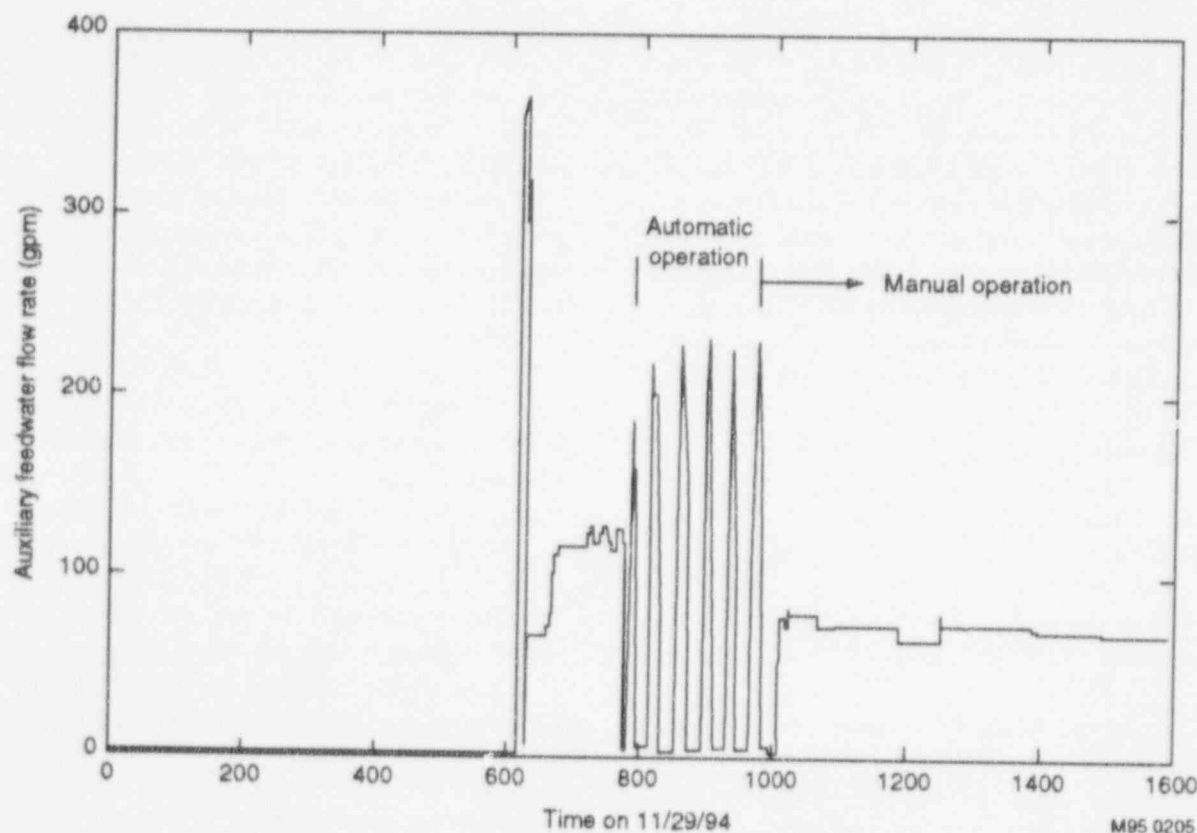
Fatigue damage progresses much more rapidly in the automatic mode, during which the flow fluctuates between 0 and about 760 l/min (200 gpm) at a rate of approximately 3 times per hour and cyclic thermal stratification takes place, than in the manual mode, during which the flow is relatively constant at about 300 l/min (80 gpm) and large fluctuations in the flow rates are absent. The automatic mode of operation, because of the relatively high flow rates, might also be producing thermal striping at the interface between the cold auxiliary feedwater and the hot fluid from the steam generator. Thermal striping imposes high-cycle stresses on the pipe inside surface and contributes to crack initiation. (See Section 7.1 for a description of thermal stratification, thermal striping, and thermal cycling.) In the automatic

Figure 29. Loop 1 auxiliary feedwater flow rates during manual and automatic operation at Sequoyah Unit 1 on November 29, 1994. Courtesy of W. Ludwig, TVA.

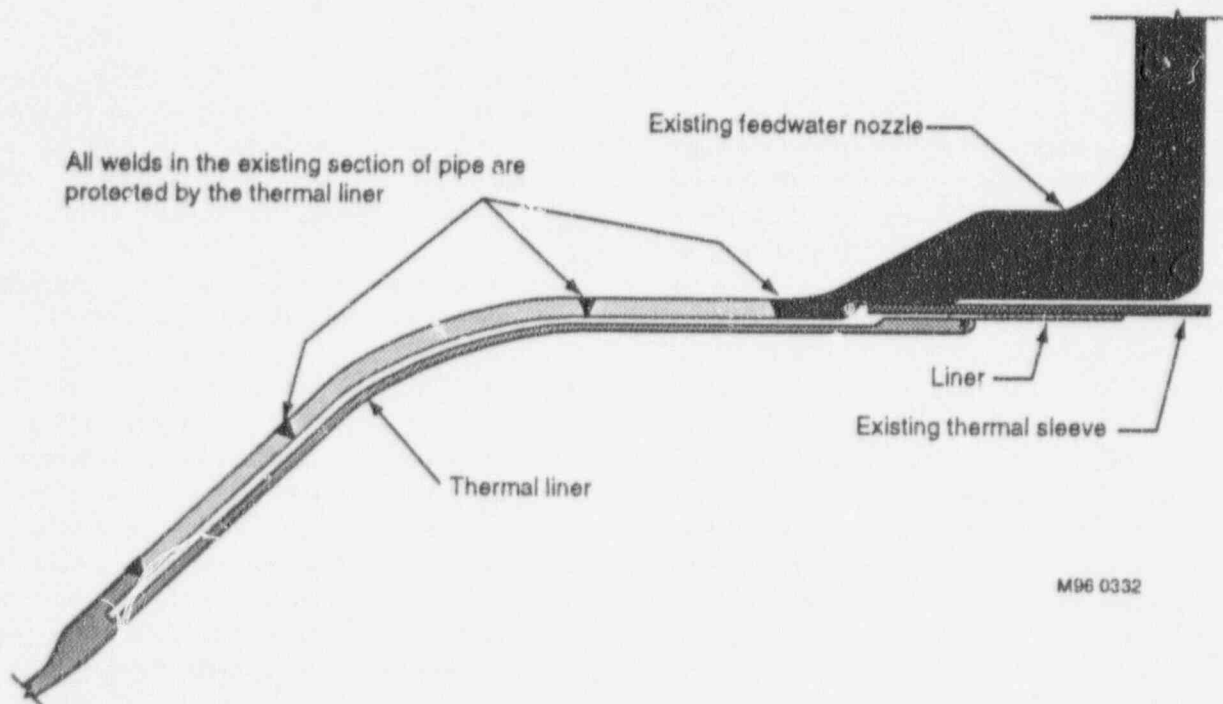
There are two potential concerns about the structural integrity of the liner: (1) wall thinning of the liner by the flow-accelerated corrosion process, and (2) fatigue cracking of the liner. The first concern has been addressed by selecting SA-335,

Figure 30. New thermal liner protecting the feedwater nozzle and elbow from thermal stratification loadings (Cofie et al. 1994). Copyright American Society of Mechanical Engineers; reprinted with permission.

Long thermal liners with 356-mm (14-in.) inside diameters were installed in loops 2 and 3 of Unit 2. The thermal liner, shown in Figure 30, extends over the nozzle-to-transition piece weld, transition piece, transition piece-to-elbow weld, and a portion of the elbow and protects these components from

the fatigue damage caused by thermal stratification and striping. It is estimated that the thermal liner is capable of sustaining the thermal fatigue loads caused by about 900 h of automatic operation of the auxiliary feedwater system. Online fatigue monitoring of Loops 2 and 3 of Sequoyah Unit 2 is being continued and it includes monitoring of both main and auxiliary feedwater temperatures.

Grade P11 as a liner material. The chromium content of this material is in the range of 1.0 to 1.5 wt%; therefore, as discussed in Section 7.2, significant wall thinning of the liner will not take place.¹ The second concern about fatigue cracking can be addressed by monitoring the outside wall temperature of the piping components protected by the liner. If there is any leakage of auxiliary feed water through the liner, it will affect the wall temperatures, which can be detected by the monitoring system. There is also a concern that thermal fatigue might damage the liner and produce loose parts. However, the broken pieces of the liner would have to be of such small size that they can pass through the 51-mm (2-in.) diameter J-tubes in order to damage the steam generator tubes. Long

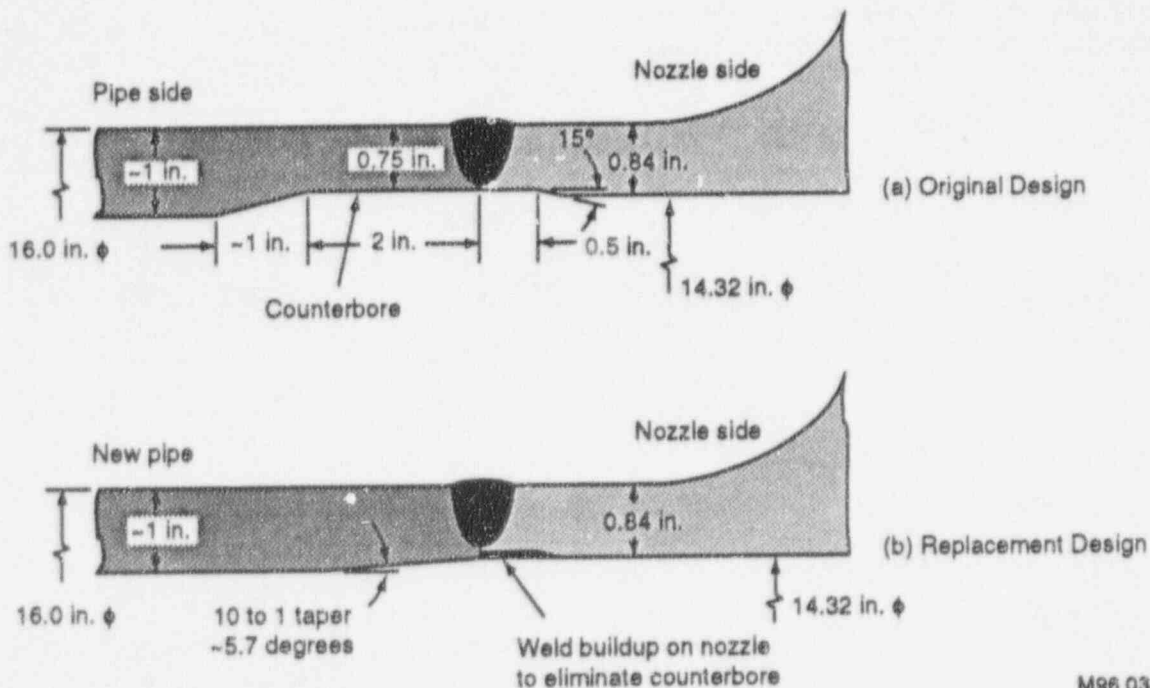
Figure 31. Weld buildup to eliminate counterbore as a stress raiser (Cofie et al. 1994). Copyright American Society of Mechanical Engineers; reprinted with permission.

Two other steps in addition to the installation of the thermal liner have been taken to provide protection against thermal fatigue damage: elimination of stress raisers and improved water chemistry. The end of the feedwater nozzle was built up such that there is no change in the wall thickness from the feedwater nozzle to transition piece, which eliminates the stress raiser where fatigue cracking occurred earlier. At least one other PWR has its feedwater nozzle ends built up to eliminate the stress raiser. Figure 31 shows how the counterbore region can be redesigned to eliminate the stress raiser. The utility is also eliminating copper from

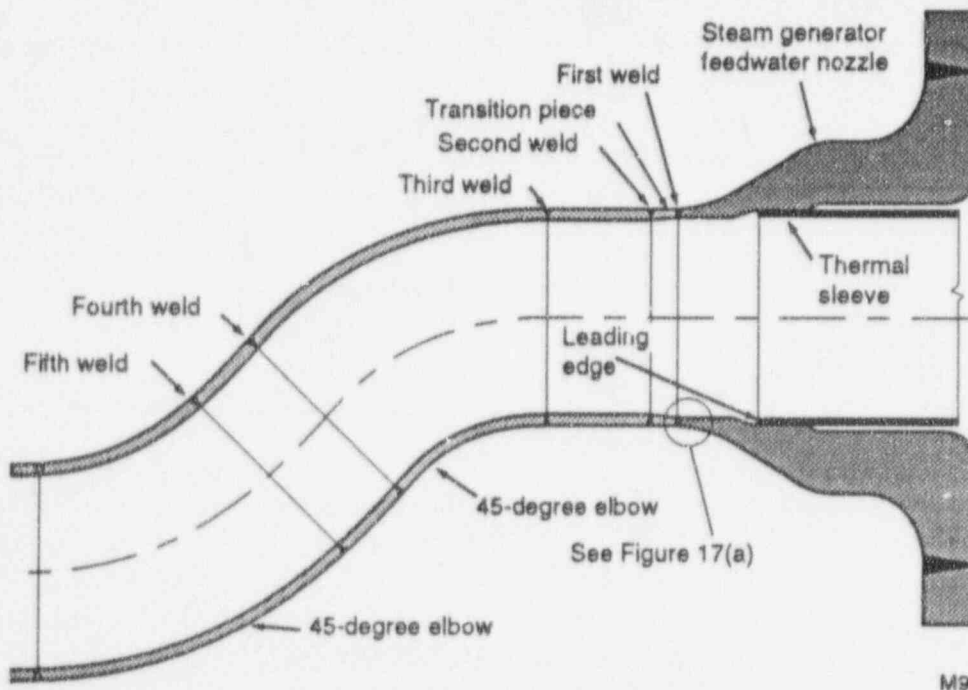
Diablo Canyon Units 1 and 2 are 4-loop Westinghouse PWRs. Figure 32 is a drawing of the SA-508 Class 2 steam generator nozzle and the adjacent SA-106 Grade B feedwater piping, typical for both units. A 51-mm (2-in.) long transition piece was field welded to the nozzle at the downstream end. At its upstream end, it is welded to a 203-mm (8-in.) long horizontal section of pipe, which in turn is welded to a 45-degree elbow. Figure 17 shows a construction drawing of the field welds (Cofie et al. 1994). The inside surfaces were counterbored in this region, resulting in a reentrant corner on each side of the weld at the transition to the thinnest section. Figure 17(a) shows that the thickness change is more pronounced, and the counterbore reentrant angle is

Figure 32. Feedwater nozzle area layout at Diablo Canyon Units 1 and 2 (Shvarts et al. 1994). Copyright American Society of Mechanical Engineers; reprinted with permission.

The discussion in Section 6.3 about feedwater nozzle cracking in the Salem 1 and Diablo Canyon 1 and 2 plants mentioned the thinning of the leading edge of the thermal sleeves, shown in Figure 32. Thermal sleeves at other Westinghouse (Prairie Island and Trojan) and Combustion Engineering (San Onofre and Arkansas Nuclear One Unit 2) plants have also experienced thinning. Wall thinning at this location had not been reported until recently (after 1989). The damage mechanism is believed to be flow-accelerated corrosion. In the original Westinghouse steam generators, slip-on type thermal sleeves were tightly fitted in the feedwater nozzle with

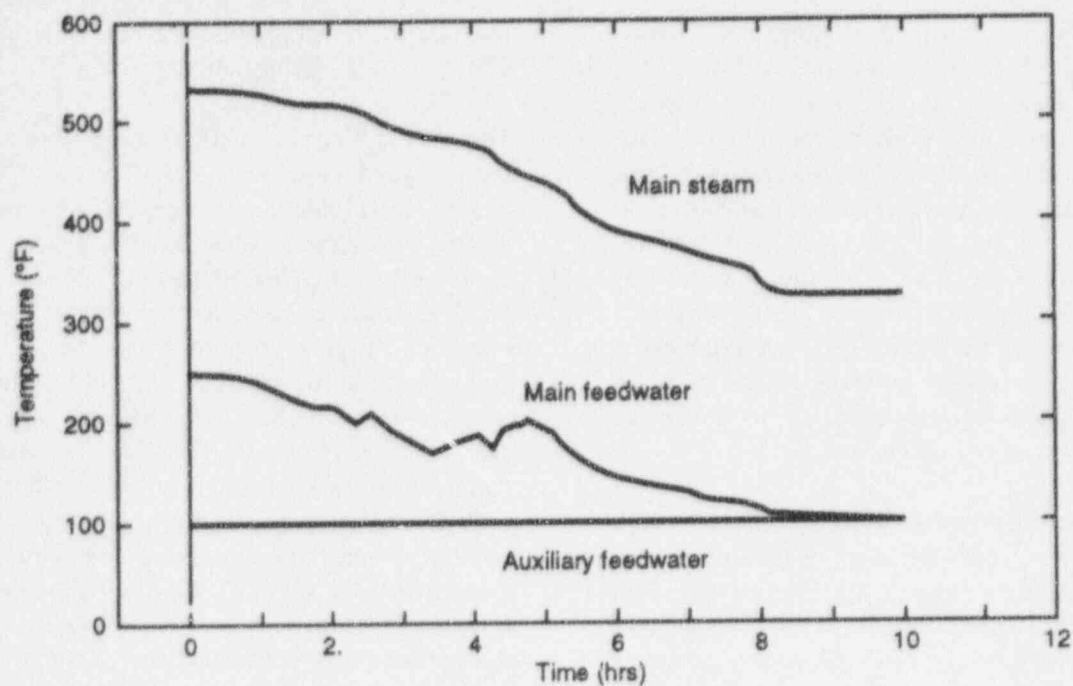
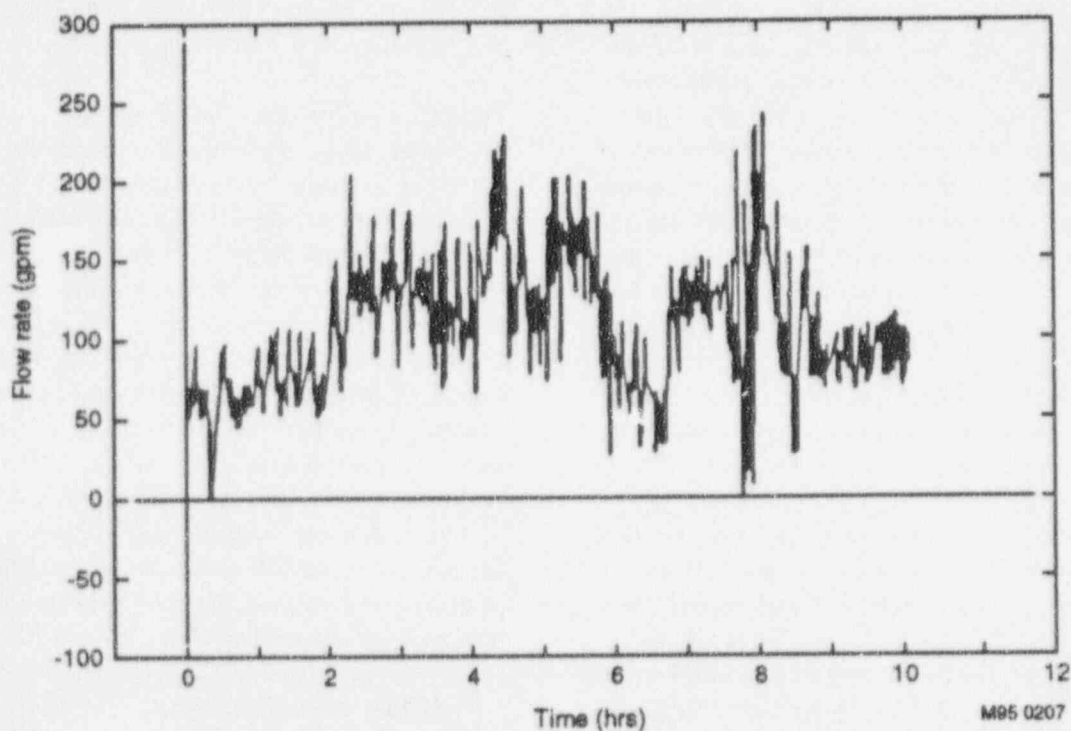
(a) Main steam, main feedwater, and auxiliary feedwater temperatures

(b) Auxiliary feedwater flow rates

Figure 33. Temperatures and flow rate during cooldown on 9/13/82 at Diablo Canyon Unit 1, Steam Generator 1 (Peterson 1992).

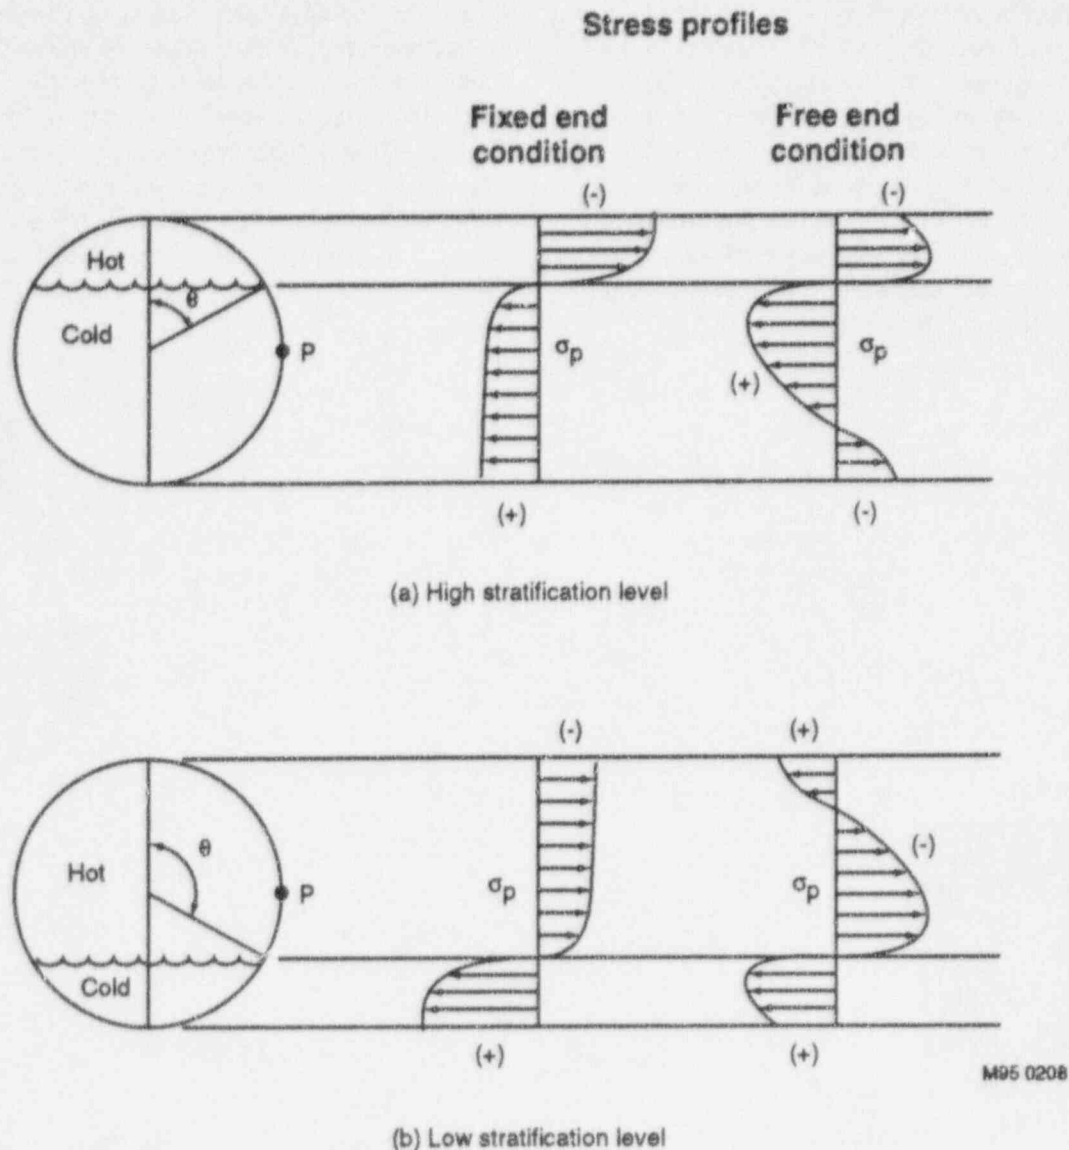
Figure 34. Distribution of axial stresses in a long horizontal feedwater pipe for two different elevations of hot-and-cold coolant interface and for two different boundary conditions for the pipe ends (Shvarts et al. 1994). Copyright American Society of Mechanical Engineers; reprinted with permission.

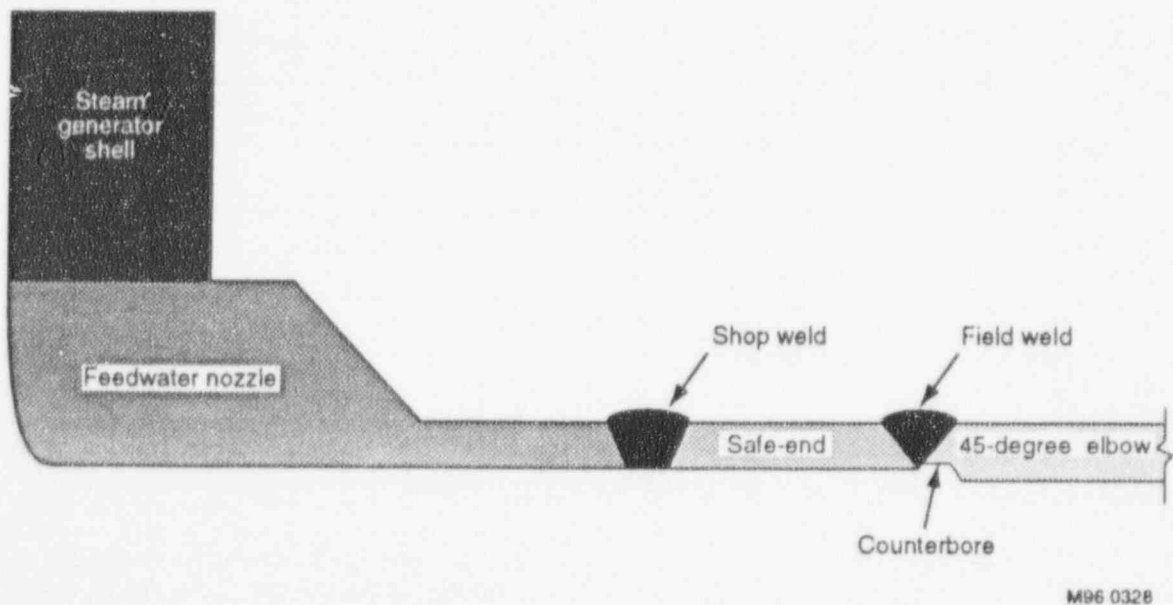
San Onofre Units 2 and 3 are 2-loop, System 80, Combustion Engineering PWRs. In this design, a safe end is welded to the nozzle in the shop, and a field weld connects the safe end to a 45-degree elbow, as shown in Figure 35. This elbow is the terminus of the feedwater piping, and it is welded to another 45-degree elbow at its other end. A counterbore has been machined into the safe-end-to-elbow weld area. The auxiliary feedwater inlet connects to the main feedwater system upstream of the two 45-degree elbows.

Figure 35. San Onofre Units 2 and 3 feedwater nozzle region (Mostafa and Ramsey 1994). Courtesy of E. Regala, Southern California Edison.

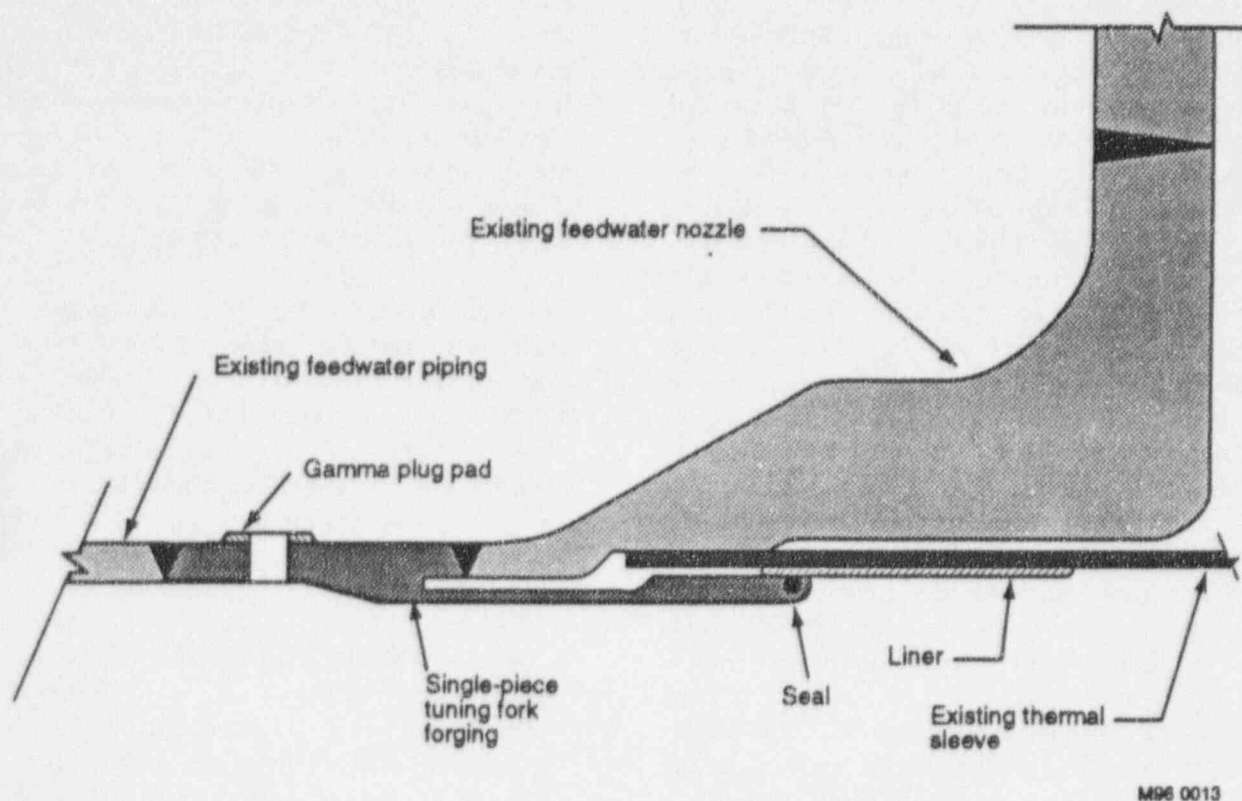
Figure 38. A redesigned feedwater nozzle-to-piping connection at Diablo Canyon Units 1 and 2 (Cofie et al. 1994). A single piece forging protects the thermal sleeve from flow-accelerated corrosion damage and feedwater nozzle weld from thermal fatigue damage. Copyright American Society of Mechanical Engineers; reprinted with permission.

A single-piece *tuning fork* forging (shown in Figure 38), sometimes referred to as a *transition piece*, was installed in Units 1 and 2 in 1994. The forging is made of SA-508 Class 2 low-alloy steel having 0.25 to 0.45 wt% chromium, which provides improved resistance to flow-accelerated corrosion. The ends of the transition piece are welded to the feedwater piping and nozzle. The downstream end of the forging supports a sealing device consisting of a spring and a piston ring installed in a groove to provide a tight seal between the forging and a thin liner installed inside the original thermal sleeve. The chromium content

of the liner material was greater than 0.1 wt%. The counterbore was eliminated, which reduces the thermal stresses and the potential for fatigue cracking at the pipe-to-nozzle junction. Thus the forging protects the leading edge of the thermal sleeve from flow-accelerated corrosion and protects the feedwater piping and nozzle from fatigue damage.

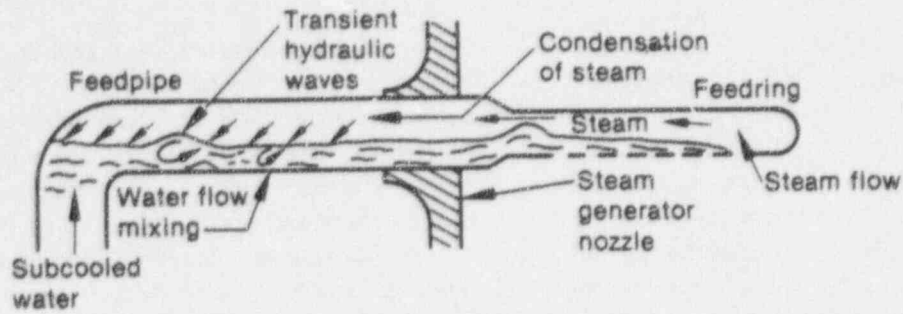
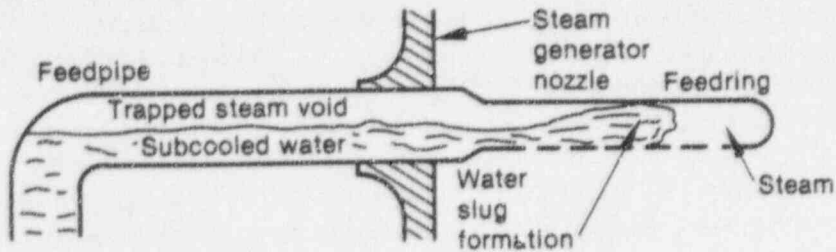
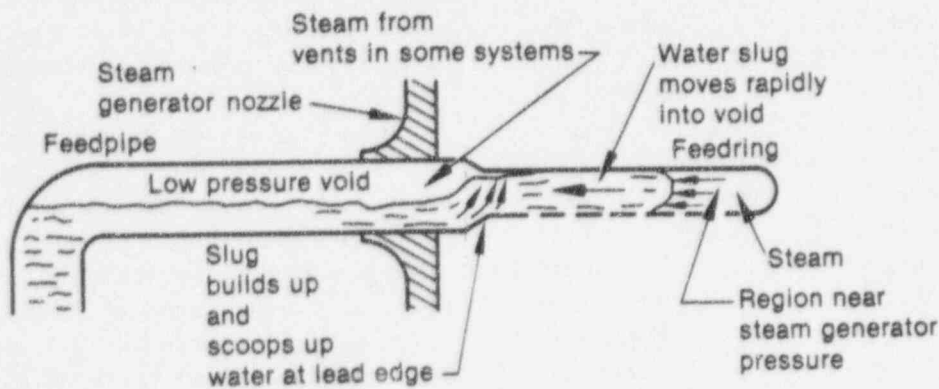
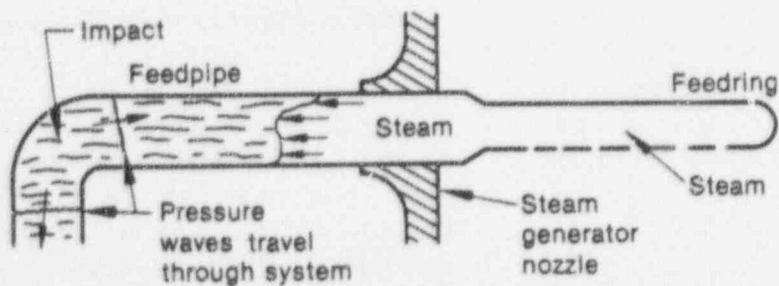
The sequence of events presented in Figure 40 has generally been accepted as a cause for steam generator water hammer occurrences (Han and Anderson 1982). This mechanism has been demonstrated with experiments reported by Block et al. (1976). Initially, the upper portions of the drained feeding and the horizontal length of the adjacent feedwater piping are filled with steam. When auxiliary feedwater flow, which is usually highly subcooled, is resumed, it enters the horizontal run of the feedwater piping into the feeding and flows under the steam blanket as shown in Figure 40(a). If the flow rate is high, interaction forces between the steam and water can

Figure 40. Sequence of events leading to water hammer (Han and Anderson 1982).

create enough turbulence to form a slug, as shown in Figure 40(b). The slug seals the main feedwater line and thus prevents the normal flow of steam from the steam generator from replenishing the trapped steam void being condensed by the cold feedwater layer. As steam is condensed at the steamwater interface, the pressure of the trapped steam drops, and, as a result, a slug accelerates into the void, away from the steam generator, as shown in Figure 40(c). The forces causing acceleration of the slug can be very large and include the steam generator pressure, which can be in excess of 1000 psi, on one side and trapped vapor pressure on the other side. As the condensation continues, the trapped steam pressure decreases and, as a result, the slug achieves a very high velocity. As shown in Figure 40(d), when a slug traveling with a high velocity impacts an incoming water column, a pressure pulse is produced. The velocity of the slug at the time of impact depends on the acceleration forces acting on it and the distance it has traveled. This distance is usually equal to the length of the horizontal section of the feedwater piping adjacent to the feedwater nozzle. The pressure pulse may be as high as thousands of psi for a severe water hammer. However, because of the incompressibility of the water, inelastic expansion of piping reduces the amplitude of the pressure wave and a smaller value is transmitted through the system (Izenson, Rothe, Wallis 1988). The pressure pulse travels throughout the system and could damage the feedring, piping and supports, or valve internals, such as a check valve disk.

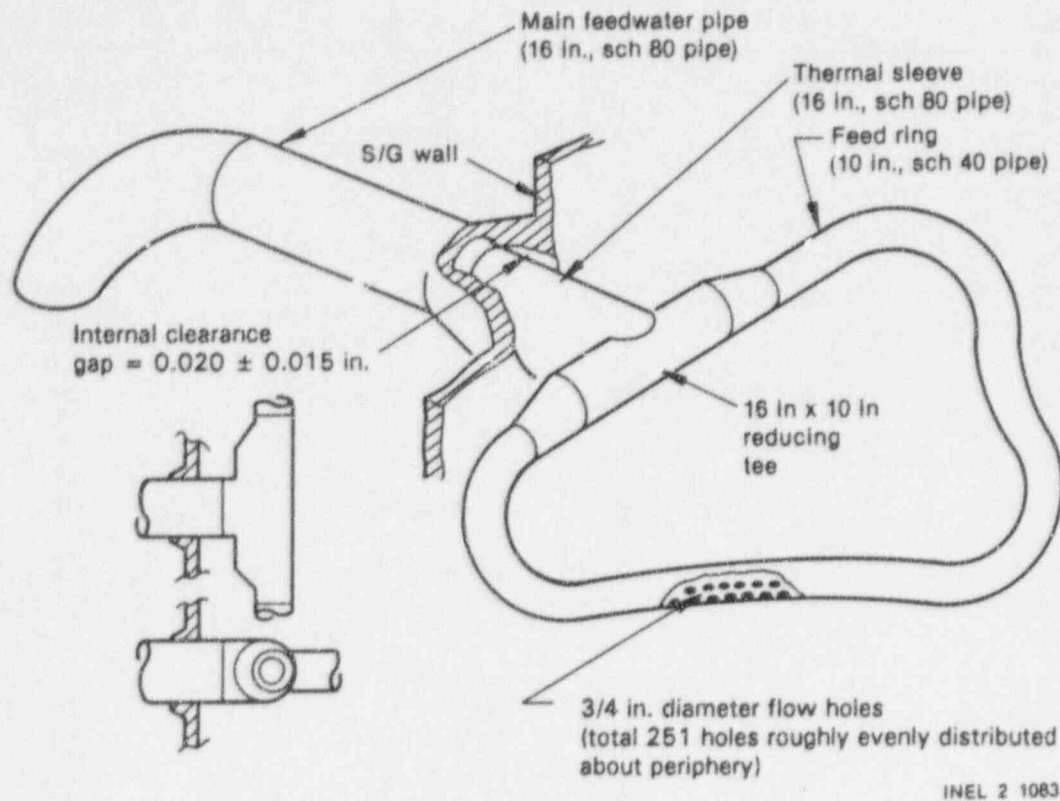
The original feedrings in the top-feed steam generators had bottom-discharge holes, as shown in Figure 41. When the water level in the steam generator dropped below the feedring, the feedring became uncovered and drained in 1 to 2 minutes. As discussed, the draining of a feedring can lead to a water hammer. The design of the feedrings was eventually modified at most of the operating Westinghouse and Combustion Engineering units to mitigate water hammers. The holes in the bottom-discharge feedring were plugged, and J-tubes or discharge elbows were installed on the top of the feedring, as shown in Figures 5 and 14.

Figure 41. Older vintage feeding design for top feed steam generators (Han and Anderson 1982).

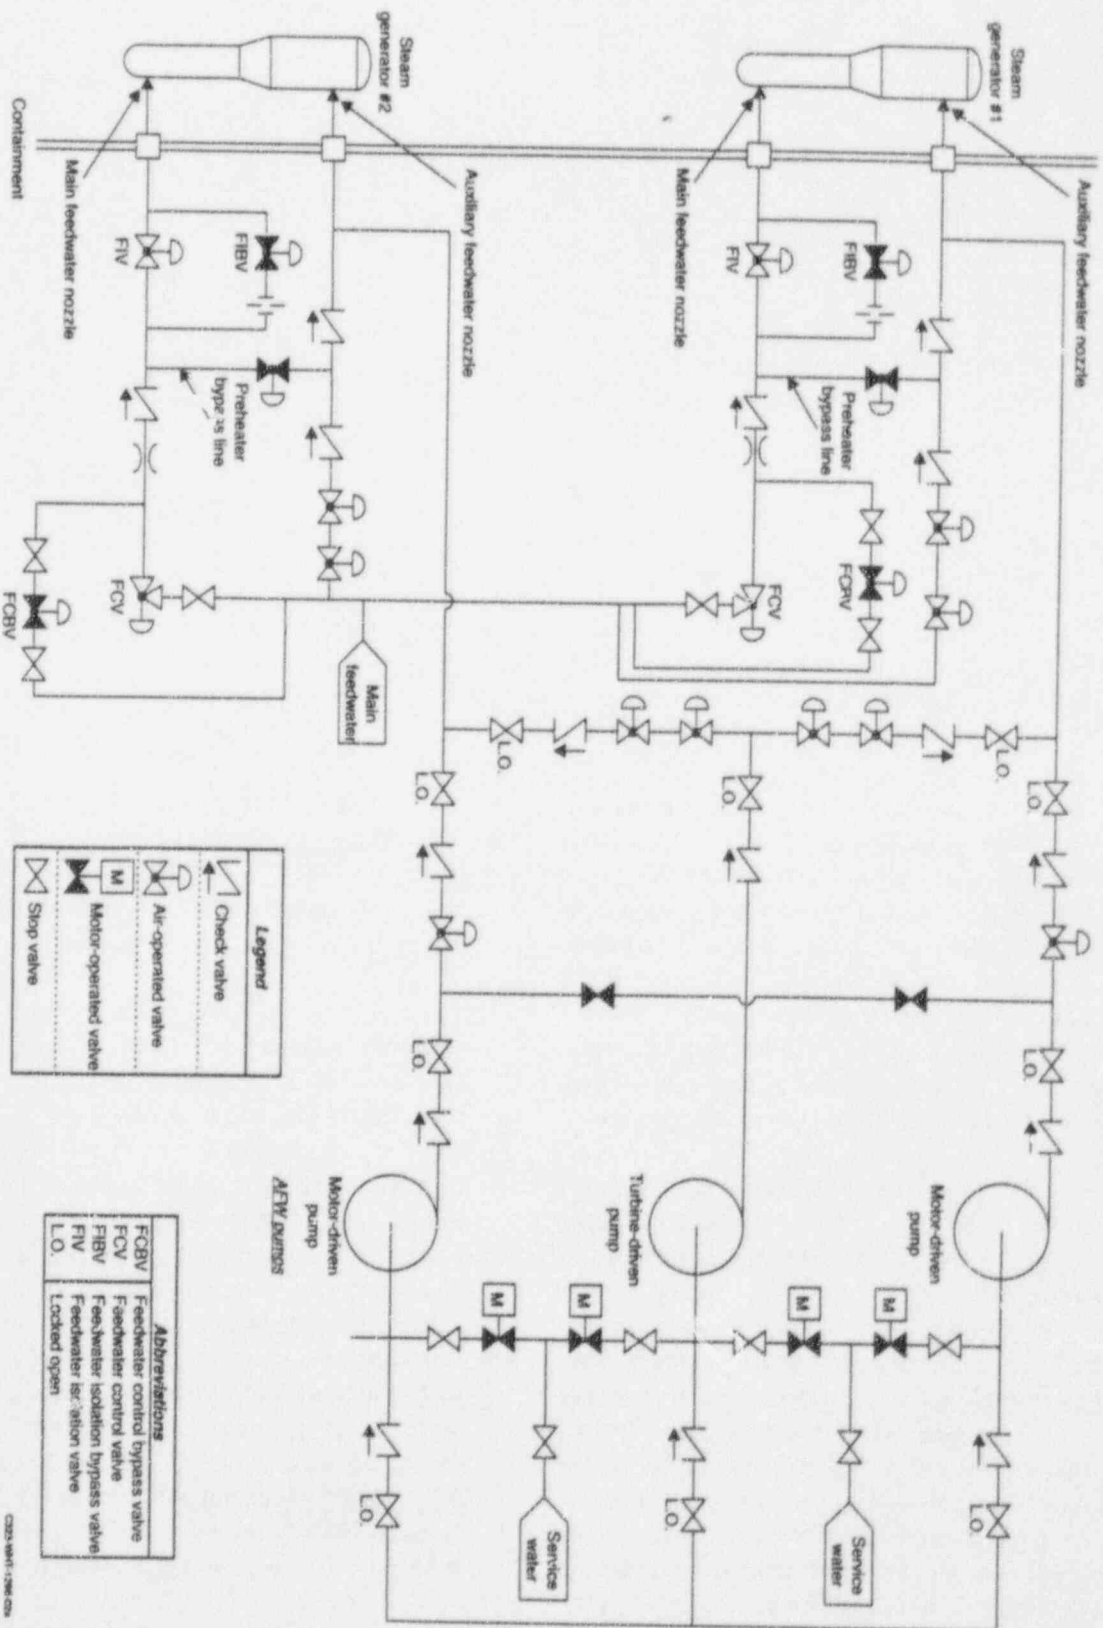
ational testing of the auxiliary feedwater line. The schematic for the main and auxiliary feedwater systems for KRSKO is shown in Figure 42.

Figure 42. Main and auxiliary feedwater systems for KRSKO (Sexton, Kasahara, and Uffler 1982).
