UNITED STATES
NUCLEAR REGULATORY COMMISSION

AEOD/E97-01

SUBJECT: "REVIEW OF INDUSTRY EFFORTS TO MANAGE PRESSURIZED
WATER REACTOR FEEDWATER NOZZLE, PIPING, AND FEEDRING
CRACKING AND WALL THINNING," NUREG/CR-6456
(INEL 96/0089)

Review of Industry Efforts To Manage Pressurized Water Reactor Feedwater Nozzle, Piping, and Feedring Cracking and Wall Thinning

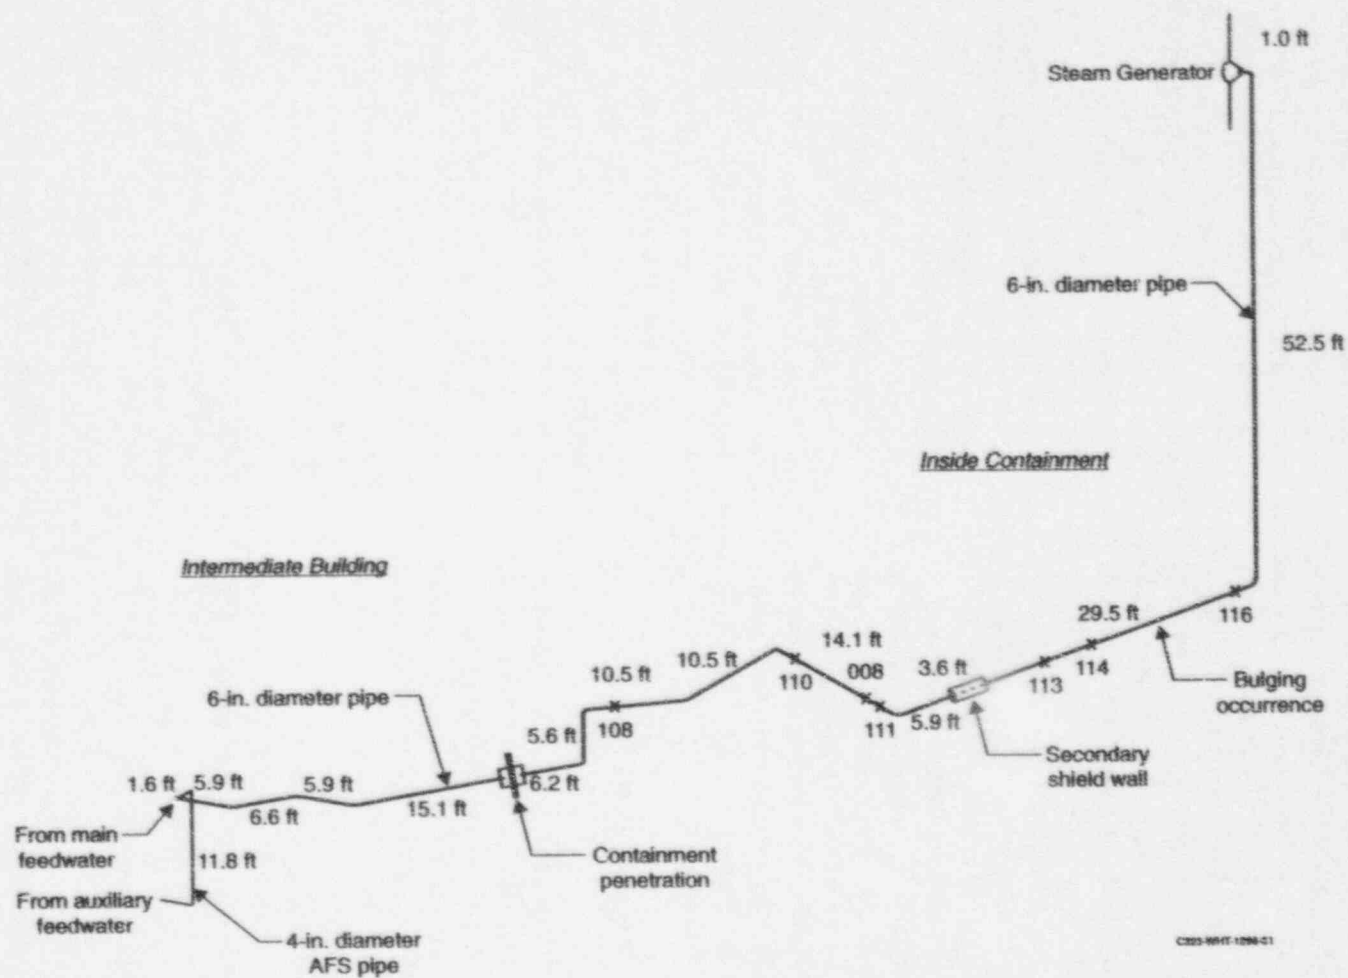
The water hammer at KRSKO was caused by a steam bubble collapse in an auxiliary feedwater line during a hot functional test in July, 1981. The horizontal portion of the line where the water hammer occurred was about 16 m (52.5 ft) below the auxiliary feedwater nozzle, as shown in Figure 43. The auxiliary feedwater pumps were being run intermittently during the test. Damage was mainly limited to inside the containment: the piping was shifted and bulged about 6 mm (0.25 in.) near the secondary wall (the probable location of water slug impact), and the pipe hangers were damaged. The piping movement was negligible in the intermediate building but paint on the auxiliary feedwater piping was blistered back to the motor-driven auxiliary feedwater pumps (Sexton, Kasahara, and Uffer 1982).

here. The steam generator water level was below the elevation of the auxiliary feedwater nozzle internal extension discharge. Then the significant back leakage of steam from the steam generator through the auxiliary feedwater line took place and caused the observed paint damage back to the motor-driven auxiliary feedwater pumps. The check valves in the discharge and suction lines of the auxiliary feedwater pumps had to have leaked to allow the back leakage of steam. The significant back leakage also resulted in the presence of steam in the horizontal portion of the auxiliary feedwater line. Then, when the cold feedwater was introduced into this portion of the line, the water hammer caused by steam bubble collapse occurred (Sexton, Kasahara, and Uffer 1982).

Figure 43. KRSKO Loop 2 auxiliary feedwater systems for KRSKO (Sexton, Kasahara, and Uffer 1982). (1 in = 25.4mm)

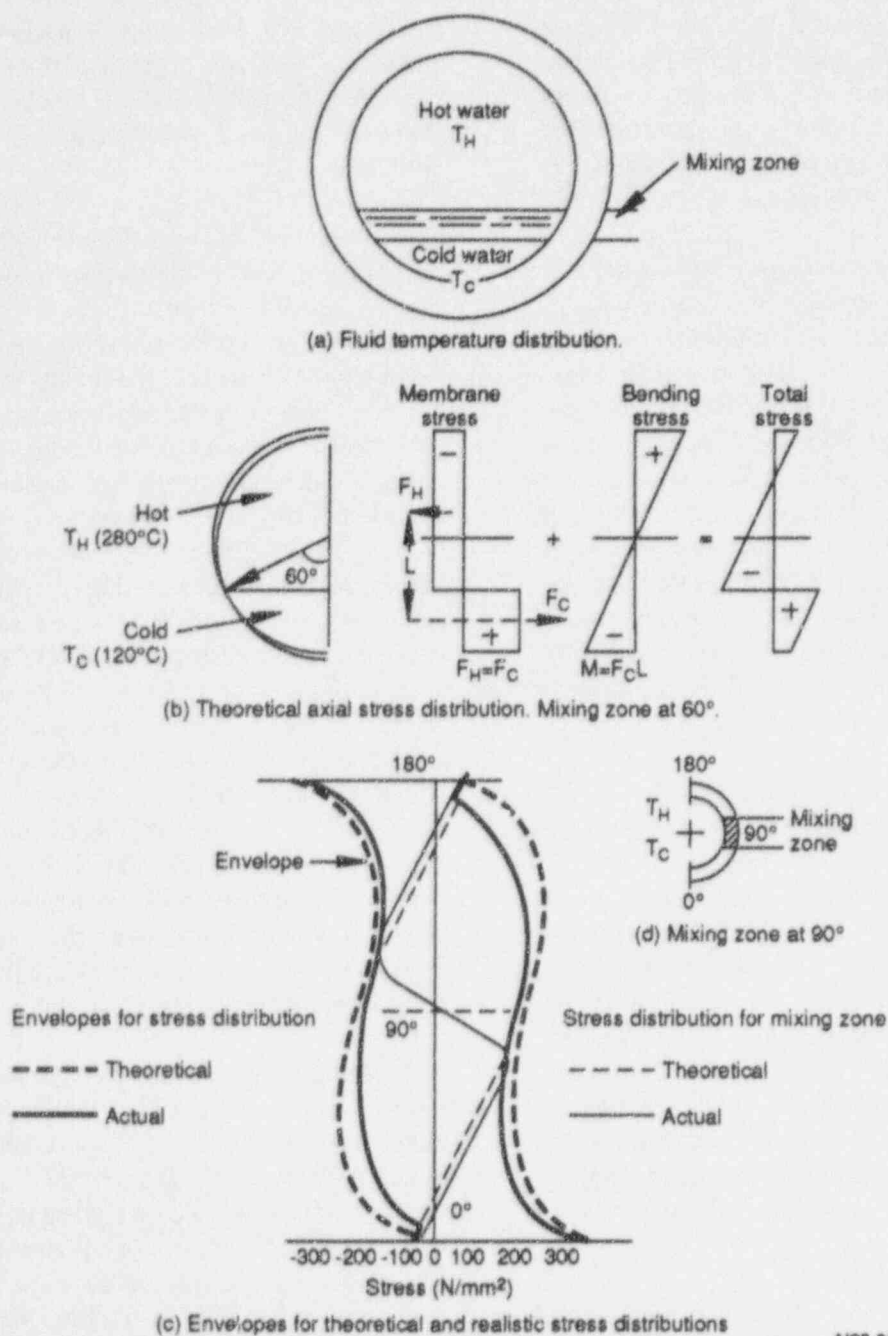
An interface layer (mixing zone) is developed between the hot and cold fluid layers, as shown in Figure 44(a) (Miksch et al. 1985). The elevation of the interface layer (height of the cold fluid layer) and its thickness depend primarily on the mass

Figure 44. Thermal stresses in a pipe with stratified flow (Miksch et al. 1985). Copyright Elsevier Science Publishers; reprinted with permission.

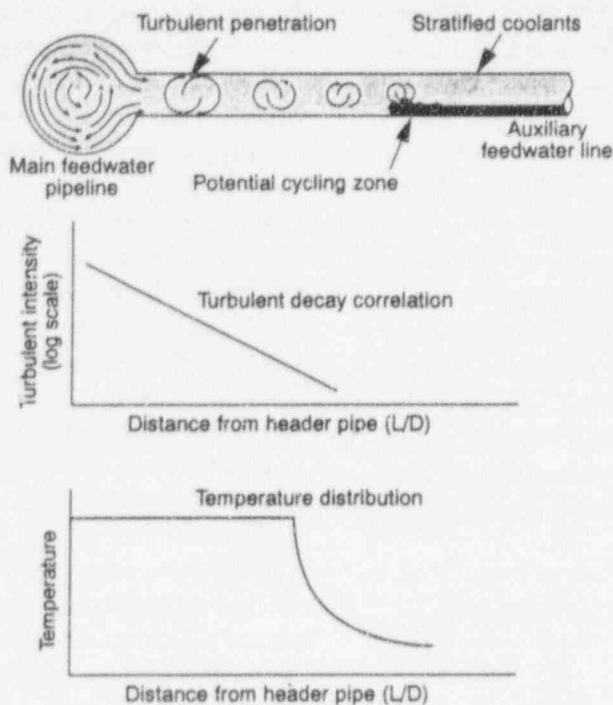
leakage. Figure 46 illustrates how the turbulence in the main piping, such as main reactor coolant piping or feedwater piping, penetrates into a connecting branch line such as a safety injection line or an auxiliary feedwater line. The turbulence intensity decays exponentially from the header pipe into the branch line, but the temperature remains fairly constant over the length of several diameters and then decays. The length of turbulent penetration changes with time, and it is greater for a higher flow velocity in the main pipe and smaller for an increasing stratified flow in the branch line.¹

Figure 46. Turbulence interaction regions (Roarty 1993). Copyright Electric Power Research Institute; reprinted with permission.

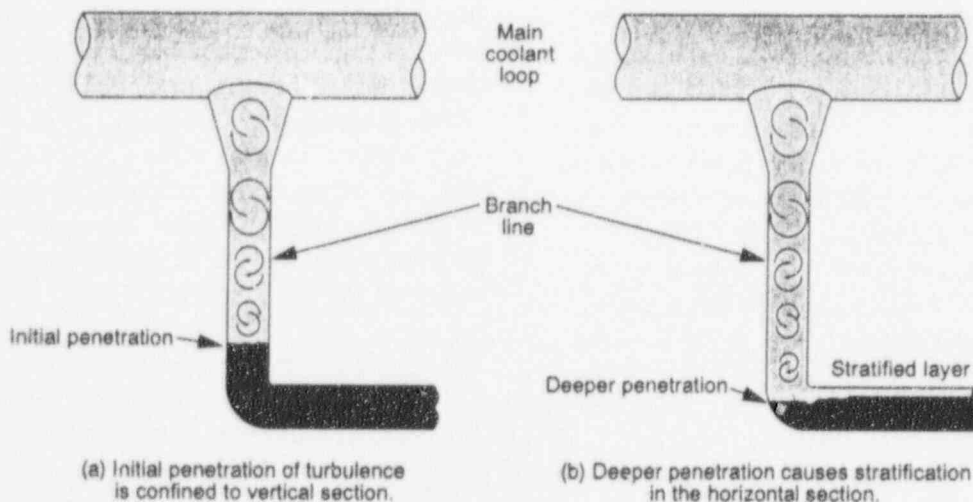
Figure 47(a). Then, an operational transient such as a power change caused the turbulence to penetrate the full length of the vertical section and produce stratification in the elbow at the end and in the adjacent horizontal section of the branch line, as shown in Figure 47(b). With further changes

in power, the length of the turbulent penetration receded and the stratified layer was no longer present. Thus, the base metal and welds of the elbow and the horizontal portion of the branch line experienced cyclic thermal stresses and fatigue damage.

Figure 47. A change in the penetration depth of turbulence from power variations can cause thermal stratification and cycling in a branch line (Martin 1993).

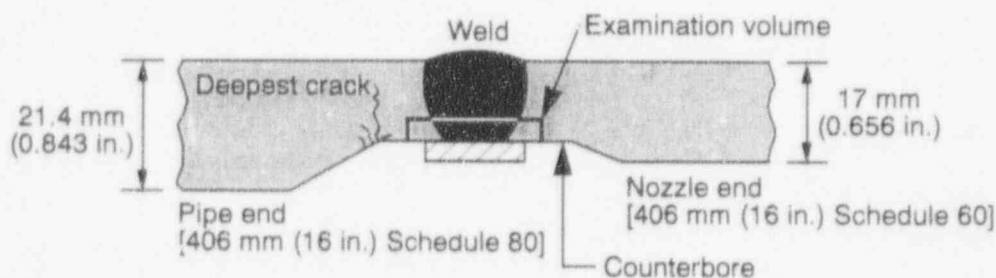
As a result of these inspections, cracking was detected in 18 operating PWRs. The cracks were generally oriented circumferentially and located either at the weld root location or at the reentrant corner of the counterbore on the upstream (pipe) side of the nozzle weld, as shown in Figure 57. The cracking was determined to be caused by thermal fatigue, possibly assisted by the corrosive environment of the secondary system. As shown in the figure, cracking occurred at some plants at the counterbore corner outside the Code examination volume and, therefore, could have been overlooked during previous periodic inservice inspections. Several plants also noted pitting, which was revealed by destructive analysis. Code ultrasonic examination methods employ angle beam techniques (i.e., 45-degree shear waves) designed to detect cracks but not pits. Pit detection requires use of specialized, small-diameter, focused 0-degree probes.

Figure 57. Typical PWR feedwater nozzle-to-pipe weld with geometric discontinuity (counterbore) and cracking outside the Code examination volume.
