RADIOLOGIC AND ENGINEERING ASSESSMENT

DOE ID NO.: GJ-03491-RS  
ADDRESS: 2028 LINDA LANE

SEPTEMBER 1985

BENDIX FIELD ENGINEERING CORPORATION  
P.O. Box 1569  
Grand Junction, Colorado 81502

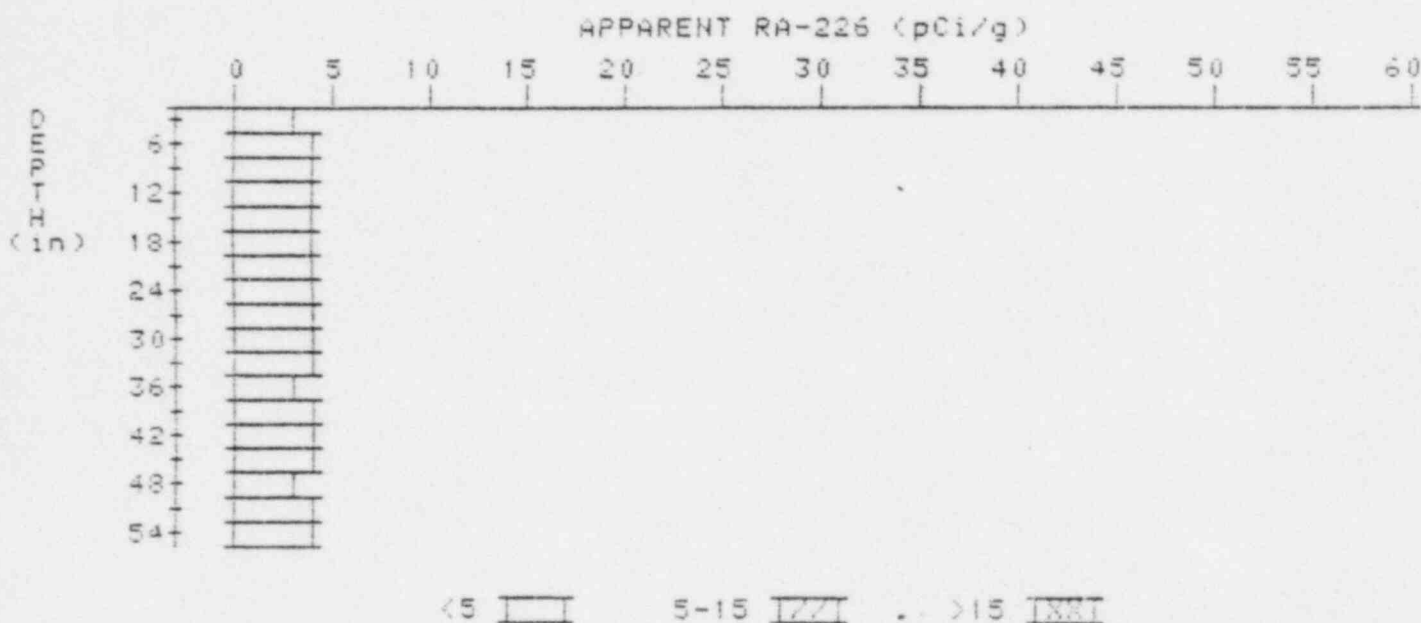
PROPERTY NUMBER: GJ-03491-RS  
HOLE NUMBER: 10  
LOCATION: 176231

# APPARENT RADIUM-226 CONCENTRATION 10 DECONVOLUTION GRAPH

Depth (in)	Apparent Radium-226 (pCi/g) Undeconvolved	Apparent Radium-226 (pCi/g) Deconvolved
3	3.4	3.4
6	3.6	3.8
9	3.7	3.7
12	3.8	3.8
15	3.9	4.1
18	3.9	3.9
21	3.9	3.7
24	4.0	4.4
27	3.9	3.8
30	4.0	4.4
33	3.9	4.1
36	3.7	3.3
39	3.7	3.7
42	3.7	3.8
45	3.8	4.2
48	3.7	3.6
51	3.8	4.0
54	3.8	3.8
