RADIOLOGIC AND ENGINEERING ASSESSMENT

DOE ID NO.: GJ-12956-RS
ADDRESS: 310 WEST OURAY AVENUE

SEPTEMBER 1985

BENDIX FIELD ENGINEERING CORPORATION
P.O. Box 1569
Grand Junction, Colorado 81502

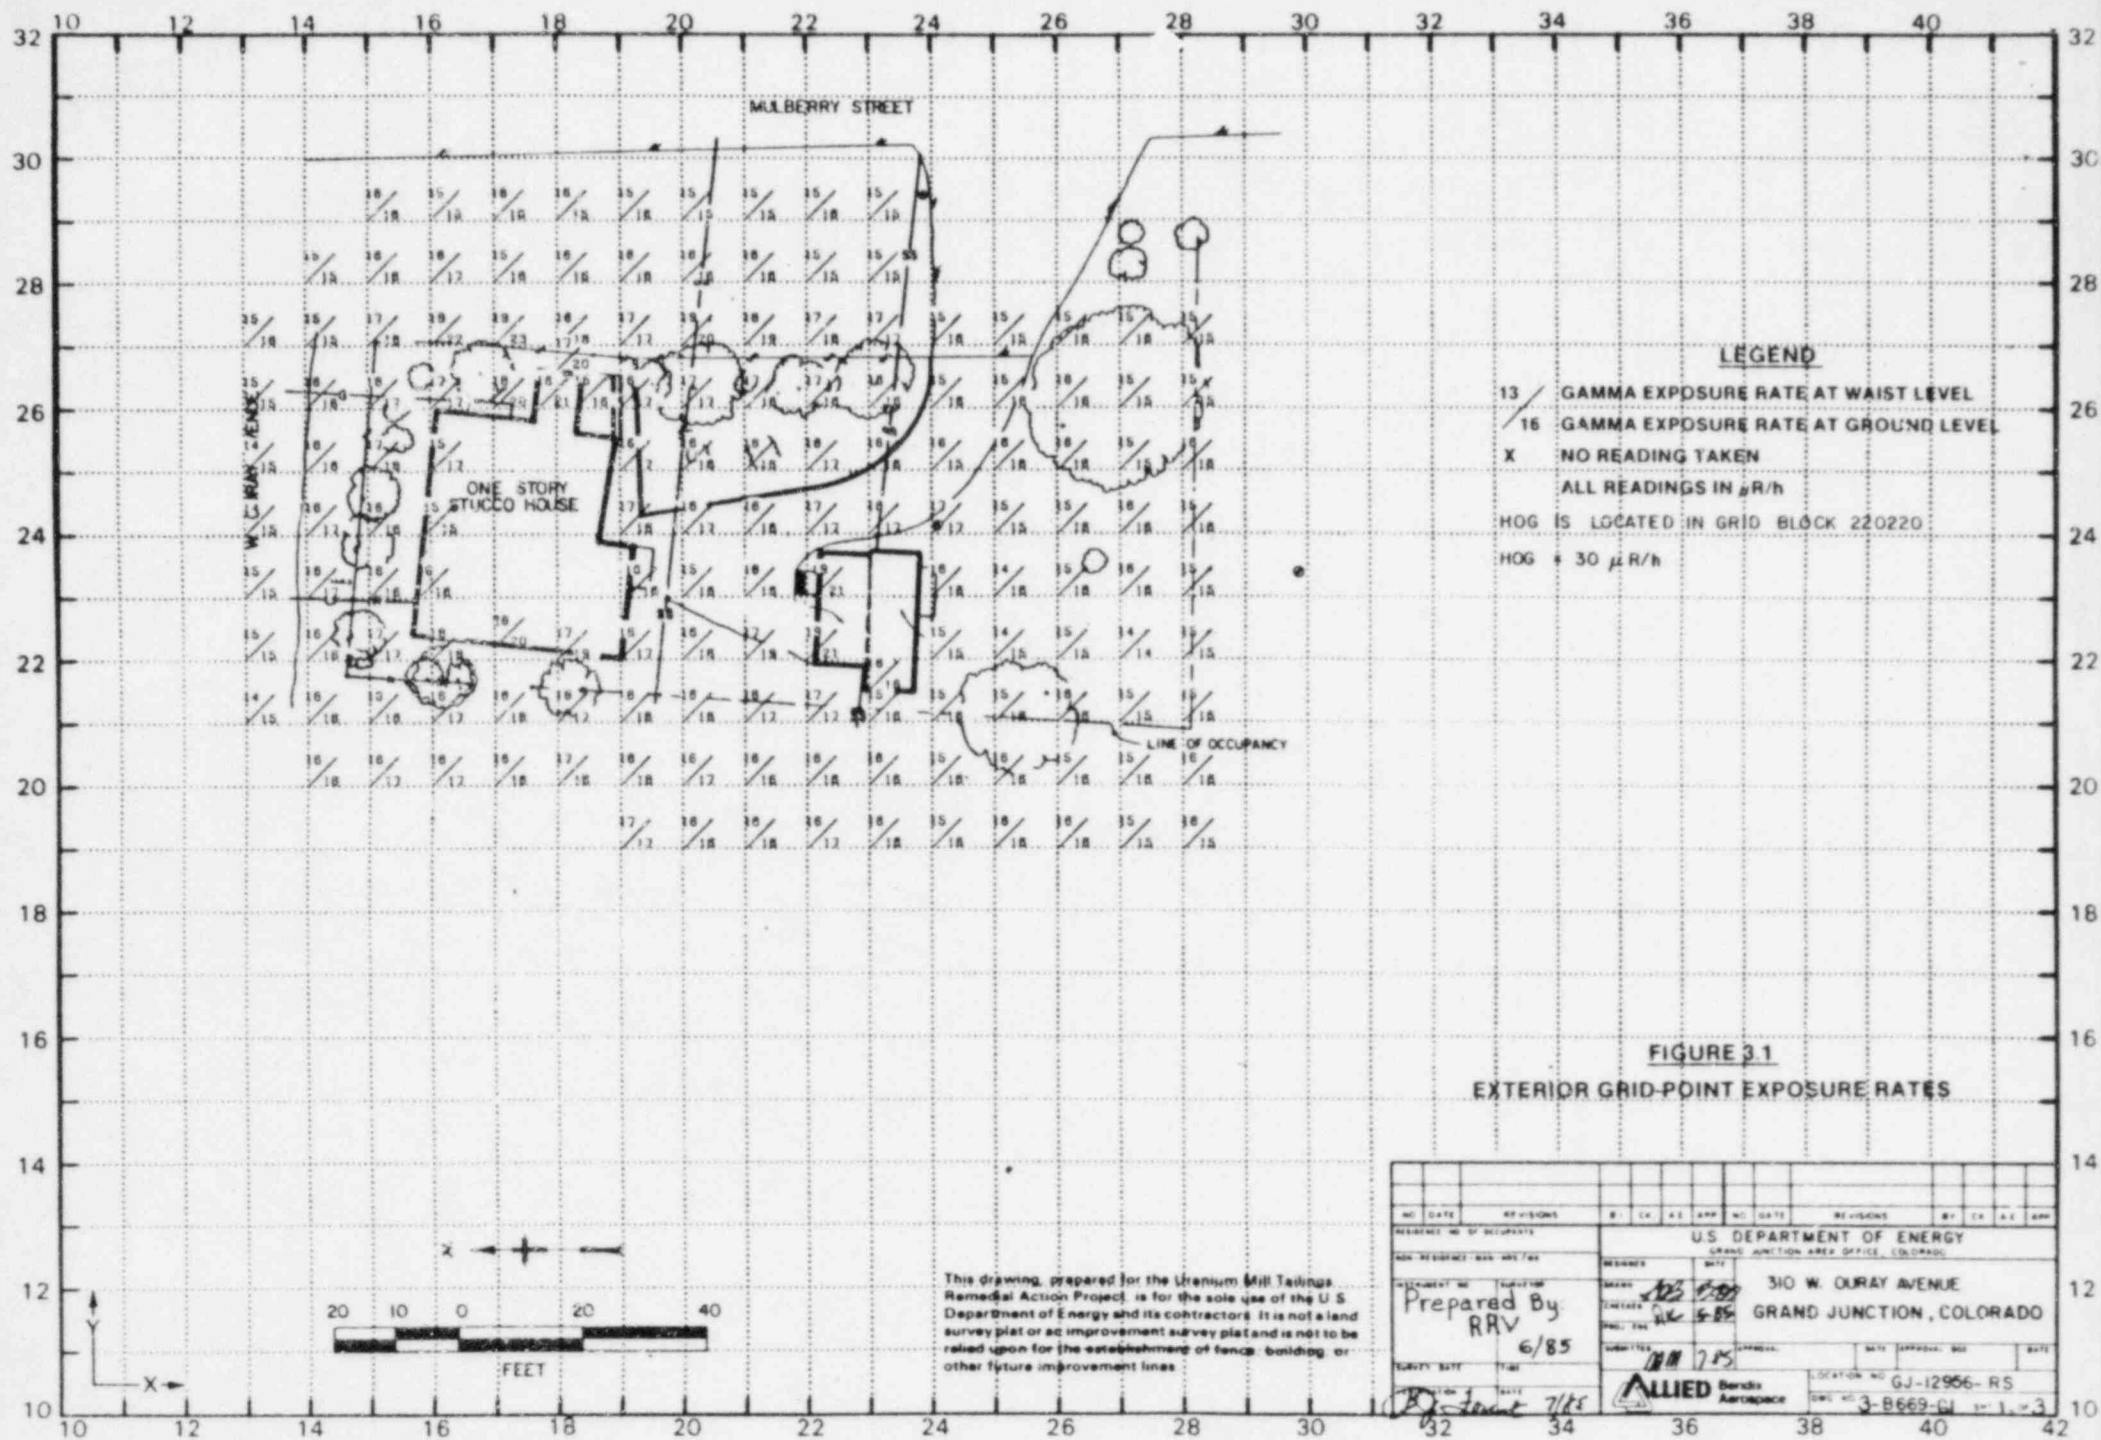
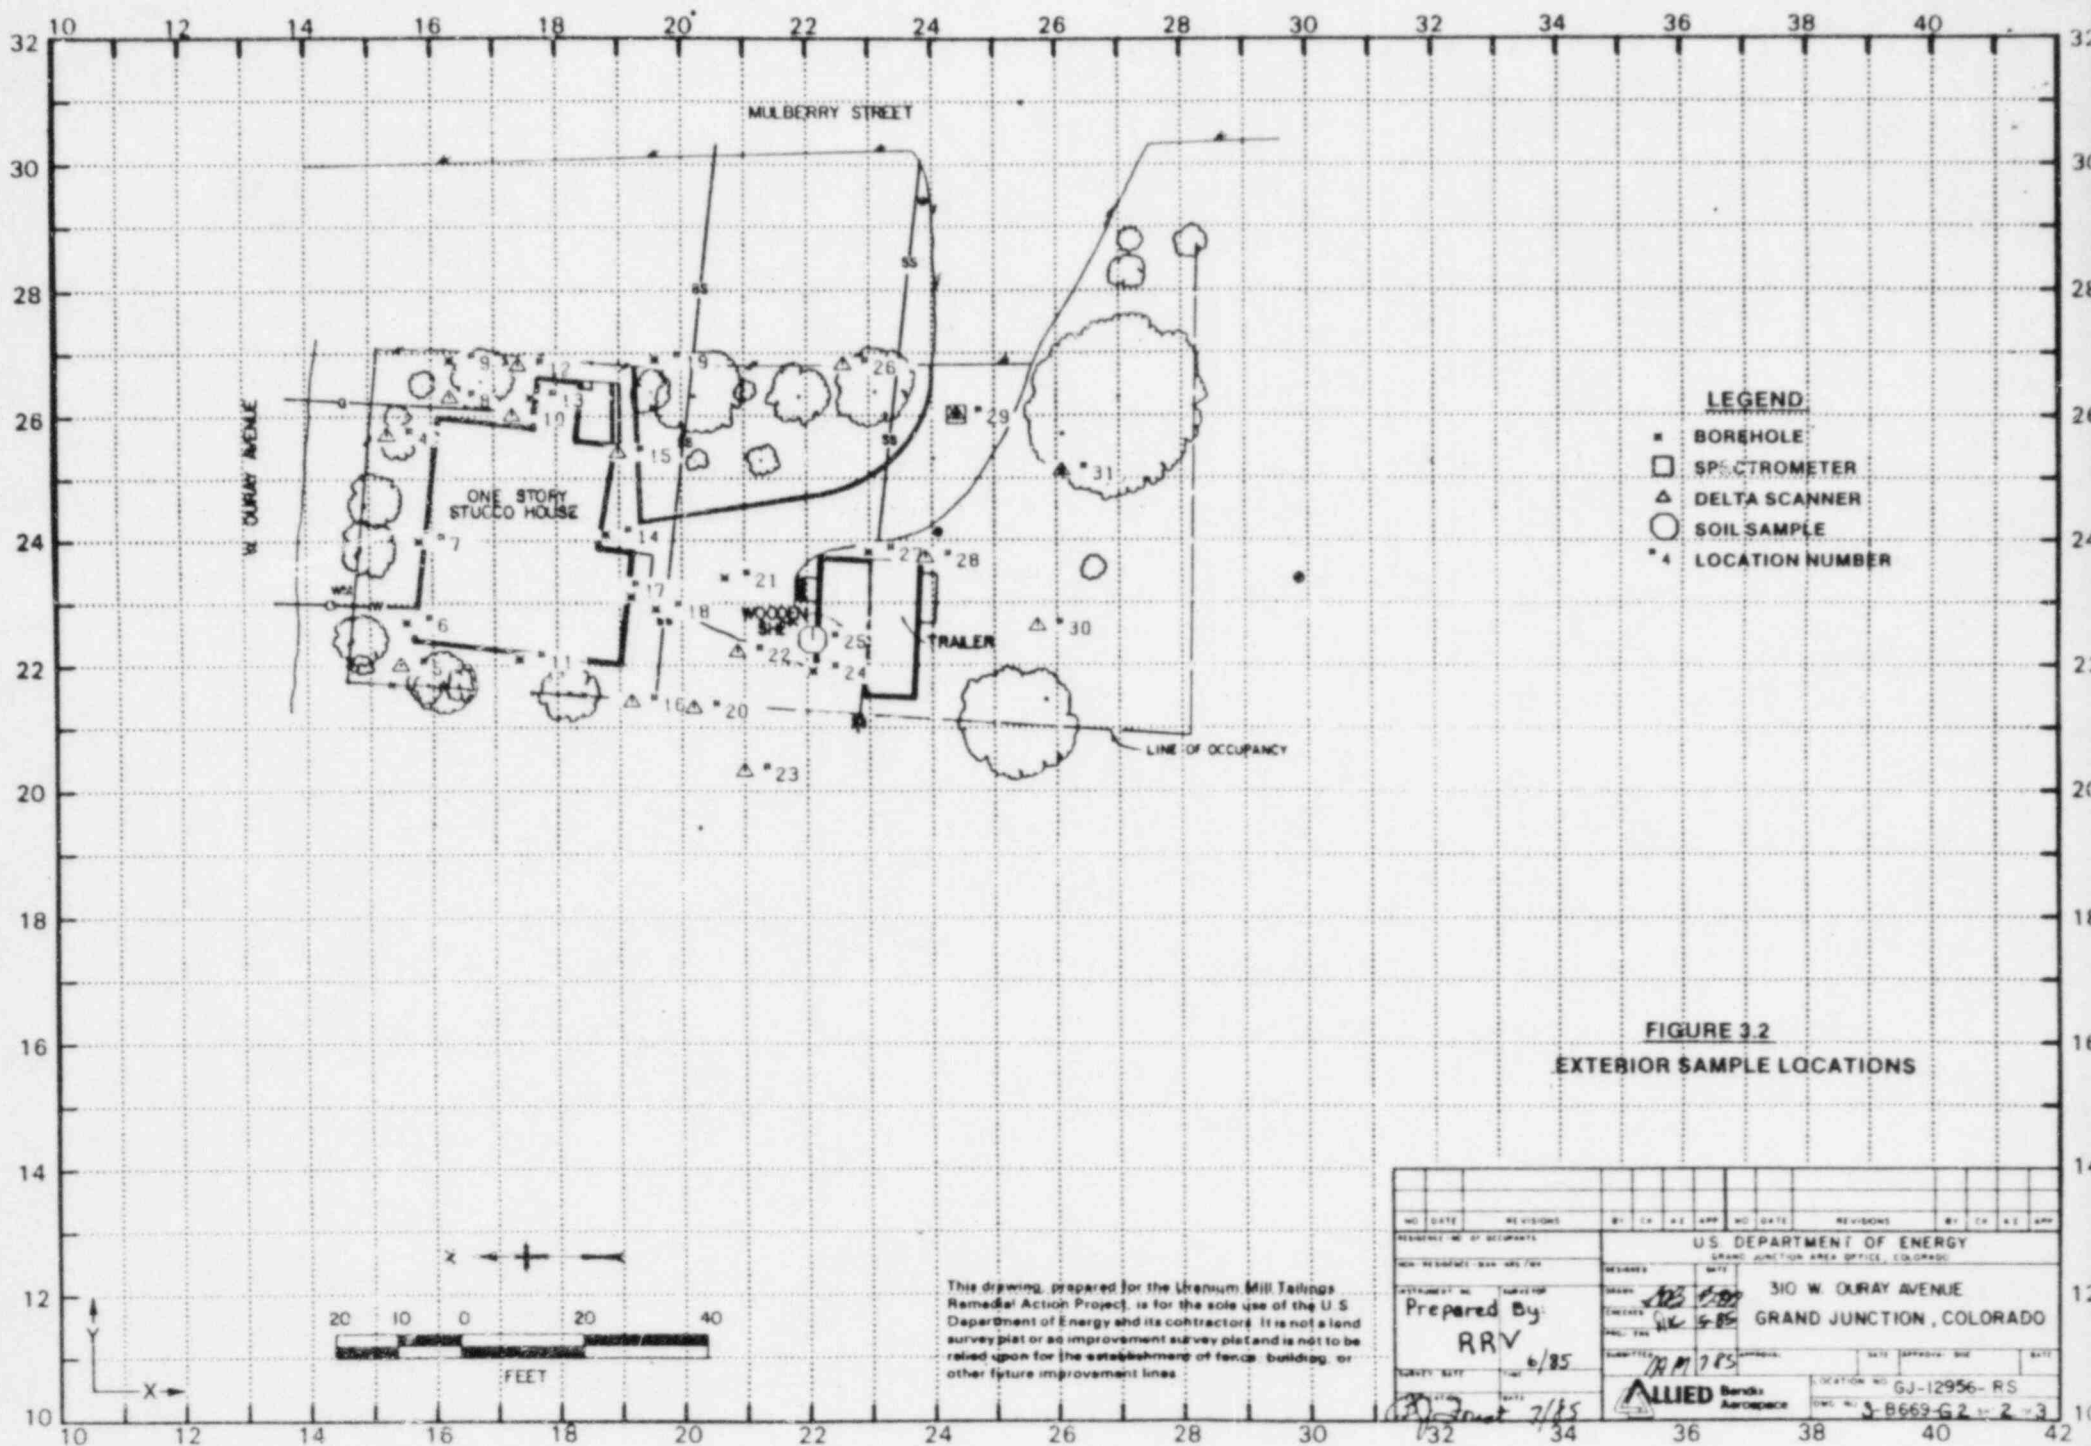
Appendix Figure 3.3 shows identified areas and estimated depths of contamination on this property, based on assessments of all measurements taken. As noted in this figure, areas recommended for remedial action that contain identified residual radioactive materials are:

The recommended remedial action for this property, DOE ID No. GJ-12956-RS, includes removal of all areas identified as containing radioactive material (as discussed in Section 3.5 and shown in Appendix Figure 3.3) and transport of removed material to the disposal site.

Area I is on an unmaintained site with an abandoned house. Although it falls outside the line of occupancy, Area I is recommended for remedial action in conjunction with remedial action at 310 West Ouray because the contamination is surface brick debris originating from the 310 West Ouray property.

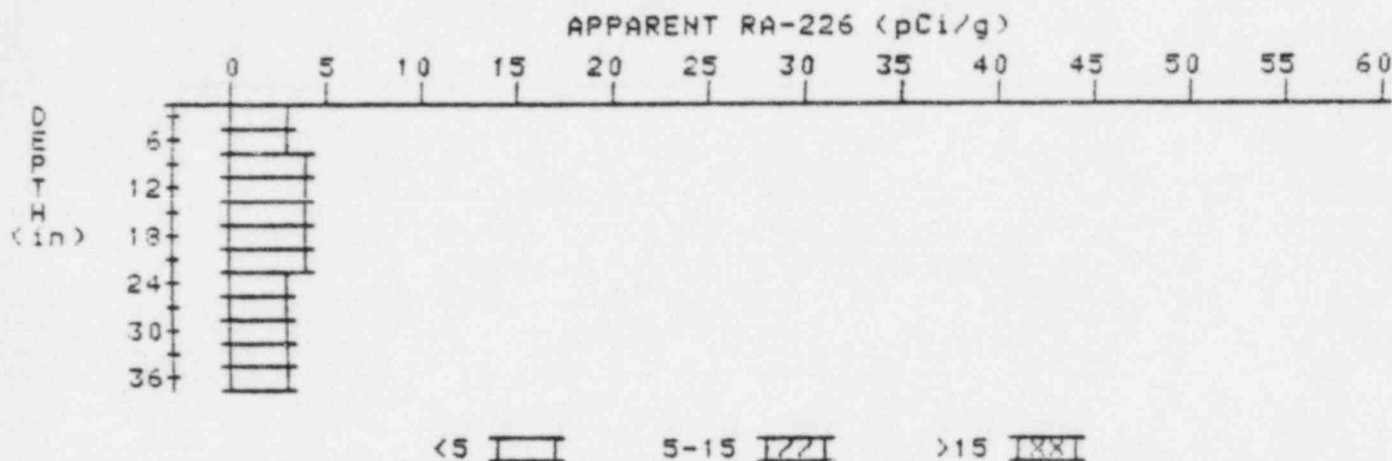
HOLE NUMBER: 6

Depth (in)	Apparent Radium-226 (pCi/g) Undeconvolved	Apparent Radium-226 (pCi/g) Deconvolved
3	3.3	3.3
6	3.4	3.4
9	3.5	3.7
12	3.5	3.5
15	3.5	3.5
18	3.5	3.5
21	3.5	3.7
24	3.4	3.4
27	3.3	3.1
30	3.3	3.3
33	3.3	3.1
36	3.4	3.4

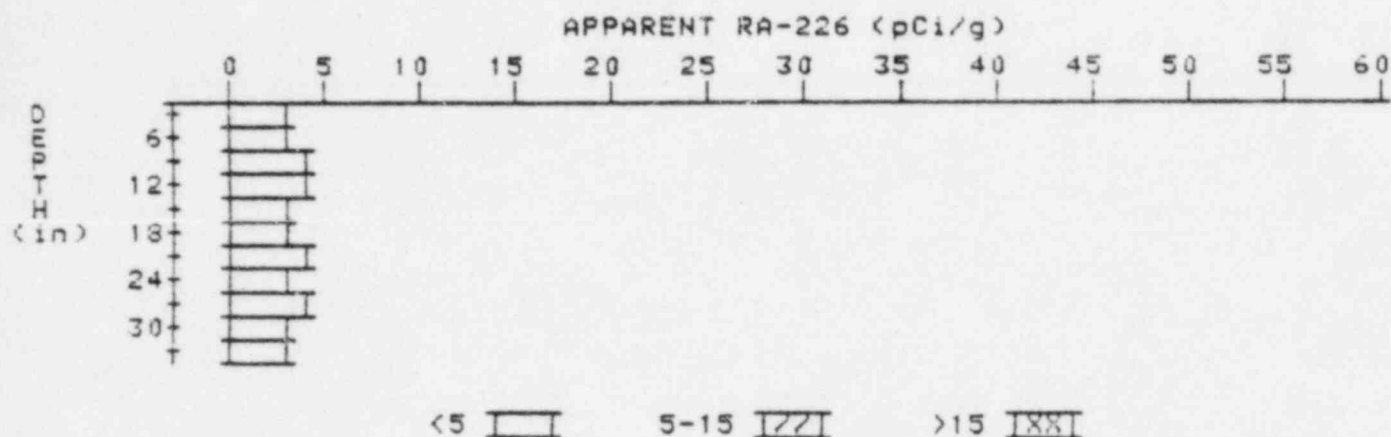
HOLE NUMBER: 7

Depth (in)	Apparent Radium-226 (pCi/g) Undeconvolved	Apparent Radium-226 (pCi/g) Deconvolved
3	3.0	3.0
6	3.2	3.2
9	3.4	3.6
12	3.5	3.9
15	3.4	3.2
18	3.4	3.2
21	3.5	3.9
24	3.4	3.2
27	3.4	3.6
30	3.3	3.1
33	3.3	3.3

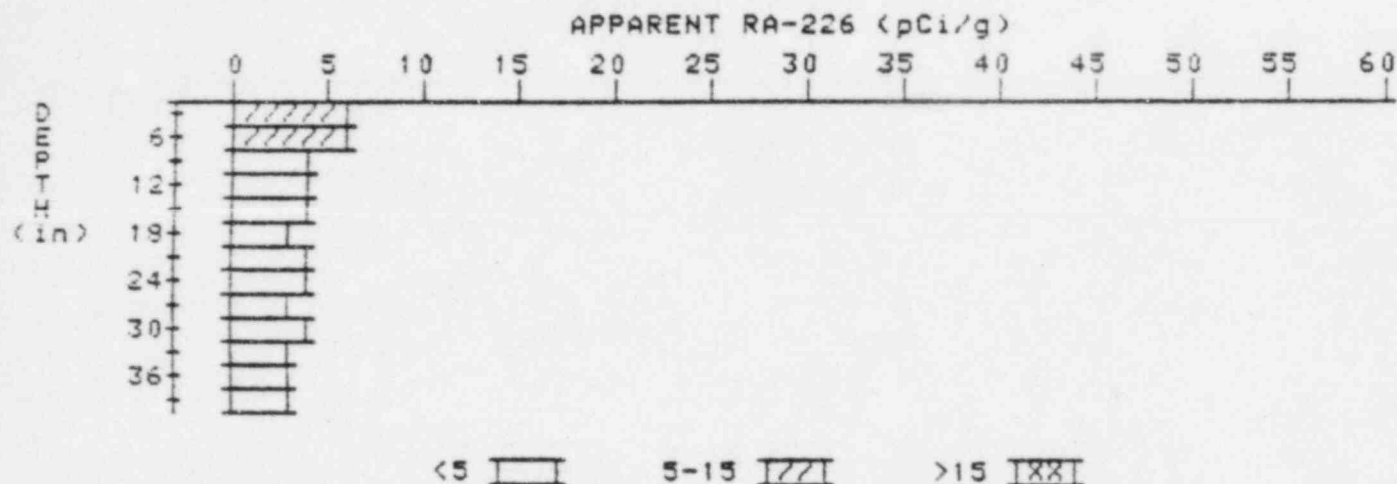
HOLE NUMBER: 9

Depth (in)	Apparent Radium-226 (pCi/g) Undeconvolved	Apparent Radium-226 (pCi/g) Deconvolved
3	6.0	6.0
6	5.5	6.0
9	4.7	4.2
12	4.2	3.7
15	4.0	4.0
18	3.8	3.4
21	3.8	4.0
24	3.7	3.9
27	3.5	3.1
30	3.5	3.7
33	3.4	3.4
36	3.3	3.3
39	3.2	3.2

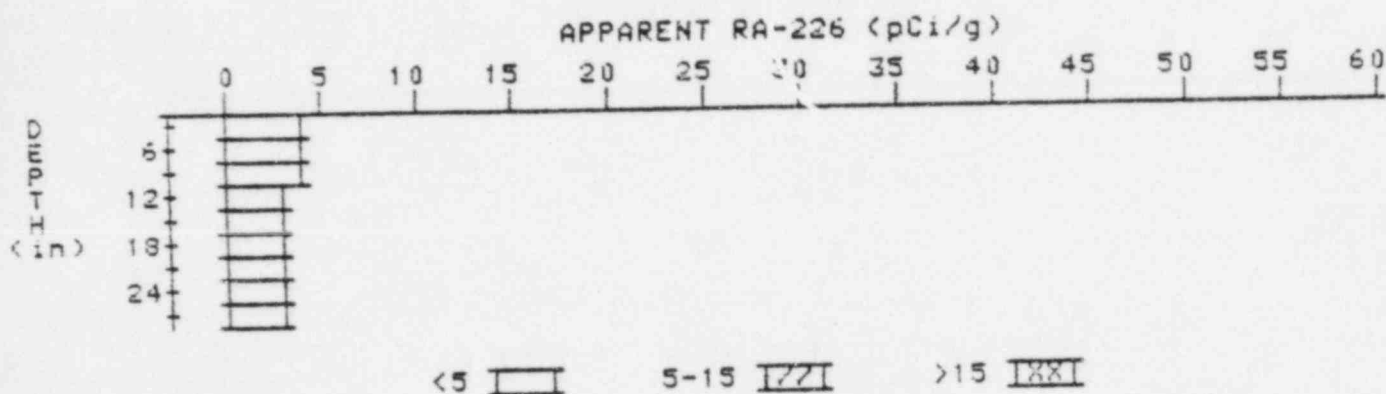
PROPERTY NUMBER: GJ-12956-RS
HOLE NUMBER: 11
LOCATION: 174221

Depth (in)	Apparent Radium-226 (pCi/g) Undeconvolved	Apparent Radium-226 (pCi/g) - Deconvolved
3	4.2	4.2
6	3.9	3.7
9	3.7	3.9
12	3.4	3.0
15	3.3	3.3
18	3.2	2.8
21	3.3	3.5
24	3.3	3.3
27	3.3	3.3

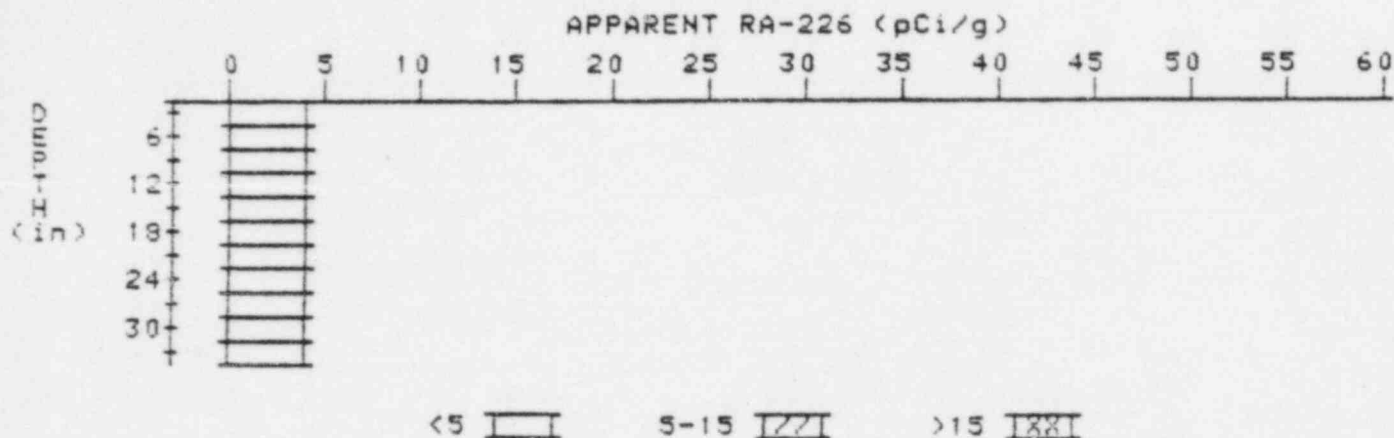
PROPERTY NUMBER: GJ-12956-RS
HOLE NUMBER: 13
LOCATION: 176263

Depth (in)	Apparent Radium-226 (pCi/g) Undeconvolved	Apparent Radium-226 (pCi/g) Deconvolved
3	4.2	4.2
6	4.1	3.9
9	4.1	4.3
12	4.0	4.0
15	3.9	3.9
18	3.8	3.6
21	3.8	3.8
24	3.8	4.0
27	3.7	3.7
30	3.6	3.6
33	3.5	3.5

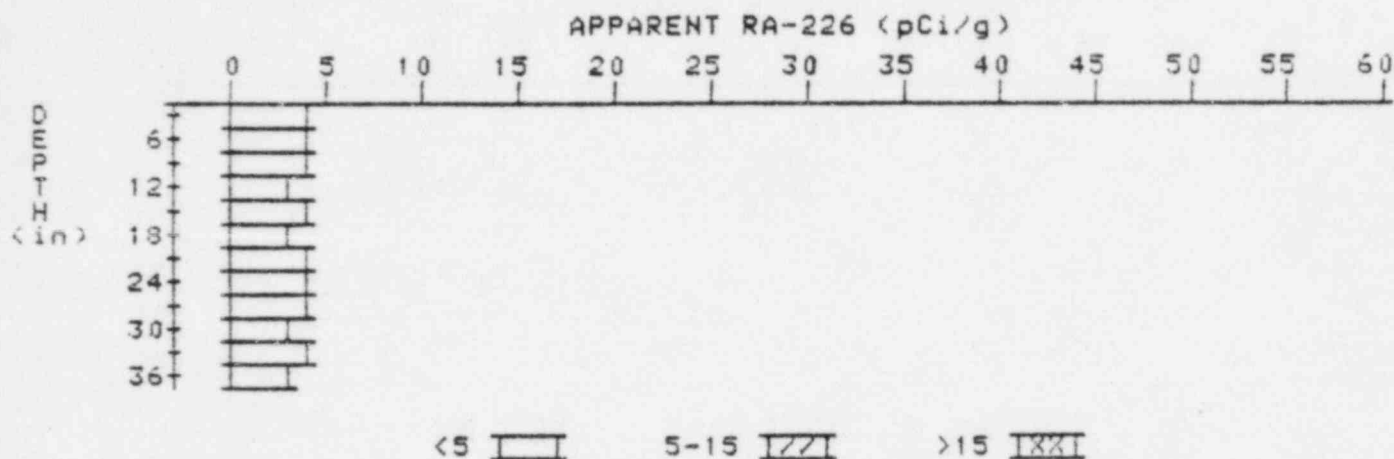
PROPERTY NUMBER: GJ-12936-RS
HOLE NUMBER: 14
LOCATION: 188241

Depth (in)	Apparent Radium-226 (pCi/g) Undeconvolved	Apparent Radium-226 (pCi/g) Deconvolved
3	4.1	4.1
6	4.0	4.0
9	3.9	4.1
12	3.7	3.3
15	3.7	3.9
18	3.6	3.4
21	3.6	3.6
24	3.6	3.8
27	3.5	3.5
30	3.4	3.2
33	3.4	3.6
36	3.3	3.3

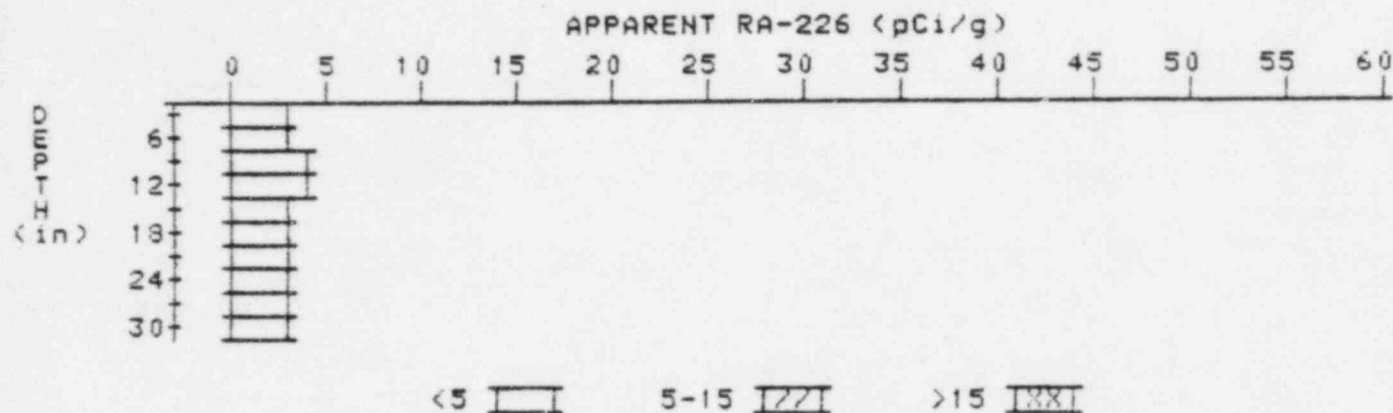
PROPERTY NUMBER: GJ-12956-RS
HOLE NUMBER: 17
LOCATION: 192231

Depth (in)	Apparent Radium-226 (pCi/g)	Apparent Radium-226 (pCi/g)
	Undeconvolved	Deconvolved
3	3.4	3.4
6	3.4	3.2
9	3.5	3.7
12	3.5	3.7
15	3.4	3.4
18	3.3	3.1
21	3.3	3.5
24	3.2	3.0
27	3.2	3.4
30	3.1	3.1

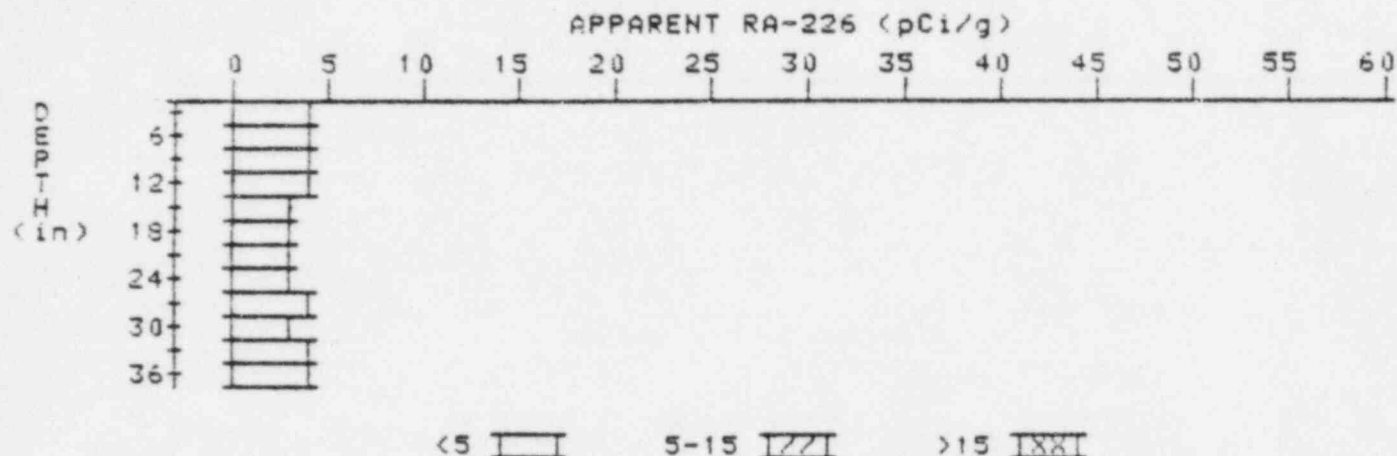
PROPERTY NUMBER: GJ-12956-RS
HOLE NUMBER: 18
LOCATION: 196229

Depth (in)	Apparent Radium-226 (pCi/g) Undeconvolved	Apparent Radium-226 (pCi/g) Deconvolved
3	4.0	4.0
6	3.9	4.1
9	3.7	3.7
12	3.5	3.5
15	3.3	3.1
18	3.2	3.0
21	3.2	3.0
24	3.3	3.1
27	3.0	3.9
30	3.5	3.3
33	3.6	3.8
36	3.6	3.6

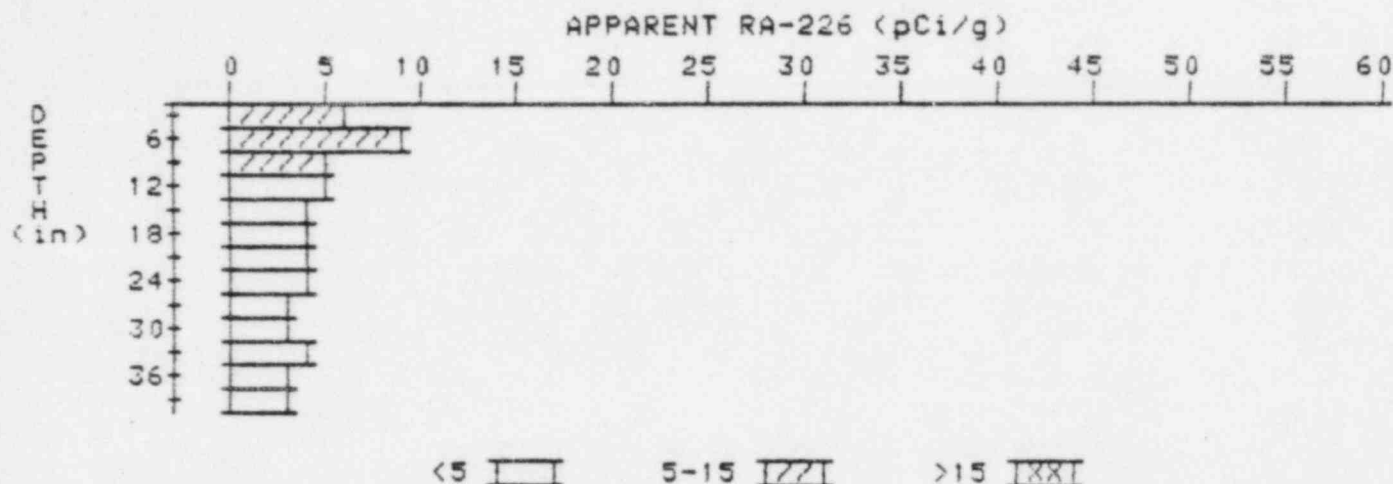
PROPERTY NUMBER: GJ-12956-RS
HOLE NUMBER: 19
LOCATION: 196269

Depth (in)	Apparent Radium-226 (pCi/g) Undeconvolved	Apparent Radium-226 (pCi/g) Deconvolved
3	5.7	5.7
6	6.3	3.8
9	5.5	5.1
12	4.9	4.7
15	4.4	4.0
18	4.1	3.9
21	3.9	3.7
24	3.8	4.0
27	3.6	3.4
30	3.5	3.3
33	3.5	3.7
36	3.4	3.4
39	3.3	3.3

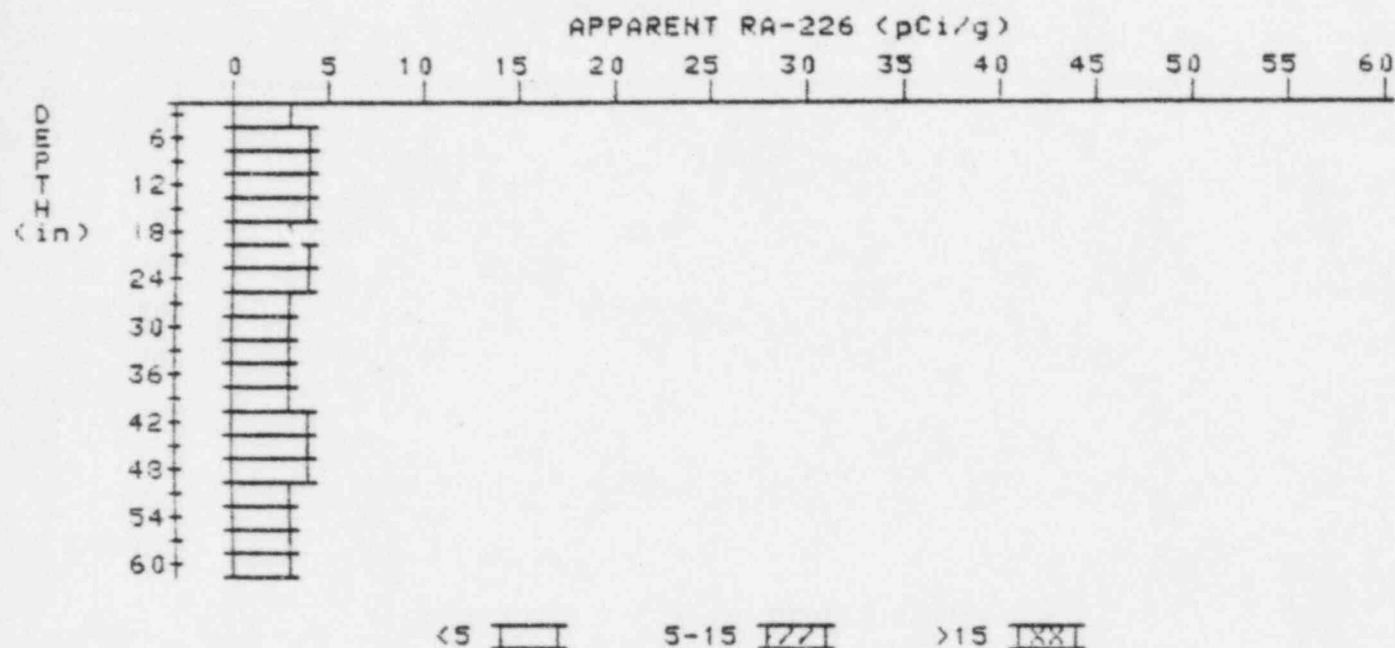
HOLE NUMBER: 21

Depth (in)	Apparent Radium-226 (pCi/g) Undeconvolved	Apparent Radium-226 (pCi/g) Deconvolved
3	3.3	3.3
6	3.6	4.0
9	3.7	3.7
12	3.8	4.2
15	3.7	3.7
18	3.6	3.4
21	3.6	3.8
24	3.5	3.7
27	3.3	2.9
30	3.3	3.3
33	3.3	3.3
36	3.3	3.1
39	3.4	3.4
42	3.5	3.5
45	3.6	3.8
48	3.6	4.0
51	3.4	3.2
54	3.3	3.3

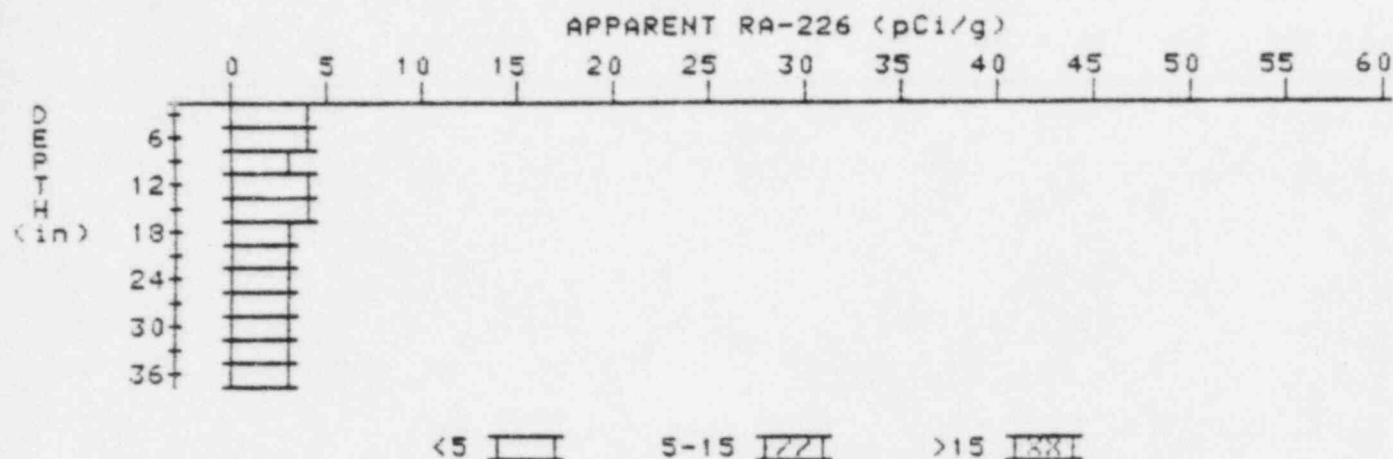
PROPERTY NUMBER: GJ-12956-RS
HOLE NUMBER: 24
LOCATION: 221219

Depth (in)	Apparent Radium-226 (pCi/g) Undeconvolved	Apparent Radium-226 (pCi/g) Deconvolved
3	3.6	3.6
6	3.5	3.7
9	3.3	2.6
12	3.5	3.9
15	3.5	3.7
18	3.4	3.4
21	3.3	3.3
24	3.2	3.0
27	3.2	3.2
30	3.2	3.2
33	3.2	3.2
36	3.2	3.2

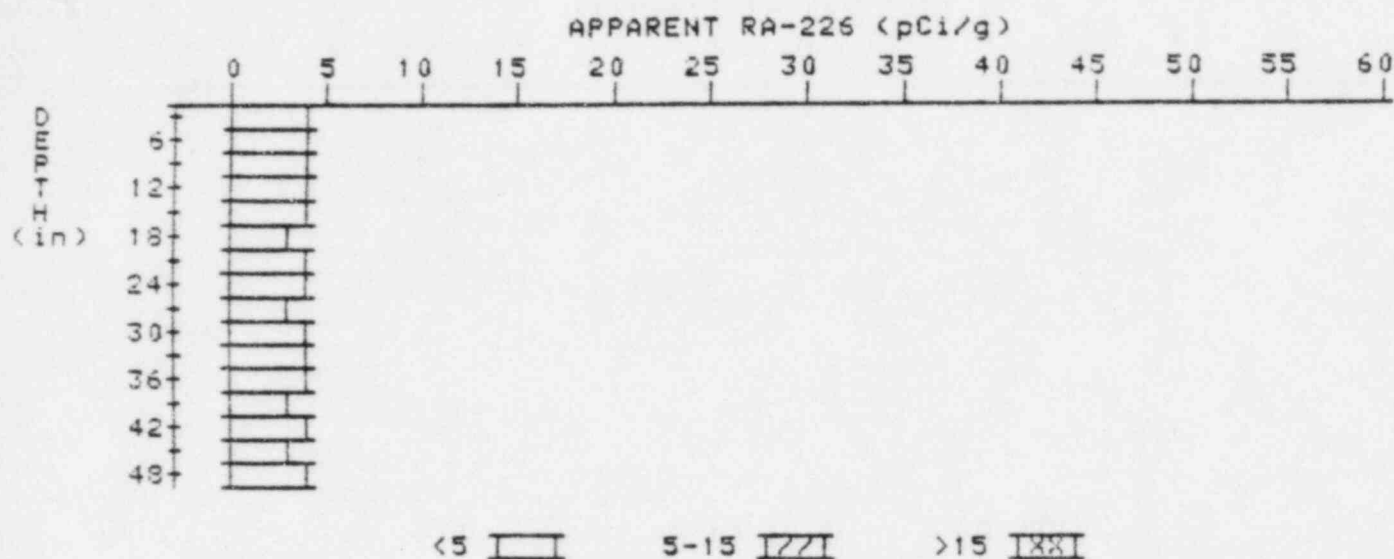
PROPERTY NUMBER: GJ-12956-RS
HOLE NUMBER: 27
LOCATION: 230238

Depth (in)	Apparent Radium-226 (pCi/g) Undeconvolved	Apparent Radium-226 (pCi/g) Deconvolved
3	3.5	3.5
6	3.6	3.6
9	3.7	3.7
12	3.8	4.2
15	3.7	3.7
18	3.6	3.4
21	3.6	3.6
24	3.6	3.8
27	3.5	3.3
30	3.5	3.5
33	3.5	3.5
36	3.5	3.5
39	3.5	3.3
42	3.6	4.0
45	3.5	3.3
48	3.5	3.5

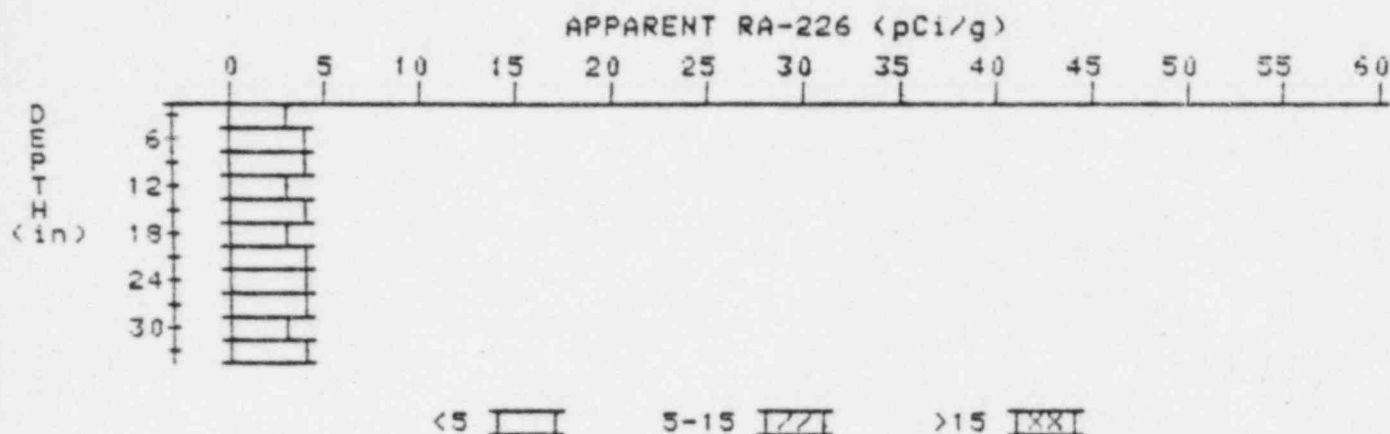
PROPERTY NUMBER: GJ-12956-RS
HOLE NUMBER: 29
LOCATION: 244260

Depth (in)	Apparent Radium-226 (pCi/g) Undeconvolved	Apparent Radium-226 (pCi/g) Deconvolved
3	3.4	3.4
6	3.6	4.0
9	3.6	3.6
12	3.6	3.4
15	3.7	4.1
18	3.6	3.4
21	3.6	3.6
24	3.6	3.8
27	3.5	3.5
30	3.4	3.0
33	3.5	3.5
