RADIOLOGIC AND ENGINEERING ASSESSMENT

DOE ID NO.: GJ-13019-RS  
ADDRESS: 139 NORTH SPRUCE STREET

SEPTEMBER 1985

BENDIX FIELD ENGINEERING CORPORATION  
P.O. Box 1569  
Grand Junction, Colorado 81502

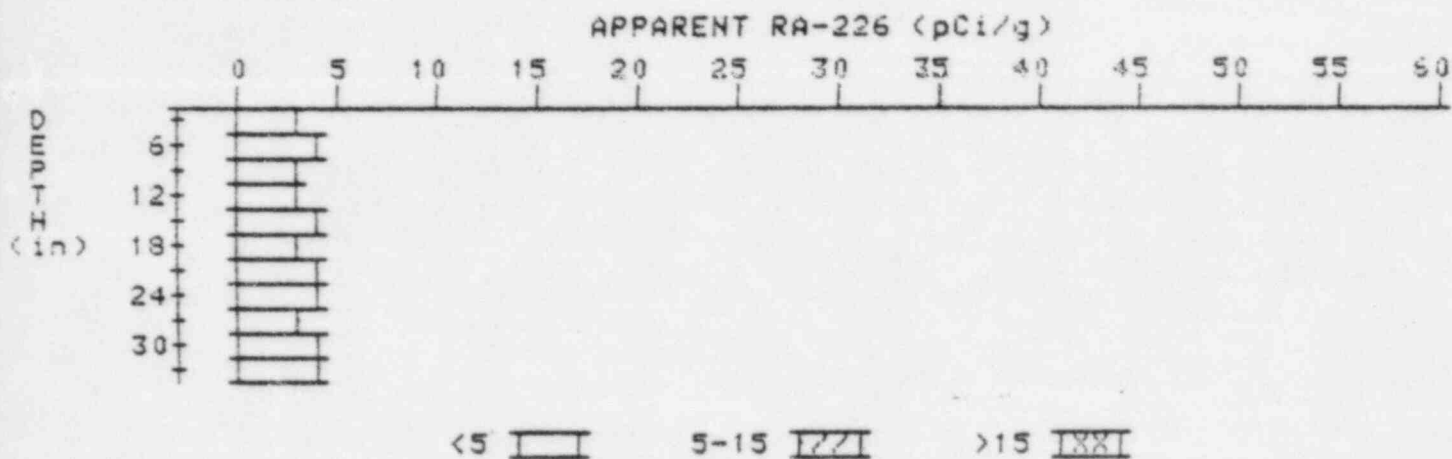
HOLE NUMBER: 1

Depth (in)	Apparent Radium-226 (pCi/g) Undeconvolved	Apparent Radium-226 (pCi/g) Deconvolved
3	3.2	3.2
6	3.4	3.8
9	3.4	3.4
12	3.4	3.2
15	3.5	3.7
18	3.5	3.3
21	3.6	3.8
24	3.6	3.6
27	3.6	3.4
30	3.7	3.7
33	3.8	3.8

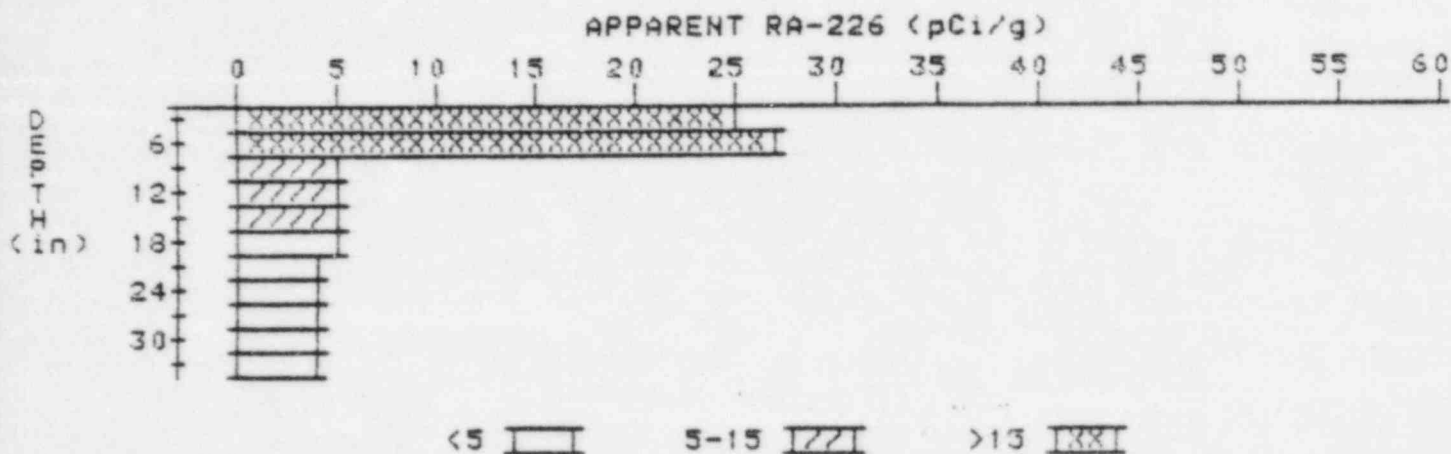
HOLE NUMBER: 5

Depth (in)	Apparent Radium-226 (pCi/g) Undeconvolved	Apparent Radium-226 (pCi/g) Deconvolved
3	25.0	25.0
6	20.6	27.0
9	12.6	5.5
12	8.6	5.0
15	6.6	5.0
18	5.5	4.6
21	4.9	4.4
24	4.6	4.4
27	4.4	4.2
30	4.3	4.3
33	4.2	4.2
