RADIOLOGIC AND ENGINEERING ASSESSMENT

DOE ID NO.: GJ-08843-MR
ADDRESS: 2525 SOUTH BROADWAY

AUGUST 1985

URANIUM MILL TAILINGS REMEDIAL ACTION PROJECT OFFICE

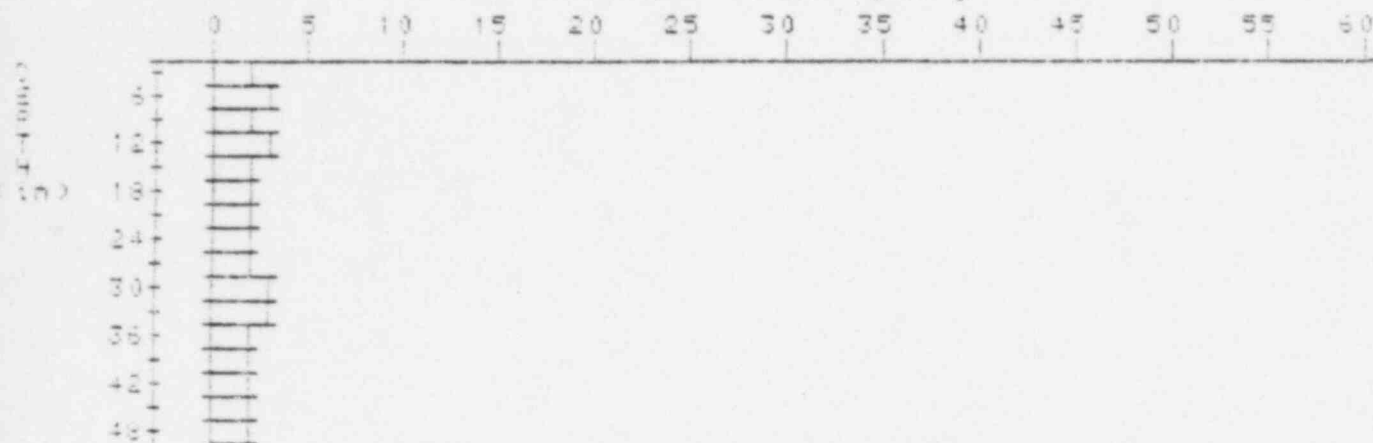
LOCATION: 235267

6. Locations 19 and 20 were called greater than 48 inches based on all data available as indicated in comment 3.
7. Location 23 could be called greater than 69 inches. Due to the possibility of spillage down the borehole it was called as greater than 48 inches.

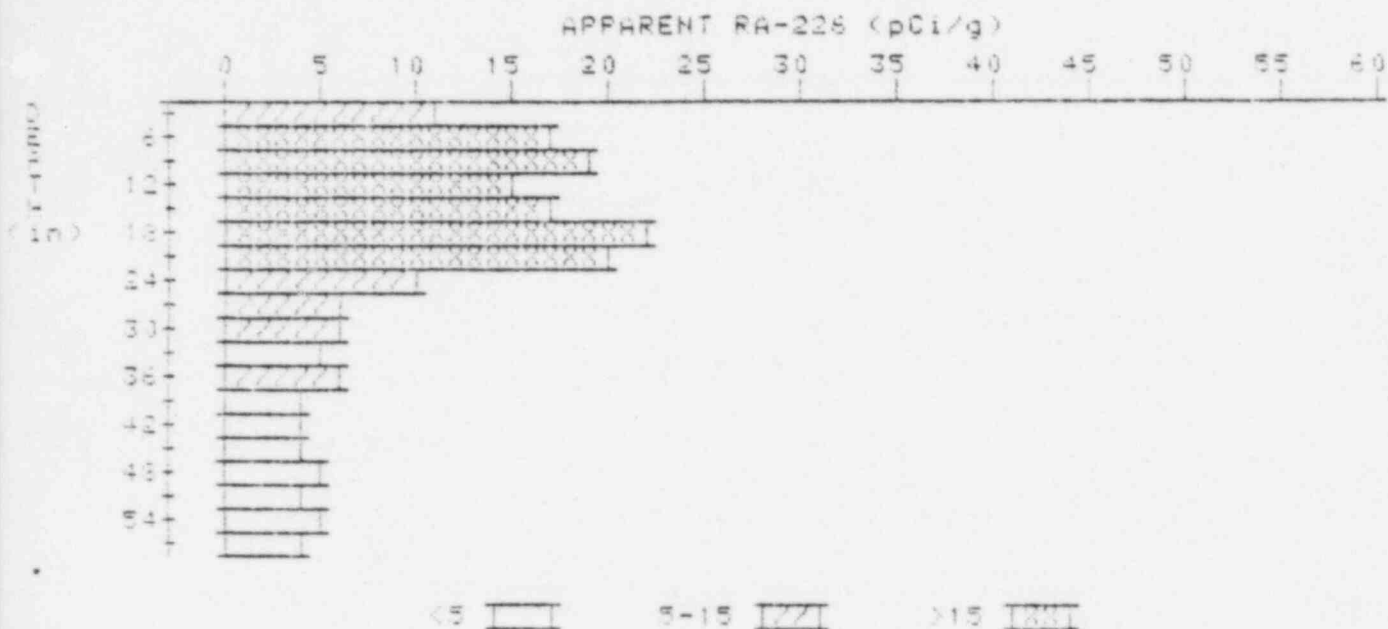
HOLE NUMBER: 4

2. An exploration hole was augered in the area of the septic tank, the results were negative.
3. Locations 4, 5, and 6 (Table 3.2) says greater than 48 inches because of the history of the property. All of the backyard was filled with at least 10 feet of assorted rubbish. The deepest contaminated hole on this property is greater than 48 inches.
