RADIOLOGIC AND ENGINEERING ASSESSMENT

DOE ID NO.: GJ-02197-MR
ADDRESS: 1320 NORTH 18TH STREET

AUGUST 1985

BENDIX FIELD ENGINEERING CORPORATION
P.O. Box 1569
Grand Junction, Colorado 81502

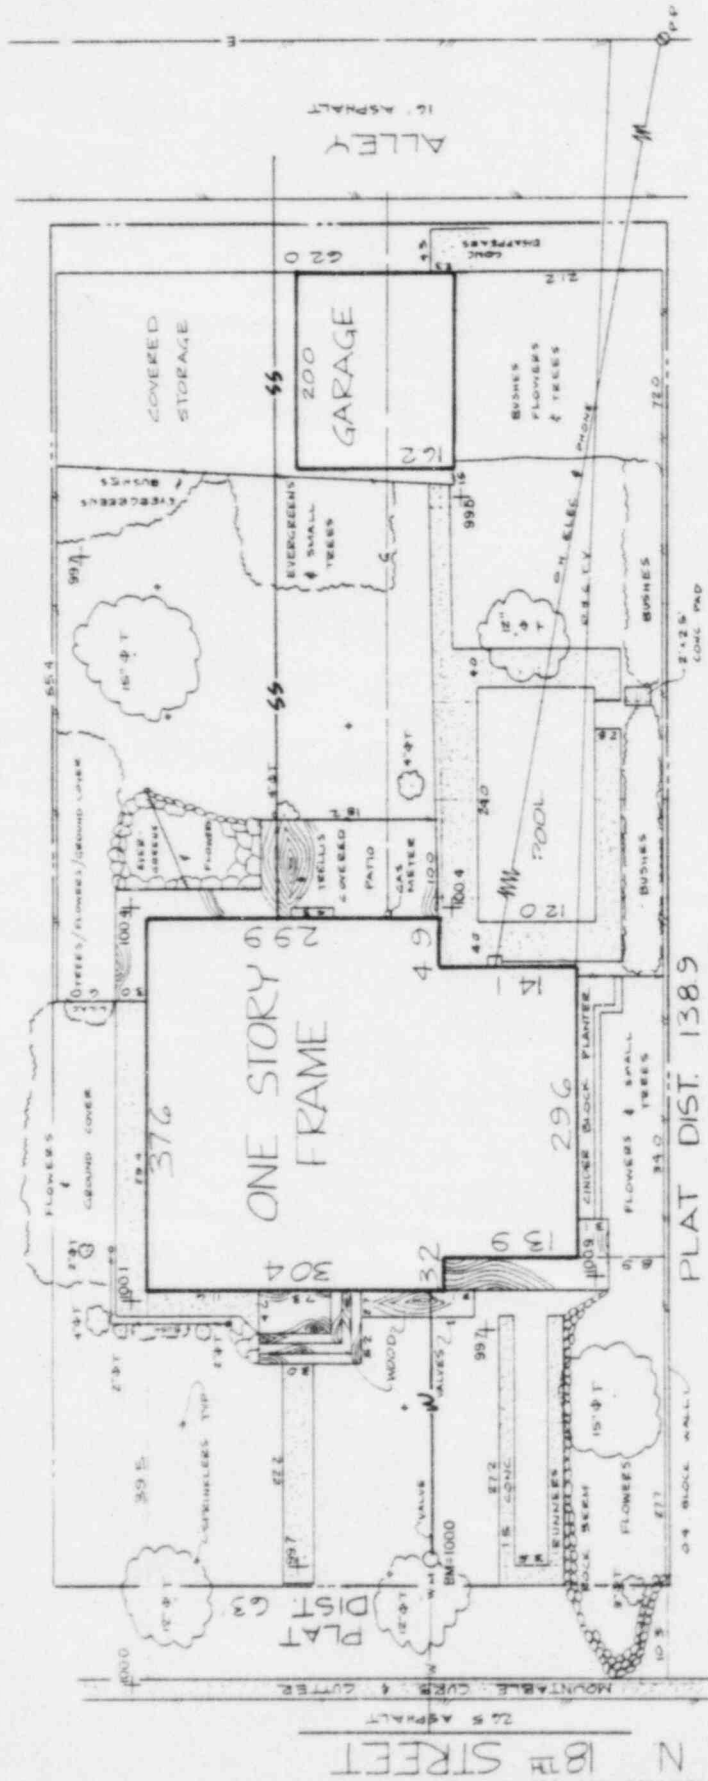
FIGURE 2.2 SITE PLAN

There is a swimming pool located in the rear yard. Structures, utilities, landscaping, and other special features of this property are included in Appendix Figure 2.2.

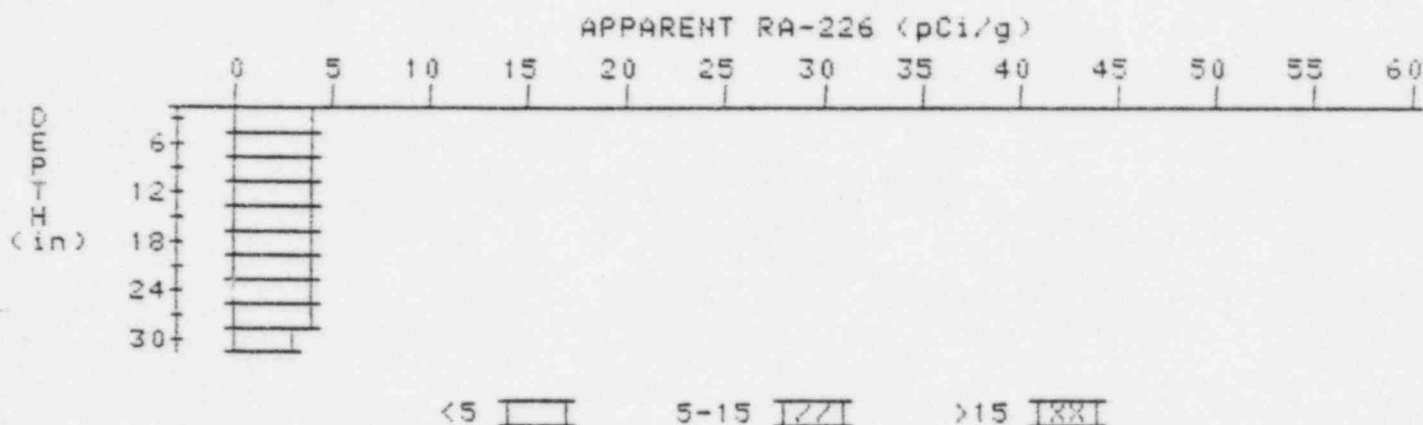
HOLE NUMBER: 6

Depth (in)	Apparent Radium-226 (pCi/g) Undeconvolved	Apparent Radium-226 (pCi/g) Deconvolved
=====	=====	=====
3	3.5	3.5
6	3.7	3.9
9	3.8	3.8
12	3.9	4.3
15	3.8	3.6
18	3.8	4.0
21	3.7	3.7
24	3.6	3.6
27	3.5	3.5
30	3.4	3.4

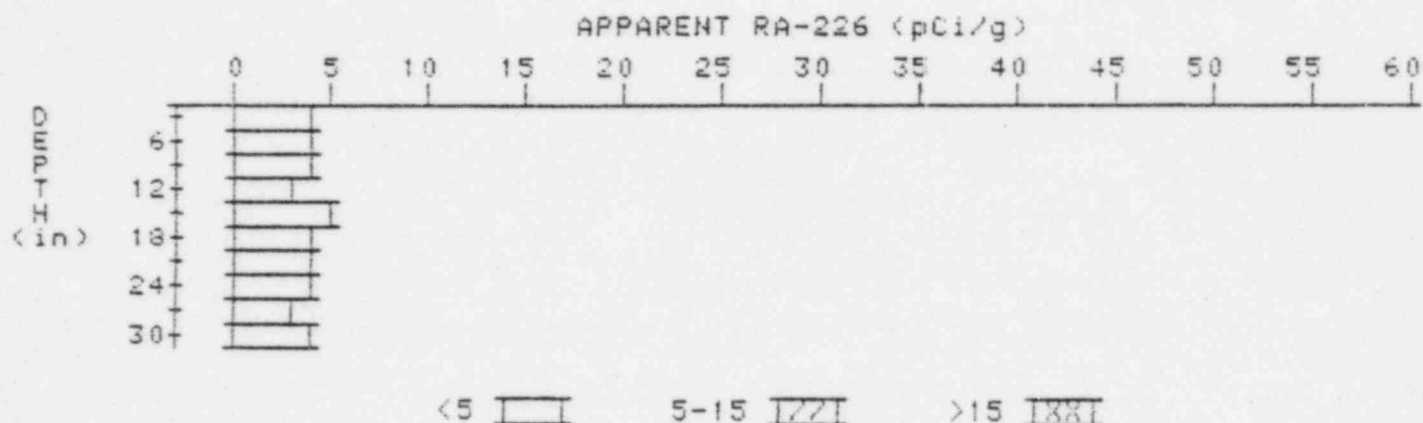
HOLE NUMBER: 8

Depth (in)	Apparent Radium-226 (pCi/g) Undeconvolved	Apparent Radium-226 (pCi/g) Deconvolved
3	3.5	3.5
6	3.7	4.1
9	3.7	4.1
12	3.5	2.6
15	3.6	4.5
18	3.7	3.5
21	3.7	3.7
24	3.7	3.9
27	3.6	3.2
30	3.7	3.7

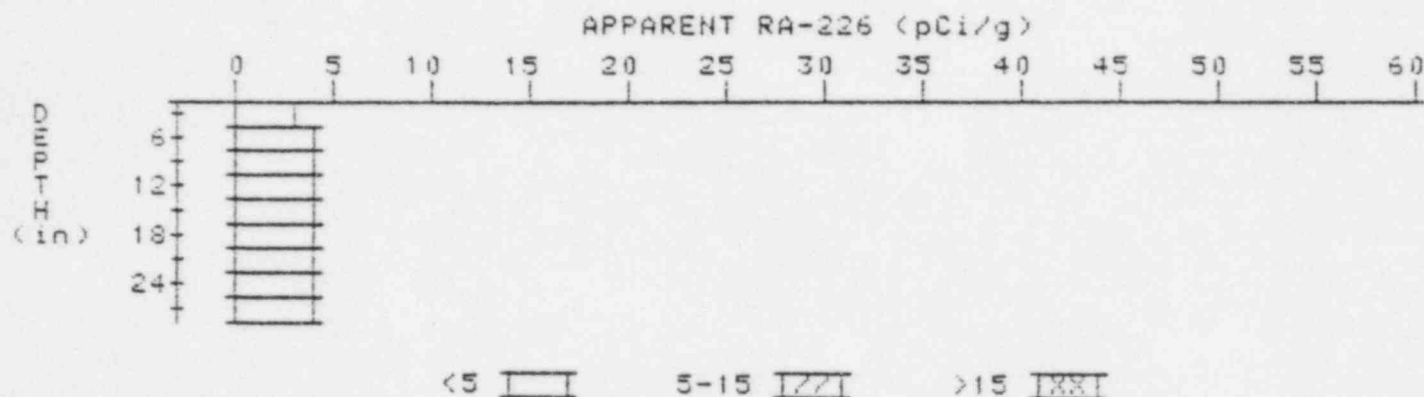
PROPERTY NUMBER: GJ-02197-MR
HOLE NUMBER: 12
LOCATION: 178215

Depth (in)	Apparent Radium-226 (pCi/g) Undeconvolved	Apparent Radium-226 (pCi/g) Deconvolved
3	3.2	3.2
6	3.6	4.1
9	3.7	3.7
12	3.8	4.2
15	3.7	3.5
18	3.7	3.7
21	3.7	3.7
24	3.7	3.7
27	3.7	3.7

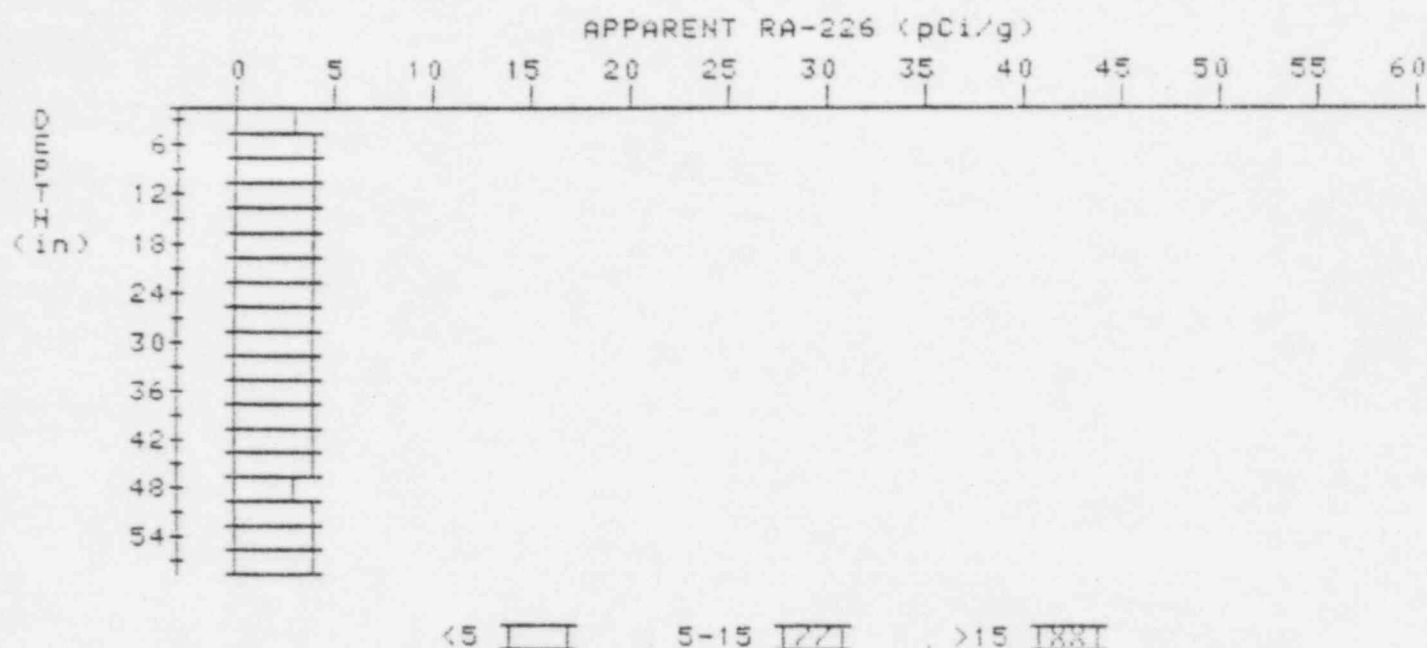
PROPERTY NUMBER: GJ-02197-MR
HOLE NUMBER: 15
LOCATION: 235245

Depth (in)	Apparent Radium-226 (pCi/g) Undeconvolved	Apparent Radium-226 (pCi/g) Deconvolved
3	3.4	3.4
6	3.7	4.1
9	3.8	4.0
12	3.8	3.6
15	3.9	4.1
18	3.9	3.9
21	3.9	3.9
24	3.9	3.9
27	3.9	3.9
30	3.9	3.9
33	3.9	3.9
36	3.9	3.9
39	3.9	3.9
42	3.9	3.9
45	3.9	4.1
48	3.9	3.4
51	3.9	4.3
54	3.9	3.6
