RADIOLOGIC AND ENGINEERING ASSESSMENT

DOE ID NO.: GJ-01358-RS  
ADDRESS: 1644 NORTH 15th STREET

AUGUST 1985

BENDIX FIELD ENGINEERING CORPORATION  
P.O. Box 1569  
Grand Junction, Colorado 81502

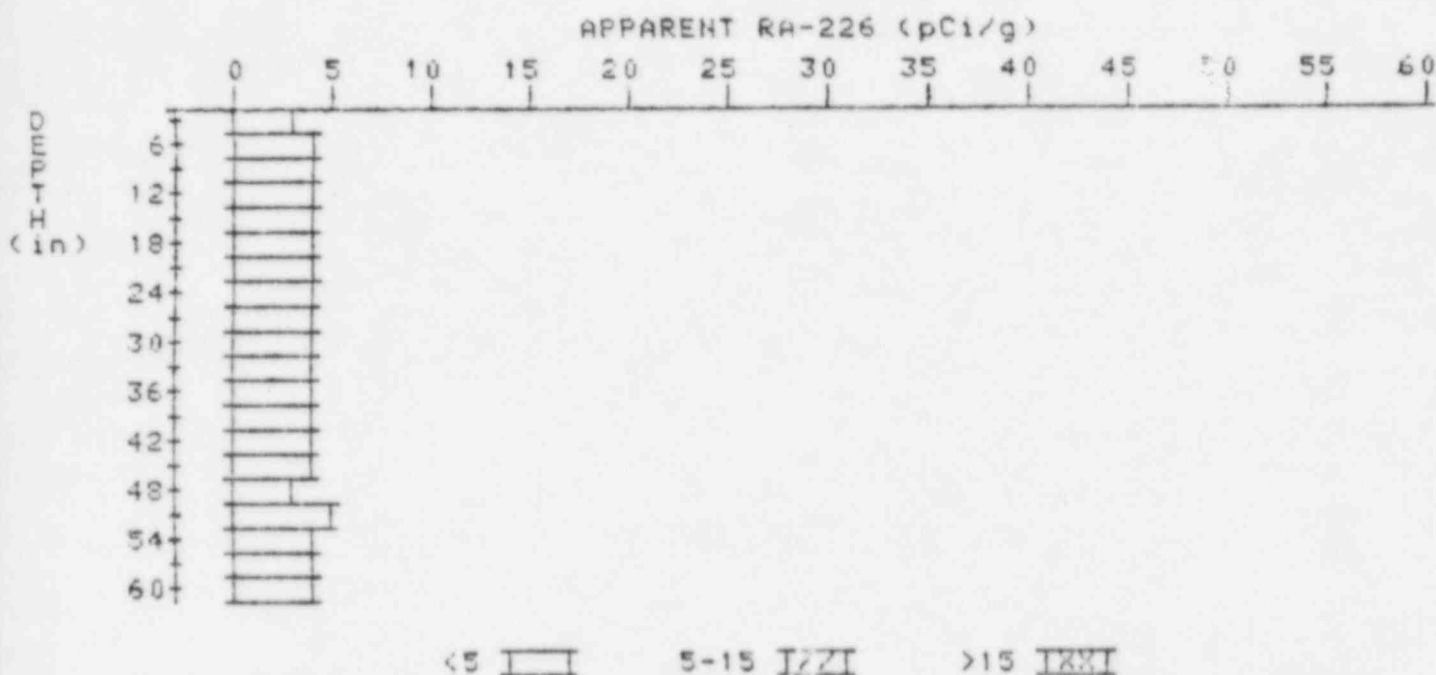
HOLE NUMBER: 1

Depth (in)	Apparent Radium-226 (pCi/g) Undeconvolved	Apparent Radium-226 (pCi/g) Deconvolved
3	3.3	3.3
6	3.5	3.7
9	3.6	3.6
12	3.7	3.7
15	3.8	4.0
18	3.8	3.8
21	3.8	3.8
24	3.8	3.6
27	3.9	3.9
30	4.0	4.2
33	4.0	4.2
36	3.9	3.9
39	3.8	3.6
42	3.8	3.8
45	3.8	4.0
48	3.7	3.8
51	4.0	4.5
54	4.0	4.0

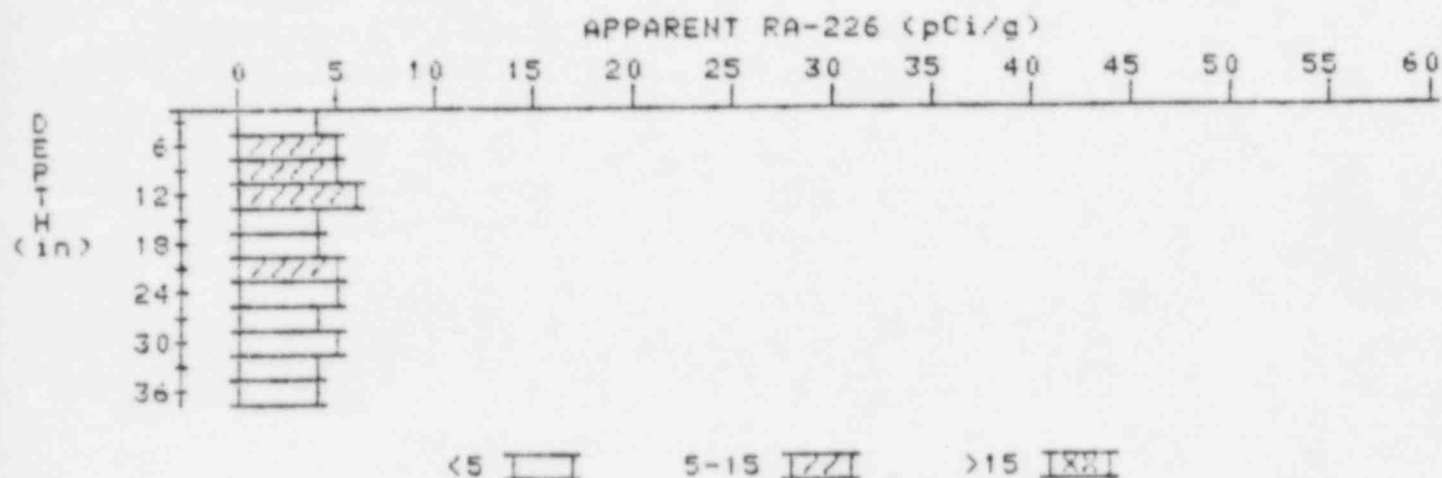
HOLE NUMBER: 6

Depth (in)	Apparent Radium-226 (pCi/g) Undeconvolved	Apparent Radium-226 (pCi/g) Deconvolved
3	4.0	4.0
6	4.6	5.1
9	4.9	5.3
12	5.0	5.9
15	4.6	4.2
18	4.4	3.7
21	4.6	5.1
24	4.5	4.5
27	4.4	4.2
30	4.4	4.6
33	4.3	4.1
36	4.3	4.3

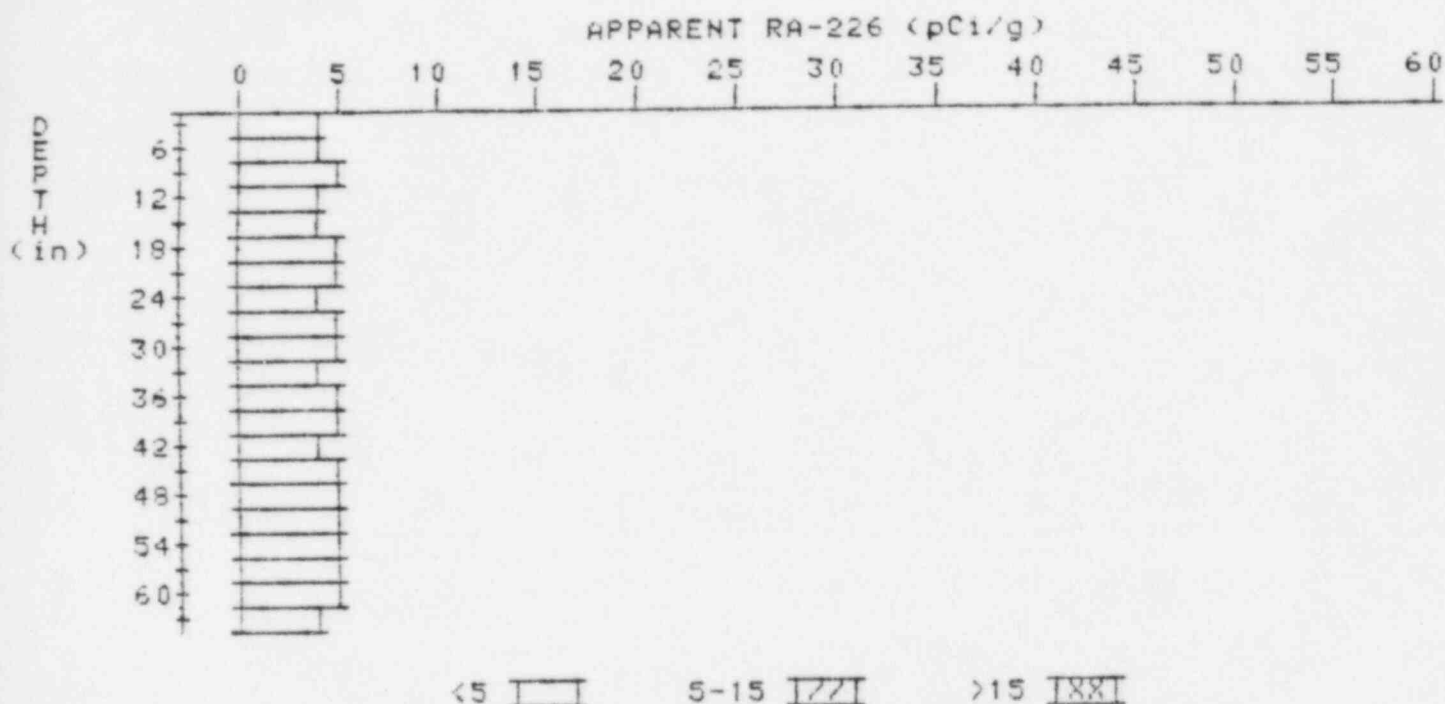
HOLE NUMBER: 7

Depth (in)	Apparent Radium-226 (pCi/g) Undeconvolved	Apparent Radium-226 (pCi/g) Deconvolved
3	3.7	3.7
6	4.0	4.0
9	4.3	4.8
12	4.3	4.1
15	4.4	4.2
18	4.6	5.0
21	4.6	4.8
24	4.5	4.1
27	4.6	4.8
30	4.6	4.8
33	4.5	4.3
36	4.5	4.8
39	4.5	4.7
42	4.4	4.0
45	4.5	4.7
48	4.5	4.5
51	4.5	4.5

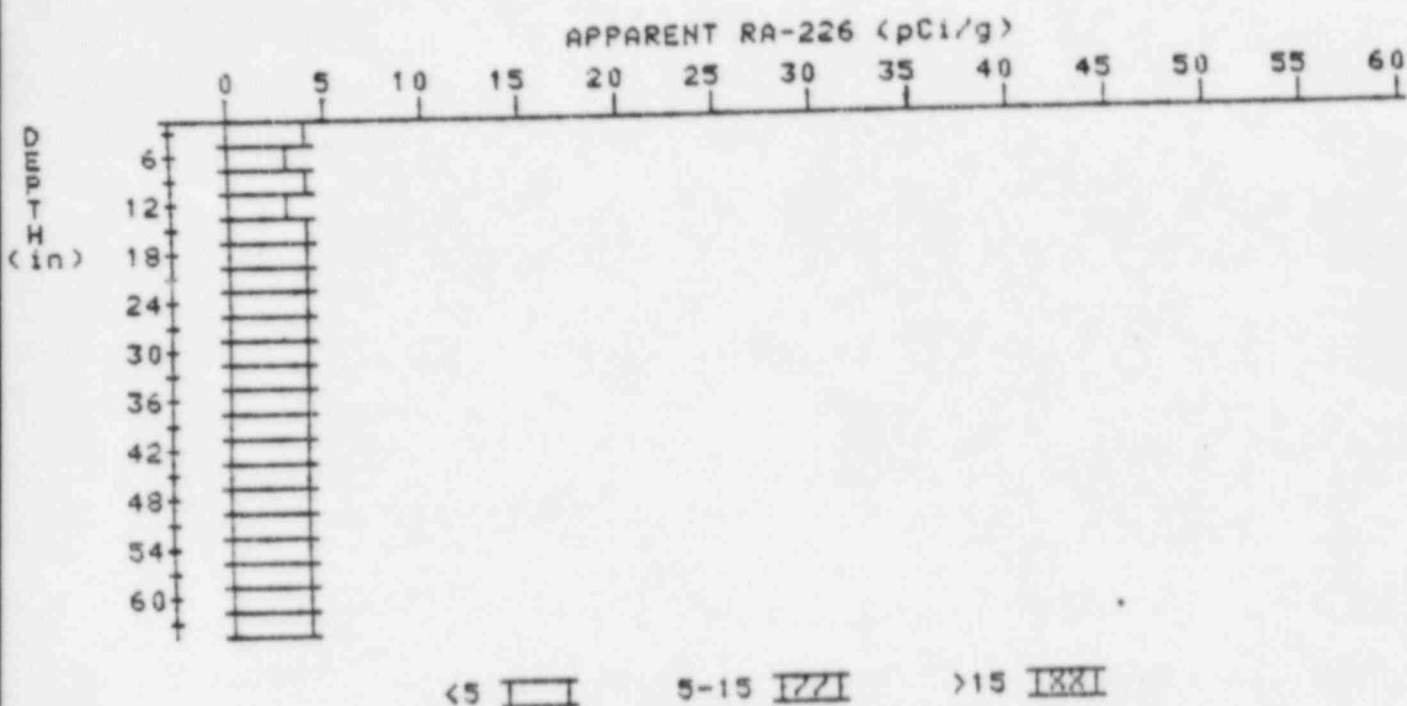
HOLE NUMBER: 9

Depth (in)	Apparent Radium-226 (pCi/g) Undeconvolved	Apparent Radium-226 (pCi/g) Deconvolved
3	3.6	3.6
6	3.5	3.1
9	3.6	3.8
12	3.6	3.4
15	3.7	3.7
18	3.8	3.8
21	3.9	4.1
24	3.9	3.9
27	3.9	3.7
30	4.0	4.2
33	4.0	4.2
36	3.9	3.9
39	3.8	3.6
42	3.8	3.8
45	3.8	3.6
48	3.9	4.1
51	3.9	3.7

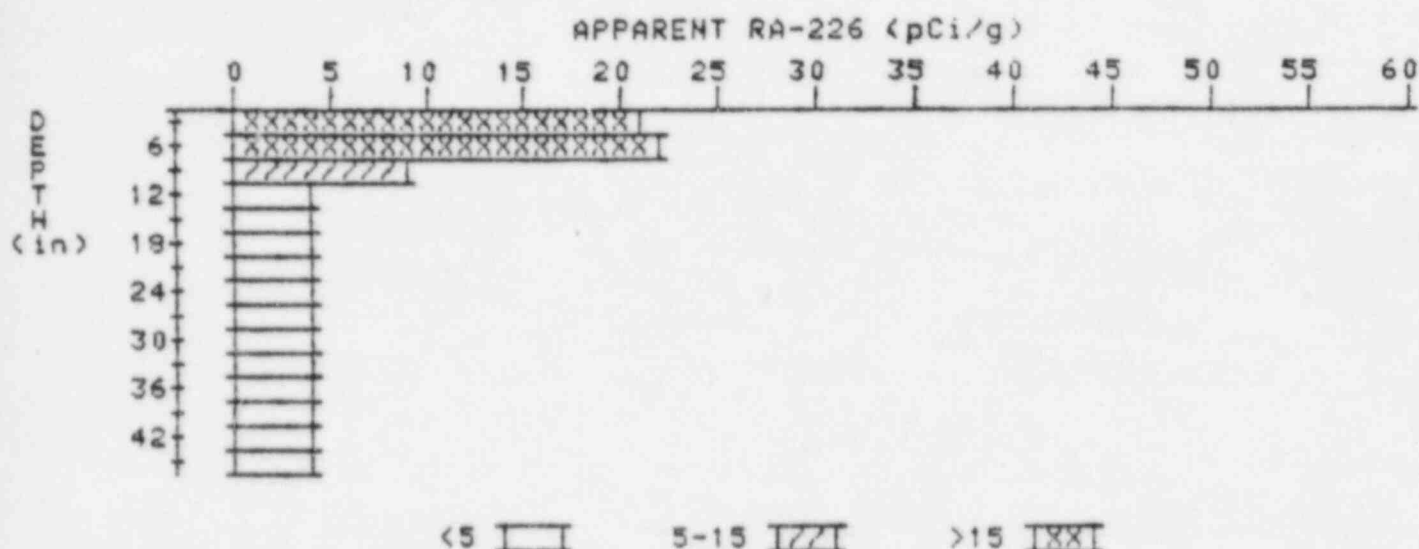
HOLE NUMBER: 15

Depth (in)	Apparent Radium-226 (pCi/g) Undeconvolved	Apparent Radium-226 (pCi/g) Deconvolved
3	21.4	21.4
6	18.0	22.3
9	12.2	9.4
12	8.0	4.3
15	5.9	3.8
18	5.0	4.3
21	4.5	4.1
24	4.2	3.7
27	4.2	4.4
30	4.1	3.9
33	4.1	4.3
36	4.0	3.8
39	4.0	4.2
42	3.9	3.7
45	3.9	3.9
