RADIOLOGIC AND ENGINEERING ASSESSMENT

DOE ID NO.: GJ-00055-MR  
ADDRESS: 2530 MESA AVENUE

AUGUST 1985

BENDIX FIELD ENGINEERING CORPORATION  
P.O. Box 1569  
Grand Junction, Colorado 81502

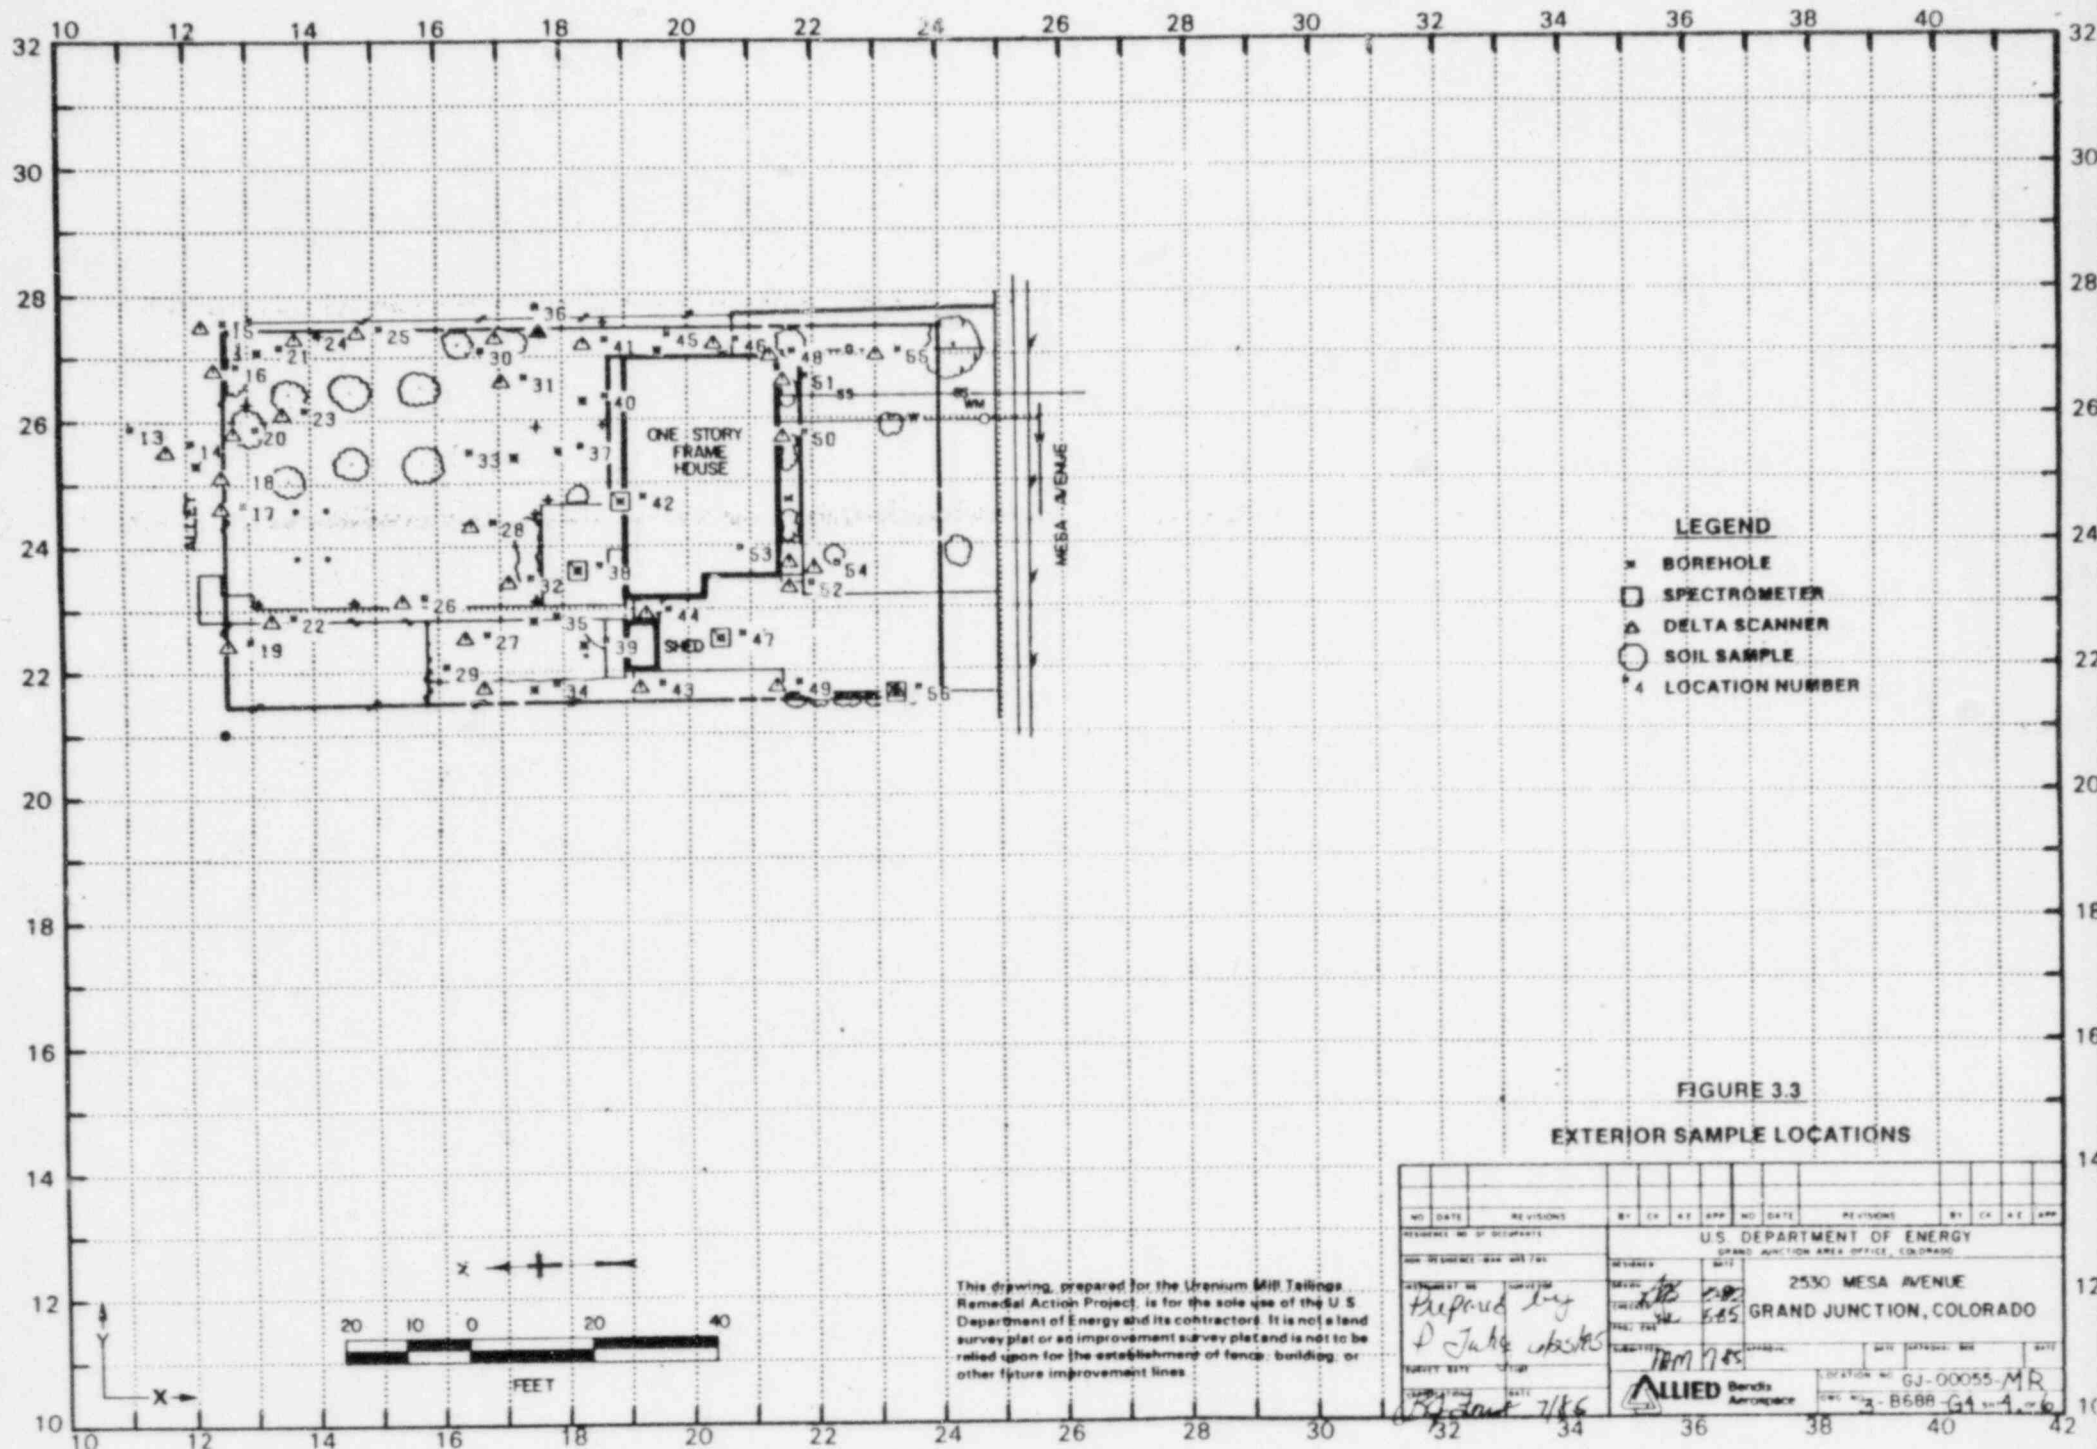
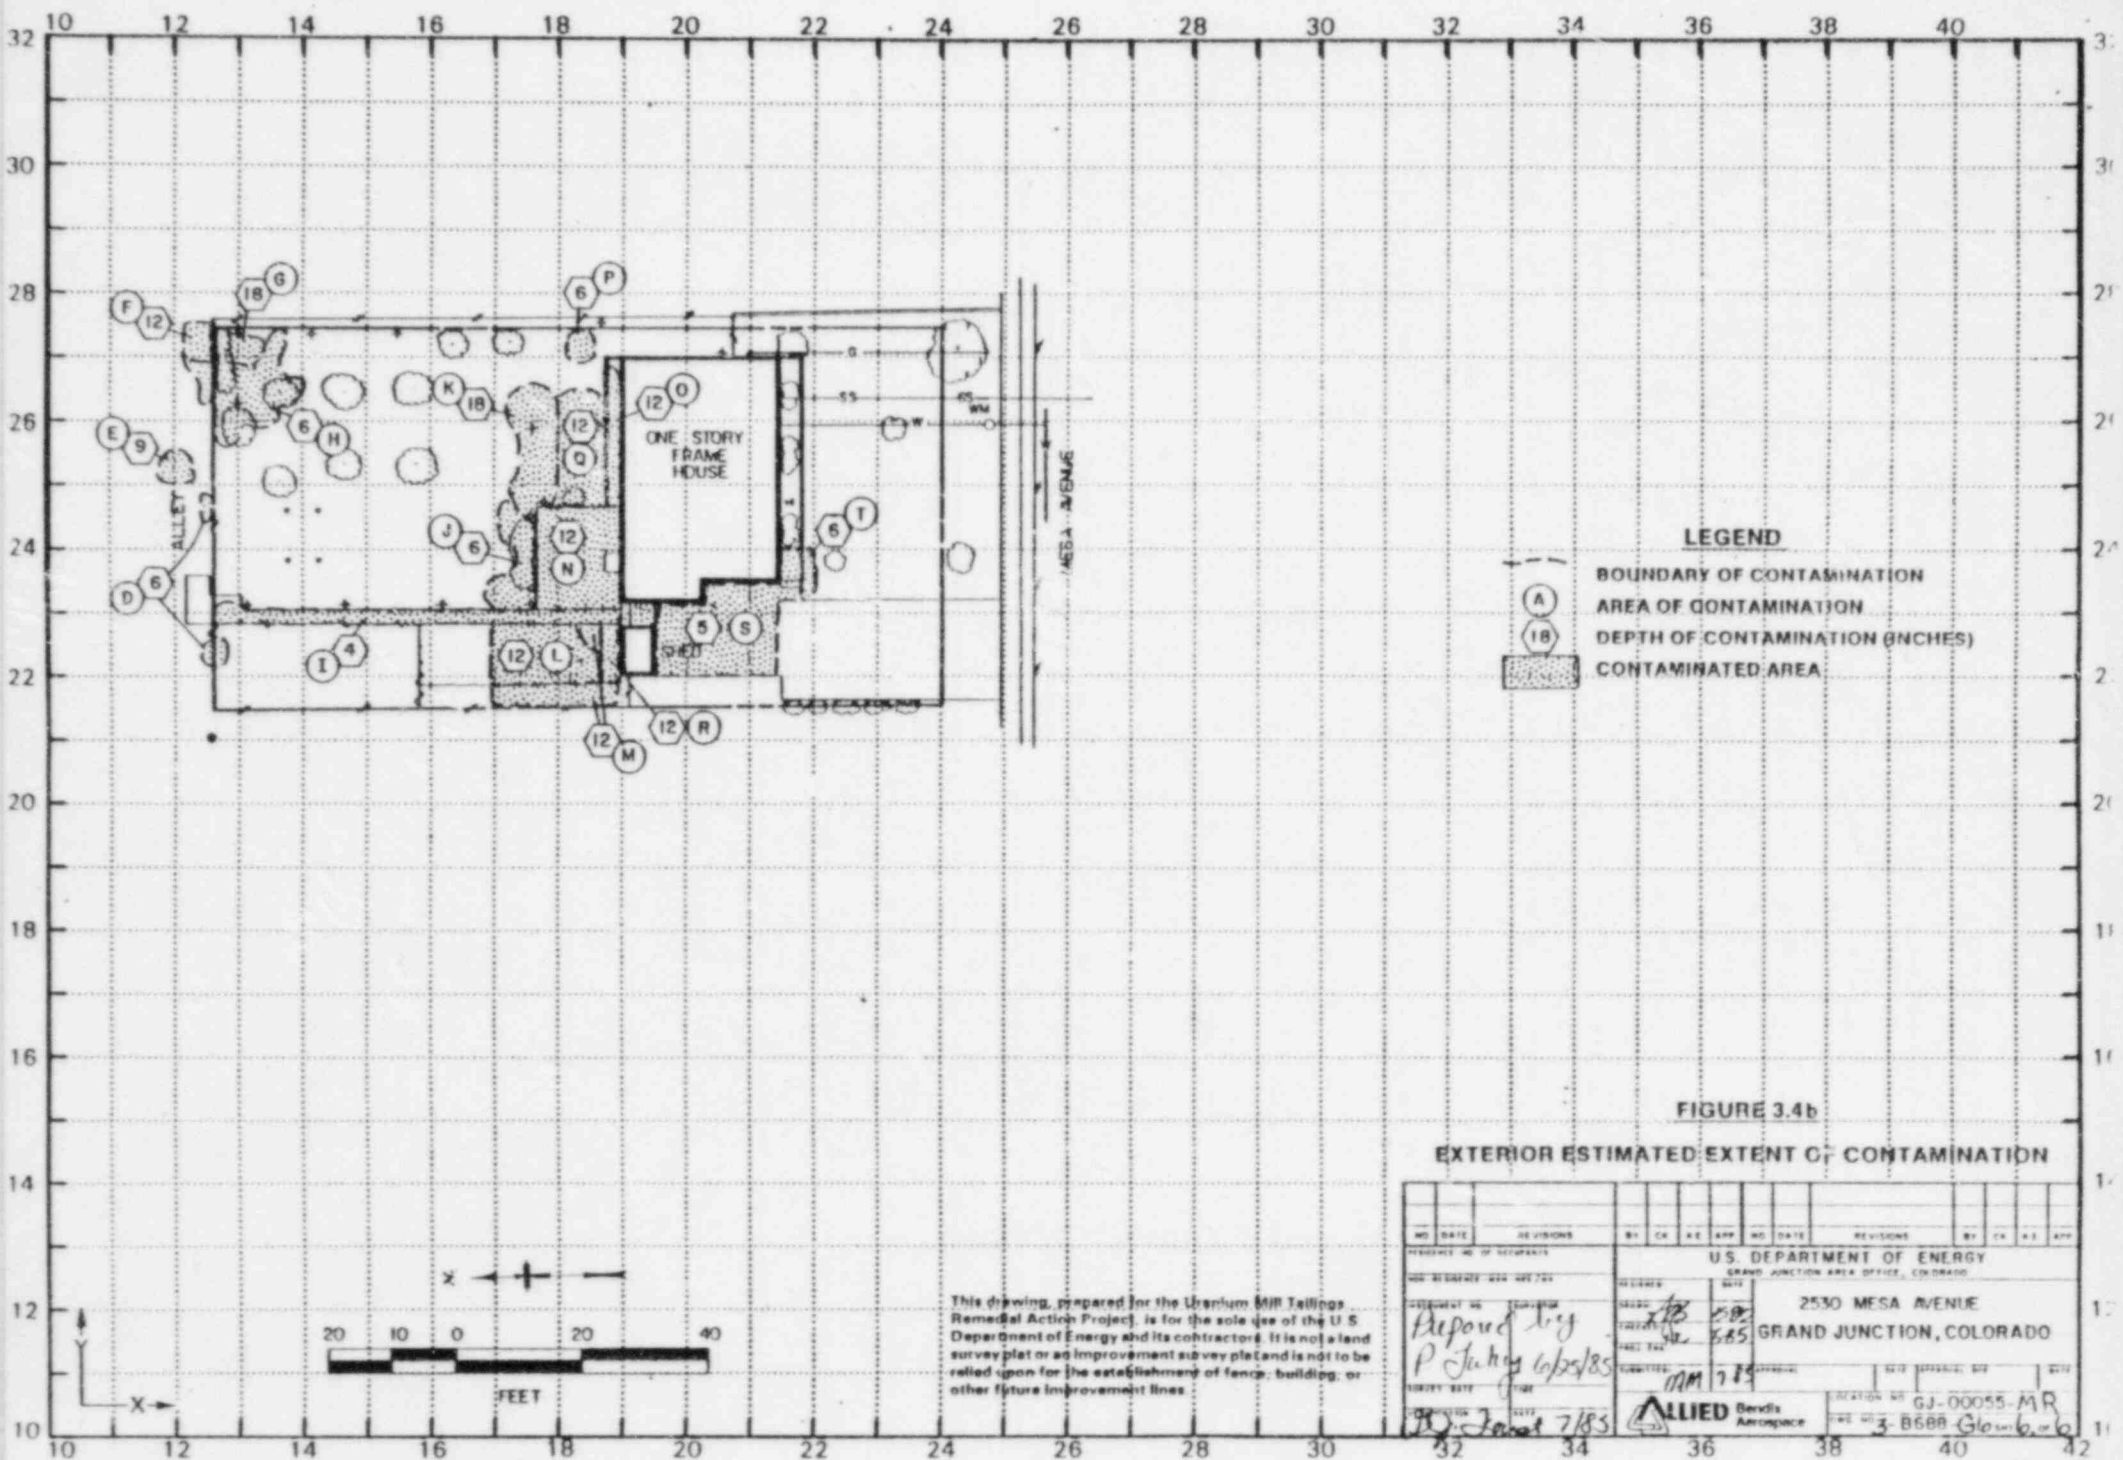
Appendix Figures 3.4a and 3.4b show identified areas and estimated depths of contamination on this property, based on assessments of all measurements taken. As noted in these figures, areas that contain identified residual radioactive materials are:

- (Area B) Surface Material: Concrete  
 Direction From Primary Structure: Crawl space  
 Other (height or thickness): See detail B  
 Comments: The footing and the foundation walls are contaminated.  
 Approximate Square Footage: N/A (This area is excluded from remedial action.)

- (Area N) Surface Material: Masonry pavers  
 Direction From Primary Structure: North  
 Other Directions: Patio; abuts north foundation  
 Total Depth of Contamination: 12 inches  
 Other (height or thickness): 2-inch-thick masonry pavers  
 Comments: The bricks have been laid without mortar.  
 Approximate Square Footage: 208

- (Area O) Surface Material: Soil  
 Direction From Primary Structure: North  
 Other Directions: Abuts north foundation  
 Total Depth of Contamination: 12 inches  
 Comments: A flower bed is within this area.  
 Approximate Square Footage: 44

The recommended remedial action for this property, DOE ID No. GJ-00055-MR, includes removal of all areas identified as containing radioactive material (as discussed in Section 3.5 and shown in Appendix Figures 3.4a and 3.4b) and transport of removed material to the disposal site.

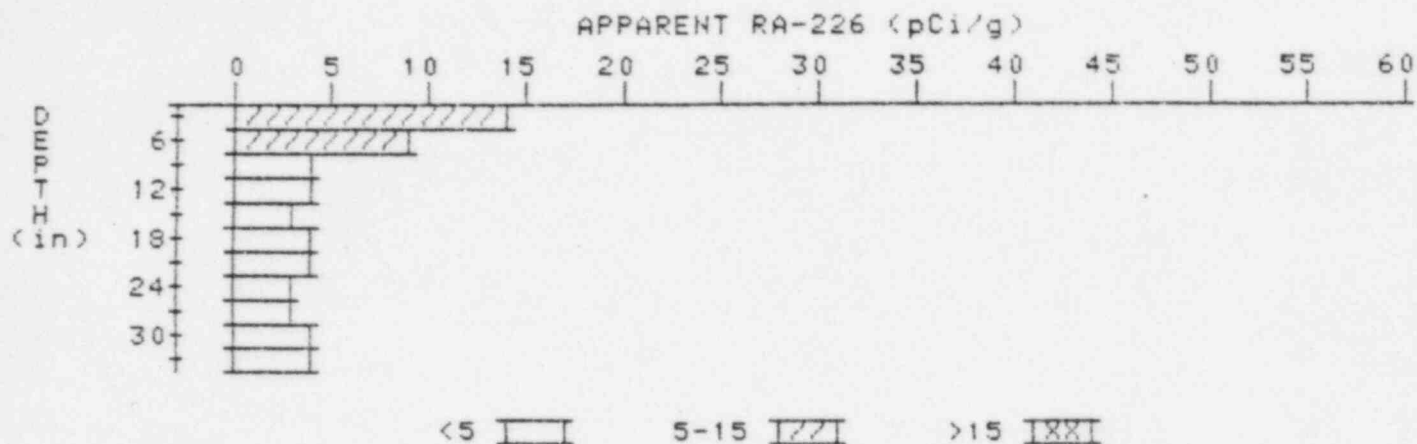
HOLE NUMBER: 14

Depth (in)	Apparent Radium-226 (pCi/g) Undeconvolved	Apparent Radium-226 (pCi/g) Deconvolved
3	13.9	13.9
6	10.2	9.3
9	7.0	4.3
12	5.3	4.1
15	4.3	3.2
18	3.9	3.5
21	3.7	3.5
24	3.6	3.4
27	3.6	3.2
30	3.8	4.0
33	3.9	3.9

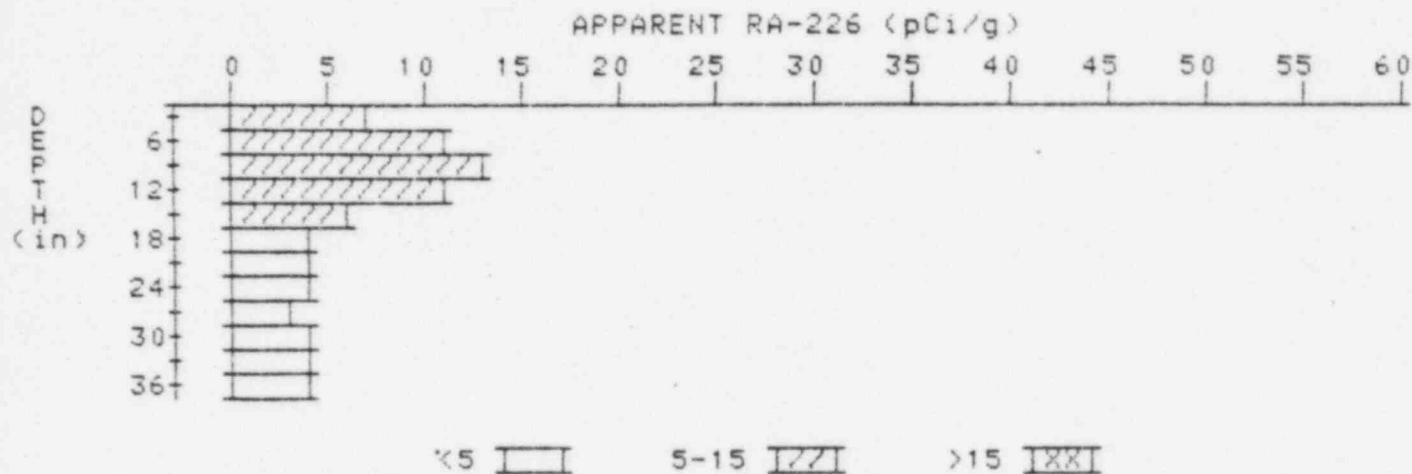
HOLE NUMBER: 21

Depth (in)	Apparent Radium-226 (pCi/g) Undeconvolved	Apparent Radium-226 (pCi/g) Deconvolved
3	7.0	7.0
6	9.0	11.1
9	9.8	12.8
12	8.9	10.7
15	7.0	6.3
18	5.5	4.4
21	4.6	3.7
24	4.2	4.2
27	3.8	3.3
30	3.7	3.7
33	3.6	3.6
36	3.5	3.5

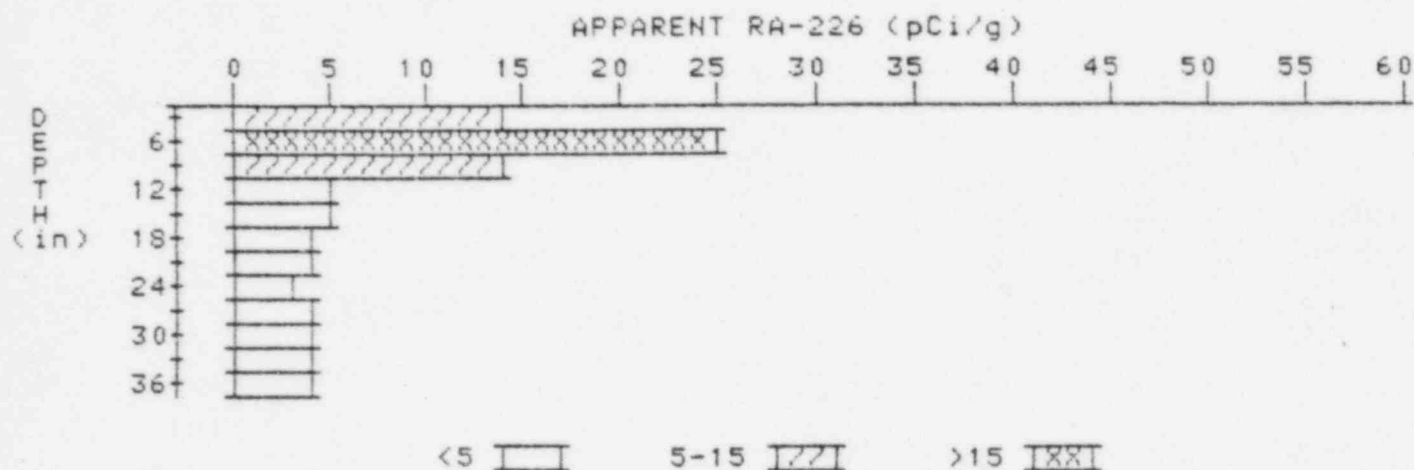
HOLE NUMBER: 35

Depth (in)	Apparent Radium-226 (pCi/g) Undeconvolved	Apparent Radium-226 (pCi/g) Deconvolved
3	13.8	13.8
6	15.8	25.2
9	12.5	14.1
12	8.3	4.7
15	6.1	4.5
18	4.8	3.7
21	4.1	3.6
24	3.7	3.0
27	3.7	3.7
30	3.7	3.7
33	3.7	3.9
36	3.6	3.6

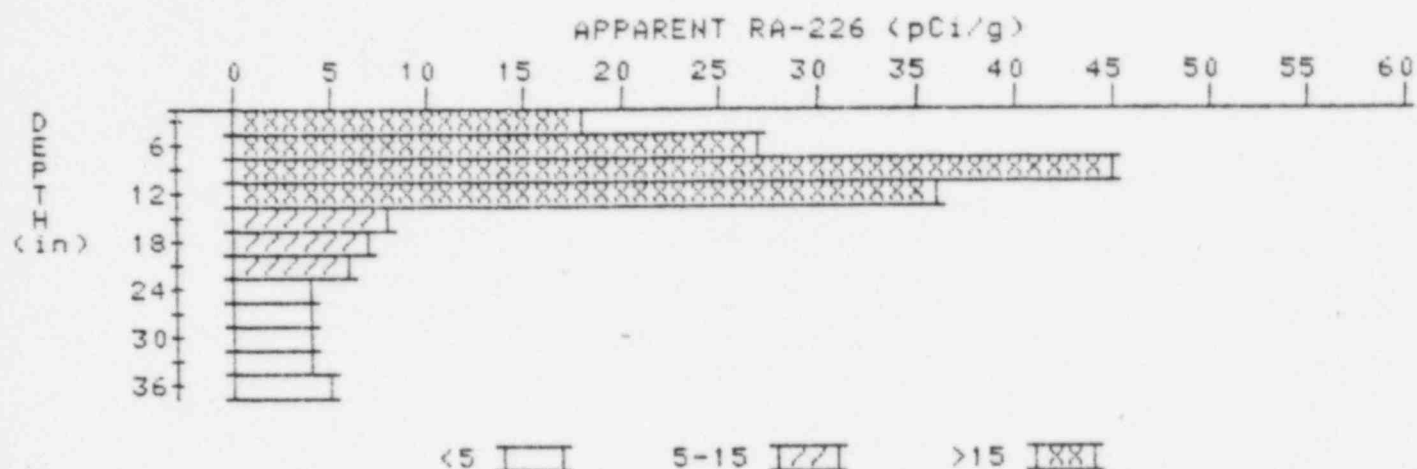
HOLE NUMBER: 37

Depth (in)	Apparent Radium-226 (pCi/g)	Apparent Radium-226 (pCi/g)
	Undeconvolved	Deconvolved
3	17.7	17.7
6	24.4	27.2
9	29.5	45.3
12	25.7	36.0
15	16.1	8.3
18	10.9	7.0
21	7.9	5.9
24	6.0	4.0
27	5.2	4.5
30	4.8	4.4
33	4.6	4.2
36	4.6	4.6

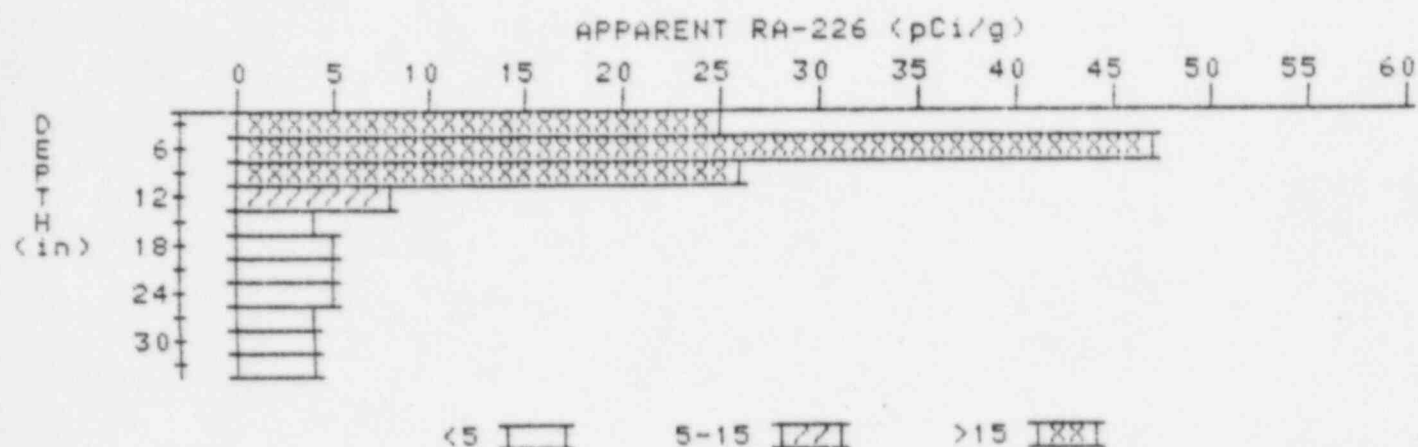
HOLE NUMBER: 39

Depth (in)	Apparent Radium-226 (pCi/g) Undeconvolved	Apparent Radium-226 (pCi/g) Deconvolved
3	24.9	24.9
6	28.6	46.6
9	22.2	25.6
12	13.9	8.2
15	8.8	3.6
18	6.6	4.6
21	5.5	4.6
24	4.9	4.5
27	4.5	4.1
30	4.3	3.9
33	4.3	4.3
