TITLE POST IRRADIATION EXAMINATION OF FORT ST. VRAIN  
CRACKED FUEL ELEMENT SN1-2415

Post Irradiation Examination  
of Fort St. Vrain  
Cracked Fuel Element SN 1-2415

NRC Fin No. A-7258  
October, 1984

Los Alamos National Laboratory

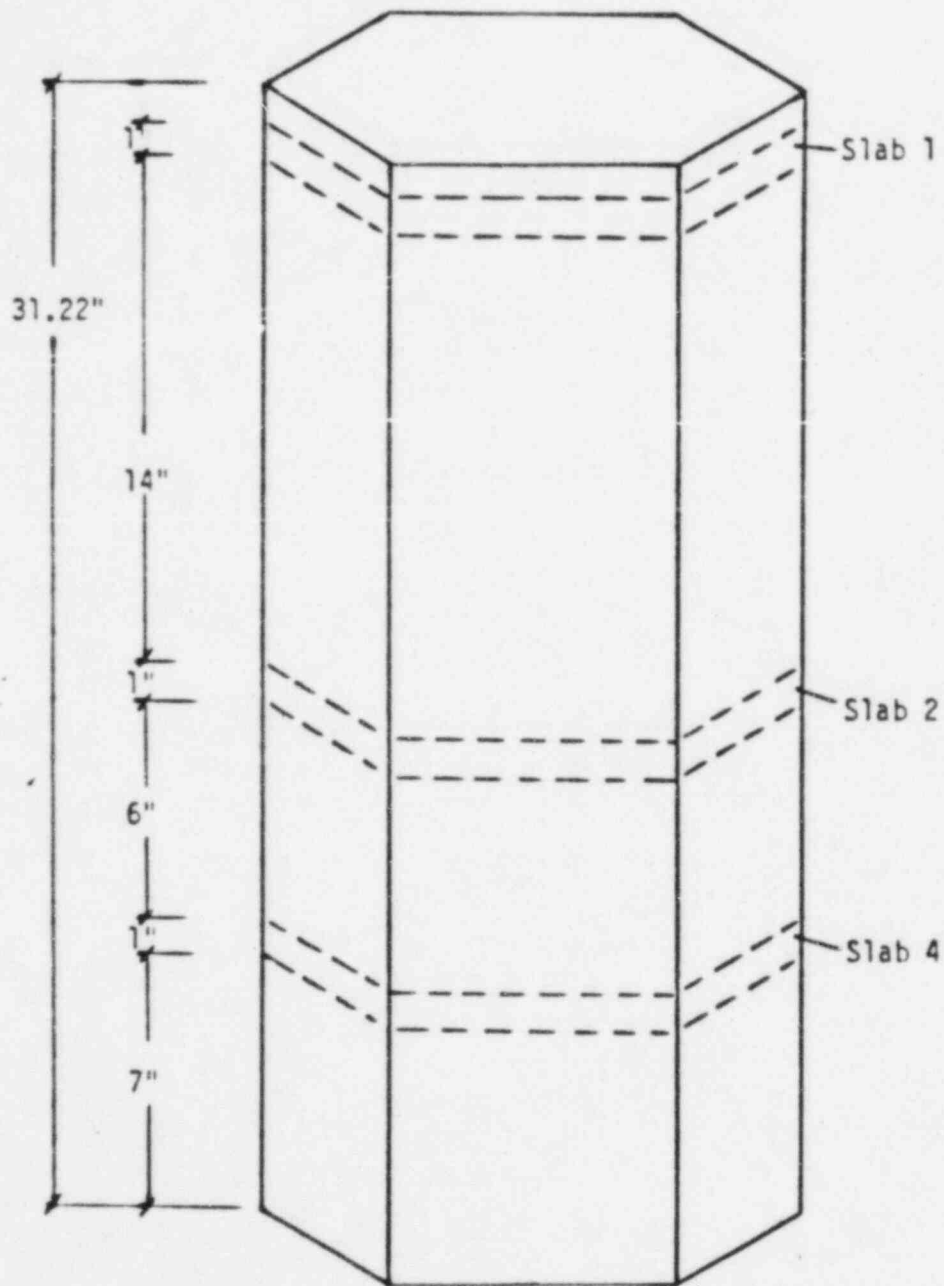
Fig. 5a Radiological Measurements

Radiological measurements were taken at the time of receipt, during which all three slabs indicated nominal radioactivity levels of 1.5 mr/hr, one meter from the slab faces. Edge surface measurements averaged 72 mr/hr, 50 mr/hr and 45 mr/hr, for slabs 1, 2, and 4, respectively, with a 40-90 mr/hr variation. Average face surface measurements were 445, 232, and 212 mr/hr, again for slabs 1, 2 and 4, respectively, with measurements ranging from 150-700 mrem/hr. Figures 5a, 5b and 5c indicate the relative radioactivity levels over each of the slabs, respectively. In general, the radioactivity levels of the three slabs were considered less than originally expected, allowing easier handling in the hot-cell environment.

Slab 1

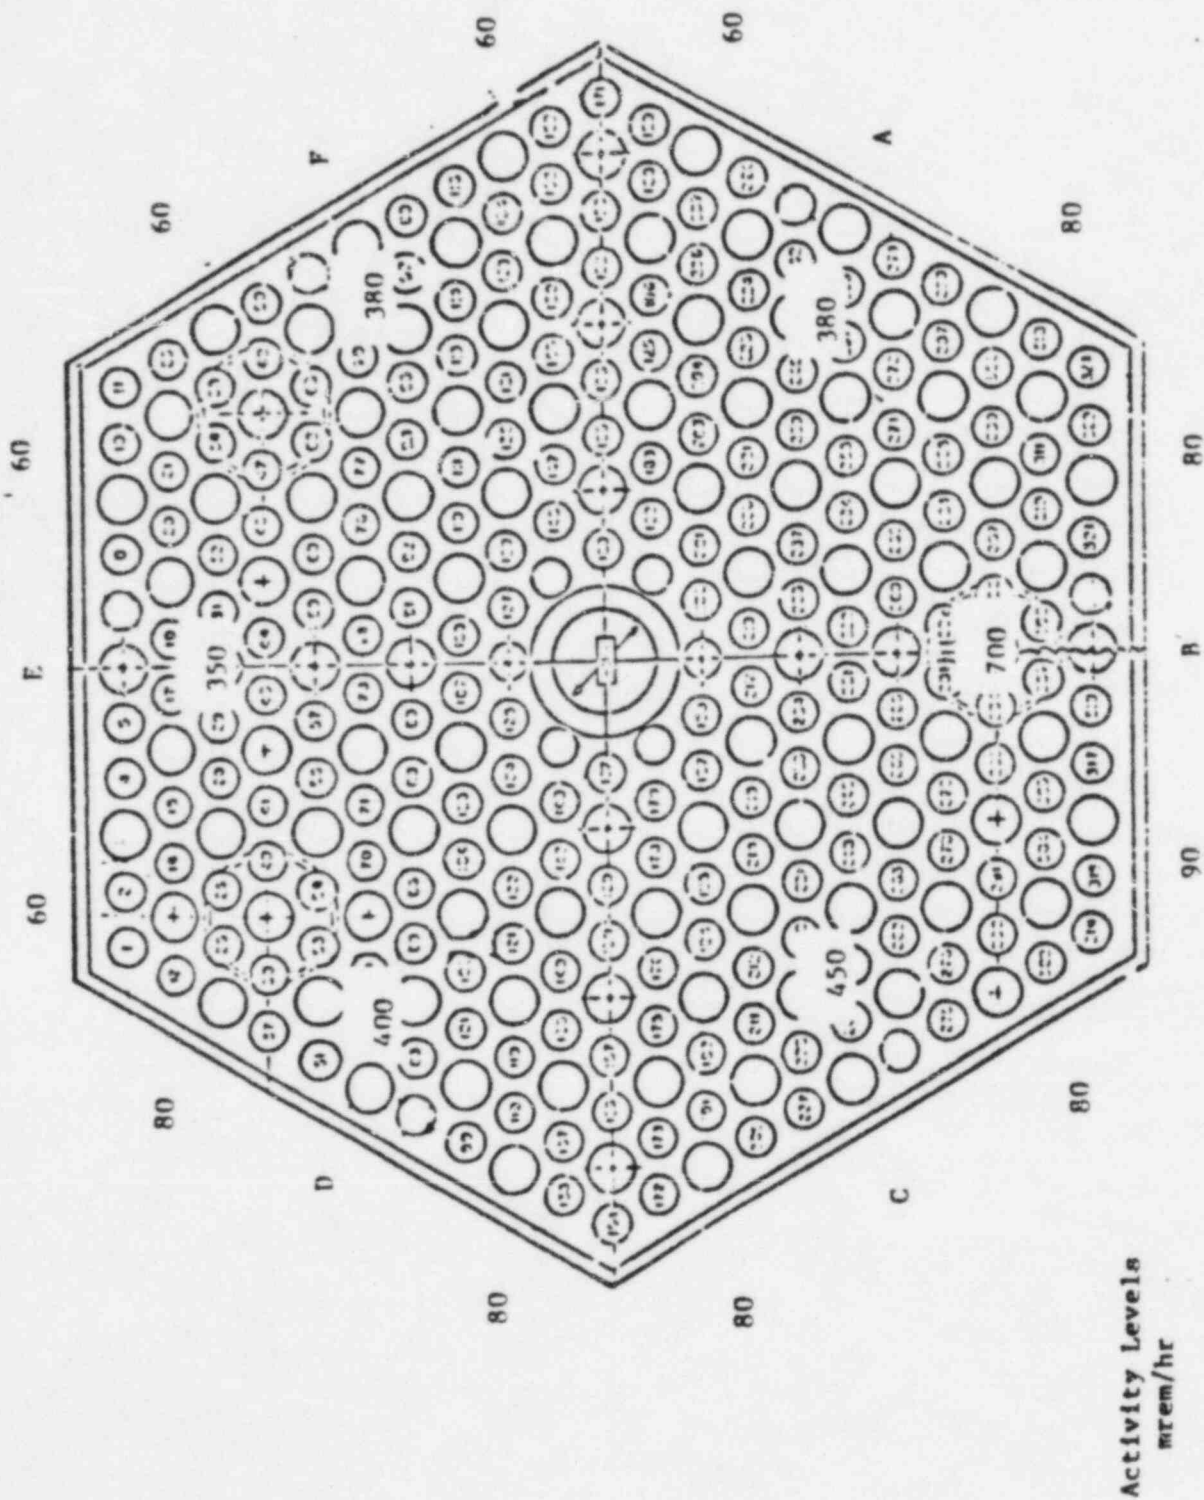
Fig. 5b Radiological Measurements

Slab 2

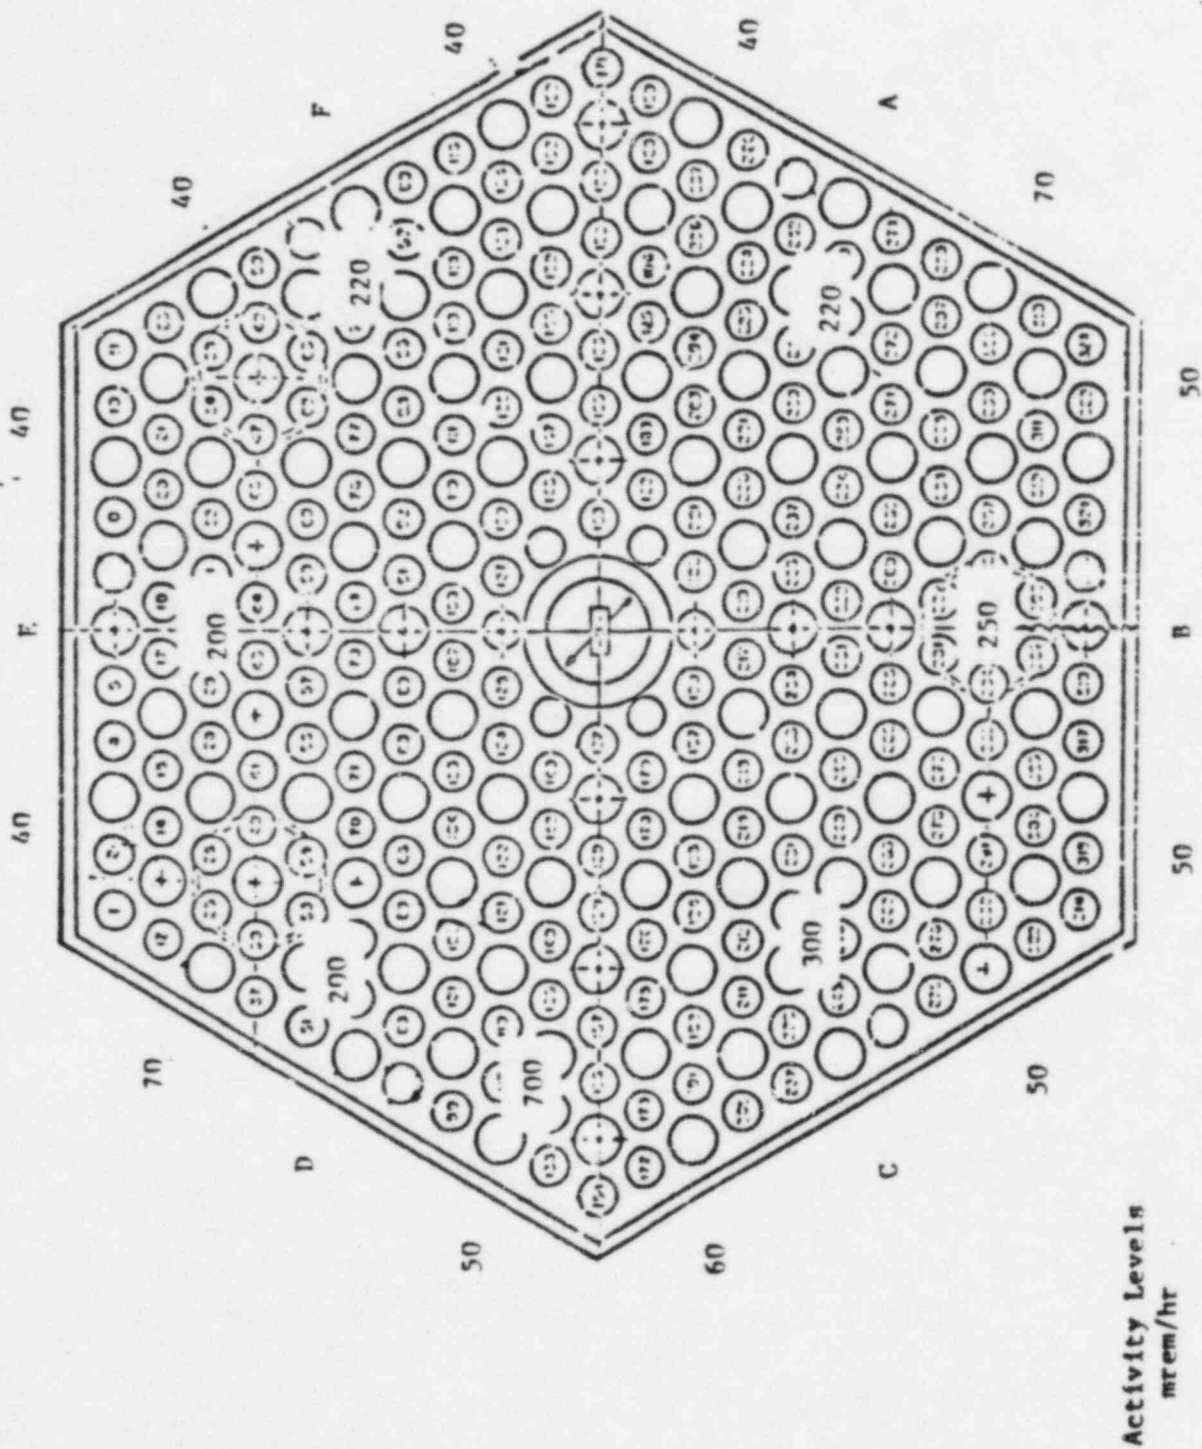
Fig. 5c Radiological Measurements

Slab 4

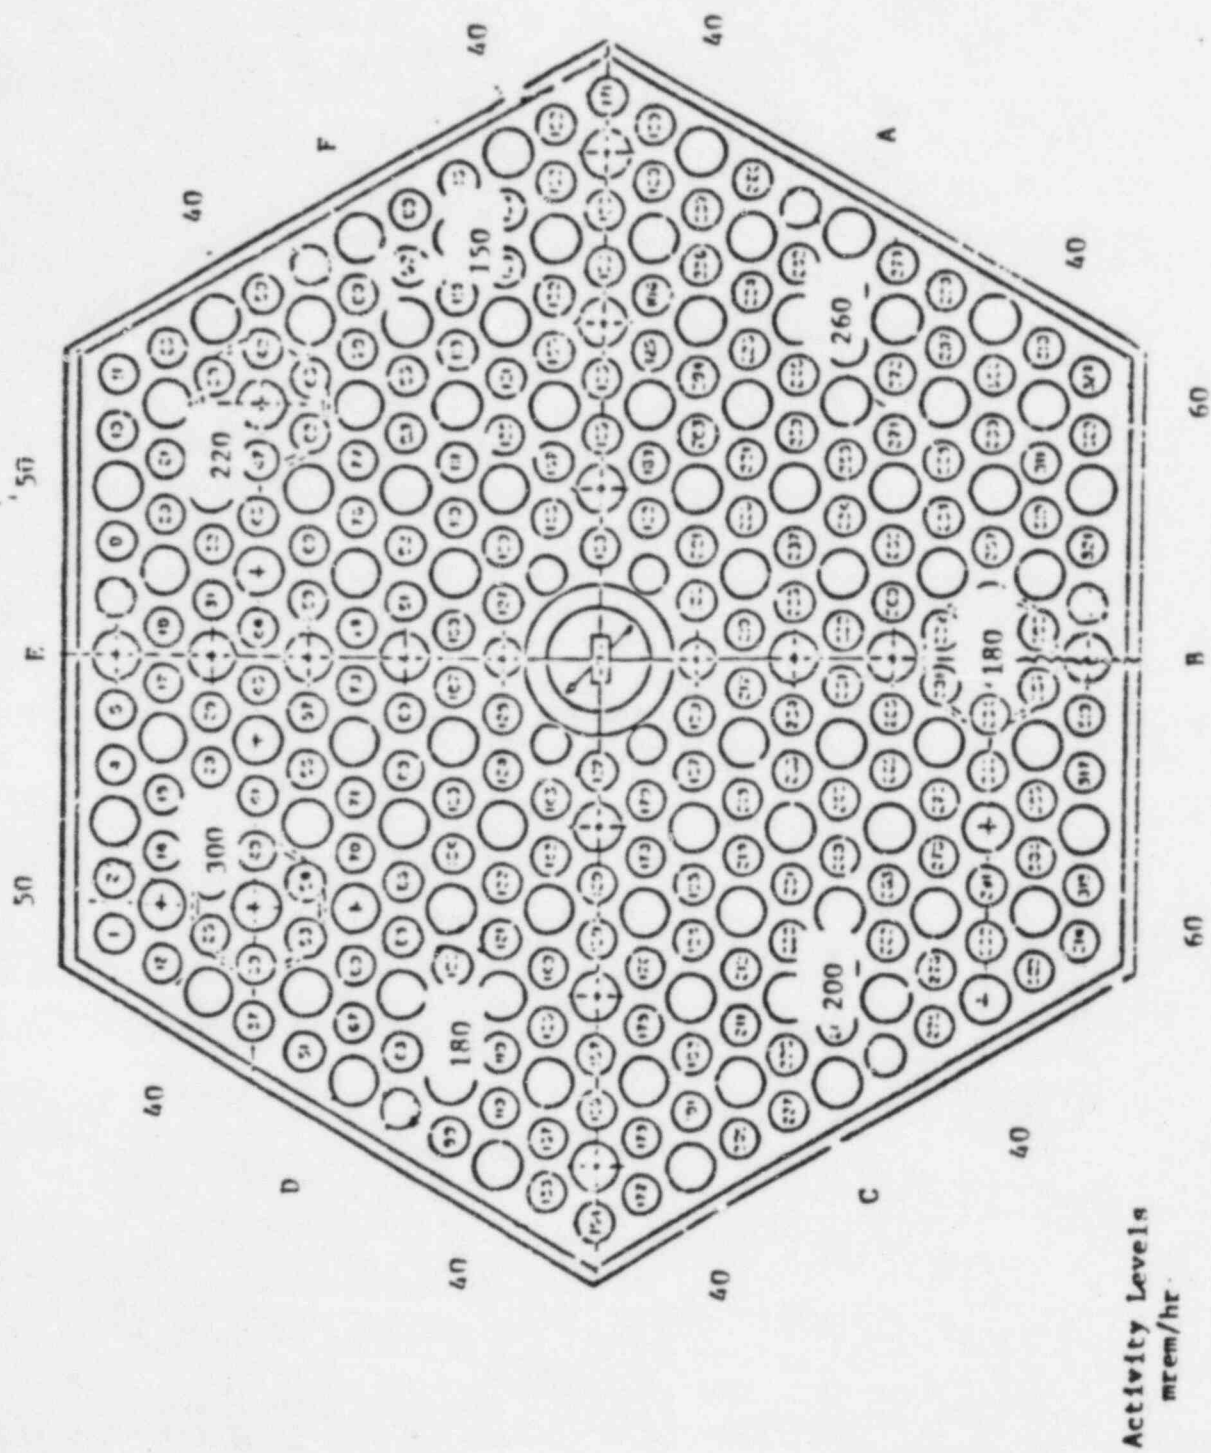
Figure 6. Fractographic and metallographic Sectioning

Because Slab 4 was closest to the core midplane, it experienced higher power and fluence levels, relative to the other two slabs. For this reason, it was chosen for initial fractographic examination. The cutting plan in Figure 6 was used to expose one side of the crack fracture surface for each of the affected webs. Photos 5(a) and 5(b) (4x original magnification, but photographically reduced 22%) show the fracture surface in the webs between the B-face and coolant channel 319 and between coolant channel 319 and fuel hole 307, respectively. In both cases, the fracture surface is considered typical of tensile cracking. It was verified at this time that indeed no crack existed in the web between fuel hole 307 and coolant channel 295.

The metallographic analyses included examining the graphite microstructure for possible anomalies, looking for differences between longitudinal and transverse microstructures, and determining crack paths. The metallographic samples from locations indicated in Figure 6 were prepared for examination by pressure-potting techniques--i.e. an epoxy resin was forced, under pressure, into the surface-accessible pores in the sample. Once the epoxy had set, the samples were ground and polished for examination. Photo 6 (32x original magnification, but photographically reduced 50%) shows typical microstructures obtained as described. The light features that have "grain" resembling that of wood are the coke filler particles. The binder areas are usually slightly darker, but are best identified using polarized light. The dark gray spots are pores filled with the epoxy mounting resin (note appearance of mounting resin at edges of samples). The few black spots that are visible are pores that did not fill with resin, and are considered to be sample preparation artifacts.

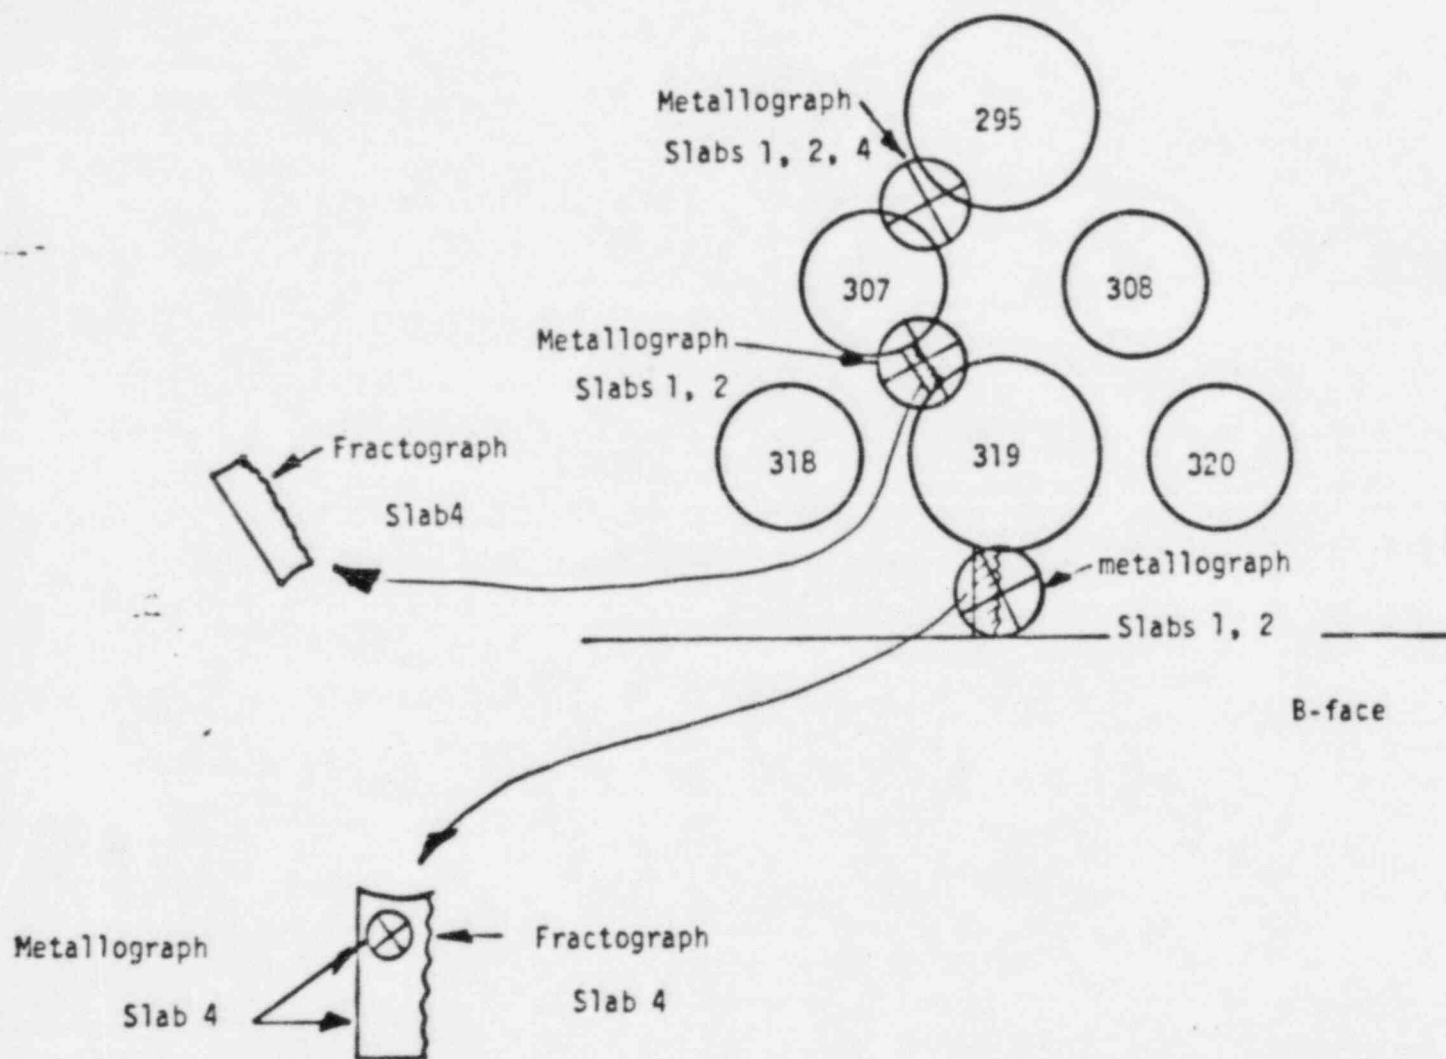
Initially, the extent of cracking in SN 1-2415 was confirmed by removing approximately a 1/4" slice from the top of the element, thereby effectively removing the cemented B-dowel from the element socket, without interfering with the fuel stacks. Photo 1 shows the top of SN 1-2415 after the removal of the first slice with the remainder of the B-dowel still in the socket. In this photo, the crack radially extends from the B face, across coolant channel 319, and disappears under the B-dowel. Photo 2, taken after the B-dowel section was removed, shows how the crack extended from coolant channel 319 to fuel channel 307, and on to coolant channel 295 under the B-dowel.

SN 1-2415 Element - - Slice  
removed showing B dowel
