NUREG/CR-6456
INEL-96/0089
AEOD/E97-01

Review of Industry Efforts To Manage Pressurized Water Reactor Feedwater Nozzle, Piping, and Feeding Cracking and Wall Thinning

Prepared by
V. N. Shah, A. G. Wire, A. M. Porter

Idaho National Engineering Laboratory
Lockheed Idaho Technologies Company

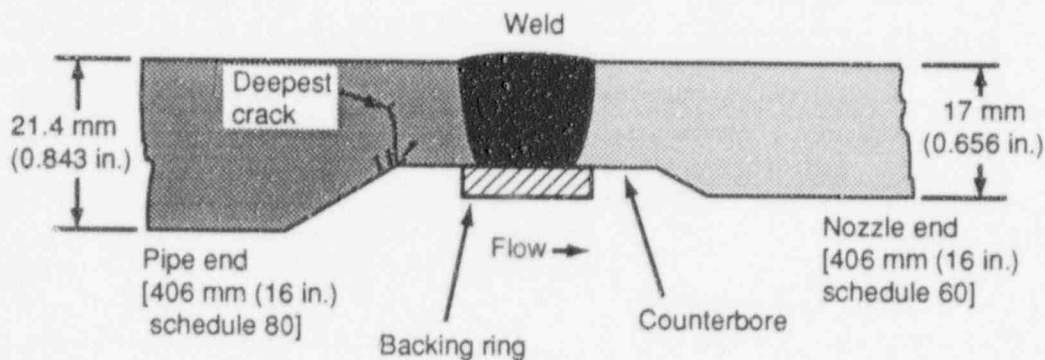
(a) Crack profile in degraded feedwater piping.

Typical cracks were transgranular, oriented in the circumferential direction and initiated at the inside surface, as shown in Figure 22. In this figure, the primary crack (deepest crack) is a circumferential crack that has grown in the radial direction. There are several shallow secondary cracks adjacent to the primary crack. Whereas the maximum crack depth in some units was less than 2.5 mm (0.100 in.), several cracks had propagated 6 to 19 mm (0.250 to 0.750 in.) through the wall. Most of the cracking occurred in the counterbore region of the base metal (see Section 3.3), primarily at the re-

Figure 22. Typical fatigue crack orientation at feedwater nozzle counterbore.

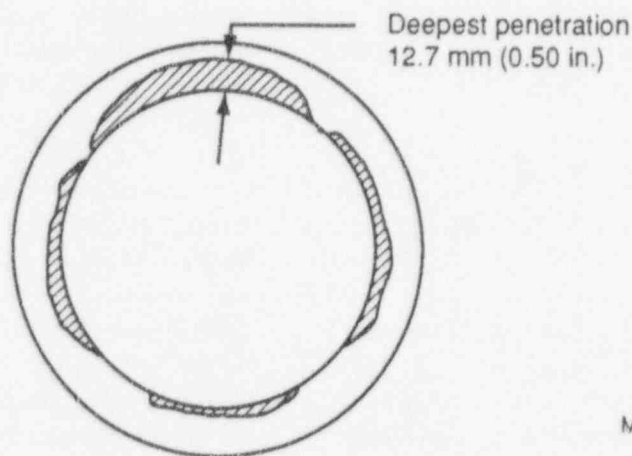
(b) Crack location in the D.C. Cook nozzle (USNRC 1980).

The cracking was attributed primarily to thermal fatigue caused by thermal stratification and striping in the nozzle region and concentrated at the stress raiser at the counterbore. Corrosion fatigue apparently played a secondary role in the cracking. Some of the cracks initiated at pits on the inside surface, and corrosion products have been found on crack surfaces. Although oxygen is thought to be a factor in accelerating the fatigue, it is not considered to be the primary factor.

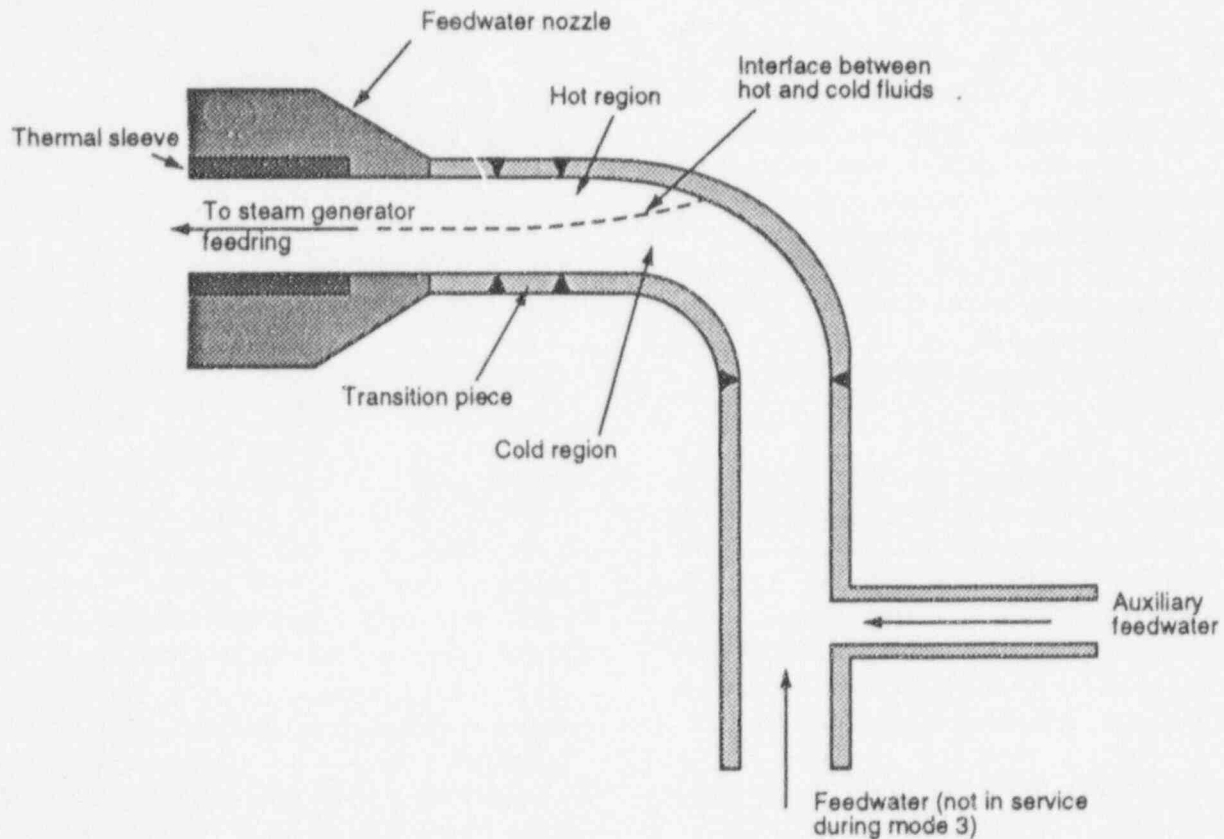
Figure 25. Stratified flows during operation of auxiliary feedwater system (TVA 1992a).

During periods of auxiliary feedwater operation, the flow partially fills the horizontal portion of the nozzle region, leading to the stratified fluid condition shown in Figure 25. The cold auxiliary feedwater [about 20 to 38°C (70 to 100°F)] fills the lower portion of the horizontal portion of the feedwater line and nozzle, and hot fluid [about 286°C (547°F)] from the steam generator fills the upper portion. When the auxiliary feedwater flow is terminated, the nozzle region temperature returns to the hot condition, and then when flow is reinitiated, the stratified condition is reestablished. This on-off auxiliary feedwater operation leads to cyclic thermal stratification. Figure 29 shows typical auxiliary feedwater flow rates with the auxiliary feedwater cycling on and off during automatic operation.

mode of operation, the auxiliary feedwater flows at about 760 l/min and fills the lower half of the feedwater piping cross section as shown in Figure 25. The pipe wall inside surface, near the interface, is probably subject to high-cycle fatigue damage caused by thermal striping.

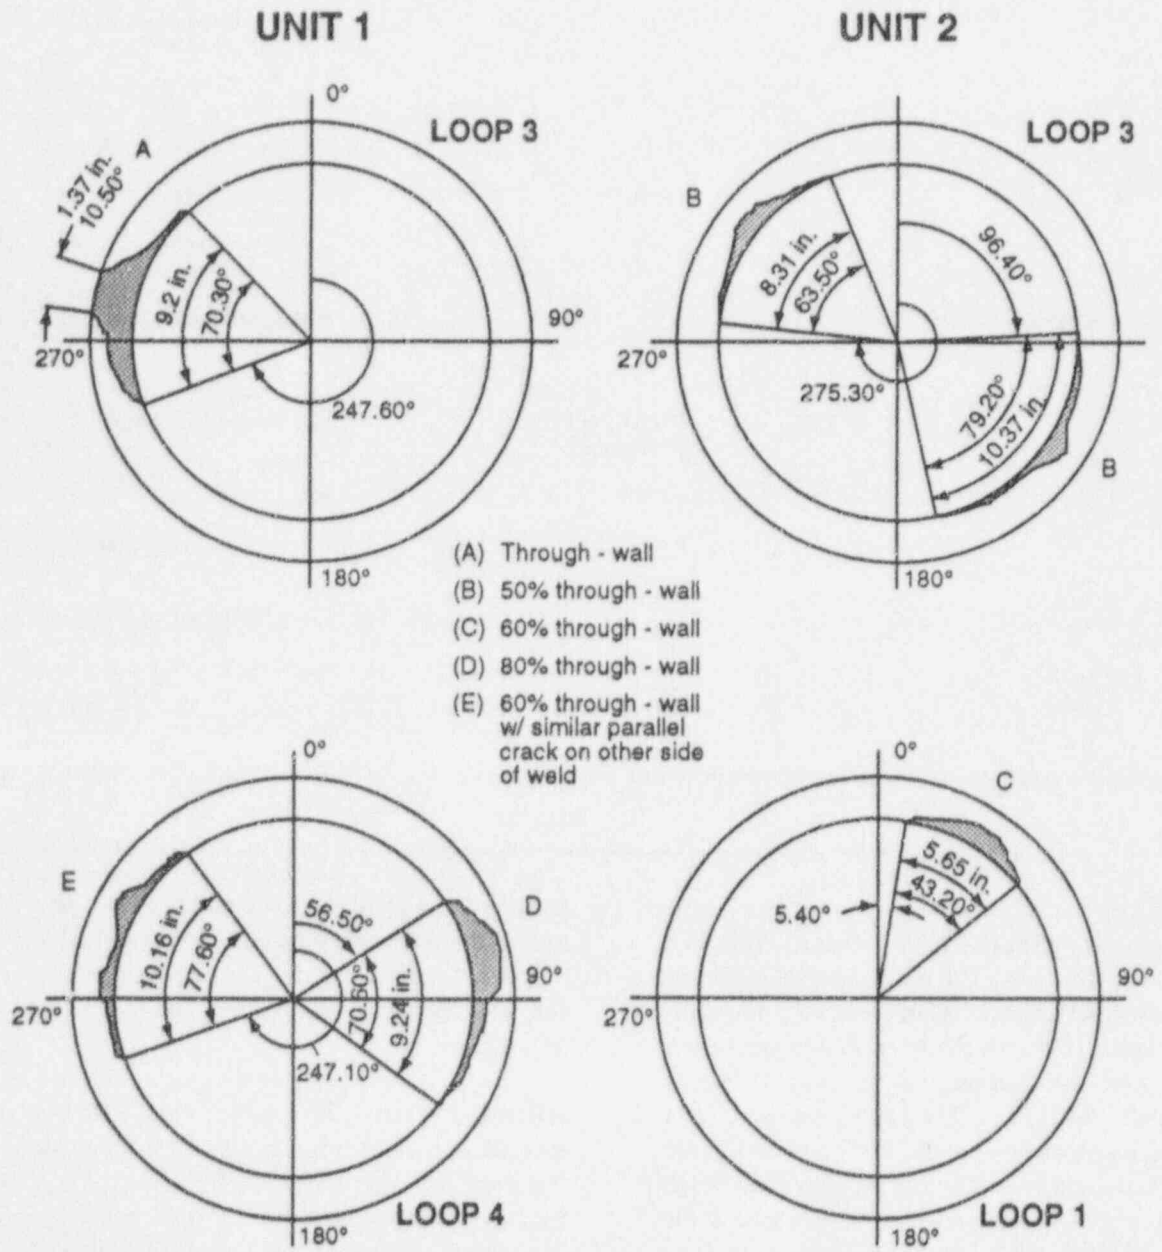
explanations for these asymmetric crack profiles are (a) the elbow may be in a plane inclined to the vertical plane instead of in the vertical plane, or (b) the counterbore may have an asymmetric geometry.

Figure 27. Extent and orientation of primary cracks in feedwater nozzle-to-transition field weld at Sequoyah Units 1 and 2 found in 1992 (TVA 1992a).

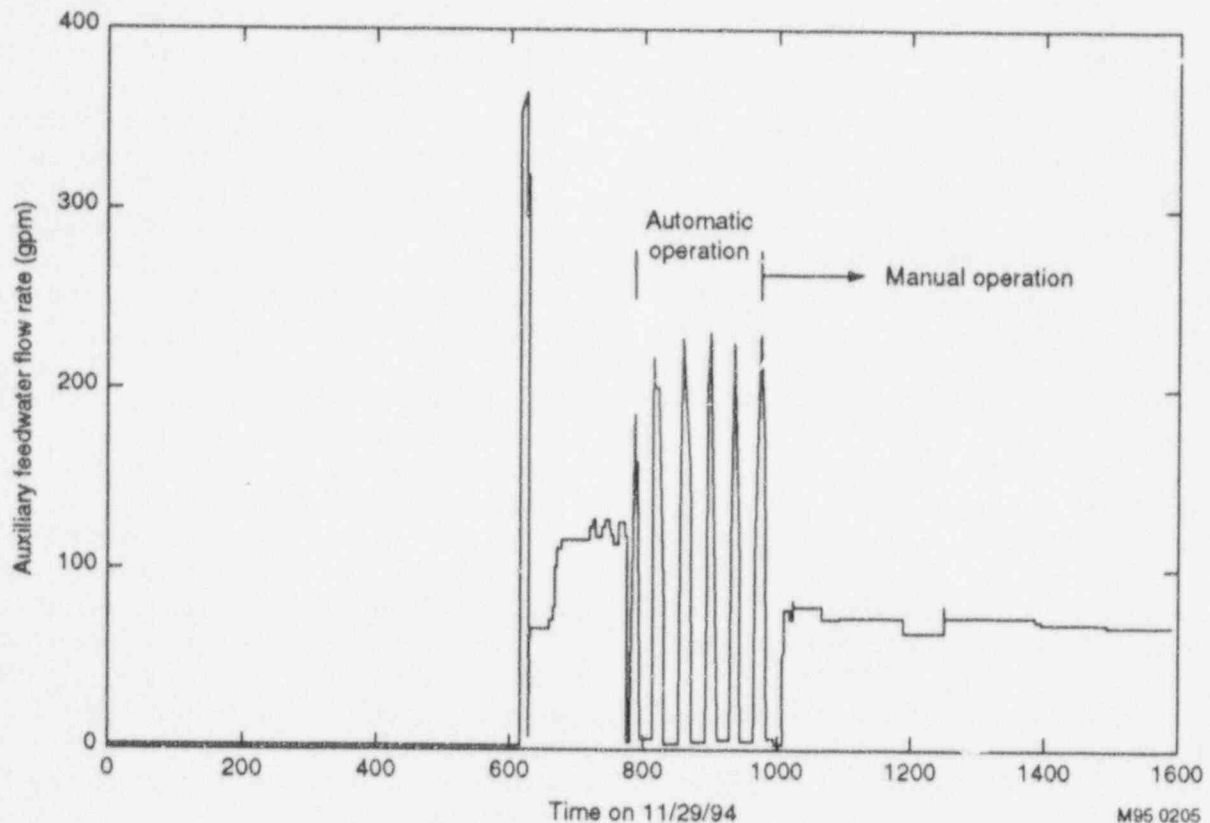
Fatigue damage progresses much more rapidly in the automatic mode, during which the flow fluctuates between 0 and about 760 l/min (200 gpm) at a rate of approximately 3 times per hour and cyclic thermal stratification takes place, than in the manual mode, during which the flow is relatively constant at about 300 l/min (80 gpm) and large fluctuations in the flow rates are absent. The automatic mode of operation, because of the relatively high flow rates, might also be producing thermal striping at the interface between the cold auxiliary feedwater and the hot fluid from the steam generator. Thermal striping imposes high-cycle stresses on the pipe inside surface and contributes to crack initiation. (See Section 7.1 for a description of thermal stratification, thermal striping, and thermal cycling.) In the automatic

Figure 29. Loop 1 auxiliary feedwater flow rates during manual and automatic operation at Sequoyah Unit 1 on November 29, 1994. Courtesy of W. Ludwig, TVA.

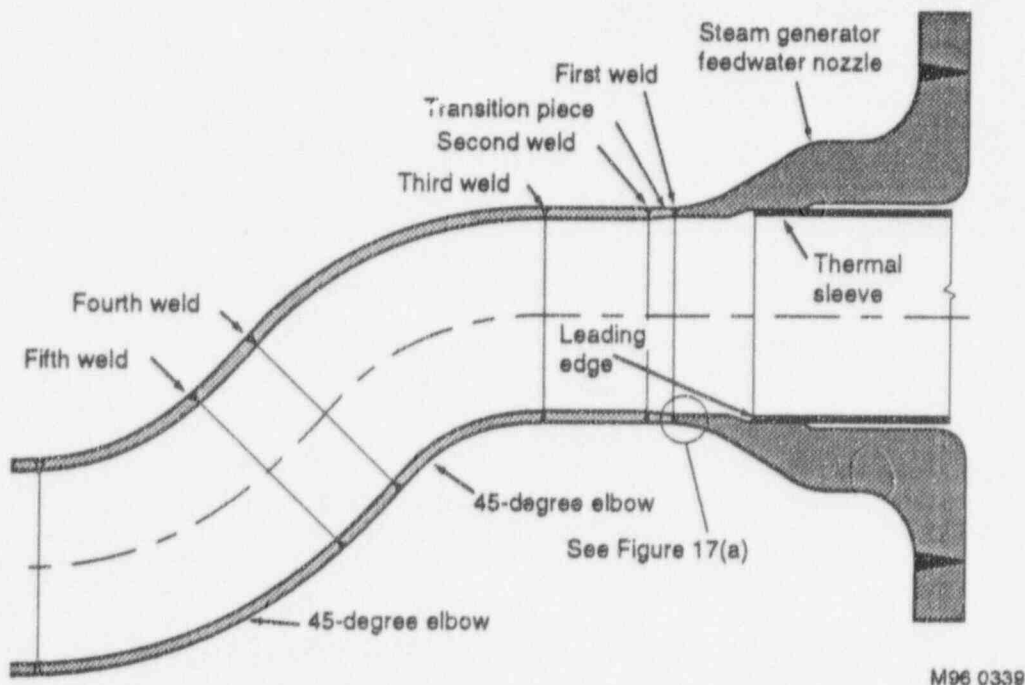
Diablo Canyon Units 1 and 2 are 4-loop Westinghouse PWRs. Figure 32 is a drawing of the SA-508 Class 2 steam generator nozzle and the adjacent SA-106 Grade B feedwater piping, typical for both units. A 51-mm (2-in.) long transition piece was field welded to the nozzle at the downstream end. At its upstream end, it is welded to a 203-mm (8-in.) long horizontal section of pipe, which in turn is welded to a 45-degree elbow. Figure 17 shows a construction drawing of the field welds (Cofie et al. 1994). The inside surfaces were counterbored in this region, resulting in a reentrant corner on each side of the weld at the transition to the thinnest section. Figure 17(a) shows that the thickness change is more pronounced, and the counterbore reentrant angle is

more notched on the upstream side of the transition piece-to-nozzle weld than for either the downstream side of this weld or for a typical transition piece-to-pipe weld counterbore. The transition piece-to-pipe counterbore, shown in Figure 17(b), has a reentrant angle of 166 degrees, versus 150 degrees for the transition piece-to-nozzle weld. Fatigue cracking typically occurs circumferentially around the pipe at the upstream end of the transition piece-to-nozzle weld, where the stress concentration is significantly more severe.

Figure 32. Feedwater nozzle area layout at Diablo Canyon Units 1 and 2 (Shvarts et al. 1994). Copyright American Society of Mechanical Engineers; reprinted with permission.

Repair and Mitigation. The licensee decided to replace (in-kind) the horizontal piping to all four Unit 1 feedwater inlet nozzles. During the Unit 2 seventh refueling outage, an enhanced

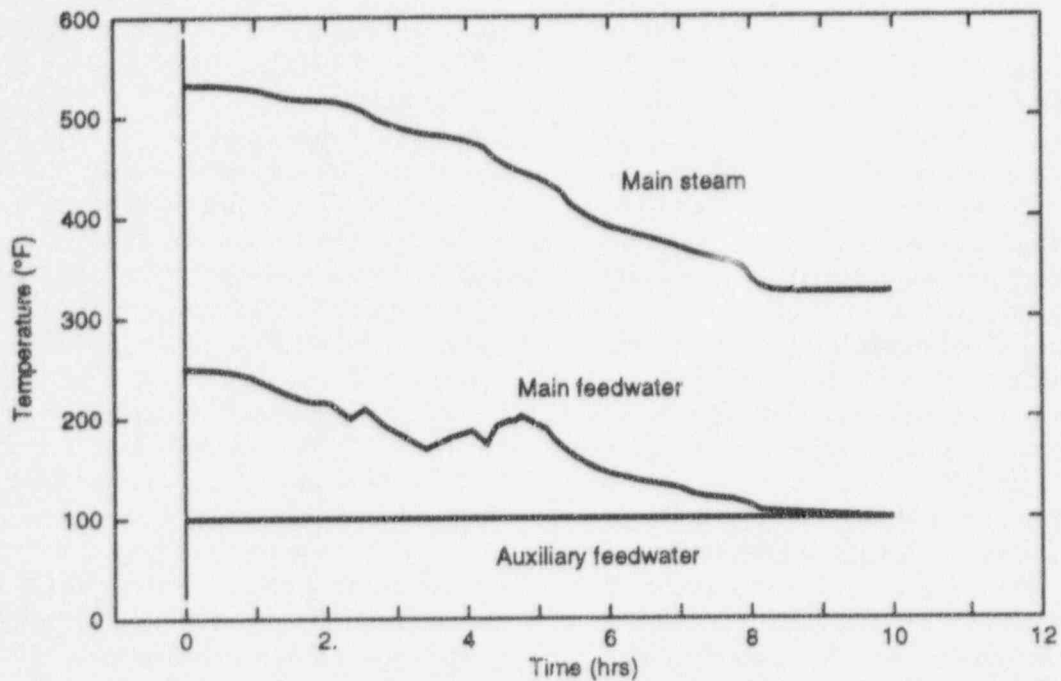
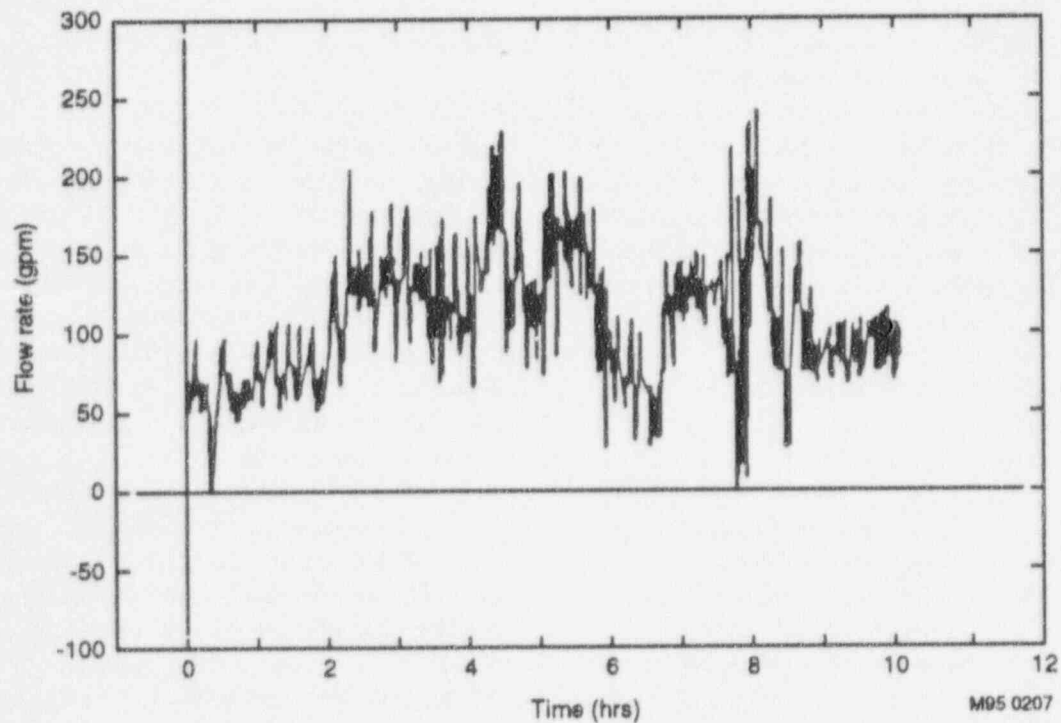
The Diablo Canyon auxiliary feedwater system was designed for minimum flow rates on the order of 830 l/min (220 gpm) per steam generator during accident conditions (PG&E 1992), but as the required flow is typically less than 830 l/min (220 gpm), fluctuations occur during automatic control operation. Figure 33(a) shows the temperatures during a cooldown on Unit 1 in 1992. The main steam temperature has been reduced from about 288 to 177°C (550 to 350°F), and the feedwater temperature has decreased from about 120 to 40°C (250 to 100°F) over about 9 hours, whereas the auxiliary feedwater temperature has remained constant at 38°C (100°F). Figure 33(b) shows the fluctuations in auxiliary feedwater flow rate during this period; the flow rate averages about 380 l/min (100 gpm). Plant data indicate that the auxiliary feedwater does not fill the nozzle until the flow rate reaches about 760 l/min (200 gpm) or more (Shvarts et al. 1994). Cycling involving changes in flow rates of about 380 l/min (100 gpm) occur at a rate of about 2 to 3 times per hour.

Figure 33. Temperatures and flow rate during cooldown on 9/13/92 at Diablo Canyon Unit 1, Steam Generator 1 (Peterson 1992).

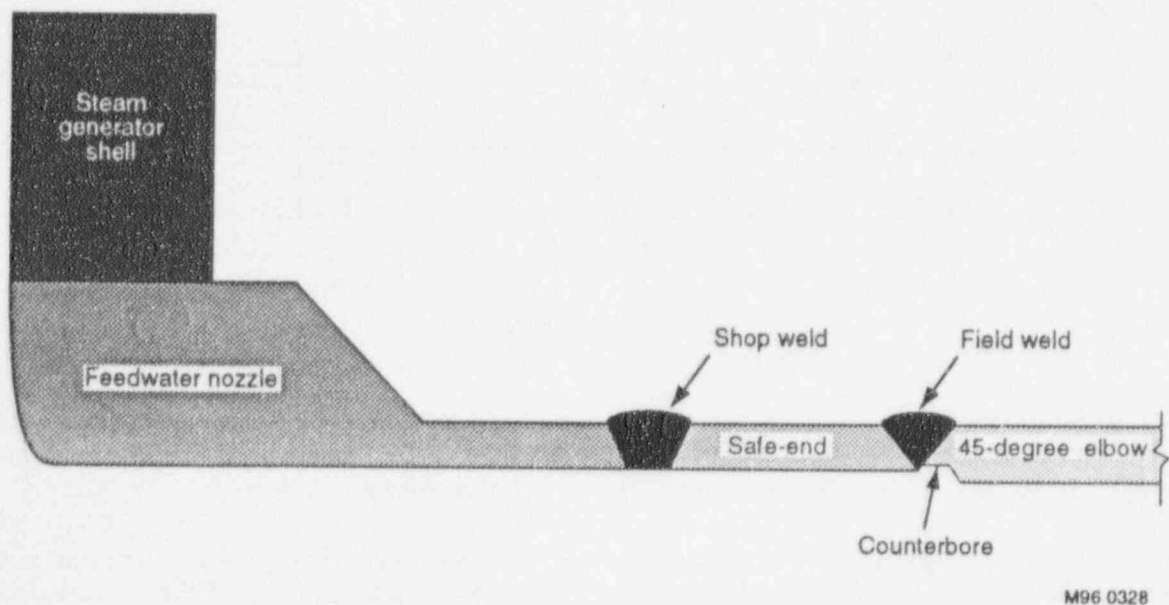
San Onofre Units 2 and 3 are 2-loop, System 80, Combustion Engineering PWRs. In this design, a safe end is welded to the nozzle in the shop, and a field weld connects the safe end to a 45-degree elbow, as shown in Figure 35. This elbow is the terminus of the feedwater piping, and it is welded to another 45-degree elbow at its other end. A counterbore has been machined into the safe-end-to-elbow weld area. The auxiliary feedwater inlet connects to the main feedwater system upstream of the two 45-degree elbows.

Figure 35. San Onofre Units 2 and 3 feedwater nozzle region (Mostafa and Ramsey 1994). Courtesy of E. Regala, Southern California Edison.

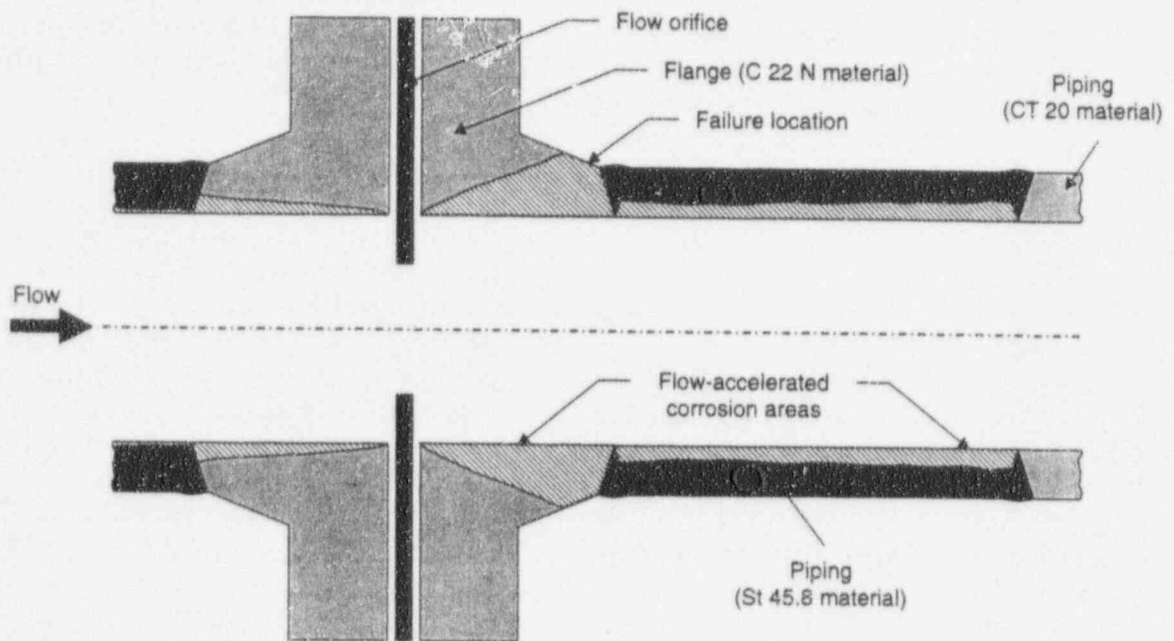
In May 1990, a feedwater pipe at Loviisa Unit 1 ruptured when the plant was operating at full power. The failure location was on the pressure side of a feedwater pump, immediately downstream of the flowmeter flange, as shown in Figure 39. The rupture was caused by a pressure

Figure 39. Loviisa Unit 1 feedwater pipe rupture caused by flow-accelerated corrosion (USNRC 1991a).
