UNITED STATES NUCLEAR REGULATORY COMMISSION

ADVISORY COMMITTEE ON REACTOR SAFEGUARDS

SUBCOMMITTEE ON REACTOR OPERATIONS

DATE: WEDNESDAY, FEBRUARY 12, 1986

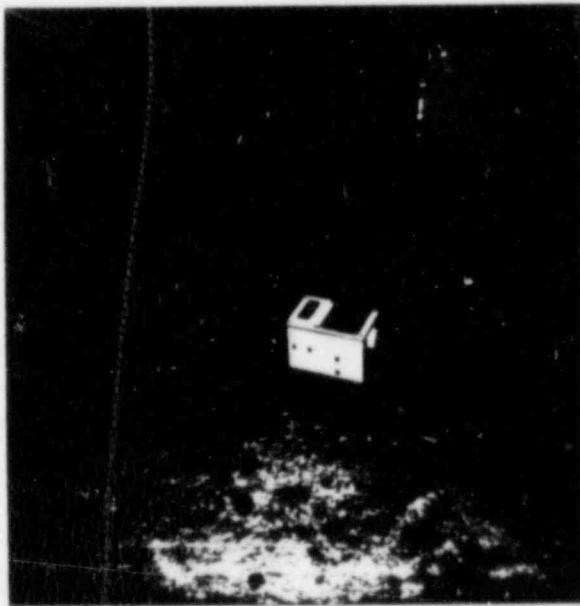
FIGURE 10 - MOUNTING OF
ENCODER TYPE PAF 40
RECORDED ON SURFACE
BUILDING SURVEILLANCE
BL. 500.

1. Reactor Recirculation Pump: Inside the drywell at Elevation 574', on recirculation pump B33-C001A. This instrument was most recently calibrated on December 4, 1985.
2. HPCS Pump Base Mat: In the HPCS Pump Room, in the Auxiliary Building foundation mat at Elevation 574', mounted as shown in Figure 10. This instrument was most recently calibrated on January 30, 1986.

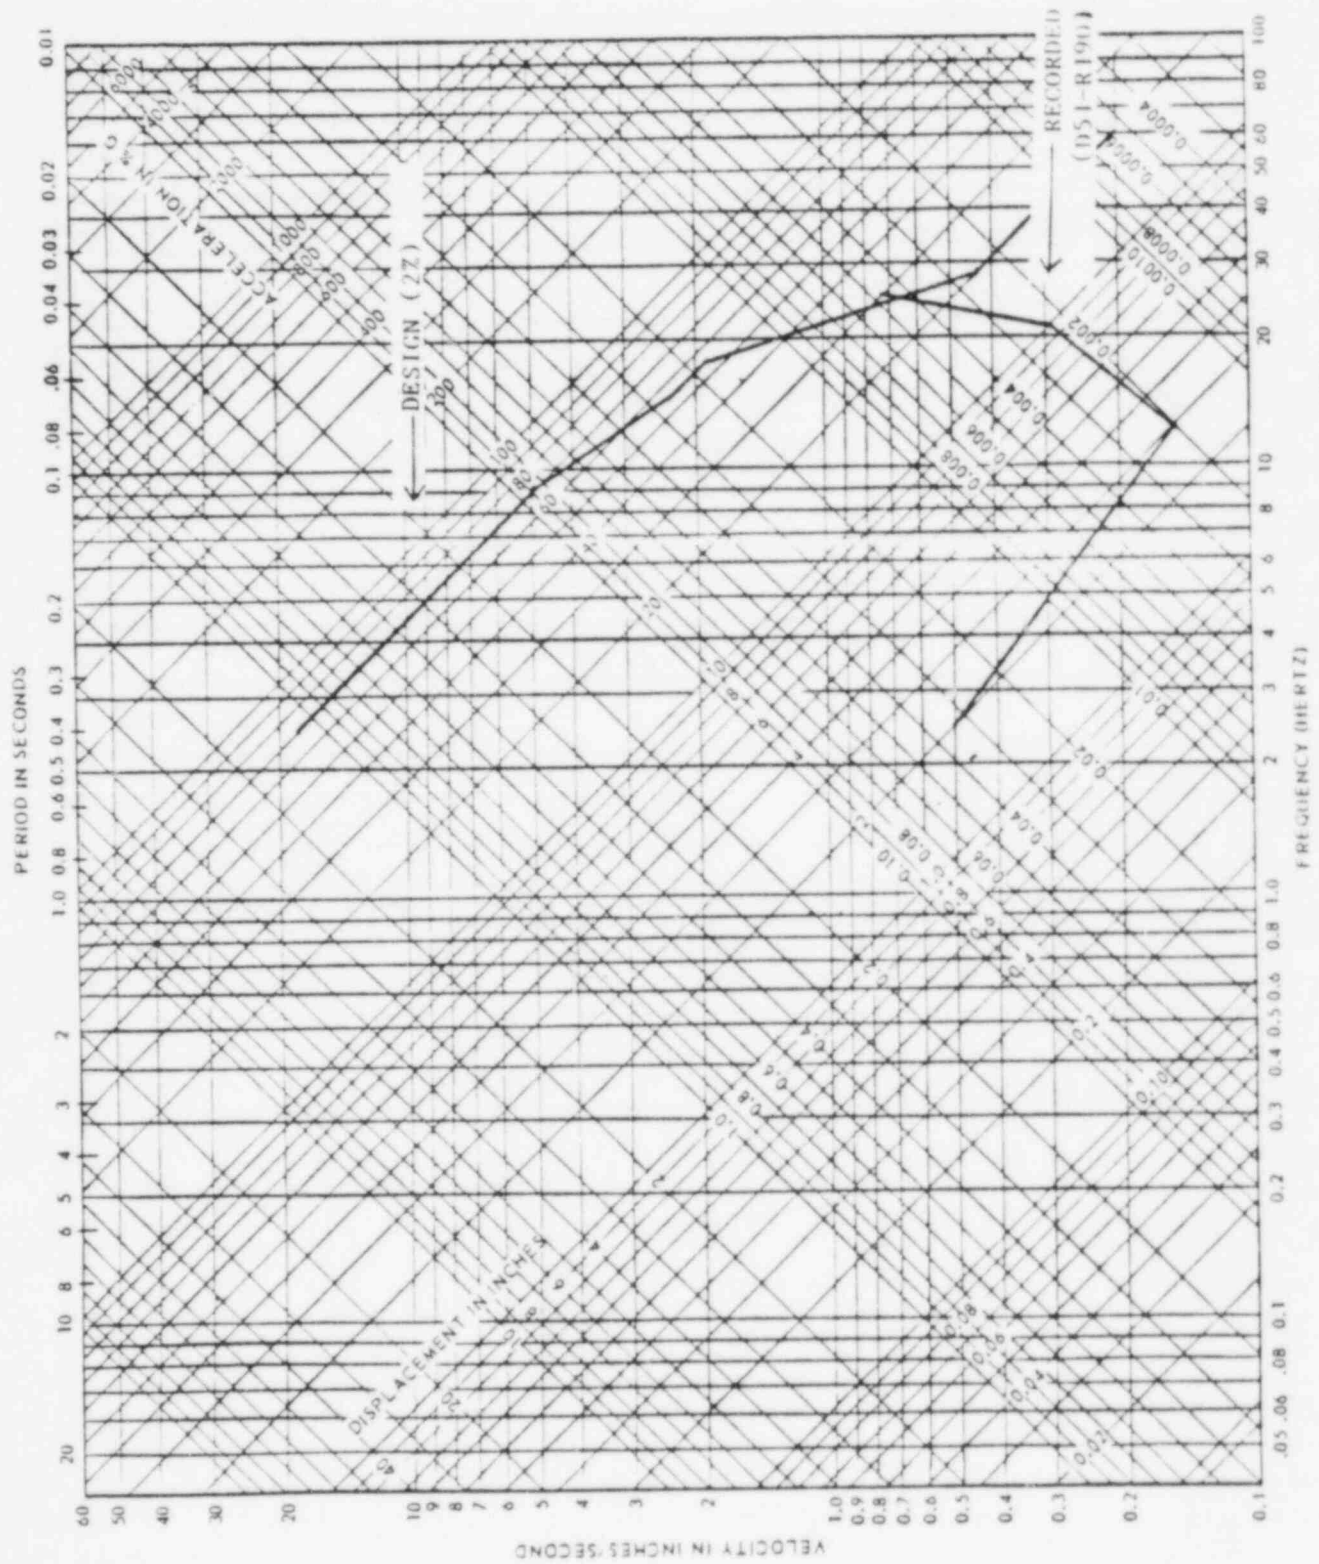
FIGURE D-3

NOTE: D51-R190

(Vertical) Out of phase
 Due to calibration
