NO. PMA 84-06

TITLE: FAILURE ANALYSIS, F010 AND F011 VALVES, CLINTON PROJECT

Date: December 3, 1985

Failure Analysis Report of F010 and F011  
Valves From The Clinton Reactor

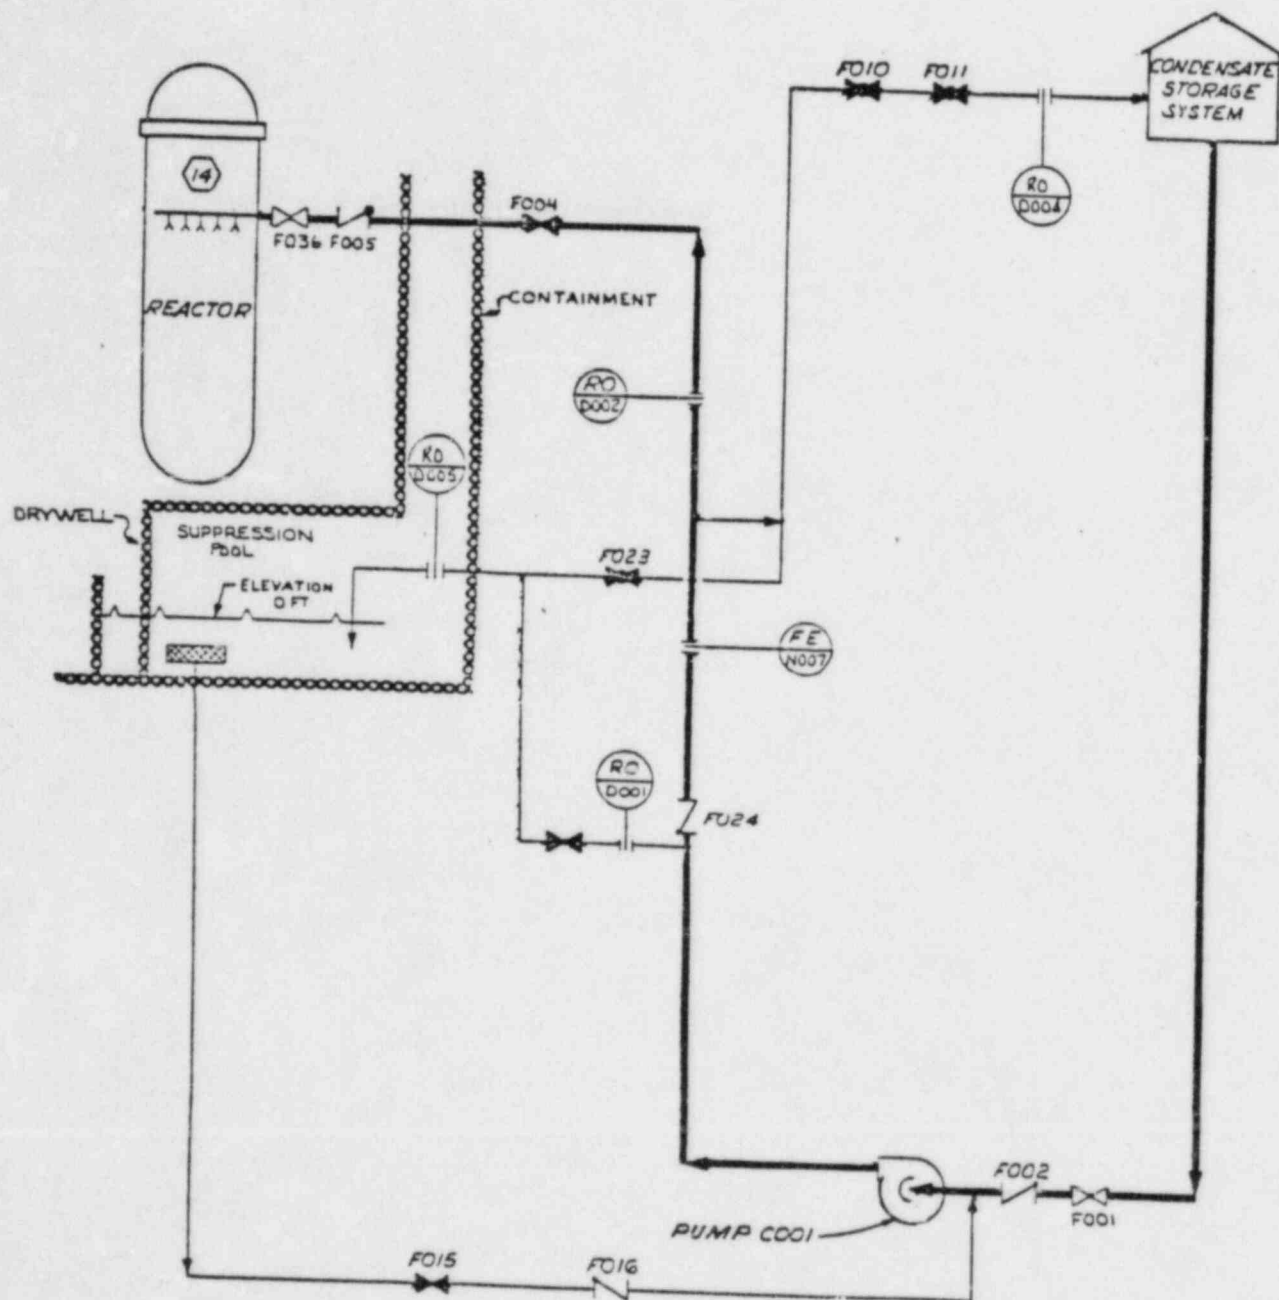
Figure A-1 High Pressure Core Spray System

Note in Figure A-1 that the F010 and F011 valves are located in the test return line running to the condensate storage tank. These valves only operate during the test mode; otherwise they are in the closed condition.

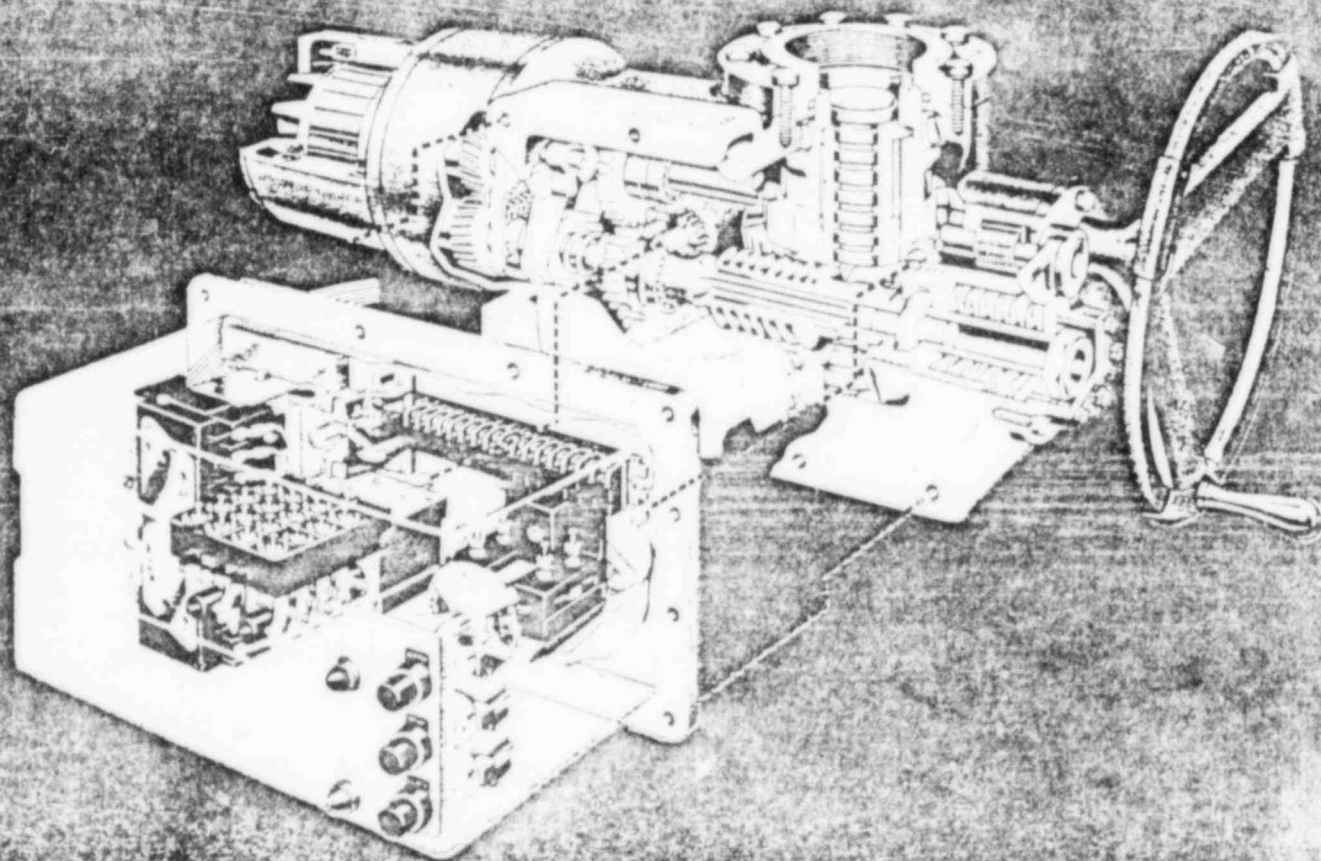
FIGURE B-3

- a. Valve Closure F010 and F011 valve motor control circuits, whose safety direction is close are designed such that either LS7 or TS17 will allow the valve to go fully closed. See figure B-2. Since full closure is imperative for all nuclear boiler isolation valves, TS17 is used to mechanically torque the valve tightly closed. In the event TS17 fails, LS7 will complete the closing cycle. LS7 must be set such that it opens just before TS17, thereby allowing TS17 to break the seal-in. This design feature prevents cycling of the valve in the event of torque switch relaxation. During testing, the valve motion being sealed-in through the torque switch provides valve protection from an overtorqued condition.

- b. Valve Opening For opening the valve the limit switch must be set to shut off the motor before the stem enters the back seat. The torque switch should be set to as low a setting as is commensurate with proper opening of the valve and yet provide some protection against damage to the back seat in event the limit switch malfunctions.

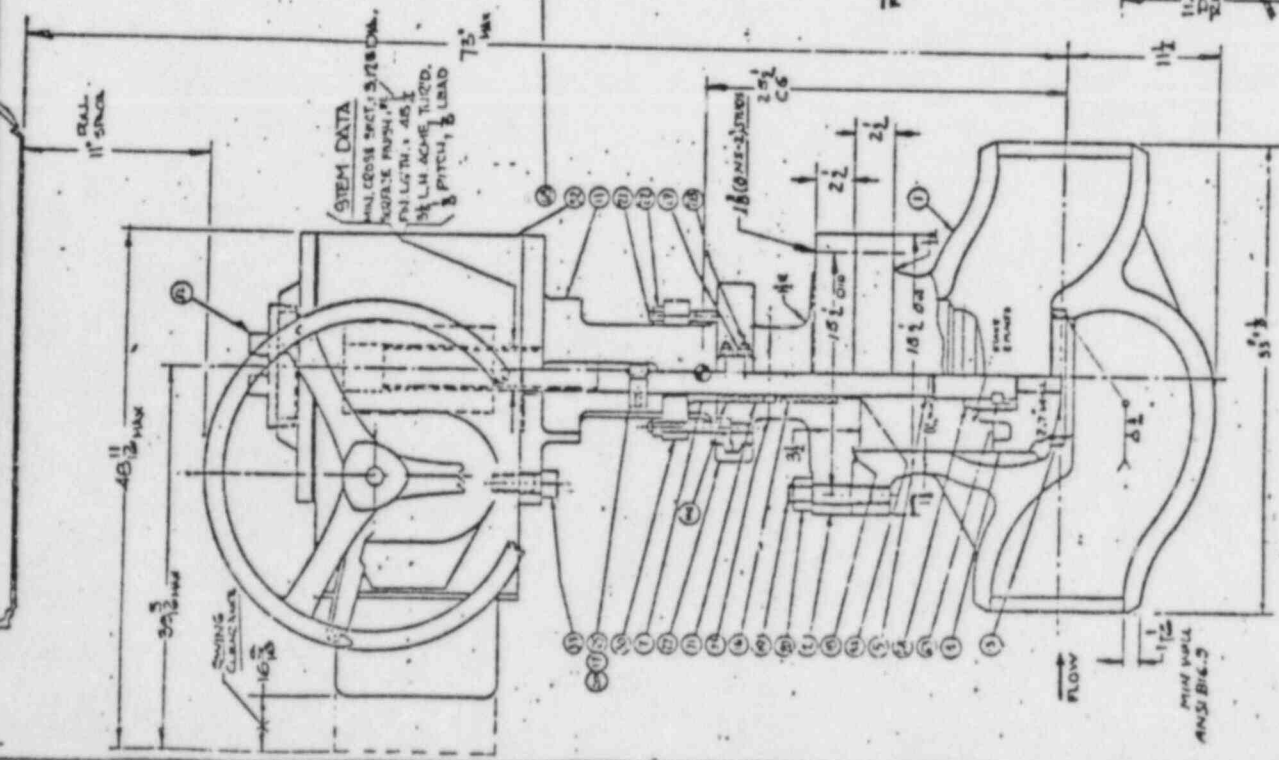
GENERAL ELECTRIC	:	DATE OF ISSUE	ISSUED	:	FDDR NO.	LH1-5504
	:		NOV 22 1985	:	REVISION	0
FIELD DEVIATION DISPOSITION REQUEST	:		PSE & SI	:	SHEET	1 OF 4
PROJECT	:	Clinton	UNIT	:	FDDR ORIGINATOR	DATE
EQUIPMENT (MPL OR DESCRIPTION OR BOTH)	:	E22-F010	I	:	J.T. Cochran	11-21-85
	:			:	J. Bruden for	
DOCUMENT NO. : SH NO.: REV : TITLE						
VPF3238-682-2 : Fig.4: : Instruction Manual Motor Operated Carbon Steel Valves						
DEVIATION DESCRIPTION NCMR 01-1960						
Valve E22-F010 has been damaged during test:

a) The valve stem is fractured approximately 1 3/4" above the back seat level.						
b) The disk was cut apart during disassembly.						
c) The disk nut was cut apart during disassembly.

d) There is a chip out of the hard face seat ring. 11/22/85						
e) There are several gouges in the valve body disk guide ribs. W. Radford for						
SITE QC CONCURRENCE		11/22/85	FIELD CONCURRENCE		J. C. Logan	DATE 11-22-85
X SUGGESTED DISPOSITION			EXPEDITED DISPOSITION			
For part numbers refer to the Reference (Anchor Darling Dwg. 2999-3 Rev.D) Sheet 3 of this FDDR. The following steps may be performed out of order to effect repairs.

a) Penetrant test the bonnet back seat hard face part 34. If free of indications the bonnet is suitable for reuse.						
(CONTINUED ON SHEET 2 OF THIS FDDR)						
Cost: 8Y275		Material: 408-20122-910				
DISPOSITION NEED DATE 11-21-85		EXPEDITED DISPOSITION APPROVAL BY			DATE	
FINAL DISPOSITION						
Same as Suggested Disposition.						
QC - Verify the requirements of this FDDR are met. 11/22/85						
ECA/ECN N/R			FDI NO. N/R			
JUSTIFICATION OF DISPOSITION DECISION (SAFETY, RELIABILITY)						
Damage to valve parts have required substantial repairs. Replacing broken parts and performing repair of pressure boundary parts in accordance with the Code Section XI will restore the valve to design conditions resulting in safe reliable operation.						
DESIGN VERIFICATION STATEMENT						
The disposition will restore the valve E22-F010 to an acceptable configuration based on an independent review and engineering judgment.

- e) IPC is to supply the following replacement parts:
  - 1) Stem part (5) Anchor Darling Drawing 5287-2-2.
  - 2) Disk nut part (64) Anchor Darling Drawing 5287-2-2.

- 5) Valve stem packings (parts 16 and 16A).
  - 6) Replacement gasket part (18)
- f) Since the disk is a pressure retaining part, the use of a substitute disk must be resolved with the authorized code inspector.

- k) Check bonnet and stem leakage, correct any observed leaks.
- l) Assemble code data package to substantiate acceptable valve repairs.
