DOCKET 50-312
RANCHO SECO NUCLEAR GENERATING STATION
UNIT NO. 1
SUMMARY AND SUPPLEMENTAL INFORMATION FROM TRANSIENT OF OCTOBER 2, 1985

HPI "A" FLOW ANOMALY

RANCHO SECO NONCONFORMING REPORT

Page 1 of 8 No. S 5150 Rev. 2

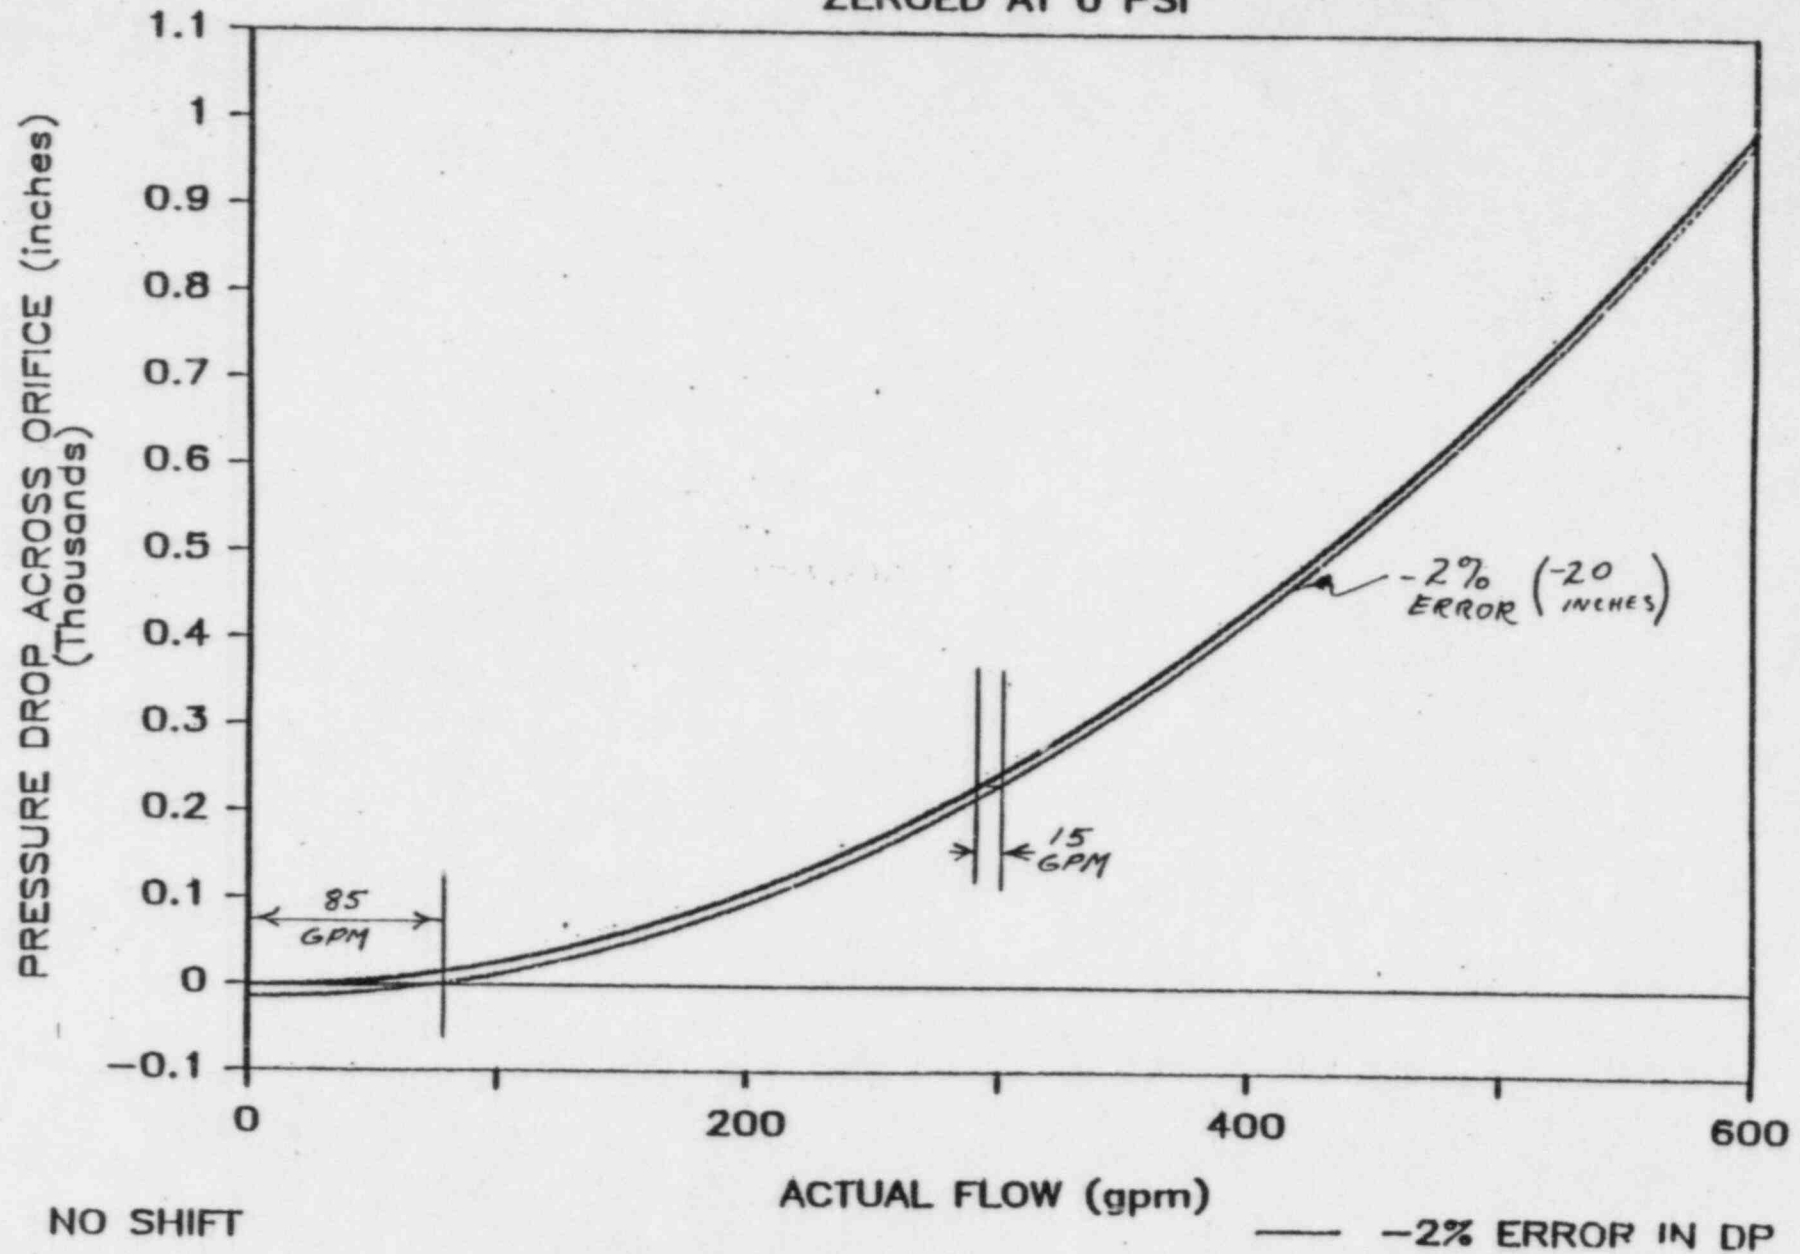
The nature of the identified error is that the HPI flow transmitters (Rosemount Model 1153HB6) have a particular characteristic which affects the zero setting as the process pressure changes. Per Rosemount literature, this can be as much as $\pm .66\%$ of full range per 1000 psi. Since the normal procedure is to calibrate at ambient pressure, the maximum error for our application could be ± 6.6 " H₂O out of the 1000" H₂O range. Per Rosemount the error is repeatable (within the limits of their repeatability specification), and causes a constant dp offset over the range. The net effect then is to introduce a large error at low flows, the flow error diminishing as flow increases as a function of the square root of the error. This effect is shown in Figure 1 for an assumed pressure (HPI header) of 1000 psig for the four FT's using as-found characteristics. Note that except for the D loop, the errors are in a direction such that actual flow is greater than indicated, and that the D loop error diminishes to 1% of maximum flow at approximately 30 gpm.

HPI FLOW VS. MEASURED DELTA PRESSURE

ZEROED AT 0 PSI

HPI A FLOW

ZEROED AT 600 PSI

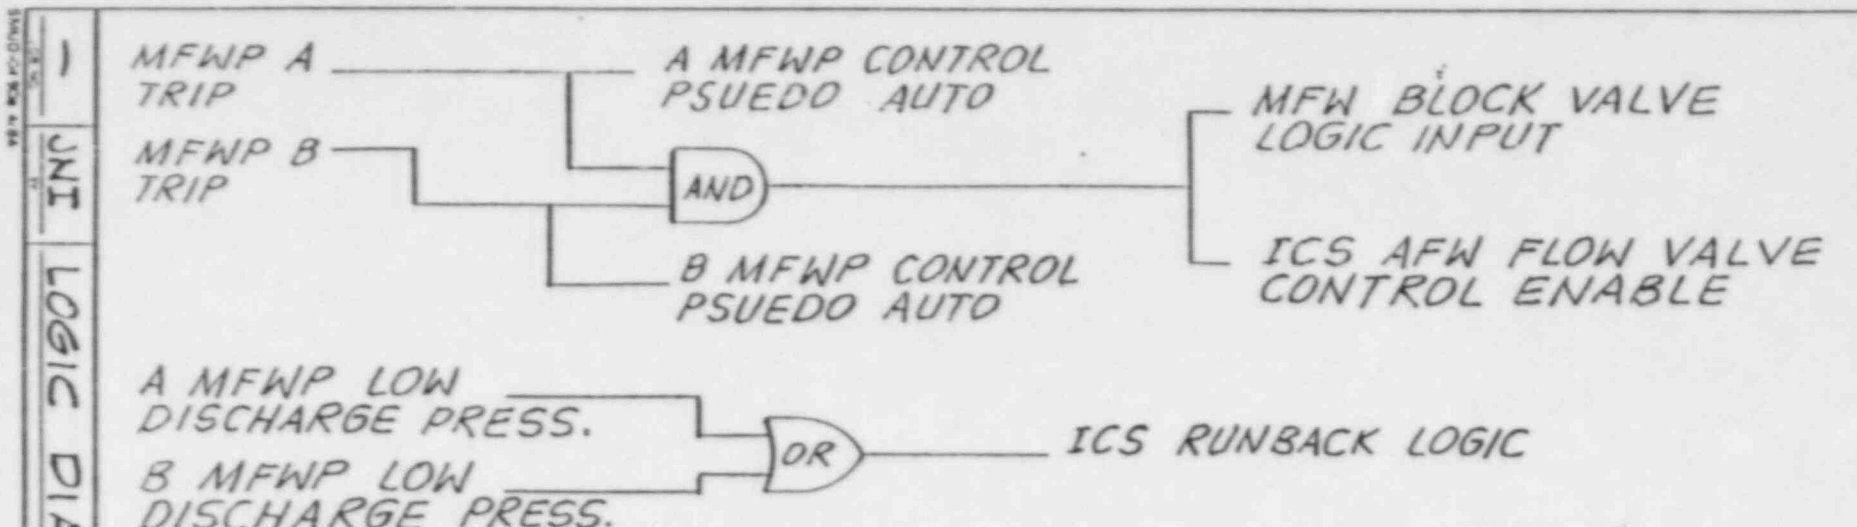
FIG. 1 - CURRENT LOGIC

MFW Block Valves - The "A&B MFW pumps tripped" signal will be replaced with the "MFW pumps discharge pressure low" signal. The remainder of the logic will remain the same (4RCP's tripped to close the block valve).

AFW Valve Control - The "A&B MFW pumps tripped" signal will be replaced with the "MFW pumps discharge pressure low" signal. This signal will allow the ICS to control the AFW valves on low OTSG level.

The logic diagram from the Design Basis Report is attached. (See Figure A)

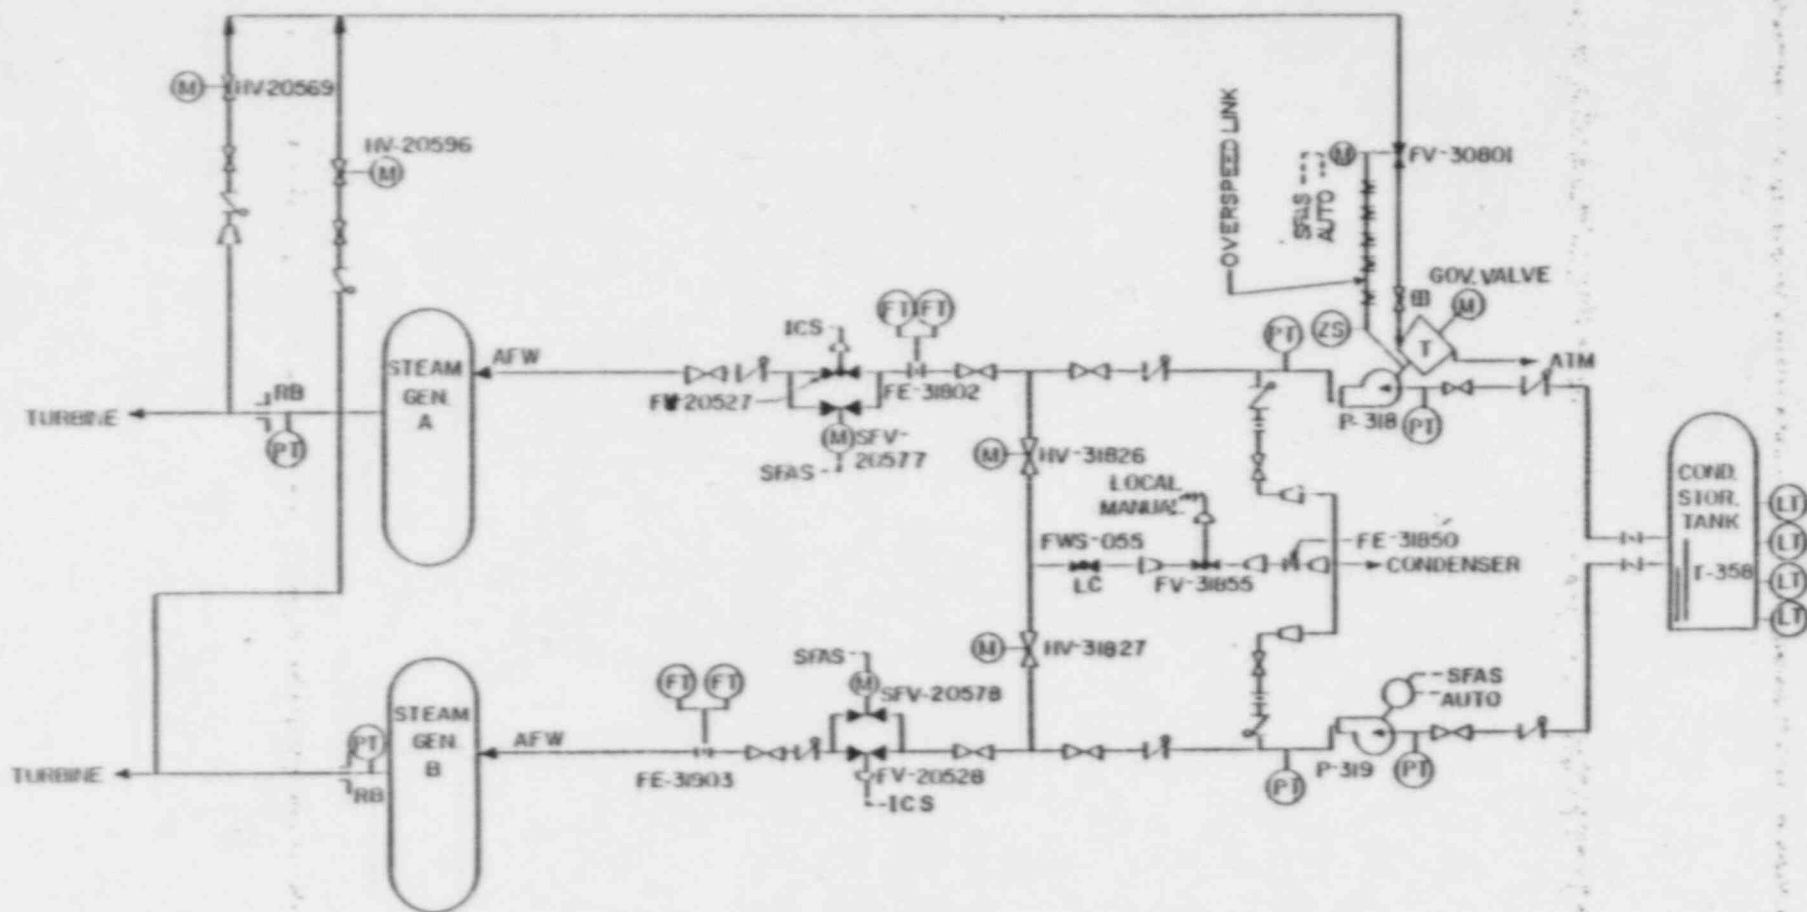
FIGURE B

The design of the AFW system was presented in detail to the NRC staff during the October 23, 1985, meeting in Bethesda. It was clearly shown that there are two separate and distinct activate/control systems and flow paths within AFW (see Figure B attached). Either system can supply AFW to the OTSG's regardless of failures in the other. The systems are briefly described below.

- 2) The second system is the Class 1 Safety Feature Activation System (SFAS). This system provides automatic AFW pump start and flow to the OTSG's when LOCA conditions are sensed. Class 1 manual start and flow control is available in the control room.

The SFAS system is completely independent of the ICS/Class 1 Pump Start System. Thus, it follows that there is no single failure which could cause loss of main feedwater flow (for example, closure of all ICS controlled main feedwater control valves), and cause the inability to provide AFW flow with the SFAS system. SFAS system AFW flow would require manual control room pump start and flow control since SFAS does not detect loss of main feedwater.

RANCHO SECO
AUX. FEEDWATER SYSTEM
OCT. 1985
