# UNITED STATES NUCLEAR REGULATORY COMMISSION

ADVISORY COMMITTEE ON REACTOR SAFEGUARDS  
QUALIFICATION PROGRAM FOR SAFETY-RELATED  
EQUIPMENT

DATE: WEDNESDAY, JANUARY 15, 1986

# **SUMMARY OF THE EFFECTS OF THE CHILE AND MEXICO EARTHQUAKES OF 1985**

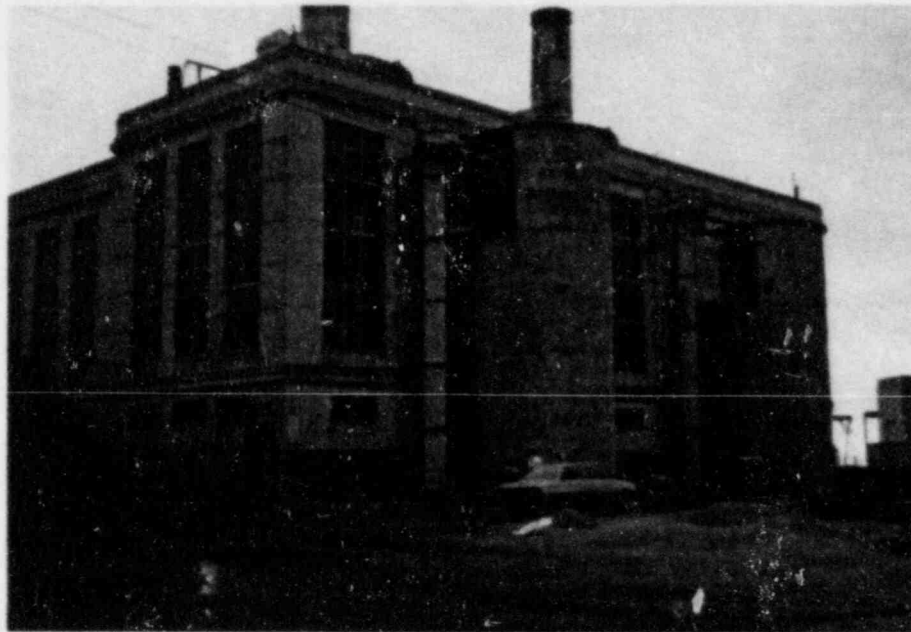
M 7.5 Chile Earthquake of March 3, 1985  
Data Base Site: LAGUNA VERDE POWER PLANT

- One condenser pipe leaked the day after the earthquake, partially or totally due to corrosion from sea water that frequently leaks into the system
- A main steam-vapor pipe came off its roller support; pipe integrity was not lost
- Asbestos insulation fell off pipes due to impact with other pipes or structural members; no pipes were damaged
- Some boiler bricks were cracked but operation was not affected
- Minor cracks were observed in a stucco filler wall

- The plant performed very well. Plants further from the epicenter sustained more damage.
- Unrestrained batteries did not fall from their rack indicating moderate motion. The batteries were on rubber friction pads, and inter-connected with rigid bus bars.
- Piping and cable trays, electrical and mechanical equipment, and typical industrial steel buildings performed well.
- There were no malfunctions, false indications, system resets, or abnormal occurrences of any form in the plant control systems.

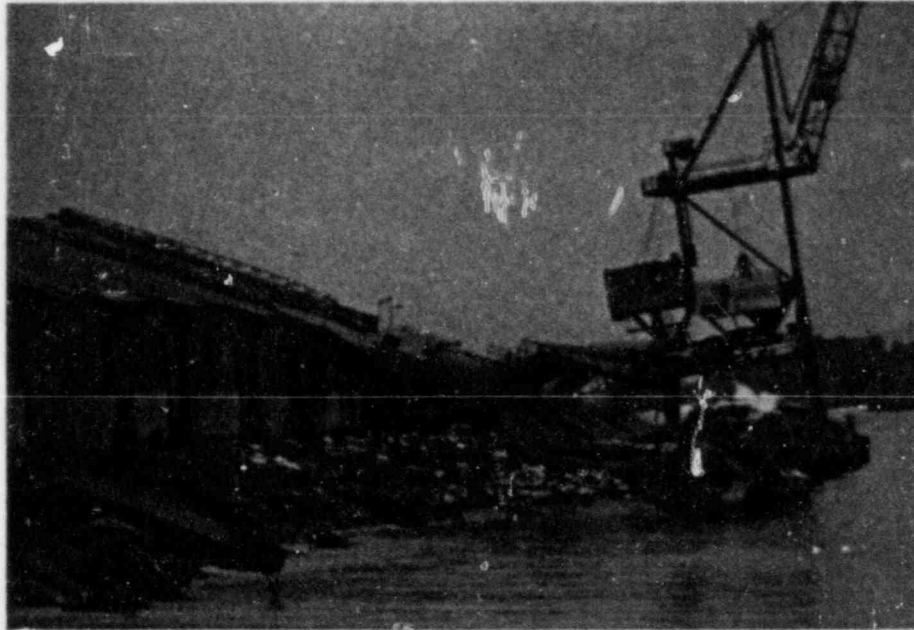
**M 7.5 Chile Earthquake of March 3, 1985**  
**Data Base Sites: SAN ANTONIO PORT AND TANK FARMS**

There was severe damage throughout the San Antonio area. Recorded accelerations, 2 miles away, were 0.67g horizontal and 0.86g vertical.

- The wharf wall, the two buildings, and the cranes located on the outer mole of the port sustained severe damage due to soil and wharf failures.
- Pavement was severely cracked and railroad tracks were badly deformed. Ground settlement to 6 feet was observed.
- Unanchored steel tanks slid on their concrete foundations.
- Walkways connecting adjacent tanks were damaged by differential displacement and deformations of the attached tanks.
- An unanchored tank on legs overturned.

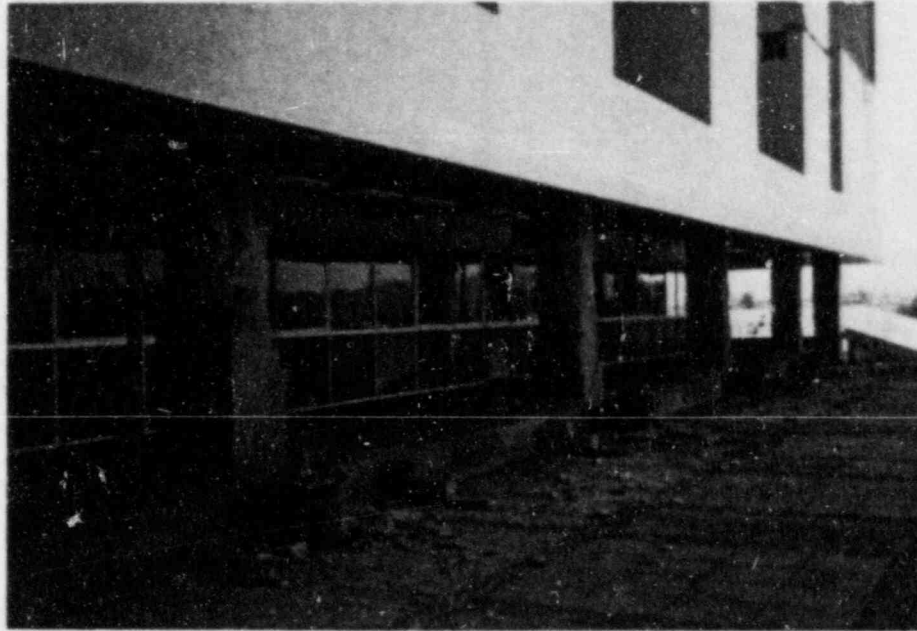
**M 7.5 Chile Earthquake of March 3, 1985**  
**Data Base Sites: CLAUDIO VICUNA HOSPITAL**

There was severe damage at the hospital facility; nearby recorded accelerations were in excess of 0.60g. The performance of equipment and control systems reinforces previous SQUG findings.

- The hospital experienced extensive structural and architectural damage. The structure experienced an earthquake that was much stronger than its design earthquake. The structural damage, in part, is due to a stiffness discontinuity.
- Three unanchored skid-supported boilers slid as much as 4" during the earthquake. The boilers were not damaged.
- A 4" pipe connected to an unanchored water storage tank failed.

- The emergency diesel generator started automatically and supplied power to the hospital and adjacent church and school for one week.
- There was no damage to the hospital's HVAC and control systems.

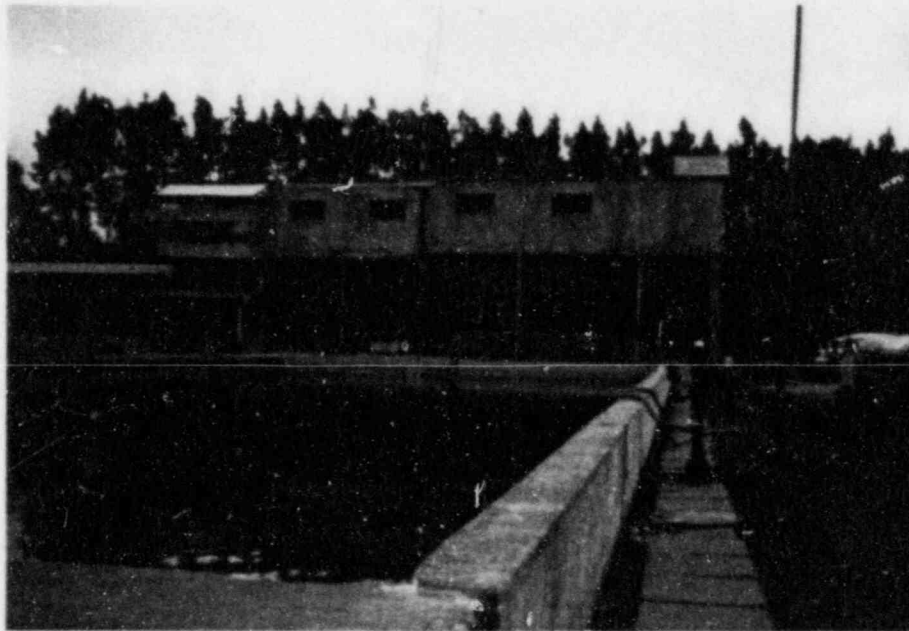
Data Base Sites: SAN JUAN DE LLOLLEO PUMPING  
STATION

There was heavy damage at the facility due to high accelerations and severe ground settlement.

- 6 to 8" ground settlement caused severe damage to concrete buildings and filtration structures at the station. The settlement also damaged a bridge crane anchorage (the crane remained operable), piping (causing flooding), and cables.
- A ceramic base of an old circuit breaker in the main control panel switchgear cracked due to pounding from relative movement and settlement.
- Pipes between two buildings which experienced settlement were lifted off their concrete saddle supports.
- Two of six deep well pumps and their casings were damaged from ground displacement and settlement. The motors for the pumps burned due to short circuits.

- Equipment and piping not damaged directly by the gross settlement of buildings performed well.
- One old circuit breaker sustained broken porcelain base from impact. The flexible panel on which it was mounted was located at the interface of two buildings where relative settlement of several inches occurred.
- The settlement of buildings tore cable and caused short circuits. When the cables were repaired, relays, switches, and contactors functioned properly.

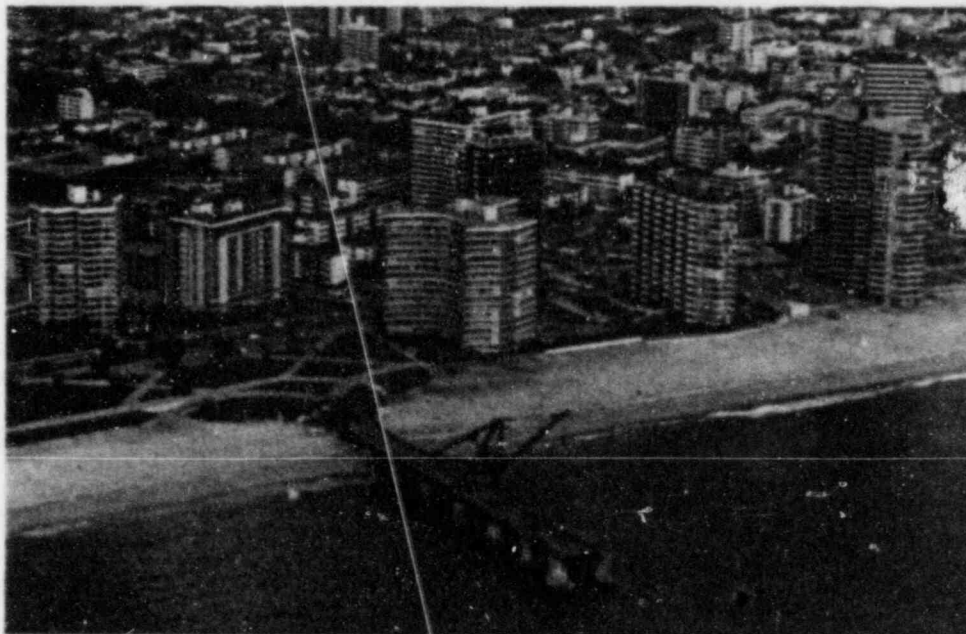
### Data Base Sites: ADDITIONAL PLACES OF INTEREST

Modern buildings performed well in spite of the long duration strong ground motion. Earthquake damage in the vicinity of the epicenter can be generally attributed to ground failure and/or poor construction or design practice.

- **PORT OF VALPARAISO:** Subsidence and horizontal lurching of the soil caused severe damage to the port and its structures. Harbor cranes were disabled by the excessive residual ground displacement. Wharf walls were severely damaged.

- **EL FARO BUILDING:** The modern 8-story apartment building was severely damaged and was demolished. Heavy damage to first floor walls left the building irreparable.

- **CANAL BEAGLE CONDOMINIUM BUILDINGS:** Most of the structures (reinforced concrete frame structures with masonry infill walls) were severely damaged, and had to be evacuated. There were many ground failures in the immediate vicinity. The damage is attributed to intense focusing.

- **GOLD COAST CONDOMINIUM BUILDINGS:** Most of these modern buildings performed well. Two 15-story buildings were severely damaged. Both buildings had irregular layouts that attributed substantially to the damage. Also, both buildings had been damaged in the 1971 earthquake and only cosmetically repaired.

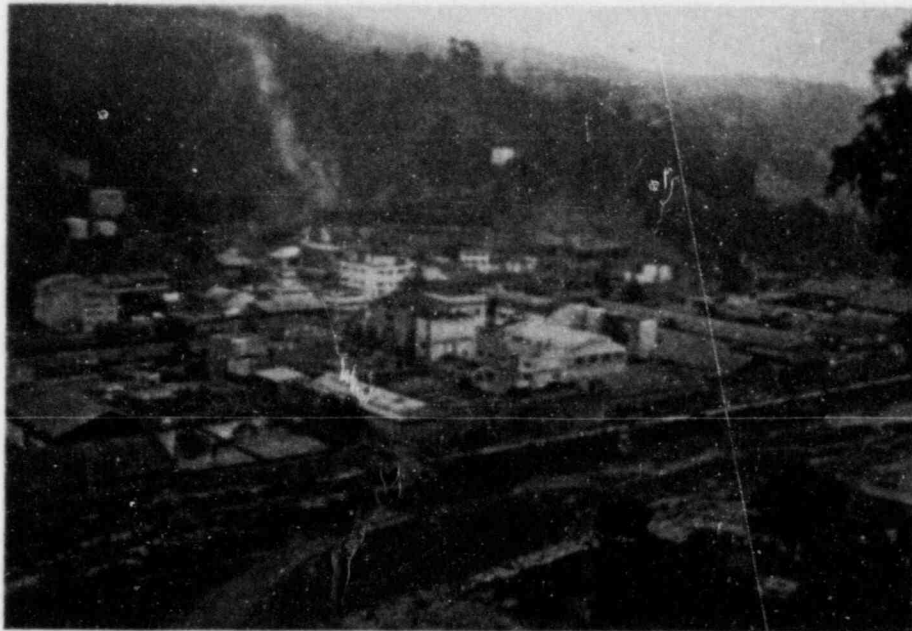
M 7.5 Chile Earthquake of March 3, 1985  
Data Base Site: OXIQUM CHEMICAL PLANT

The chemical plant was in an area of high intensities and several unanchored vertical tanks were damaged. Data collected on the performance of equipment and control systems reinforce previous SQUG findings.

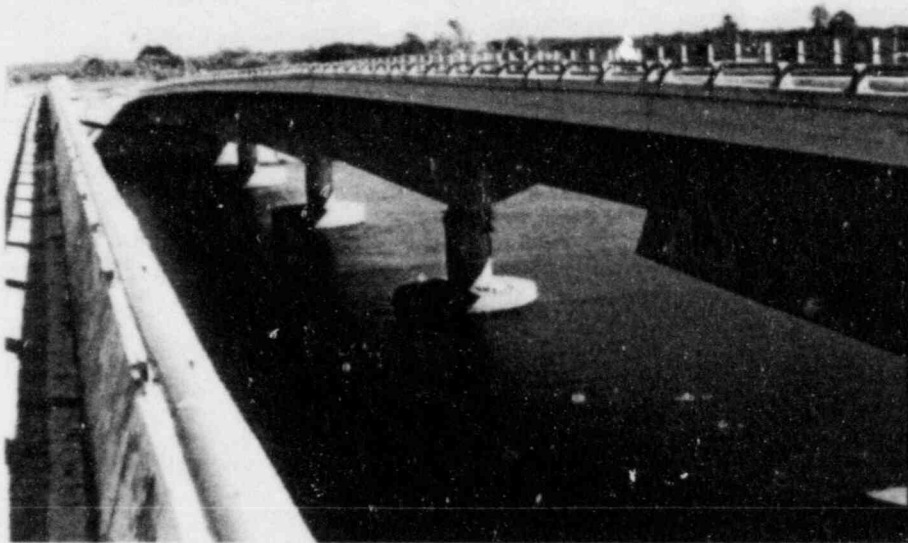
There was severe damage observed at the port and in Lazaro Cardenas. The port facility and adjacent industry include large steel buildings, several hundred feet long.

- Partially collapsed four-story building atop a large concrete silo structure
- Severely damage highway bridge
- Overturned steel silo
- Damaged dock and cranes at port facility
- Partially collapsed large sign on steel frame in front of bottling facility
- Collapsed and severely damaged buildings (one in four) in town of Lazaro Cardenas
- Damaged hospital in Lazaro Cardenas

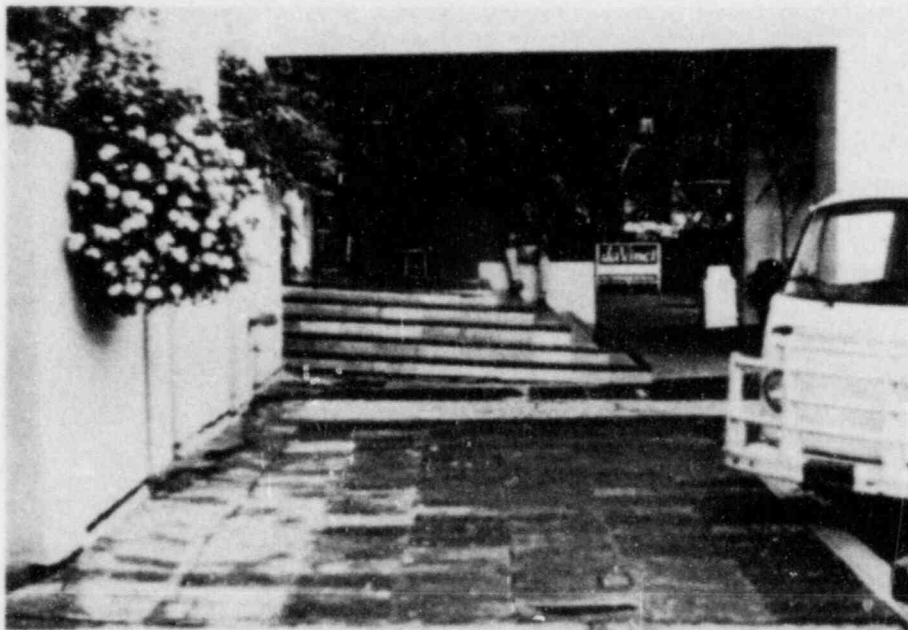
All of the 12 modern high-rise structures were significantly damaged; only two remained open. Most of the damage was caused by the aftershock.

- Every one of the reinforced concrete frame structures was significantly damaged
- Some structural damage but mostly heavy architectural damage: only two hotels remained open
- The hotels that remained open had extremely limited service; service was limited to lower floors
- Ground settlement of two to five inches observed around structures
- Most heavily damaged structures had been similarly damaged in previous earthquake (1978/79)
- Many simple one-story dwellings of timber and adobe, with thatched or clay tile roof, were undamaged

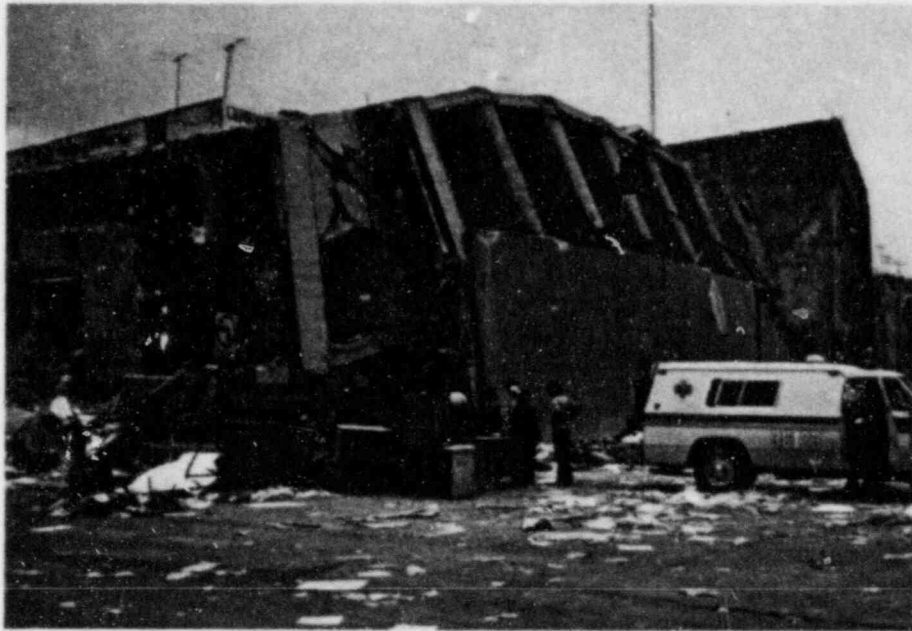
The disaster in Mexico City illustrates the need for building design to consider local soil conditions. It also illustrates the critical importance of detailing for reinforced concrete frame structures.

- Mexico City is 250 miles from the epicenter
- Over 400 buildings collapsed or were seriously damaged
- Most damaged buildings experienced a double resonance situation of soil with motion and building with soil at very low frequencies (less than 0.8Hz)
- Collapsed buildings damaged power distribution lines
- There were over 5000 breaks in the city's asbestos-cement water pipes
- There were no major industrial facilities or power plants in the affected area

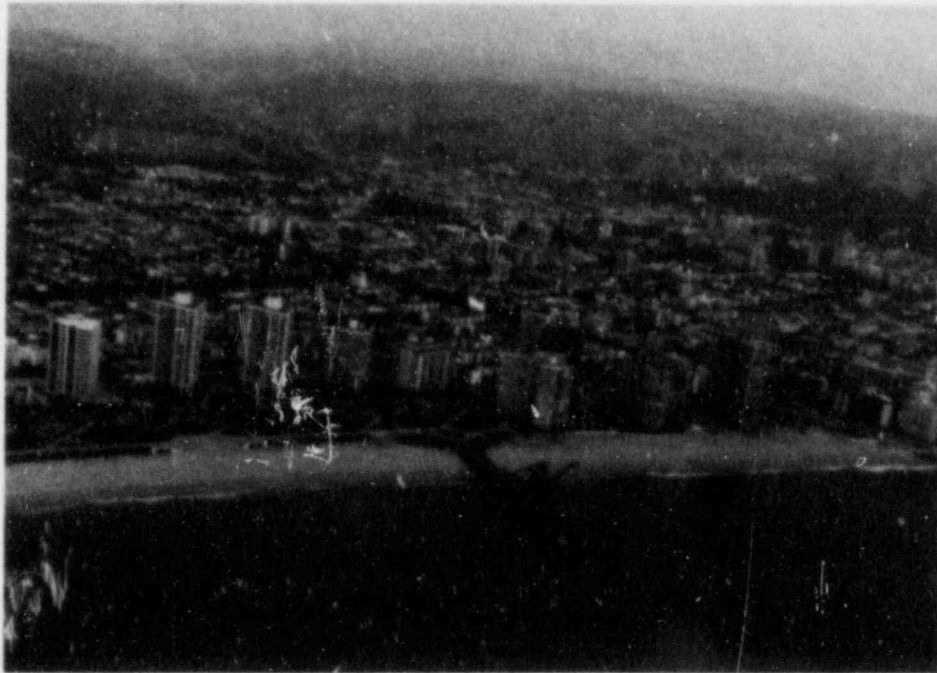
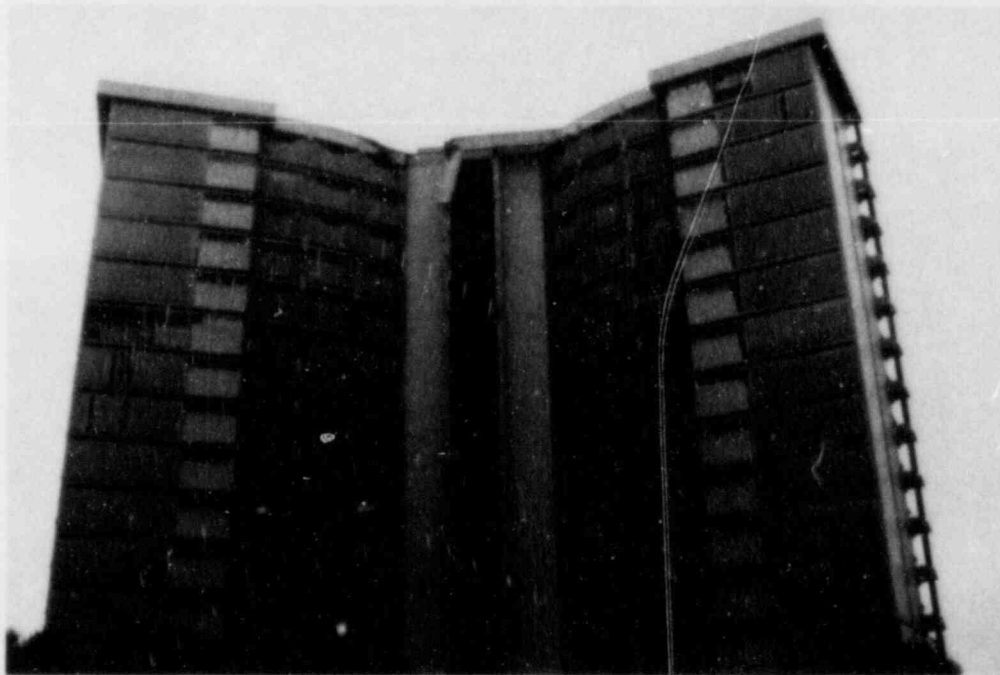
The El Faro apartment building, located north of the coastal city of Viña del Mar, was badly damaged when the ground floor collapsed. The building was condemned and demolished a few days after the earthquake. A poor conceptual design and construction problems contributed to the collapse. Soil failures were noted in the surrounding area. The same area was heavily damaged in previous earthquakes. Note several lightly damaged or undamaged buildings in the lower photograph.

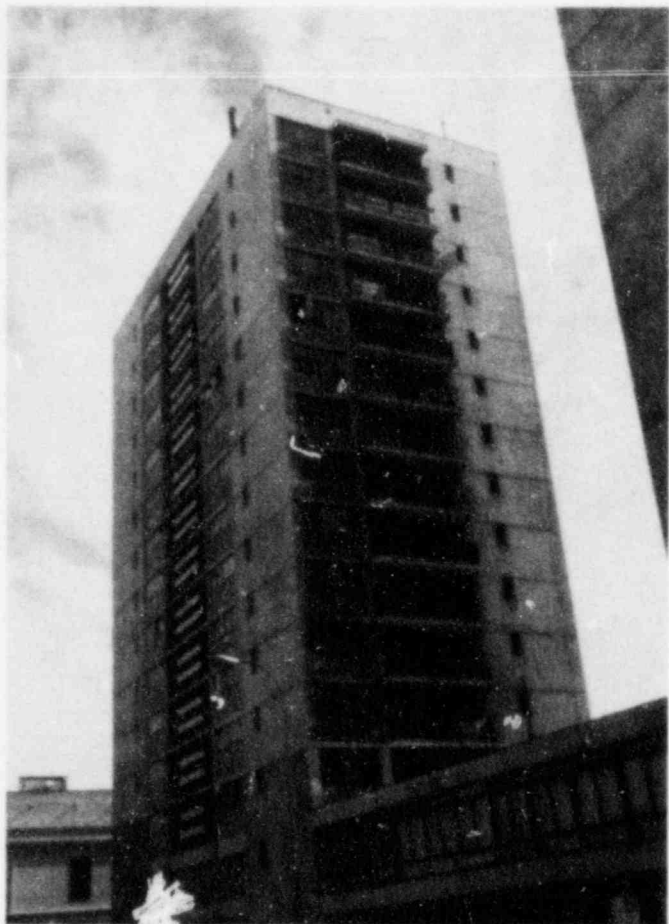
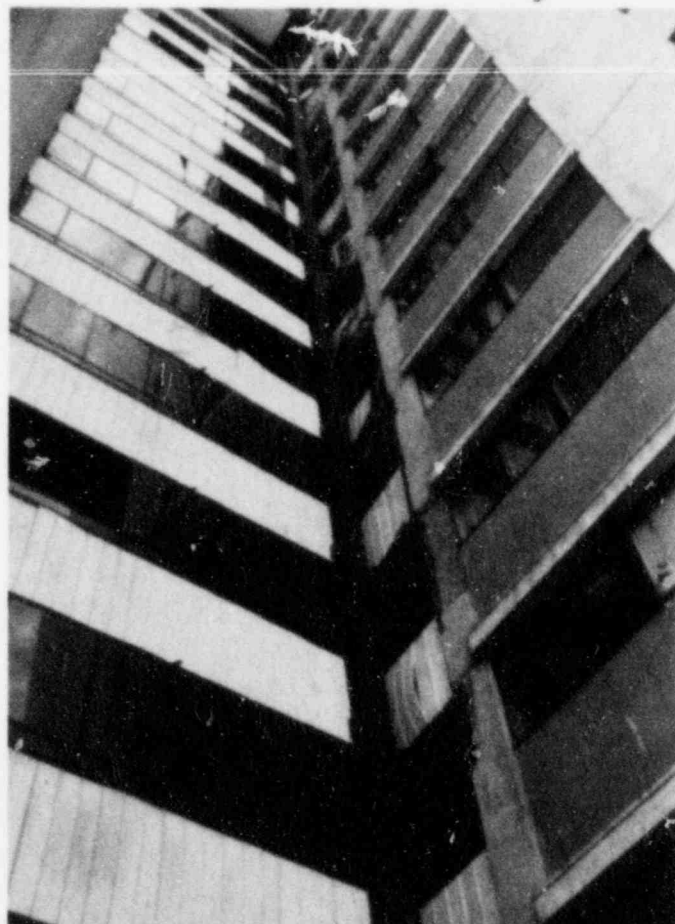
The 15-story Acapulco apartment building, adjacent to the Hanga Roa, was also severely damaged. The shear wall on the east side of the building cracked, exposing buckled reinforcing steel. Damaged interior walls revealed damage from previous earthquakes that had not been properly repaired. This building was evacuated after the earthquake, but will be repaired.

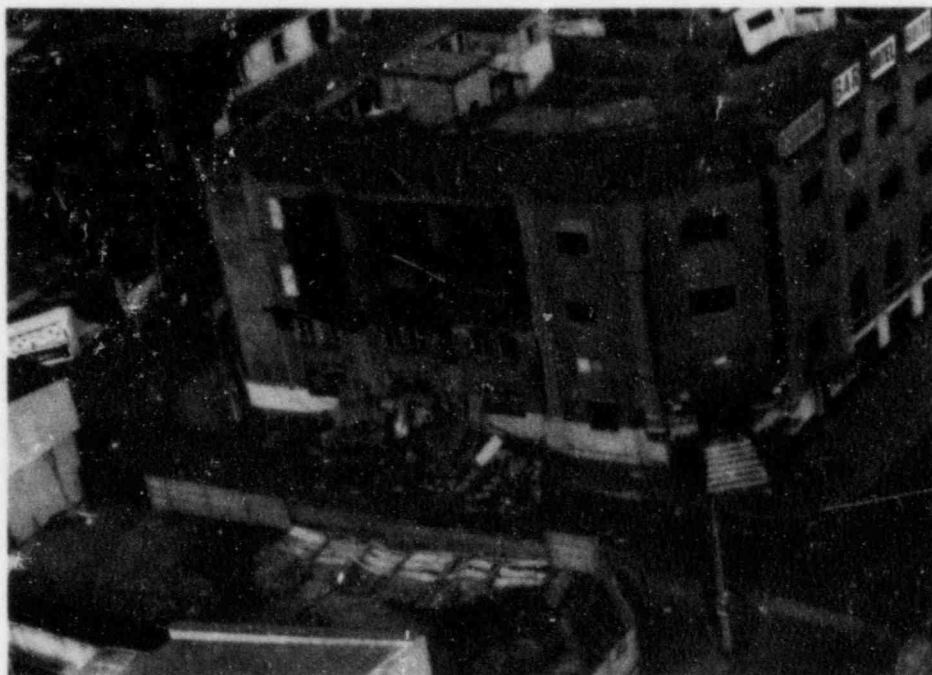
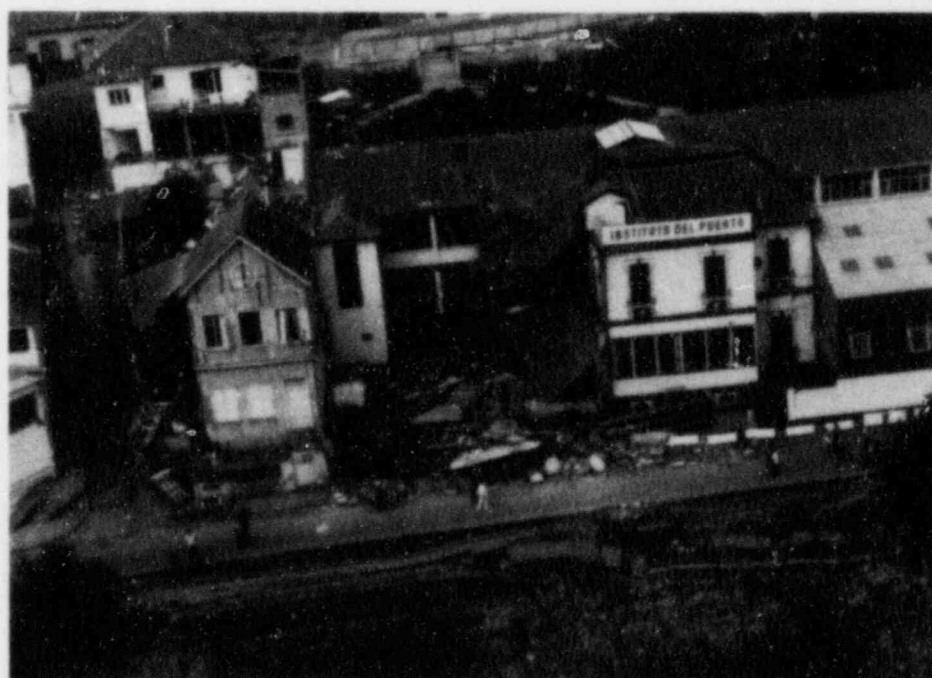
As expected, older buildings sustained more damage than seismically designed newer buildings. The two buildings in San Antonio shown above were severely damaged and posed dangerous hazards. Hundreds of similar cases were observed throughout Chile.

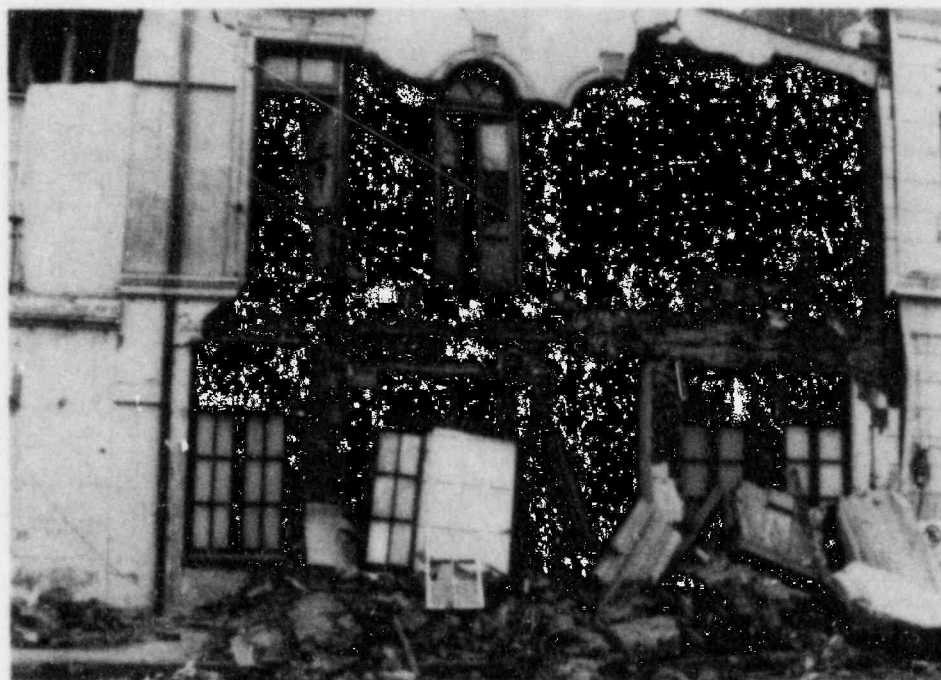
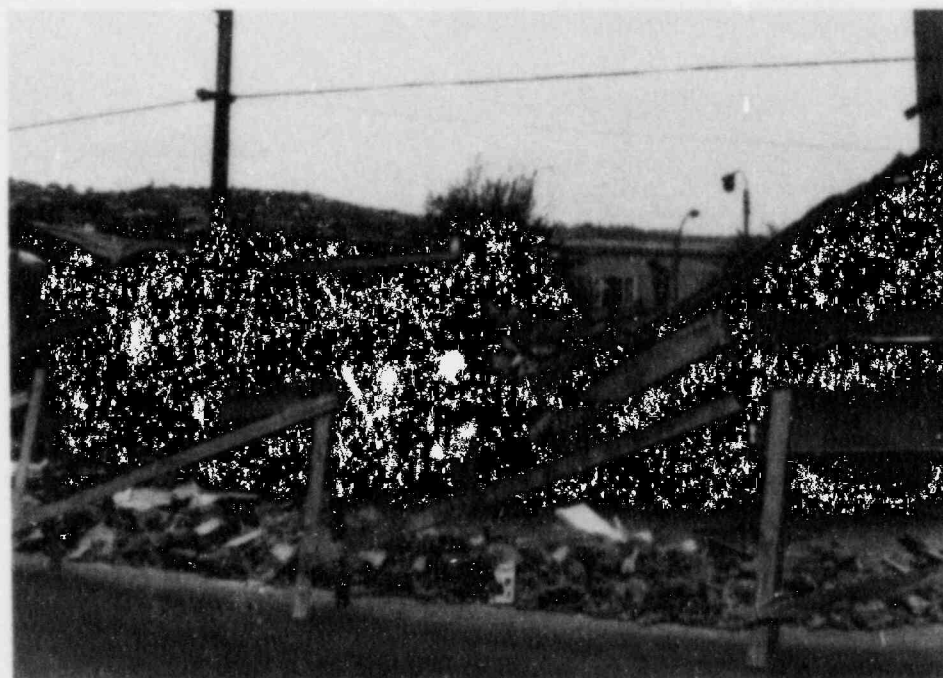
A large number of the buildings that were damaged and subsequently abandoned were constructed of adobe and unreinforced masonry. These are the same types of buildings that were severely damaged in previous earthquakes, particularly in 1939 when over 40,000 people were killed. The main problem with these types of construction is the difficulty of tying together the floors and walls.

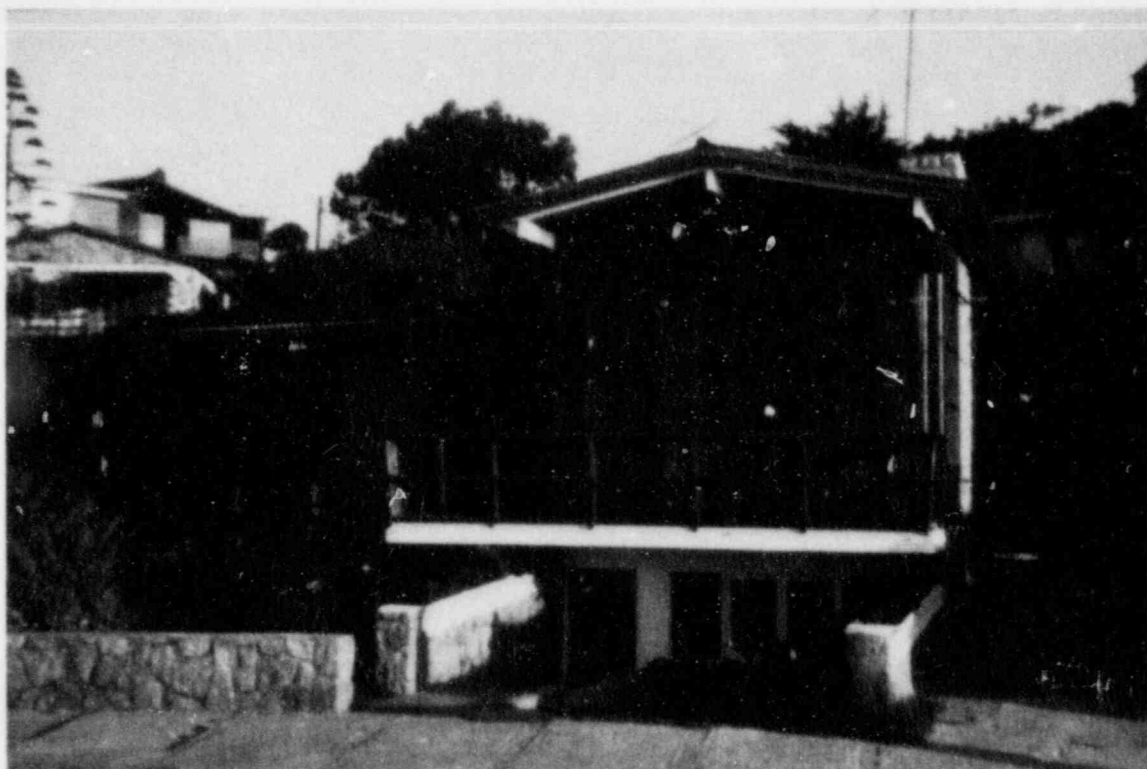
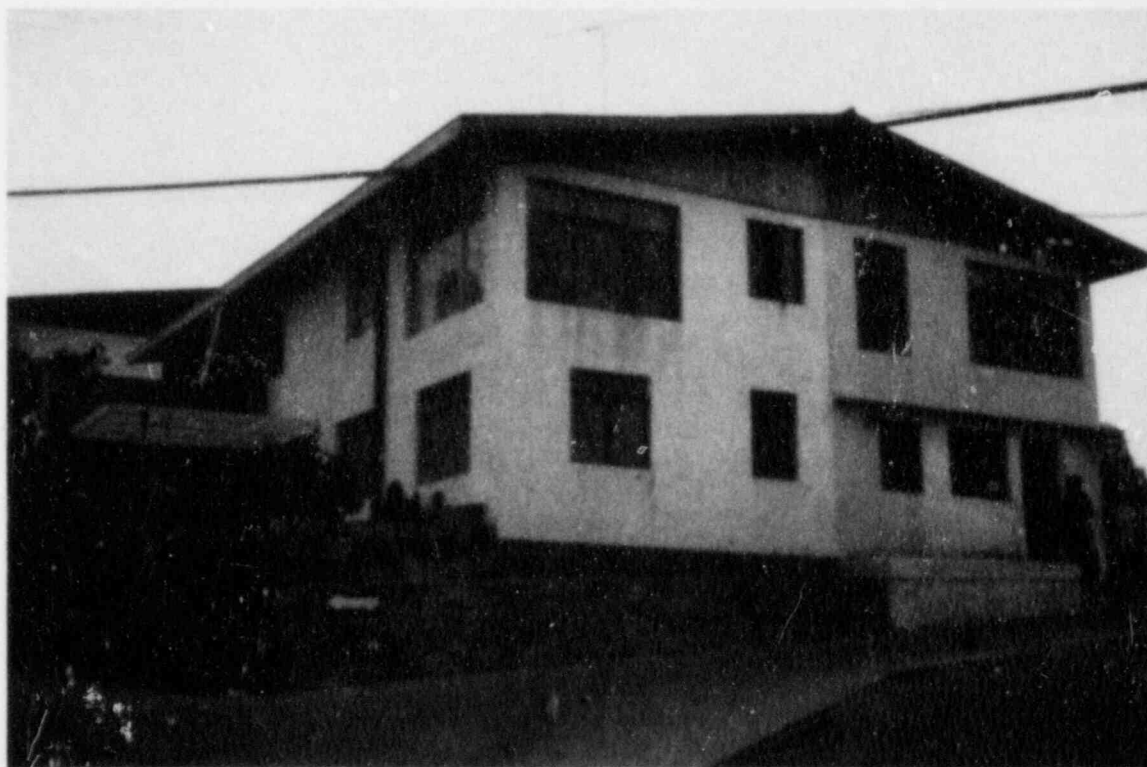
Newer houses of wood, reinforced masonry, and reinforced concrete generally performed well. The house shown in the upper photograph is situated in Algarrobo (between San Antonio and Valparaiso). The second house is masonry and is located across the street from the severely damaged Canal Beagle apartment buildings in Viña del Mar. It and others like it in the area were apparently only lightly damaged.

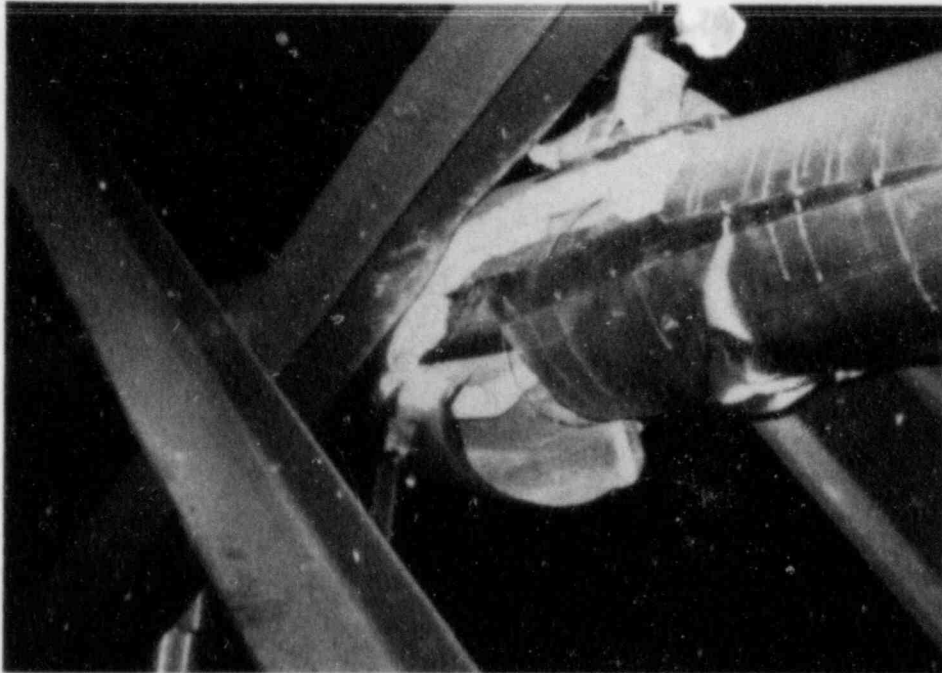
Buildings at power plants are generally large, well designed steel structures. Usually such structures and their interior piping are very flexible and can experience large motions without damage. Piping insulation is often damaged from repeated impacts with adjacent structural elements (see above), but the pipes themselves are rarely damaged. Coal fuel is commonly burned in a large, heavy boiler suspended by rods from the top of a structure which can be up to 150 feet tall. The boilers are allowed to move to prevent high stresses from developing from radical temperature changes during operation. Lateral restraints are often badly deformed during earthquakes (see above), but succeed in protecting the boiler.

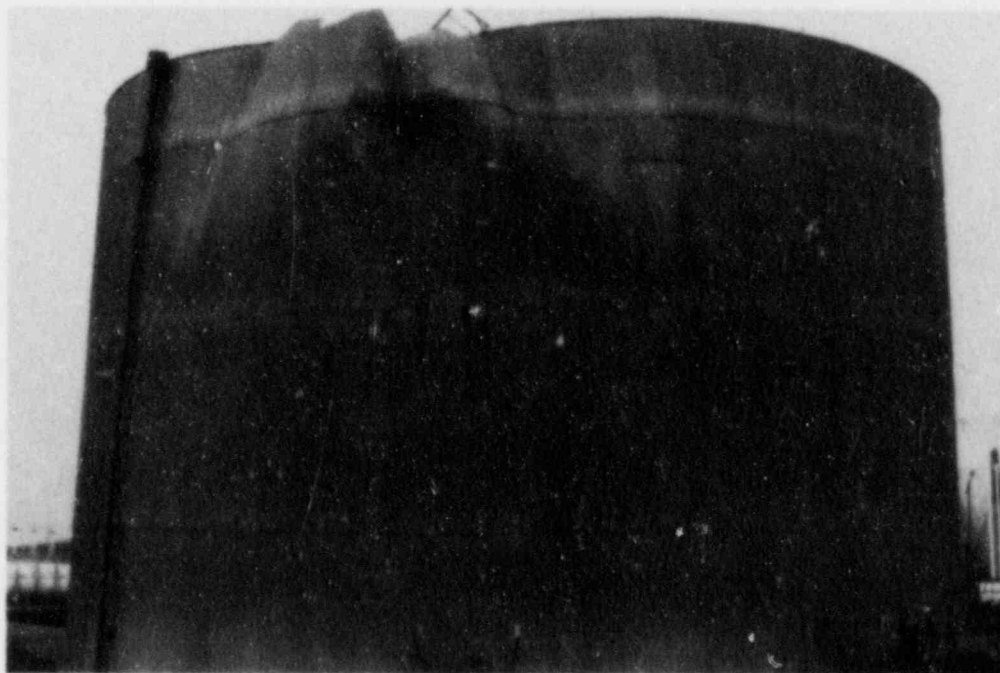
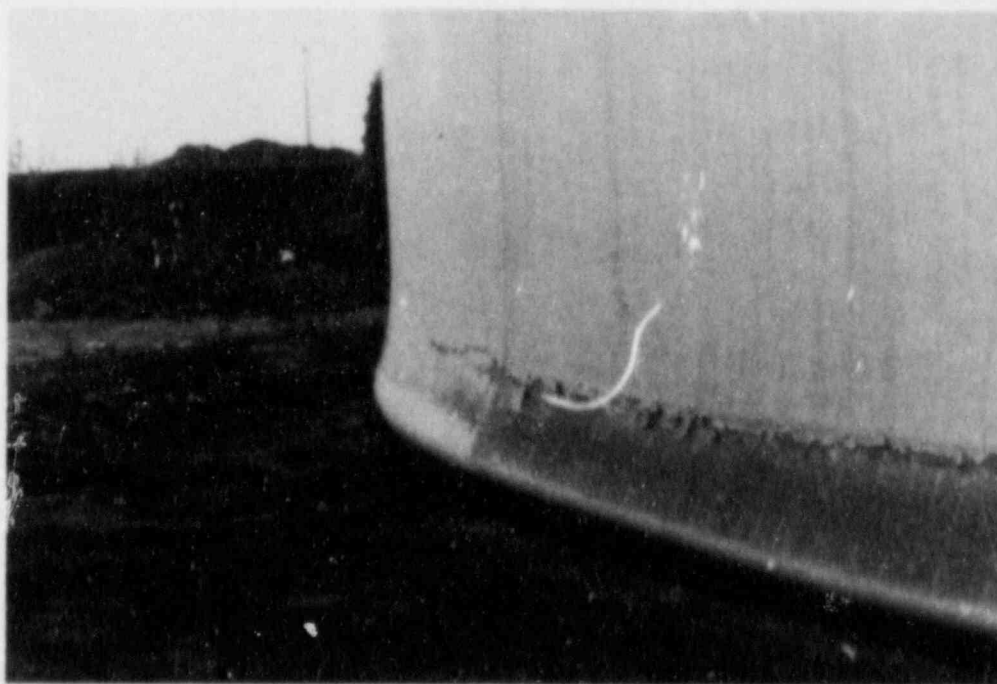
The Con Con petroleum refinery sustained severe damage to 12 of 100+ unanchored vertical storage tanks. Some of the tanks collapsed from suction created by the contents emptying quickly through holes opened near the bases of the tanks during the earthquake (top photograph). "Elephant foot" buckling at the base of a tank wall is a common type failure (bottom photo).

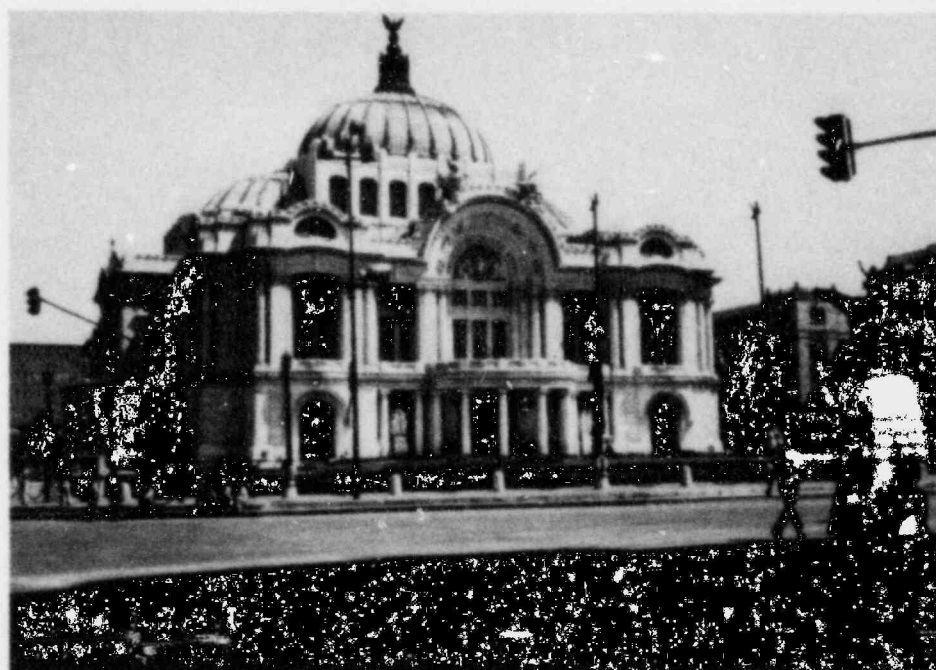
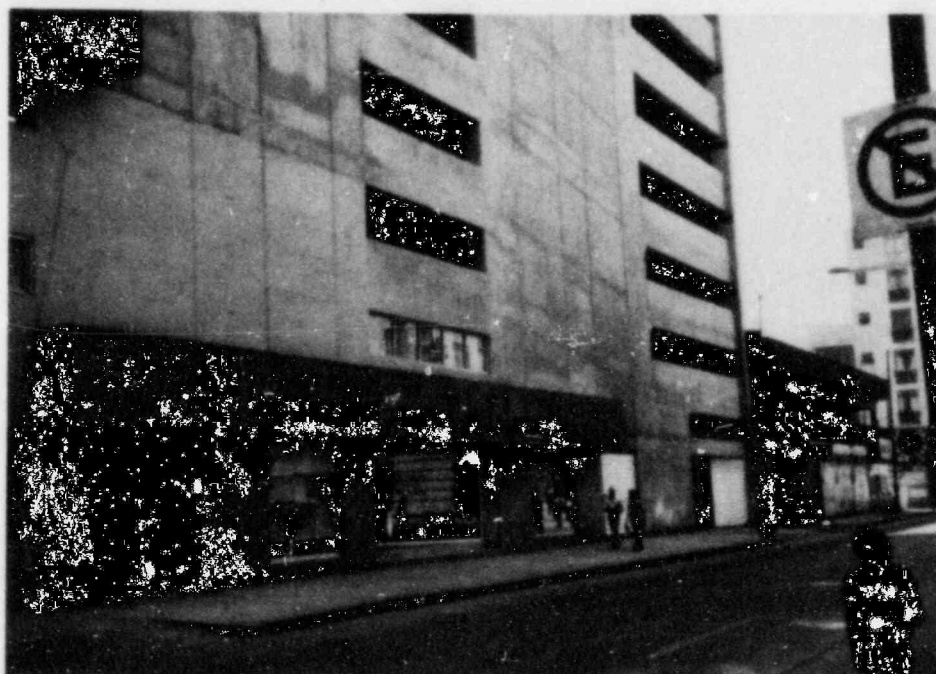
Mexico City. Most of the damage to the downtown area was concentrated in older highrise structures 8 to 15 stories high. Older lowrise buildings and newer structures had little damage. The structures shown above are very near many buildings that collapsed completely.

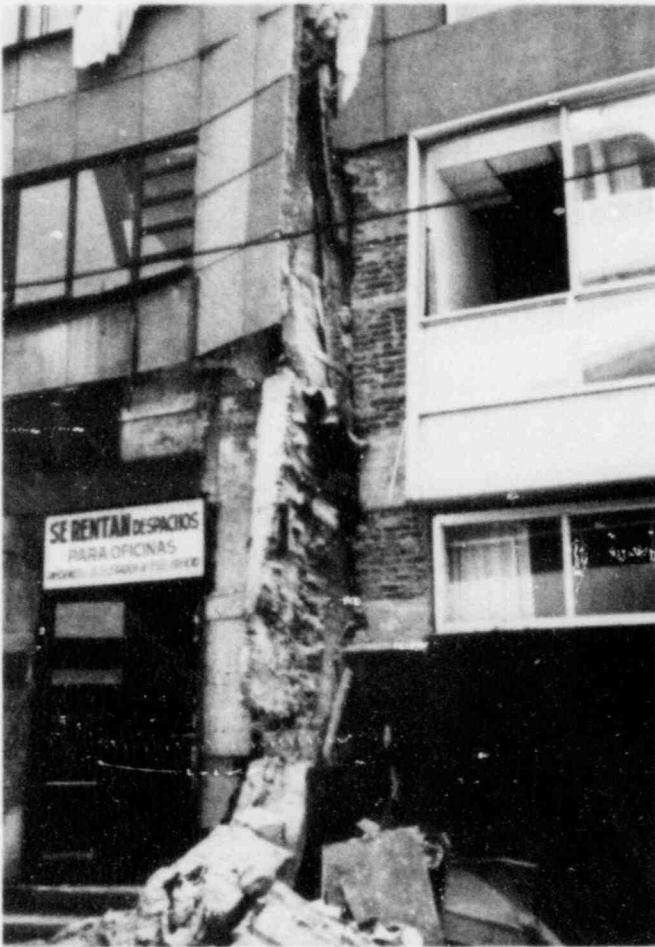
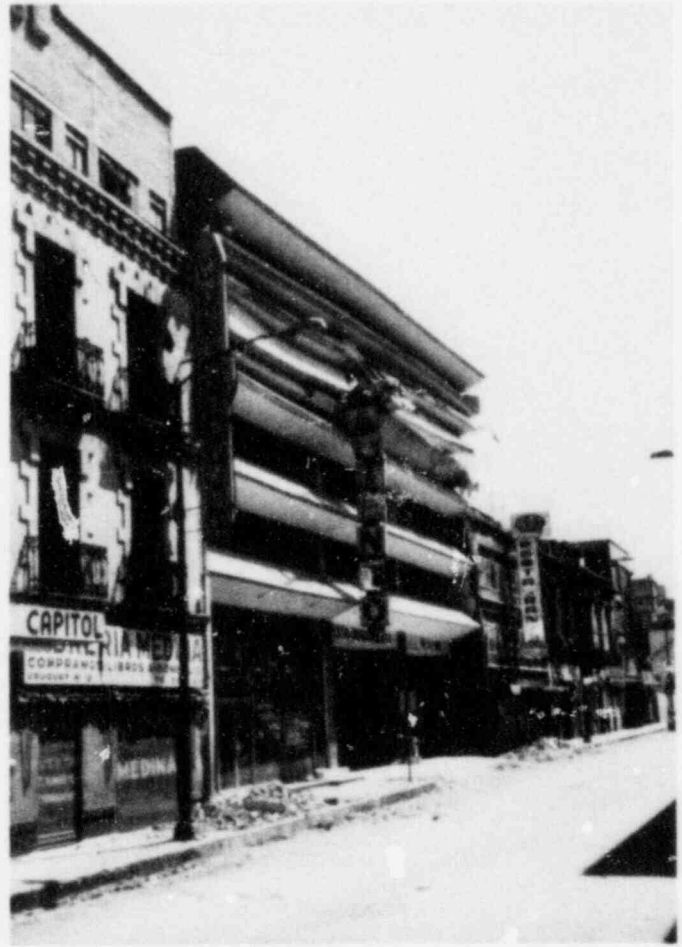
Mexico City. Building damage was mostly to concrete frame structures with masonry infills. These buildings either collapsed or were damaged so heavily that they will have to be torn down. The failure modes included pancaking, toppling, and pounding. Pounding damage was due to the flexibility of these framed structures.

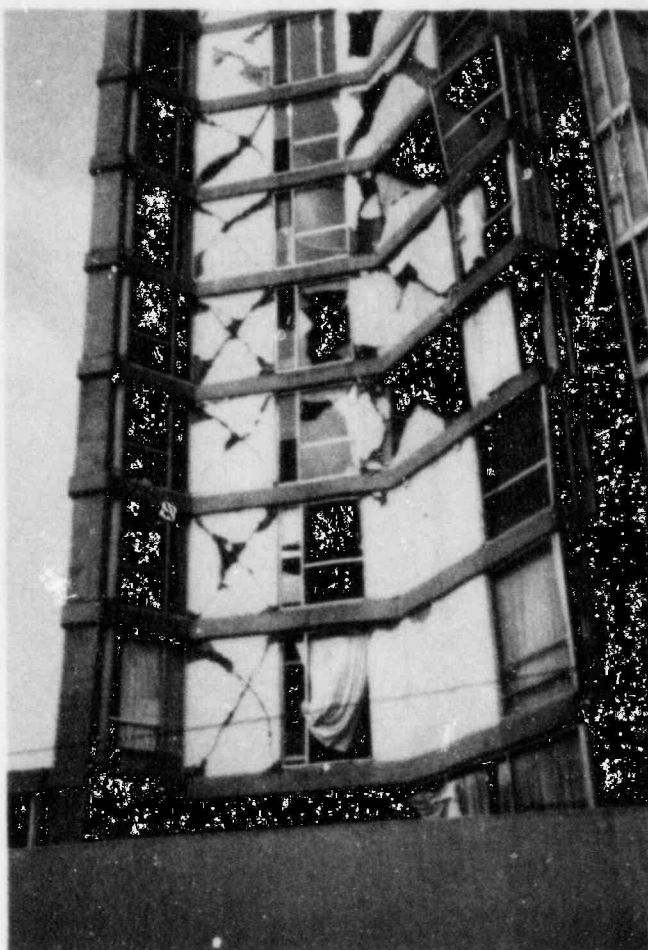
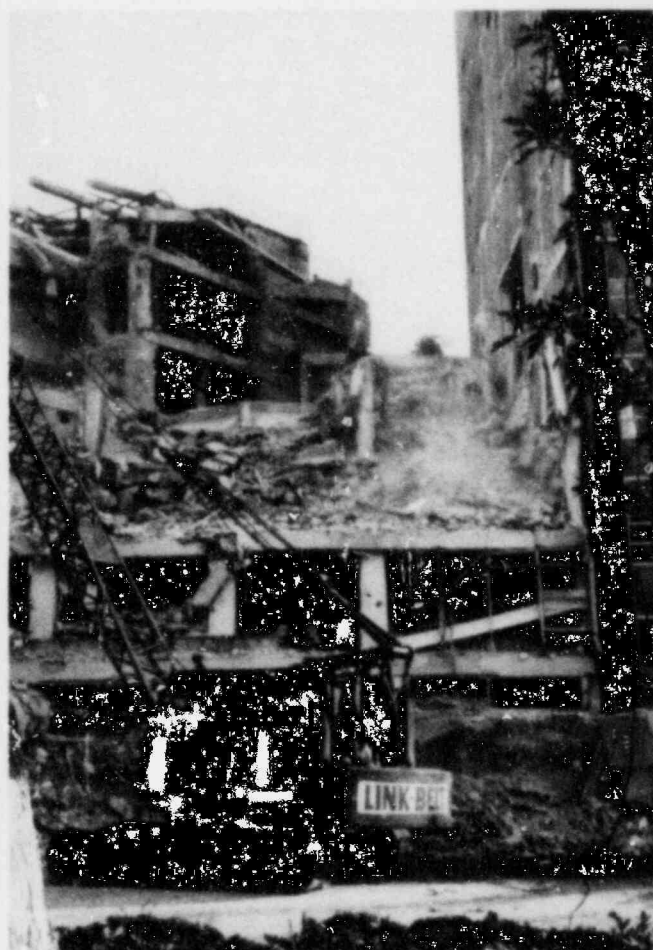
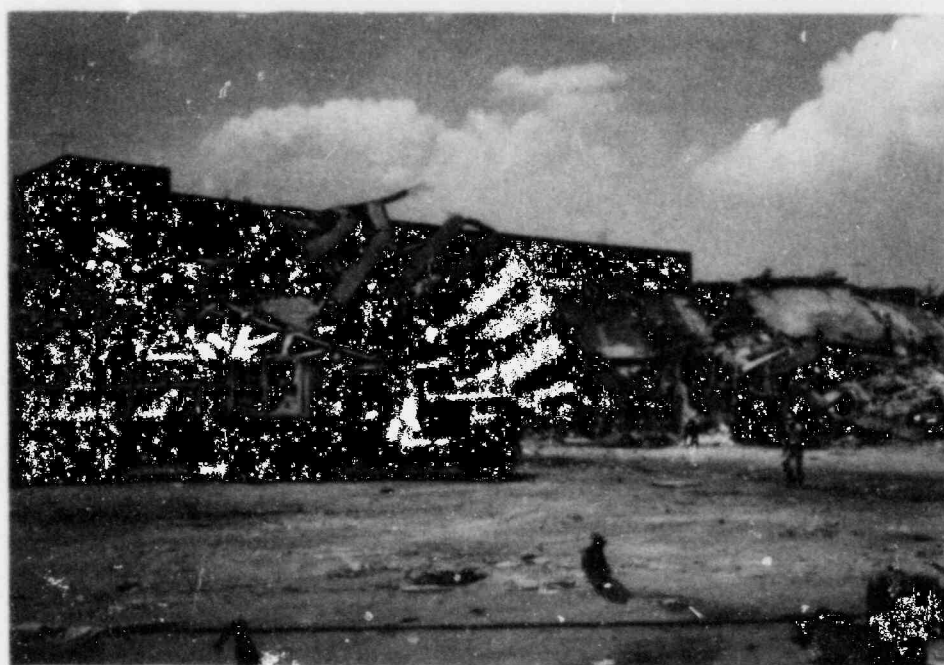
Mexico City. Damage to highrise residential structures in the downtown area was extensive. These buildings were designed with inadequate consideration for earthquake forces and were heavily damaged. Life loss was especially high in these buildings due to the high occupancy (up to 8 persons per unit or more) and the time of day that the earthquake struck (7:18 a.m.).

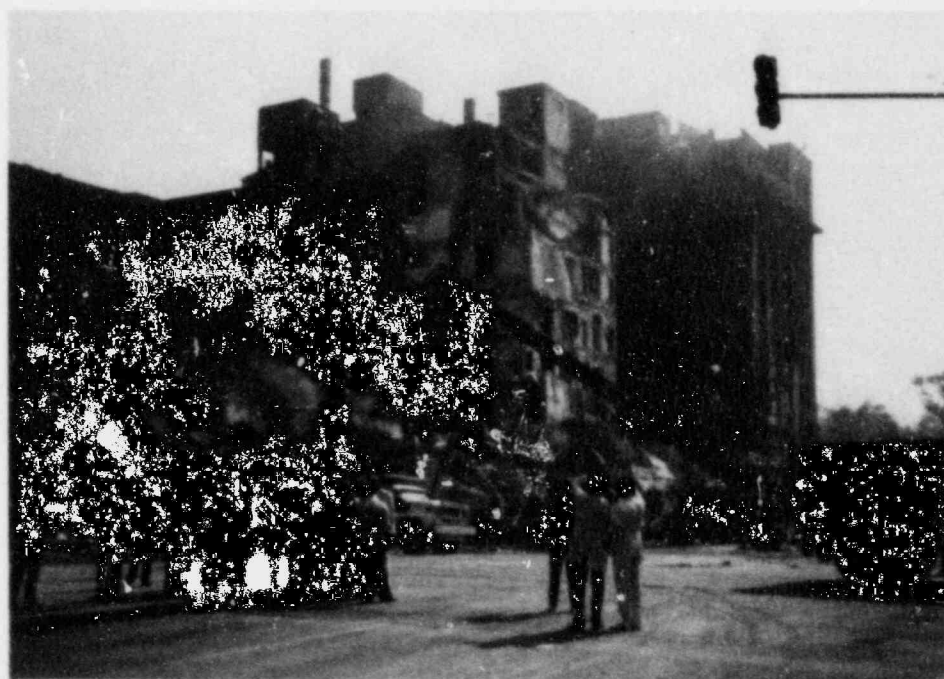
Mexico City. Several hotels in the Zona Rosa district (near the downtown area) suffered major damage or collapsed. The Regis Hotel collapsed and burned, trapping many guests in the rubble. The top floor of the Hyatt Continental's east wing pancaked.

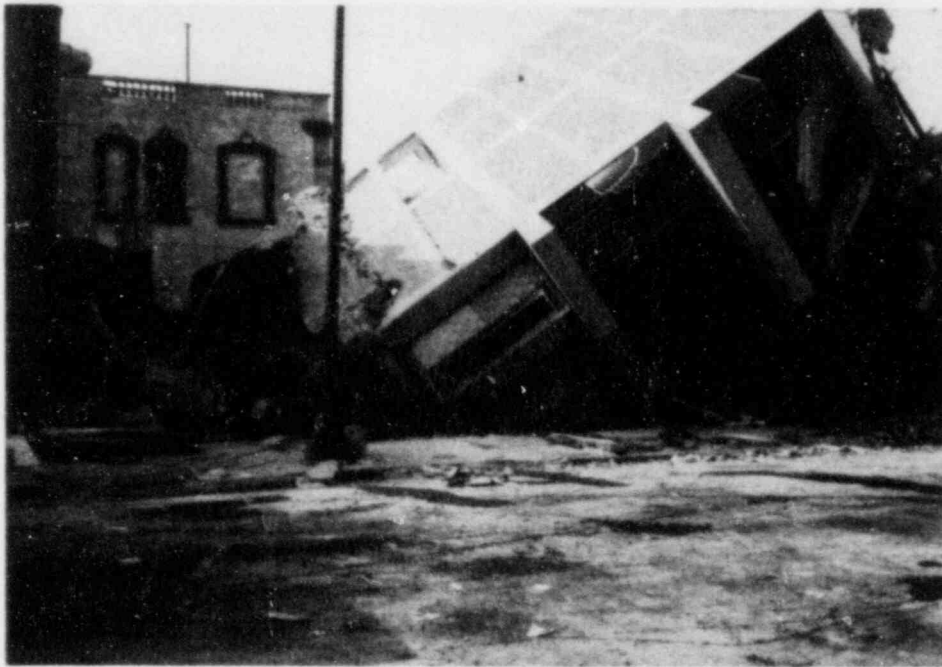
Mexico City. Soil failure occurred beneath some of the damaged buildings on the ancient lake bed. This building toppled and pulled up the foundation and piles. The exposed steel reinforcing bars and spalled concrete of the damaged column illustrate the nonductile design of the building.
