# UNITED STATES NUCLEAR REGULATORY COMMISSION

ADVISORY COMMITTEE ON REACTOR SAFEGUARDS  
QUALIFICATION PROGRAM FOR SAFETY-RELATED  
EQUIPMENT

DATE: WEDNESDAY, JANUARY 15, 1986

# **SUMMARY OF THE EFFECTS OF THE CHILE AND MEXICO EARTHQUAKES OF 1985**

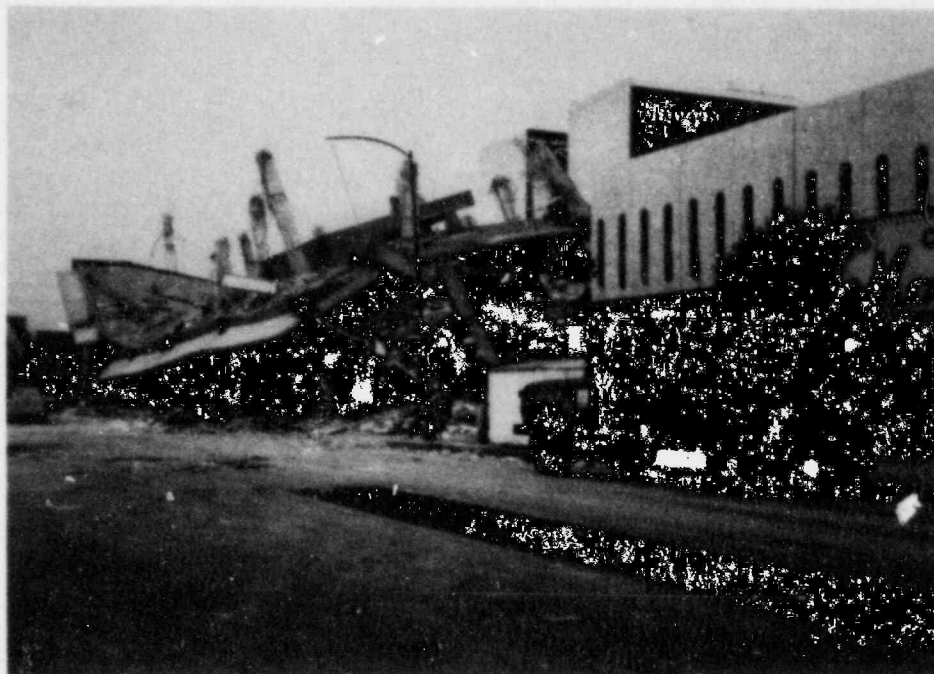
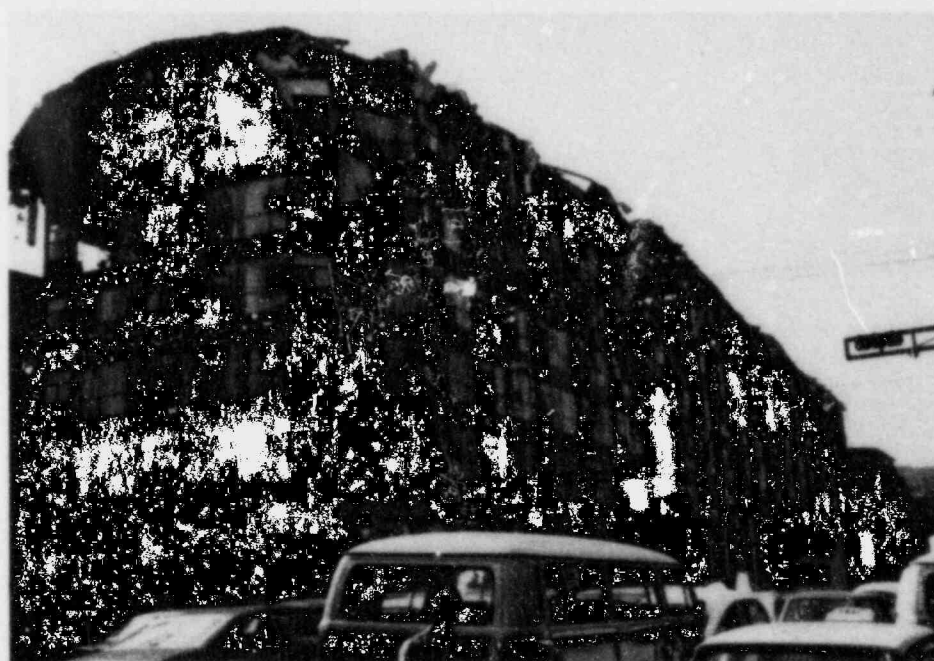
Mexico City. Many government buildings in the downtown area were heavily damaged. The jail/courthouse pancaked, leaving only the protruding columns. Many prisoners were trapped in this collapsed structure. A government building at the corner of Durango and Cuahtemoc streets also suffered major damage, with pancaking of the top floors.

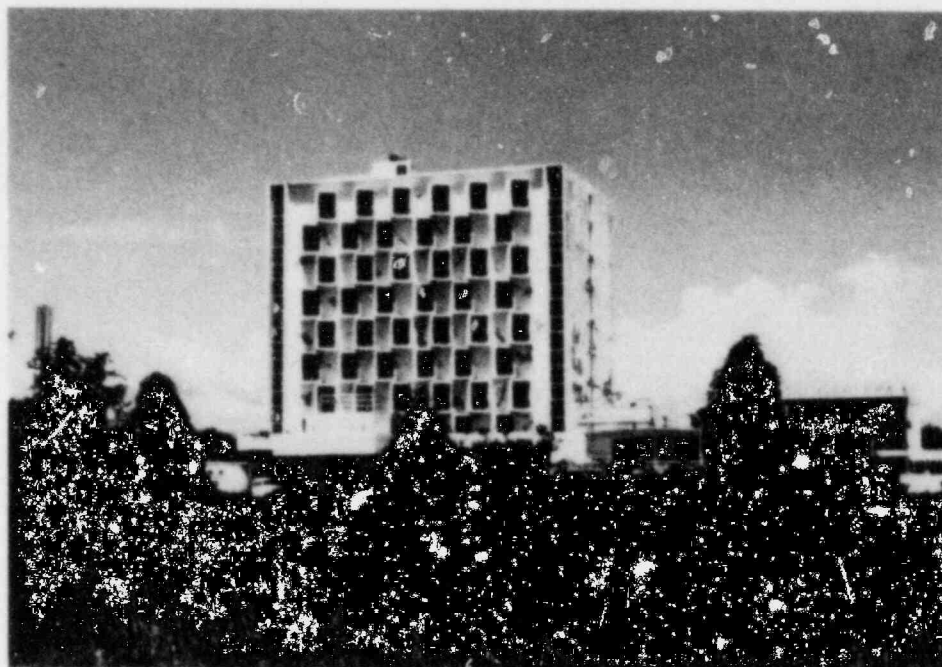
**Lazaro Cardenas.** This is one of the more developed towns in the epicentral region. Damage was extensive throughout the town and could be seen in about one of every four structures. The top photograph shows severe cracking in the discontinuous shear walls between virtually all the front balconies. The minimal reinforcement in these walls probably prevented collapse of this structure. In the bottom photograph, a complete section of an unreinforced masonry curtain wall fell.

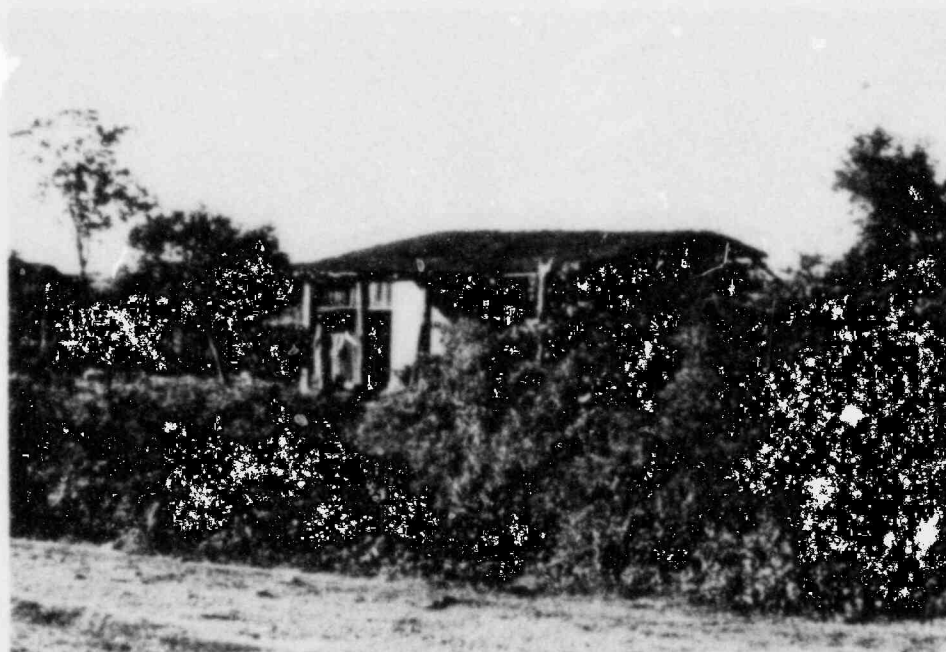
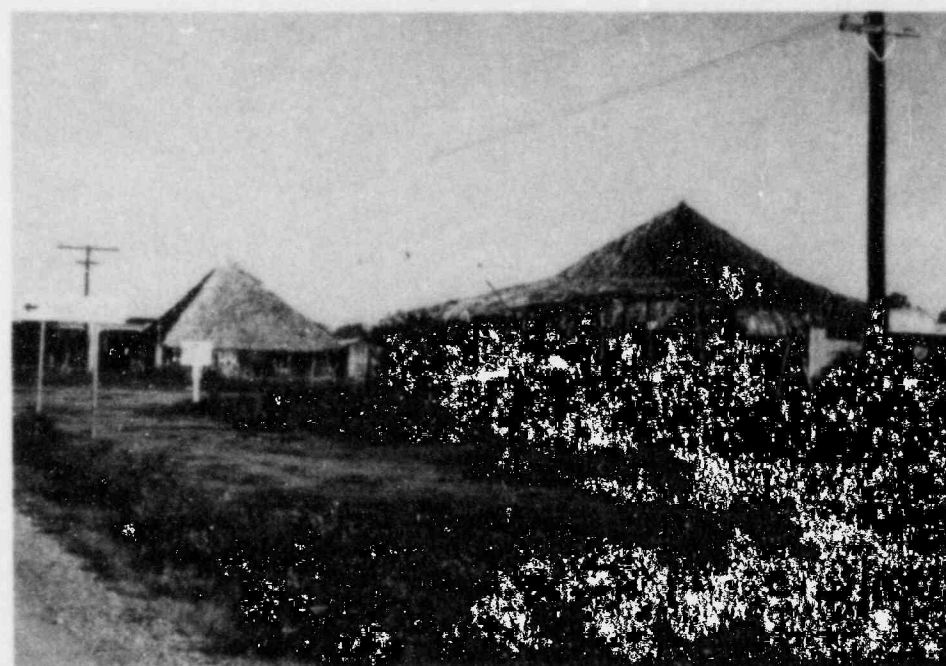
**Epicentral Region.** Many simple and crude homes are located throughout the sparsely populated epicentral region. These houses were generally built of rough timber posts and unreinforced masonry walls supporting clay tile or straw roofs. Along the Pacific coast between Zihuatenejo and Lazaro Cardenas there were few collapses reported, and none observed. A surprising number of these units had no apparent earthquake damage.

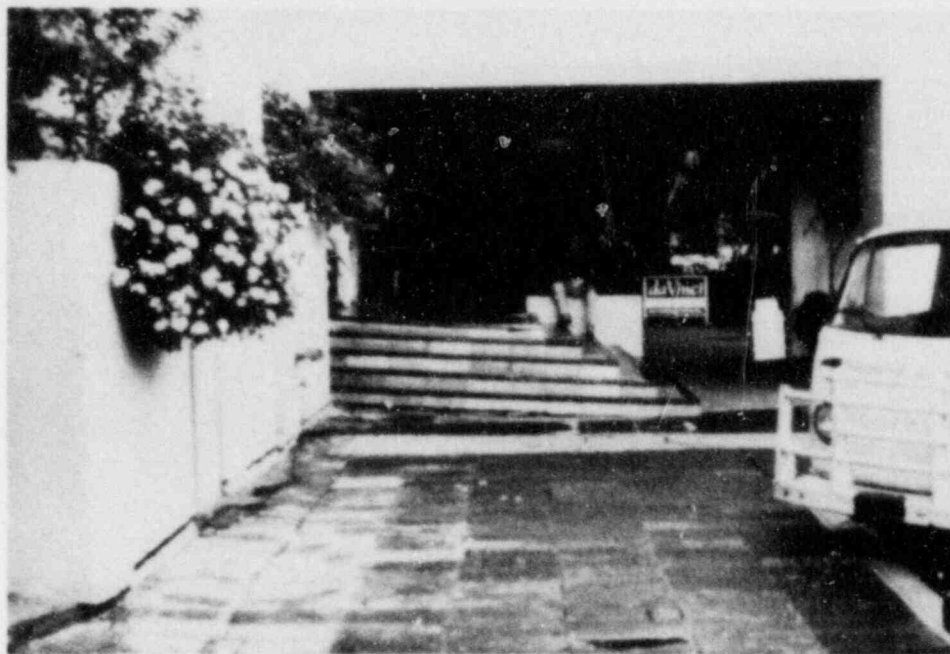
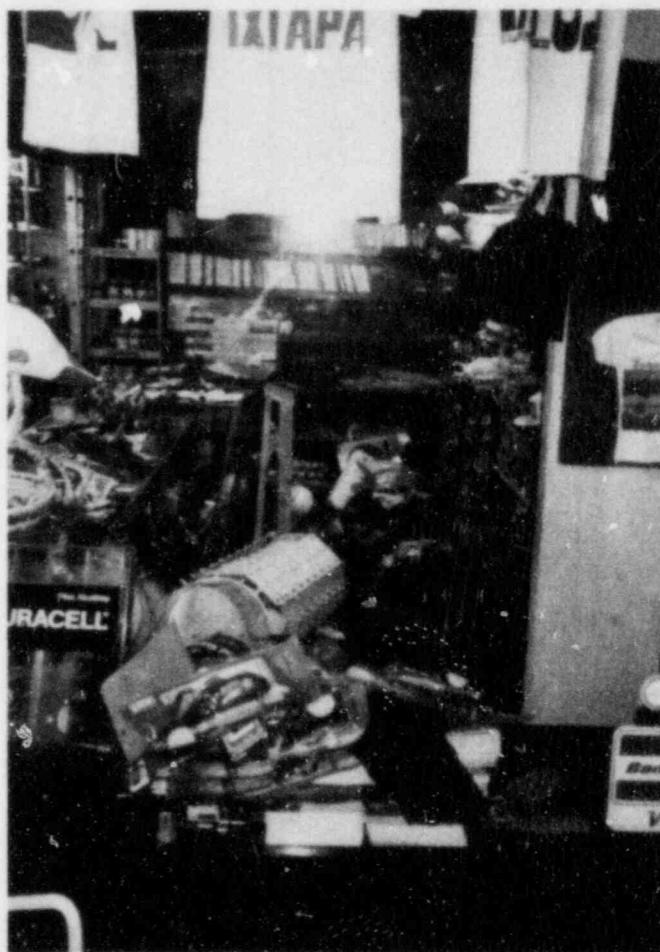
Ixtapa. Two to three inches of ground settlement occurred around the exterior of the Holiday Inn (see previous page). Stairs at the entrance of the hotel tilted considerably. Inside the hotel, goods were thrown from shelves in shops on the ground floor. Damage could be seen in essentially every room of the hotel (cracks on most walls).

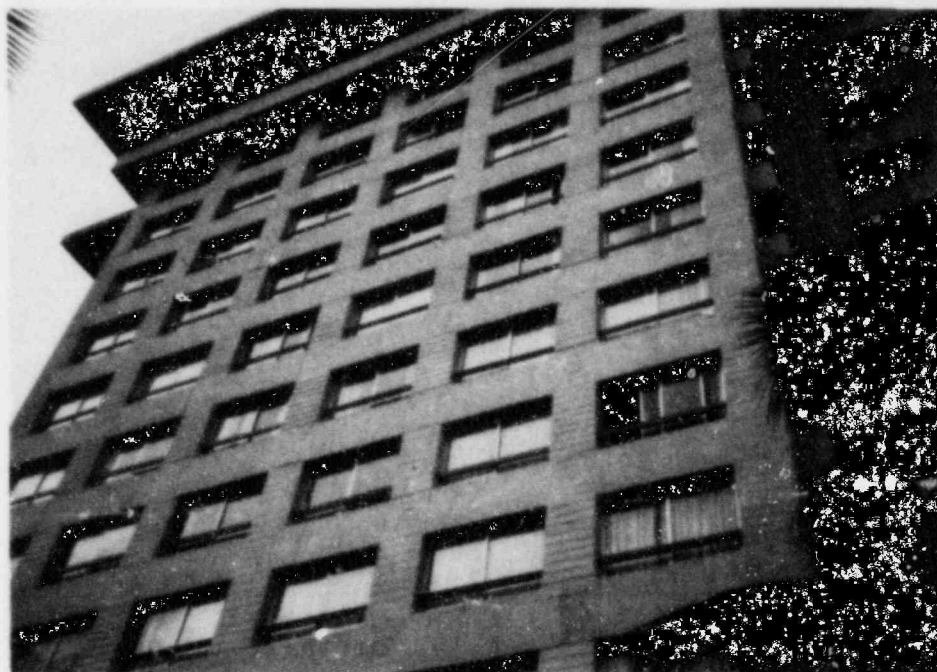
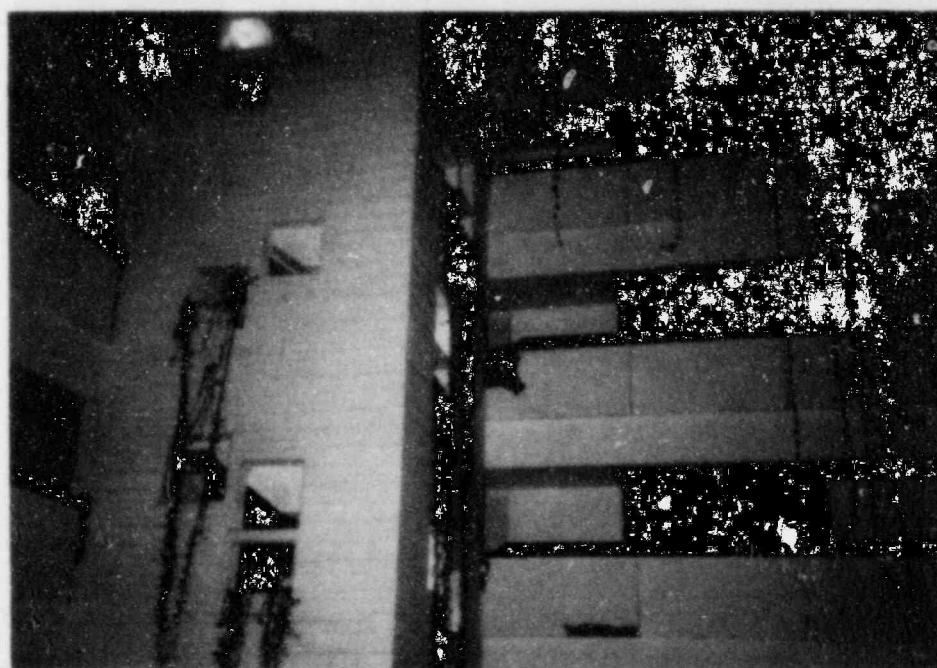
**Ixtapa.** This small, new Pacific coast resort town contains about ten modern reinforced concrete highrise hotels, with two additional hotels currently under construction. All the completed structures had extensive architectural damage to internal walls, exterior masonry curtain walls, and exterior finishes. The Holiday Inn, a modern 12 story highrise, was one of the only hotels that remained open. Even this well-designed building had some structural damage, indicating the severity of the shaking. Fortunately, the area was in the low tourist season and few people were injured.

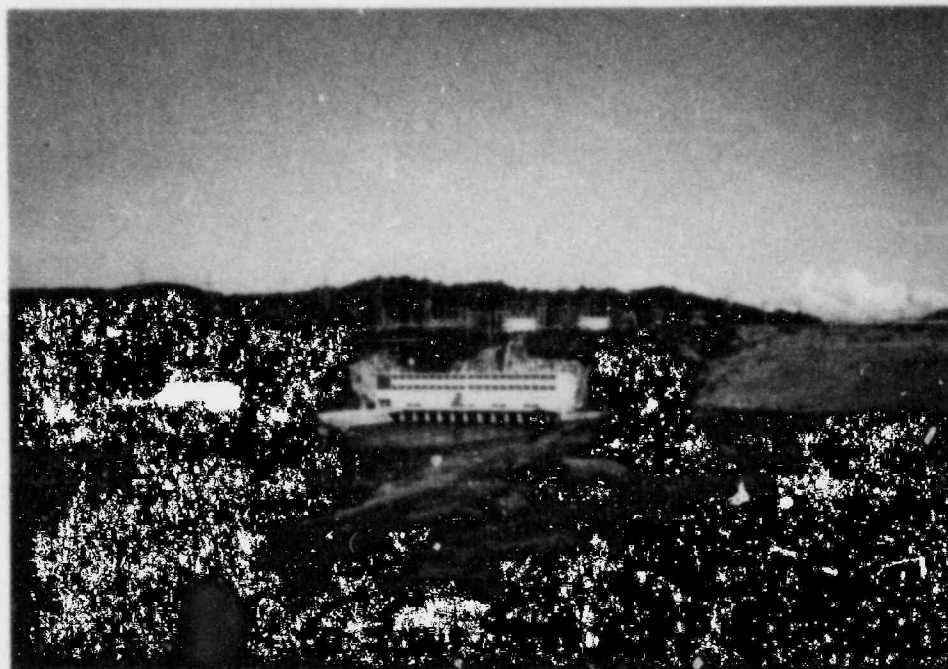
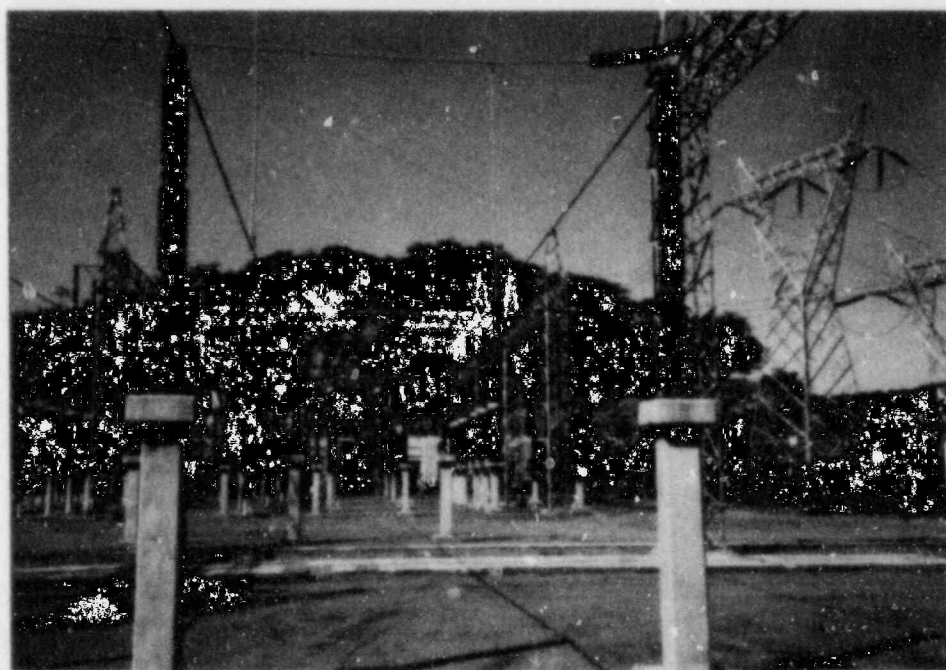
**Jose Maria Morelos Dam.** The dam and La Villita power station are located near the mouth of the Rio Balsas, adjacent to the town of Lazaro Cardenas. The earth-filled dam is approximately 150 feet high by 1,000 feet long. Superficial ground cracking occurred at the top of the dam, but there was no significant structural damage. The large array of high voltage equipment in the station switchyard (adjacent to the dam crest) was unaffected by the earthquake, even though this type of equipment is often susceptible to seismic damage.

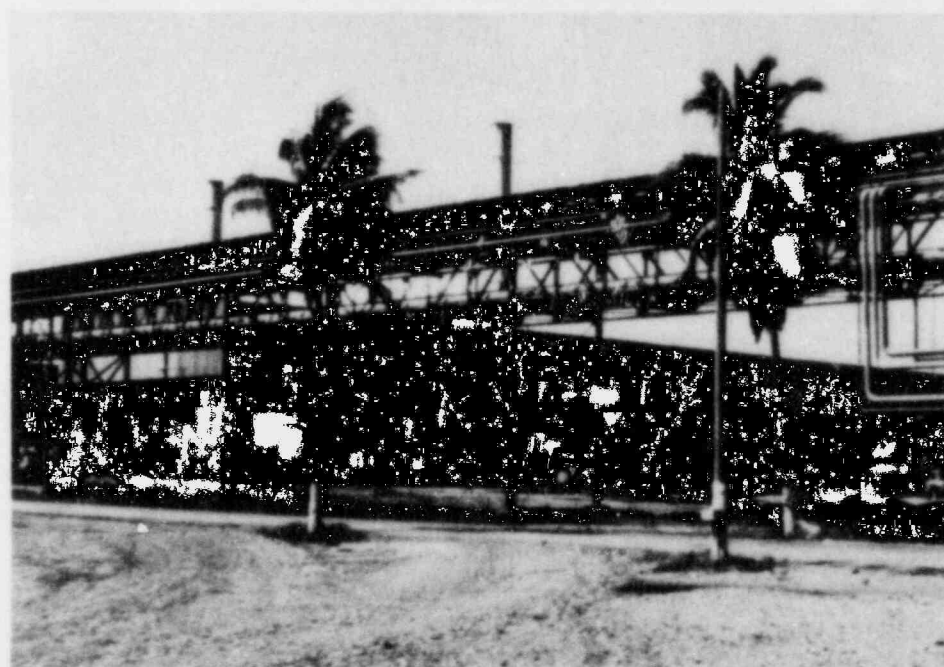
SICARTSA Steel Mill. The top photograph shows the switchyard where a disconnect switch similar to the one seen near the center of the photograph fell due to a cracked ceramic insulator. A transformer similar to the one at the left also suffered a cracked oil seal. The lower photograph shows a pipe support structure with a large structural steel building in the background. Both are representative of the types of components located at this plant, all of which performed well during the earthquake. A concrete frame administration building had severe damage to masonry panels and was evacuated.
