This forwards a copy of a letter from Promatec, dated February 17, 1986, for your information. This letter was a 10 CFR Part 21 report concerning defective material used in fire stops and may be applicable to the installations in your facility.

Reference: 10 CFR Part 21 - Notification of Defects

Pursuant to the provisions of 10 CFR Part 21 - Reporting of Defects and Non-compliance, notification is hereby given of the existence of defective conduit seals at Waterford 3 and other nuclear generating stations as identified herein. Final information leading to this report was obtained on February 13, 1986 at 12:00 p.m. and verbal notification as required by § 21.21 (2) was given on February 14, 1986 at 8:36 p.m. to Mr. David Powell, U.S. Nuclear Regulatory Commission, Washington, D.C.

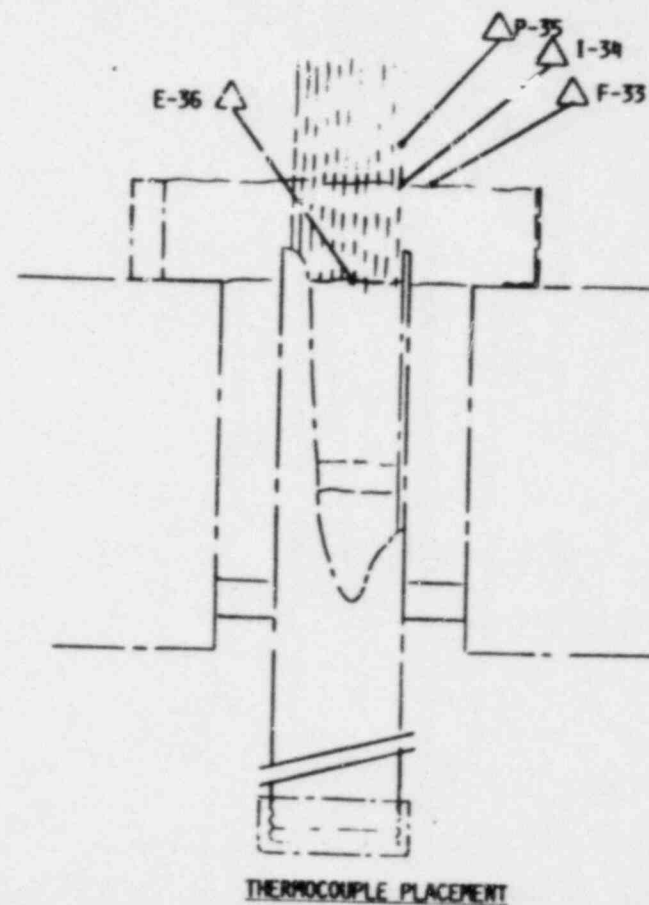
Attachment 3

- 3.3 While no flame through was noted on the unexposed side and hose stream tests did not cause openings, heat transmission as indicated by the field thermocouples exceeded the maximum temperature requirement of 325° F above ambient. An autopsy was performed and resulted in the discovery that both conduit seals were reduced to ash.

PROSSMATIC			
CTP 1097/n CONDUIT TEST					
THERMOCOUPLE PLACEMENT					
DRAWN BY LCS	CHECKED BY HTS	DATE 1/13/96	SCALE 1" = 1'	REVISION NO. B-520	DRAWING NO. B-520
