Nuclear Safety Information Center

REVIEW OF THE OPERATING EXPERIENCE HISTORY
OF OYSTER CREEK THROUGH 1981 FOR THE
NUCLEAR REGULATORY COMMISSION'S
SYSTEMATIC EVALUATION PROGRAM

July, 1982

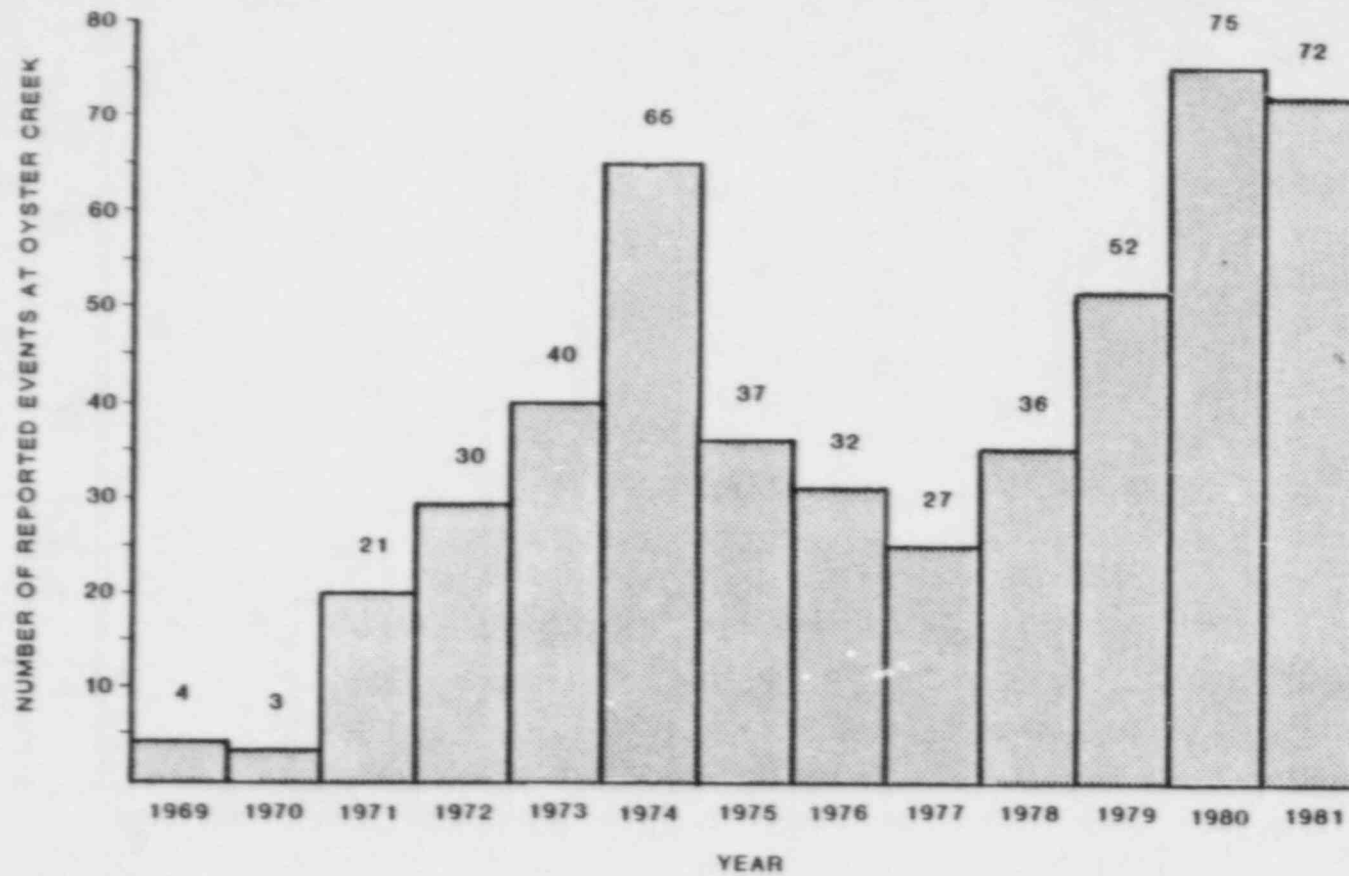
Figure 4.1 Number of Reported Events Per Year
at Oyster Creek

4.5.1.1 Yearly summary of reportable events. The event reporting pattern over the life of the Oyster Creek plant is shown in Fig. 4.1. The year-by-year trend was generally toward more reported events, with peak years in 1974, 1980, and 1981. The years 1969 through 1973 averaged nineteen reported events per year, while the years 1974 through 1981 averaged forty-nine reported events per year. Recurring failures were a contributing factor to the upward trend. From 1969 through 1973, an average of three recurring failures occurred per year while for the years 1974 through 1981 that average doubled to six per year. However, even if the recurring failures are subtracted, the upward trend in the number of reported events is still apparent.
