RADIOLOGIC AND ENGINEERING ASSESSMENT

DOE ID NO.: GJ-11586-RS
ADDRESS: 2005 ELM AVENUE

JUNE 1985

BENDIX FIELD ENGINEERING CORPORATION
P.O. Box 1569
Grand Junction, Colorado 81502

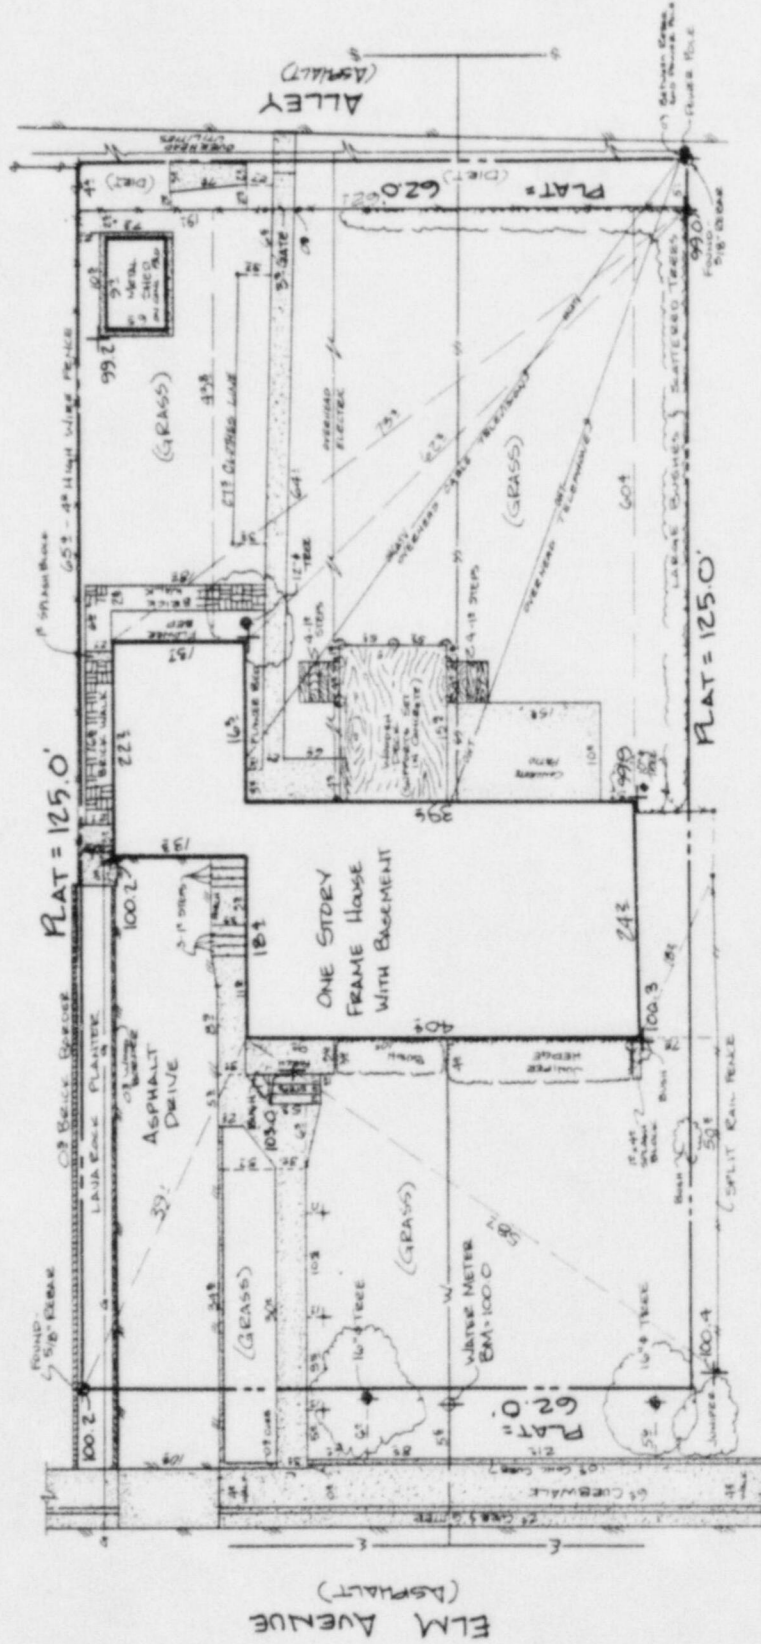
FIGURE 2.2 SITE PLAN

Utilities: Utility locations are shown in Appendix Figure 2.2.

Structures, utilities, landscaping, and other special features of this property are included in Appendix Figure 2.2.
