# Rupture of Model 48Y UF<sub>6</sub> Cylinder and Release of Uranium Hexafluoride

Sequoyah Fuels Facility  
Gore, Oklahoma  
January 4, 1986

U.S. Nuclear Regulatory  
Commission

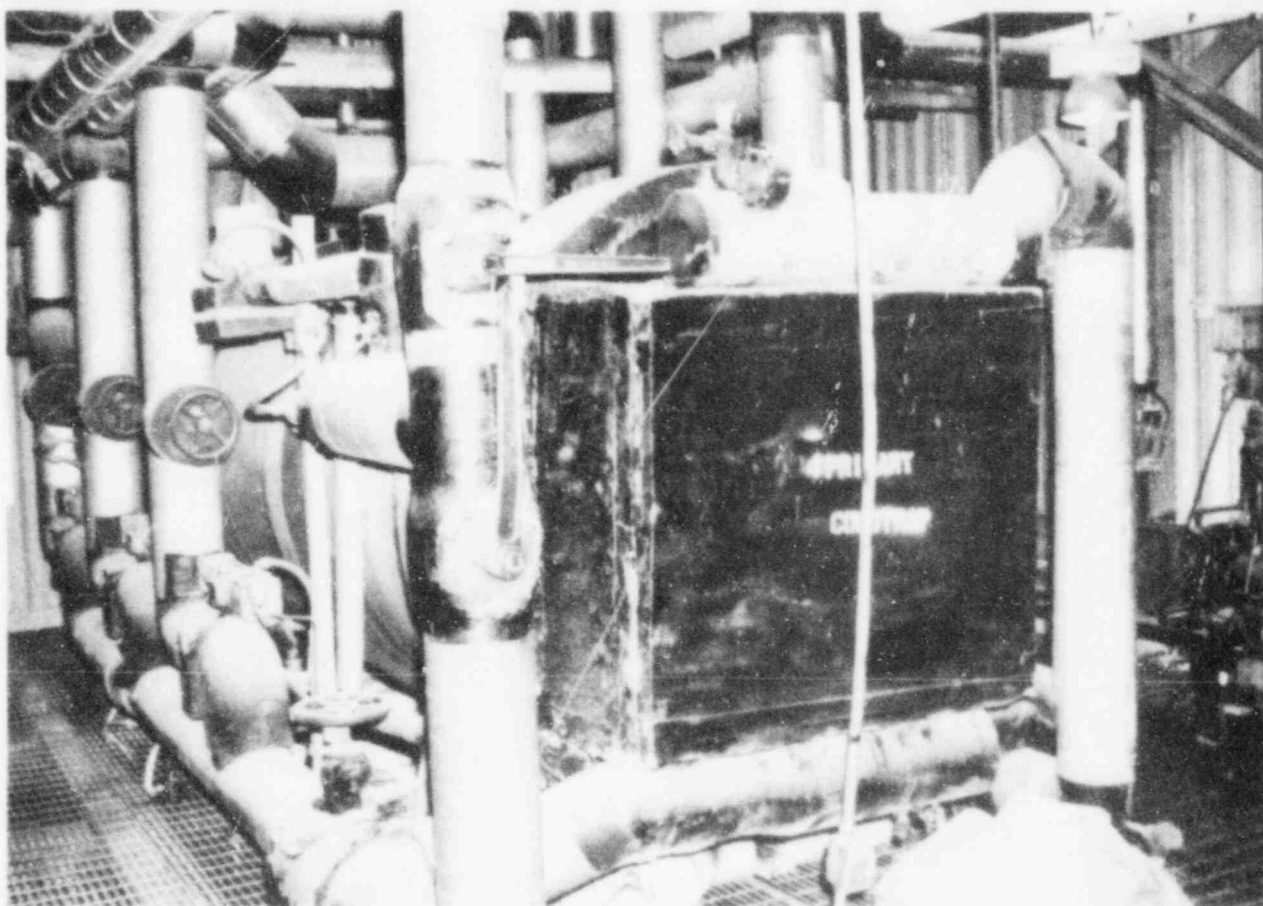
Figure 3.3  $\text{UF}_6$  cold traps

Cold traps receive gaseous  $\text{UF}_6$  and condense the material to a solid form. When loaded, traps are heated to liquefy the  $\text{UF}_6$  for draining to cylinders, two floors below.

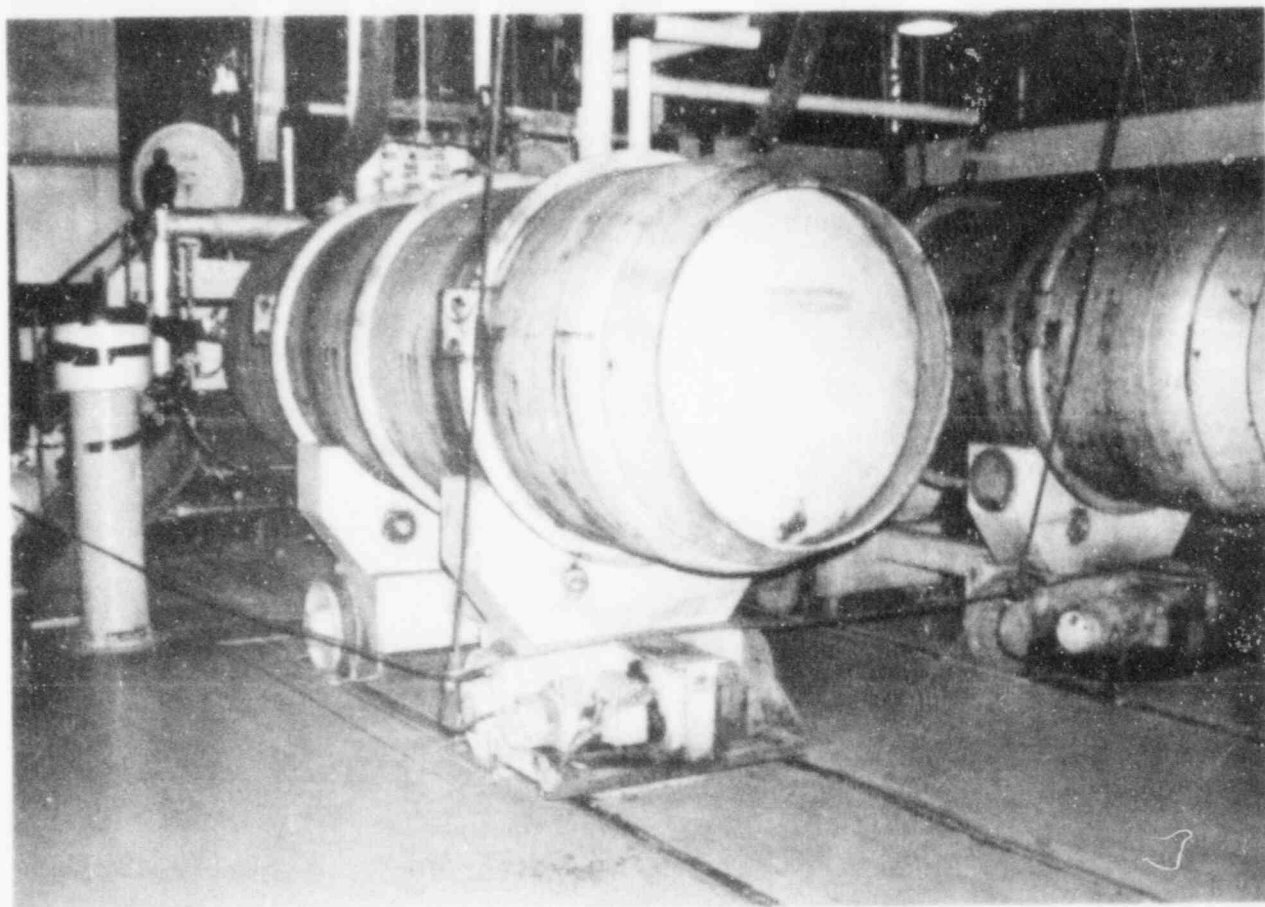
Figure 3.4 Cylinder-loading stations

Two 14-ton cylinders are positioned on scale platforms to receive liquid  $UF_6$  from heated cold traps overhead. Weight is observed on a large dial indicator in the background.

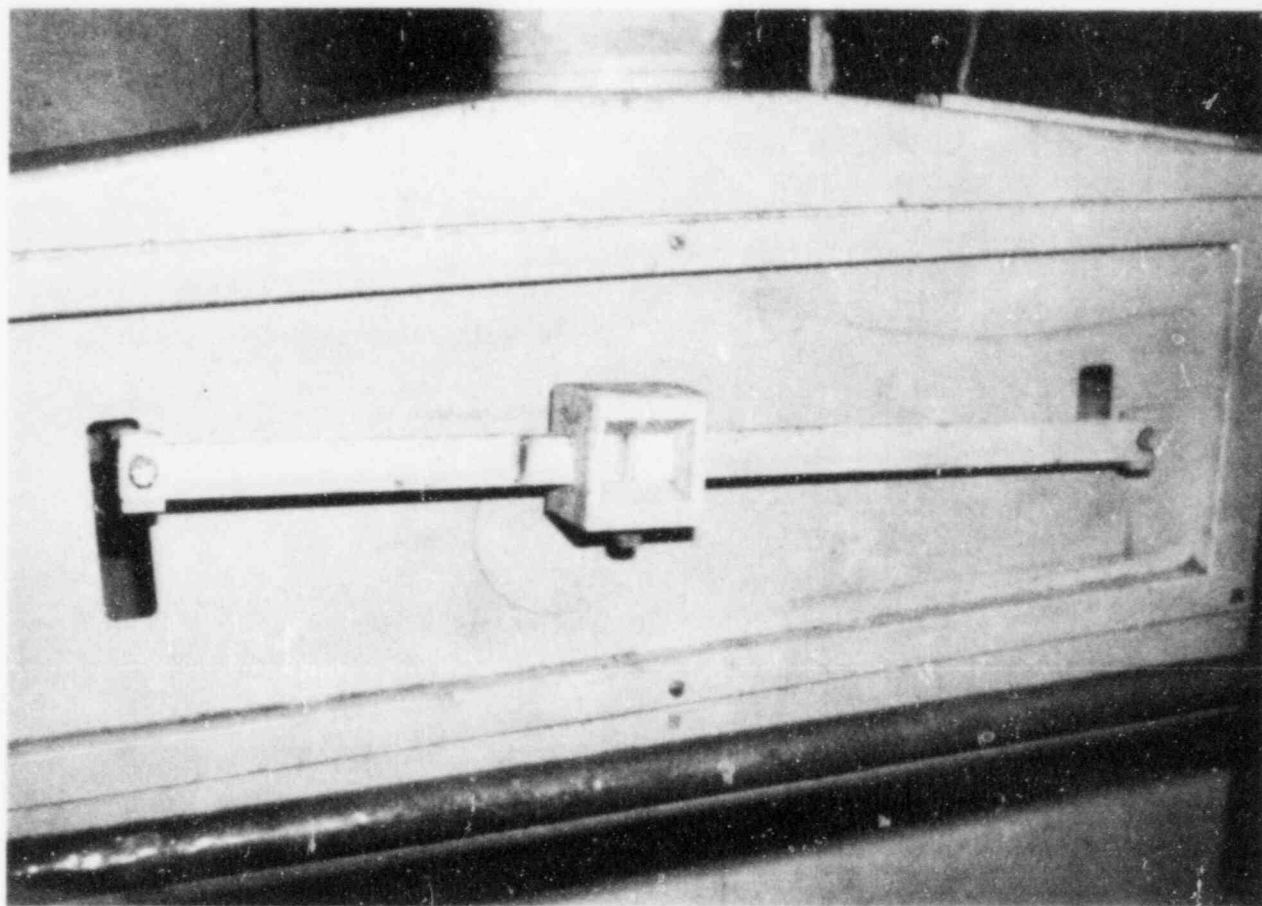
Figure 3.6 Tare-compensating weight

The tare weight of an empty cylinder and the cart is eliminated from the observed weight by moving the poise on the beam until the dial indicator reads zero.

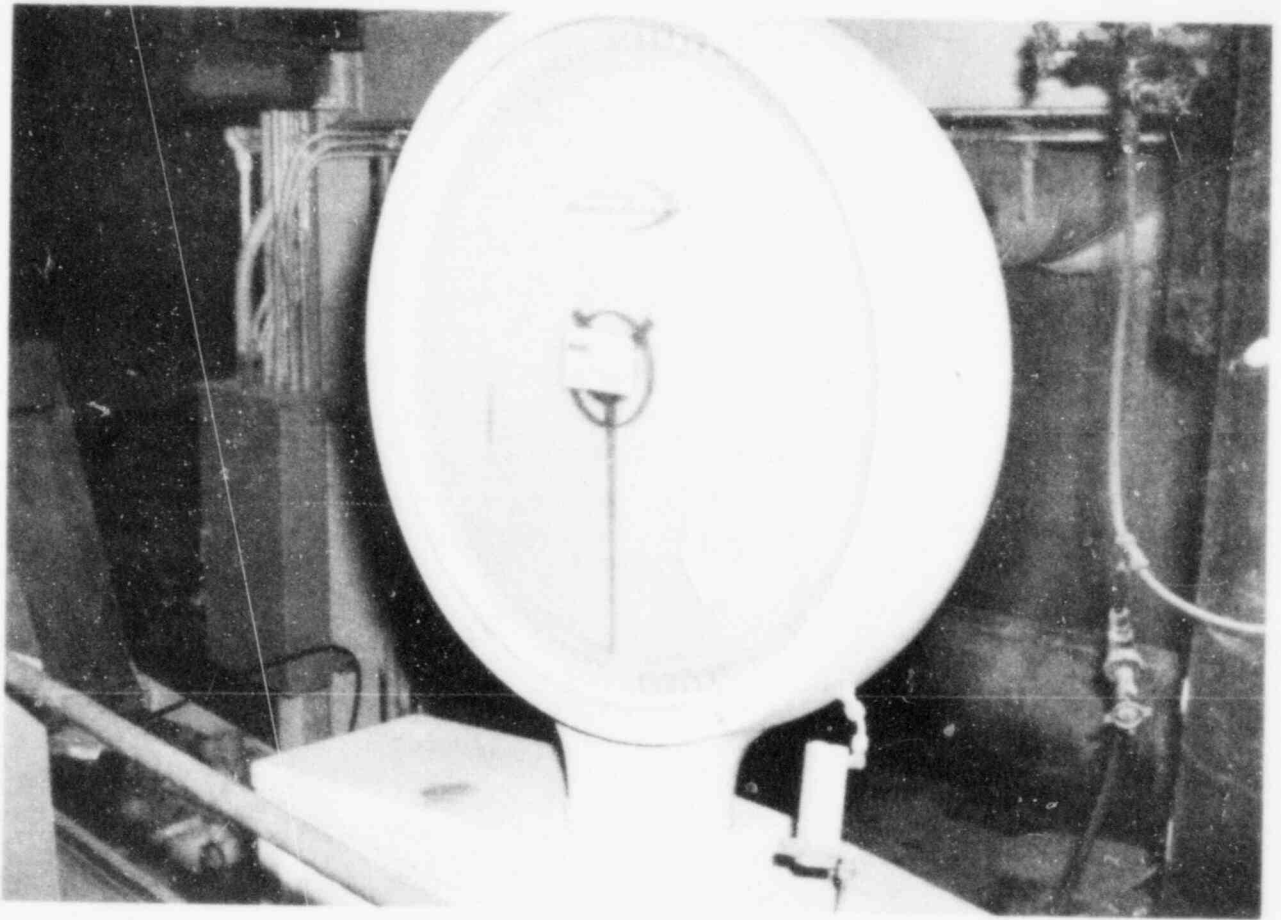
Figure 3.7 Scale dial indicator

With an empty cylinder on its cart and the tare-compensating mechanism adjusted to zero, the dial indicator records the net weight of the cylinder contents.

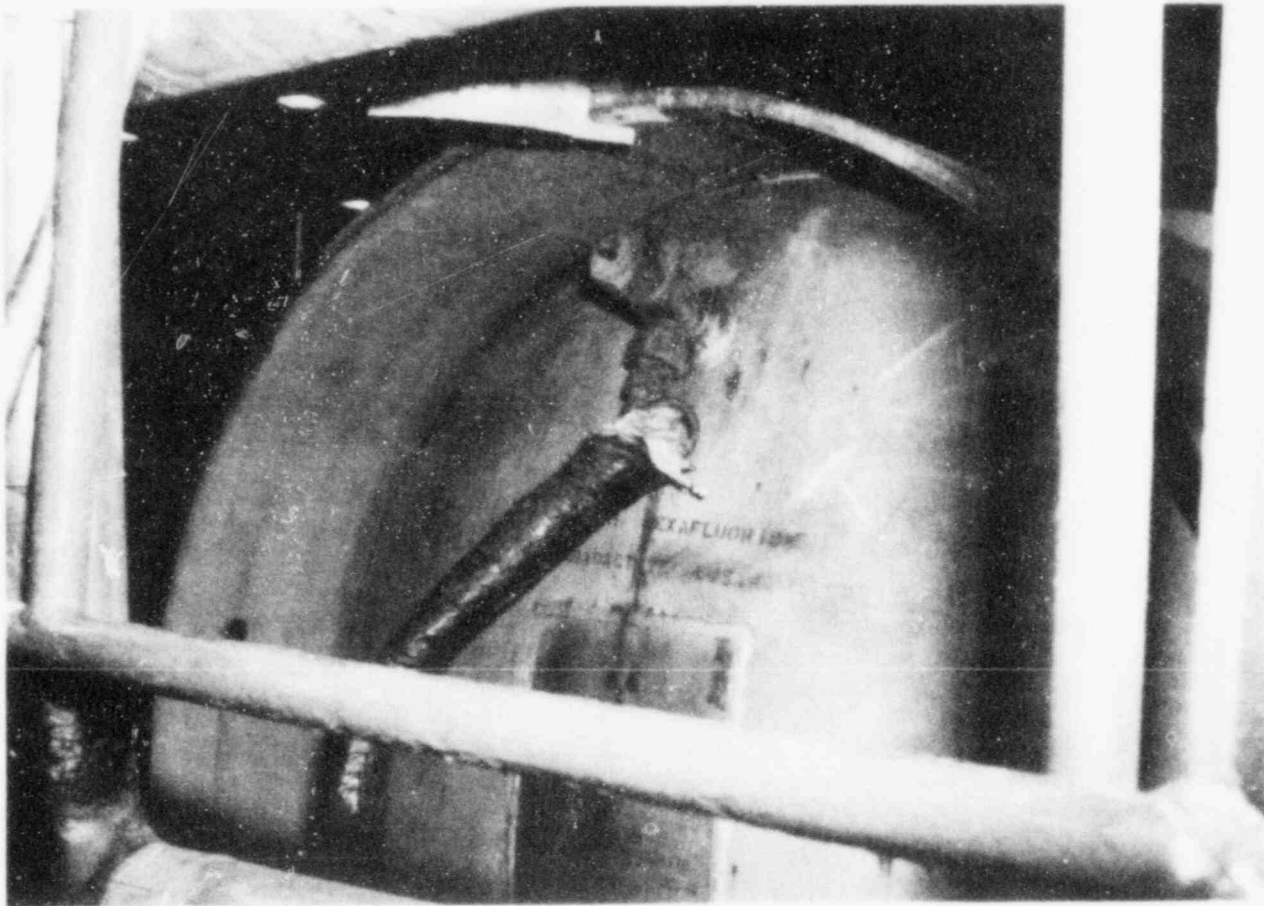
Figure 3.8 Flexible cylinder connection

Liquid  $\text{UF}_6$  enters the cylinder through this flexible line, which is connected to the cylinder fill valve.

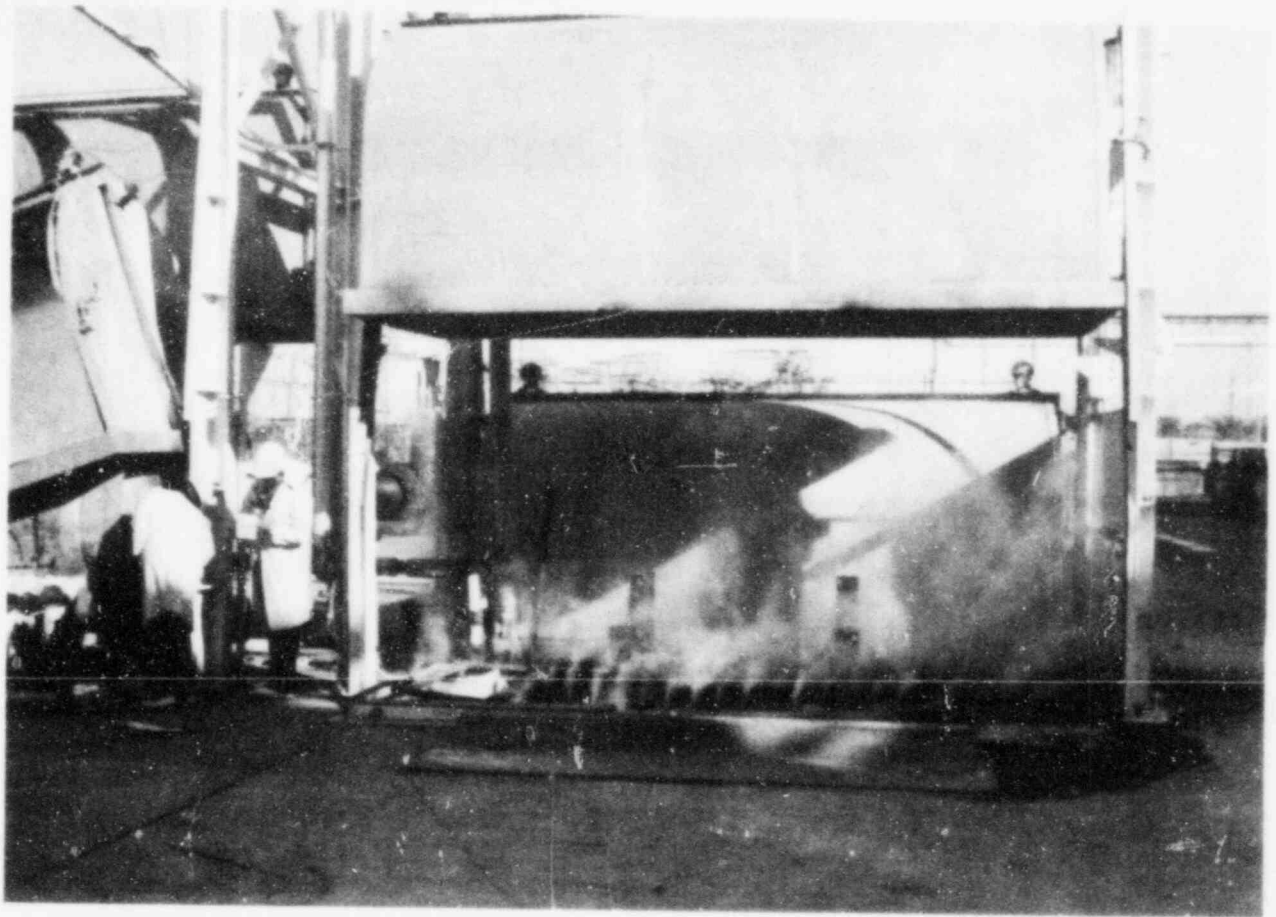
Figure 3.9 Steam chests

Two of the undamaged steam chests are shown. The nearer chest cover has been raised, showing the cradle on which the  $\text{UF}_6$  cylinder is placed and the steam manifold through which steam is introduced. In the background, the cover has been lowered for heating.

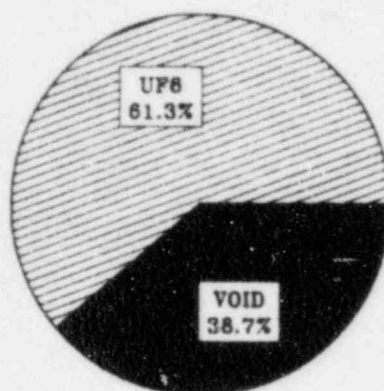
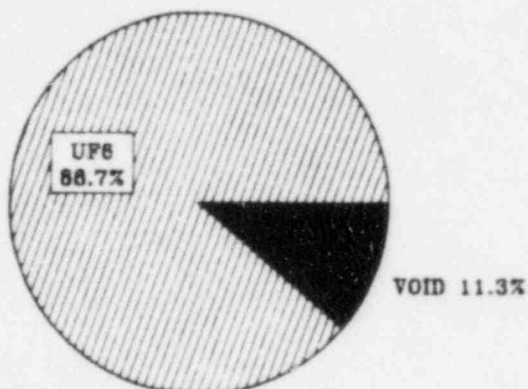
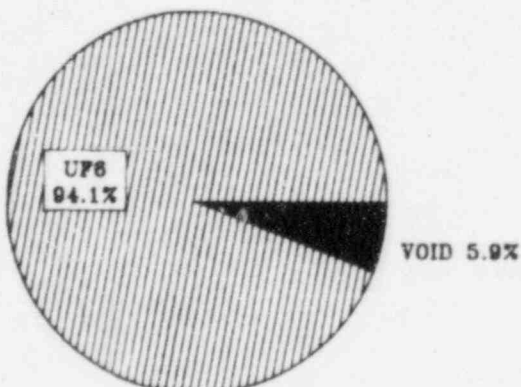
Figure 3.17  
Uranium Hexafluoride Cylinder  
Model 48Y Normally Filled  
Contents Weight: 27,560 pounds

Figure 3.17 graphically depicts the relative volumes occupied by  $UF_6$  in a normally filled cylinder when the  $UF_6$  is in the solid phase at 100°F and the liquid phase at 200°F and 250°F. The  $UF_6$  undergoes an increase in volume of about 36% when it changes from solid to liquid form at 147°F. Large internal pressures can be produced hydraulically when liquid contents expand to a volume greater than the volume of the vessel in which they are contained.
