SUBJECT: REGION V INPUT TO ACRS REQUESTS ON PALO VERDE

### Review of Startup Experience for Palo Verde Unit 1

LOSS OF LOAD EVENT

PALO VERDE LOSS OF OFFSITE POWER  
OCTOBER 3, 1985 (J. T. BEARD, NRR)

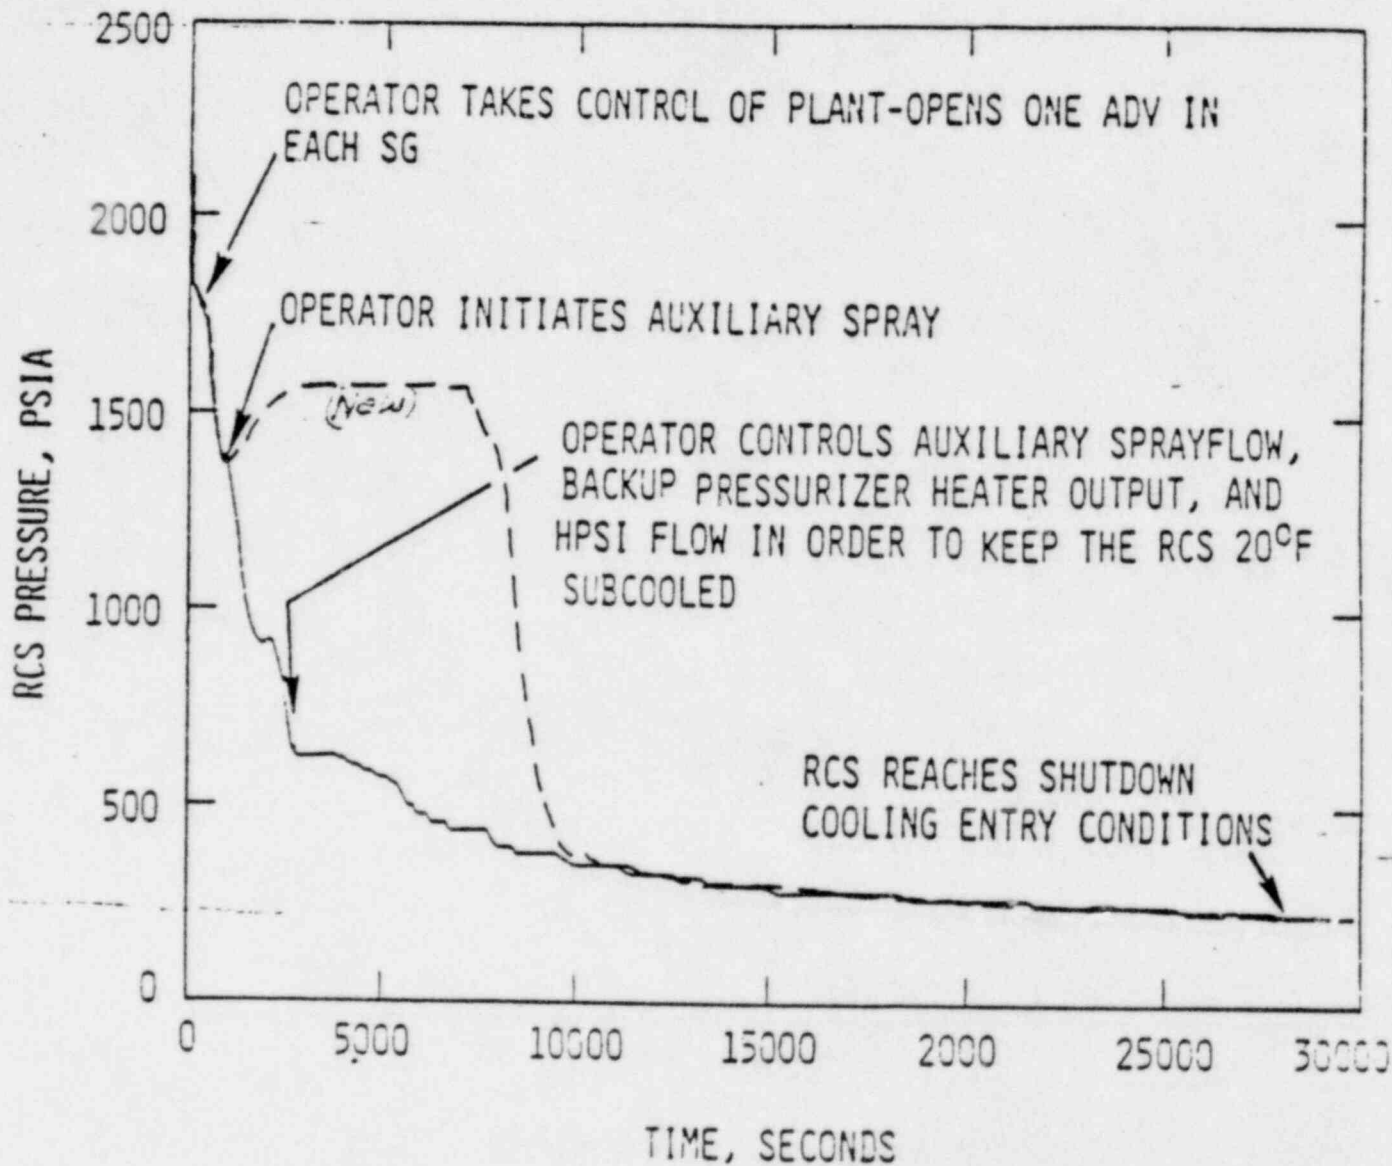
Figure 15A-3 (Sheet 2 of 2)

STEAM GENERATOR TUBE RUPTURE WITH LOSS  
OF OFFSITE POWER AND A FULLY STUCK  
OPEN ATMOSPHERIC DUMP VALVE  
RCS PRESSURE VS TIME

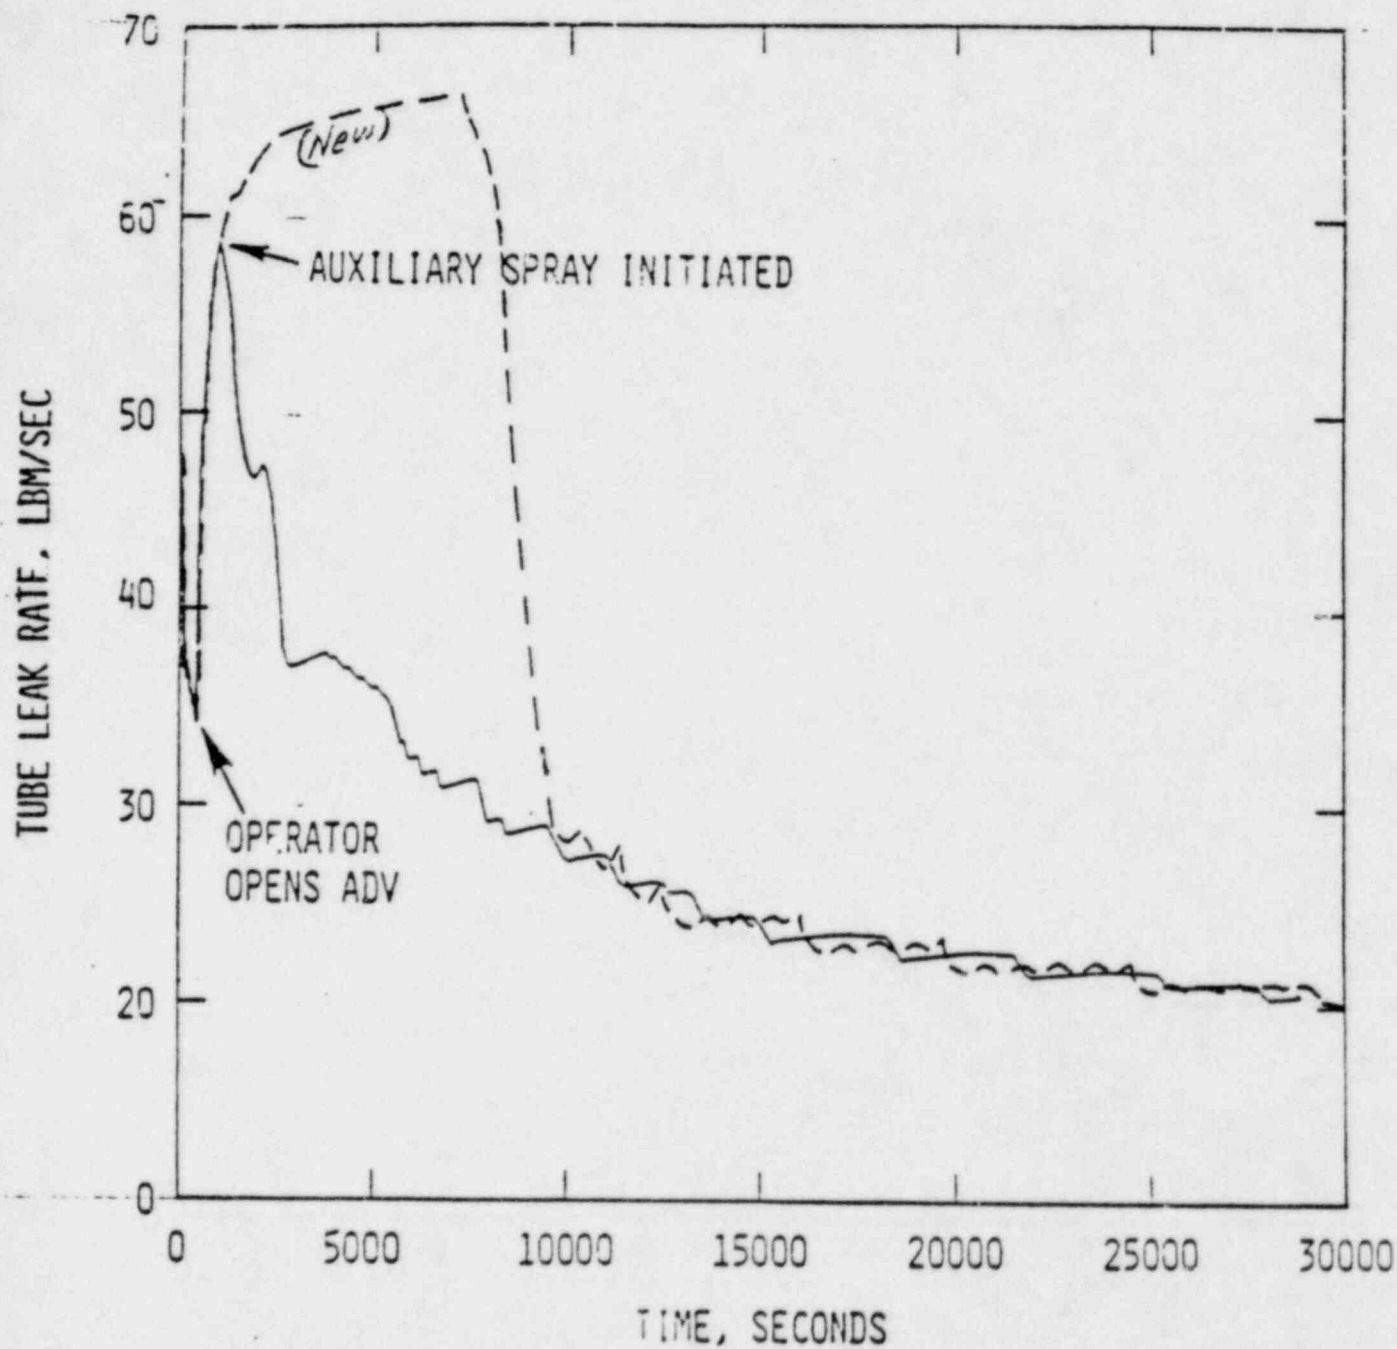
STEAM GENERATOR TUBE RUPTURE WITH LOSS  
OF OFFSITE POWER AND A FULLY STUCK  
OPEN ATMOSPHERIC DUMP VALVE  
TUBE LEAK RATE VS TIME  
Figure 15A-11 (Sheet 2 of 2)

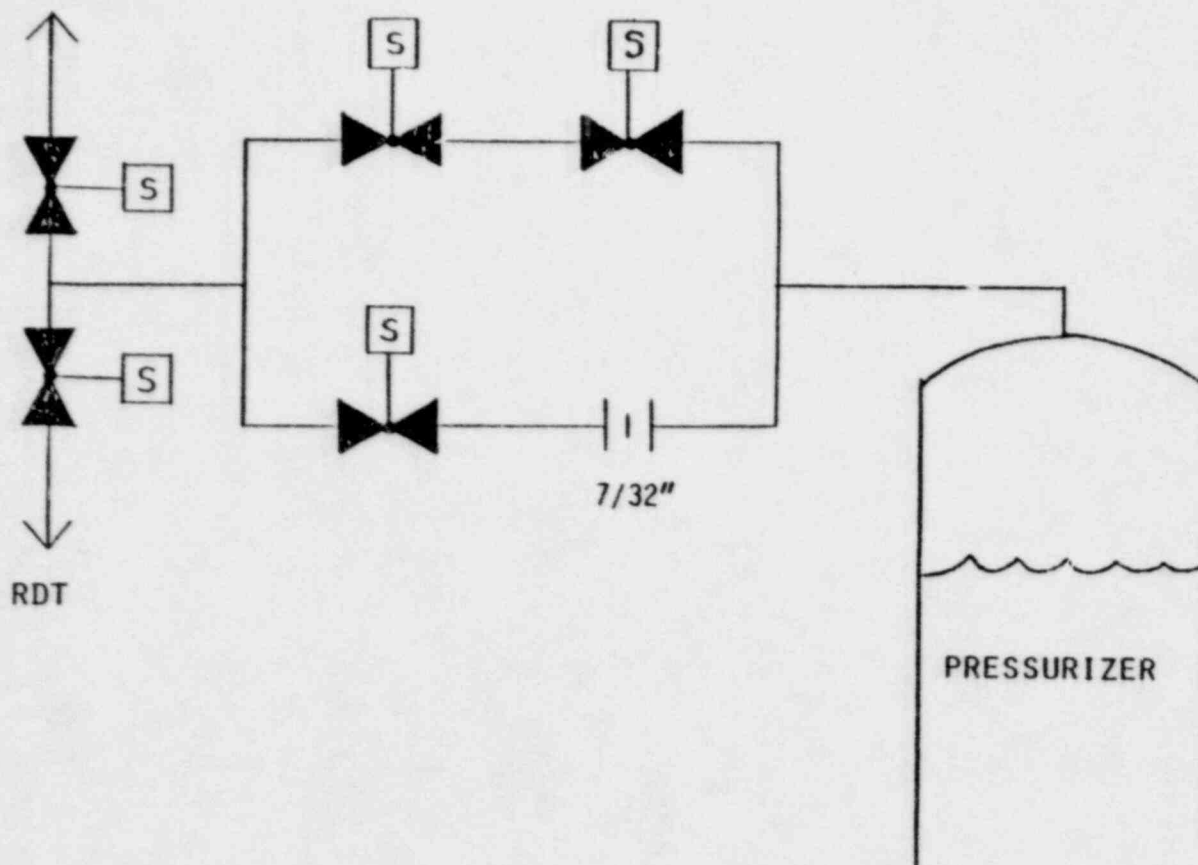
PRESSURIZER VENT PATHS

PRESSURIZER VENT SYSTEM  
DEPRESSURIZATION DURING SGTR
