Report of Construction Inspection

IE Inspection Report No. 050-330/77-02

Midland Nuclear Power Plant  
Unit 2  
Midland, MI

Inspection on February 28 and March 1, 1977, (Unit 2, 77-02): Special inspection concerning extensive bulge in the Unit 2 containment liner plate. One noncompliance item was identified relative to failure to report the bulge deficiency pursuant to the requirements of 10 CFR 50.55(e)(2).

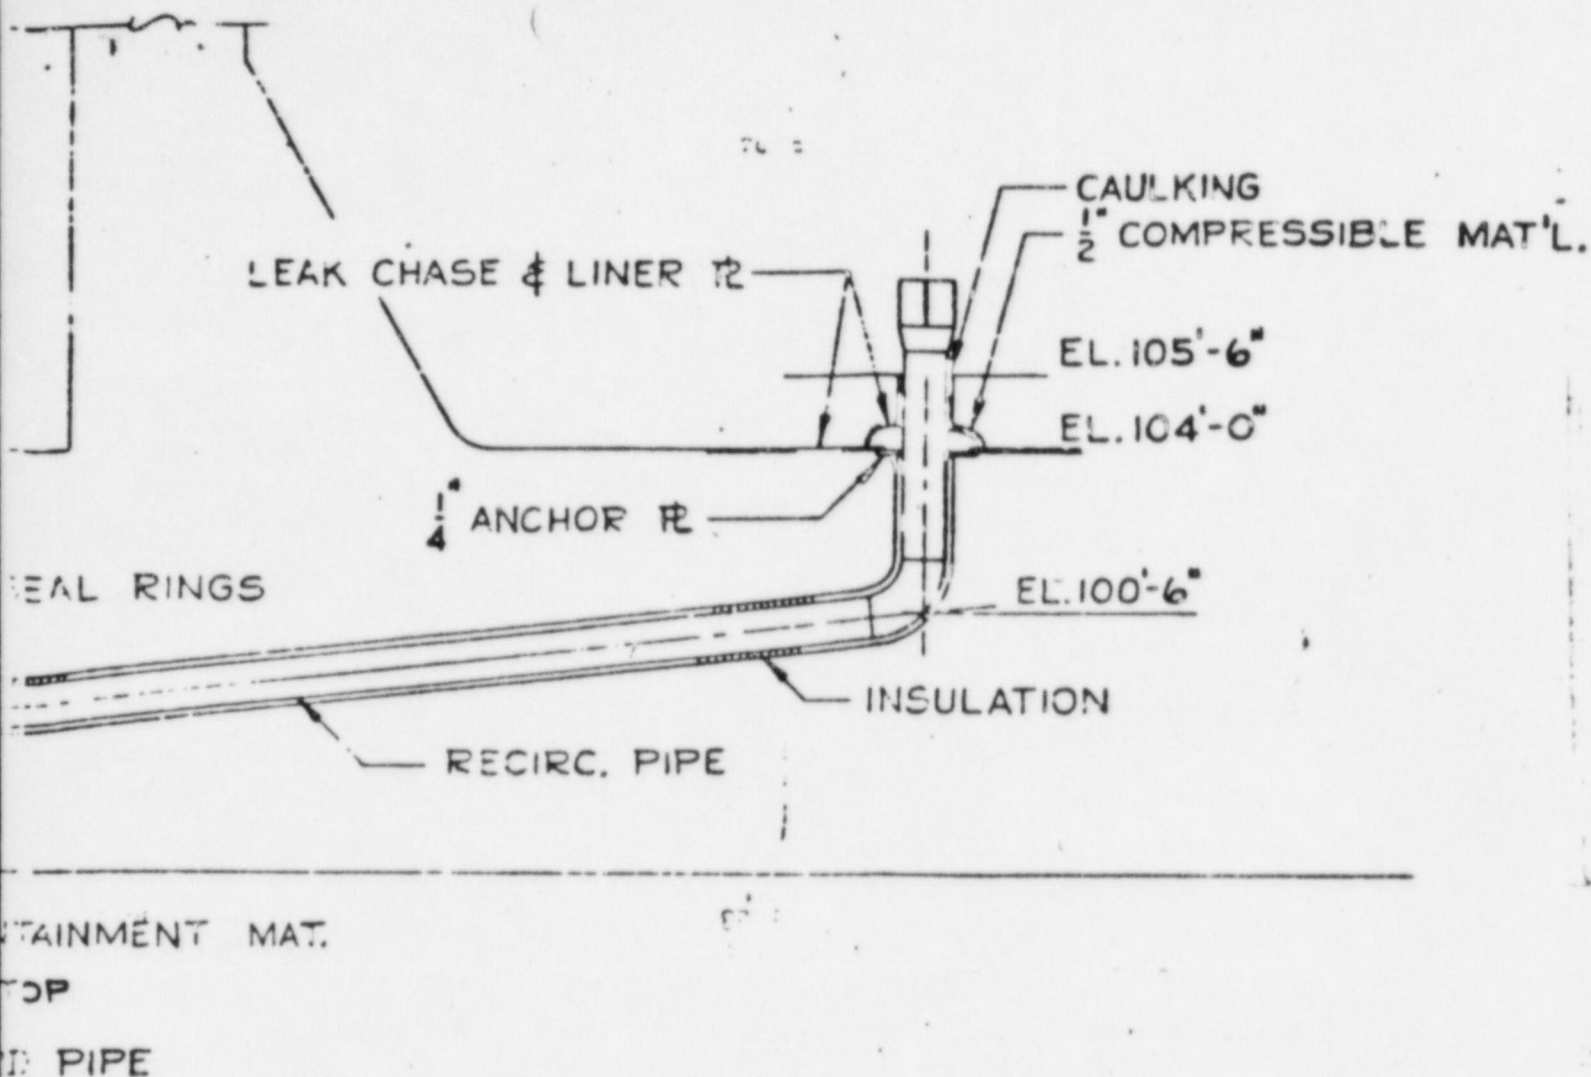
MIDLAND, UNIT 2

The bulge plate appeared to be in stable condition held by the full penetration welds to the 14-inch wide flange I-beam columns, by the base mat floor plate and by heavier penetration sections near the floor and upper end of the bulge. Tear holes were observed near the columns, adjacent to the penetrations and near a stiffener plate installed at elevation 510 feet to resist wind loads during construction. The lower penetration section was bent and may have to be replaced. The outside of the containment structure was examined and no cracks or other damage was in evidence. Also there was no apparent damage to the tendon sheaths and no unaccounted for water was in the tendon gallery.

Failure Mode on Bulged  
Liner Plate  
N.T.S.

Proposed Repaired  
Section  
N.T.S.
