ATTACHED DOCUMENT TITLE: DAVIS-BESSE COURSE OF ACTION (COA)

FINDINGS, CORRECTIVE
ACTIONS & GENERIC
IMPLICATIONS REPORTS
FROM SECTION C.1.1
PLAN NO. REV.
1A & 1B/1C 1

This report documents the troubleshooting and investigative actions performed to identify the root cause of the overspeed trips of the Auxiliary Feed Pump Turbines (AFPTs) at Davis-Besse on 6/9/85. Also presented in this report are the proposed corrective actions to eliminate the cause of the overspeed trips and a summary of the proposed confirmatory testing to ensure proper system operation.

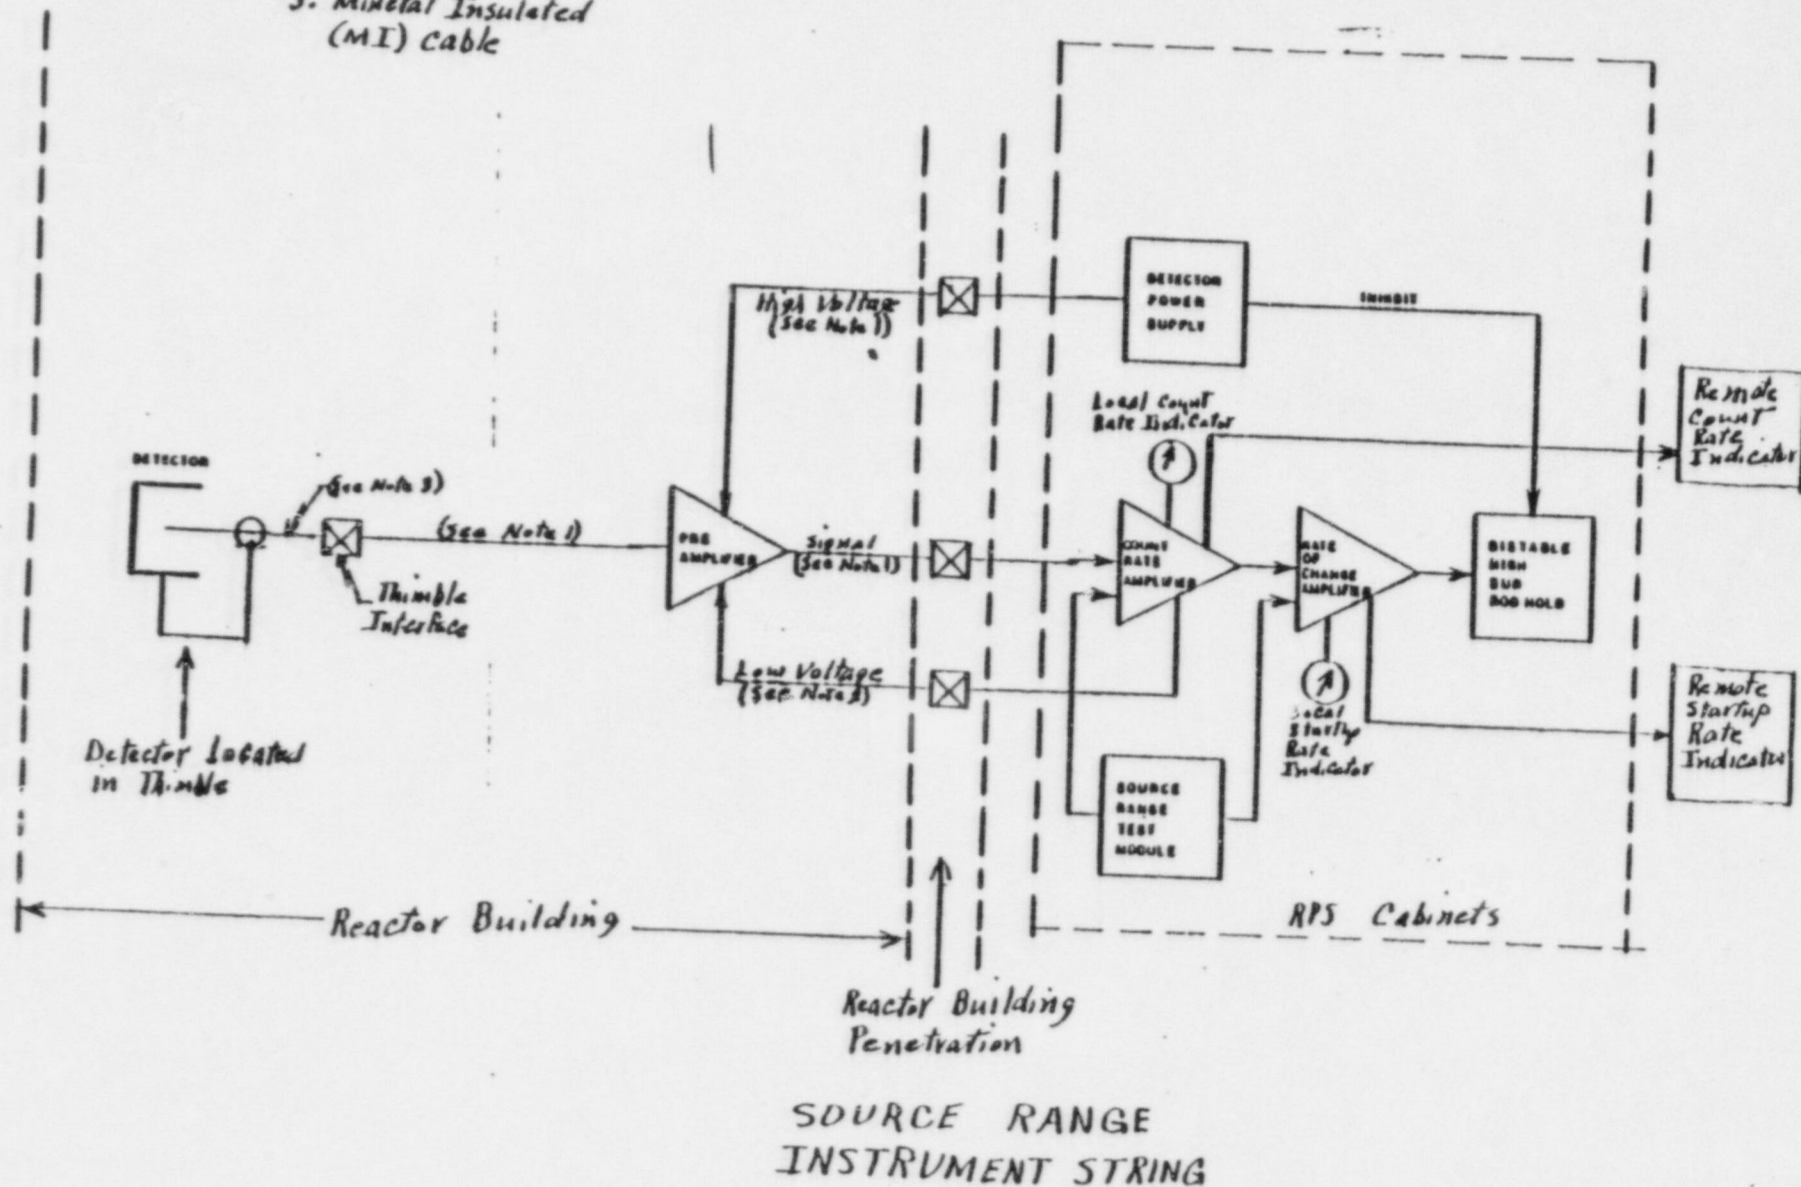
Fig 1

The subject of this report is NI-1, Source Range Instrument String as shown in Figure 1. NI-1 is located in Nuclear Instrumentation/Reactor Protection System Channel 2. |2

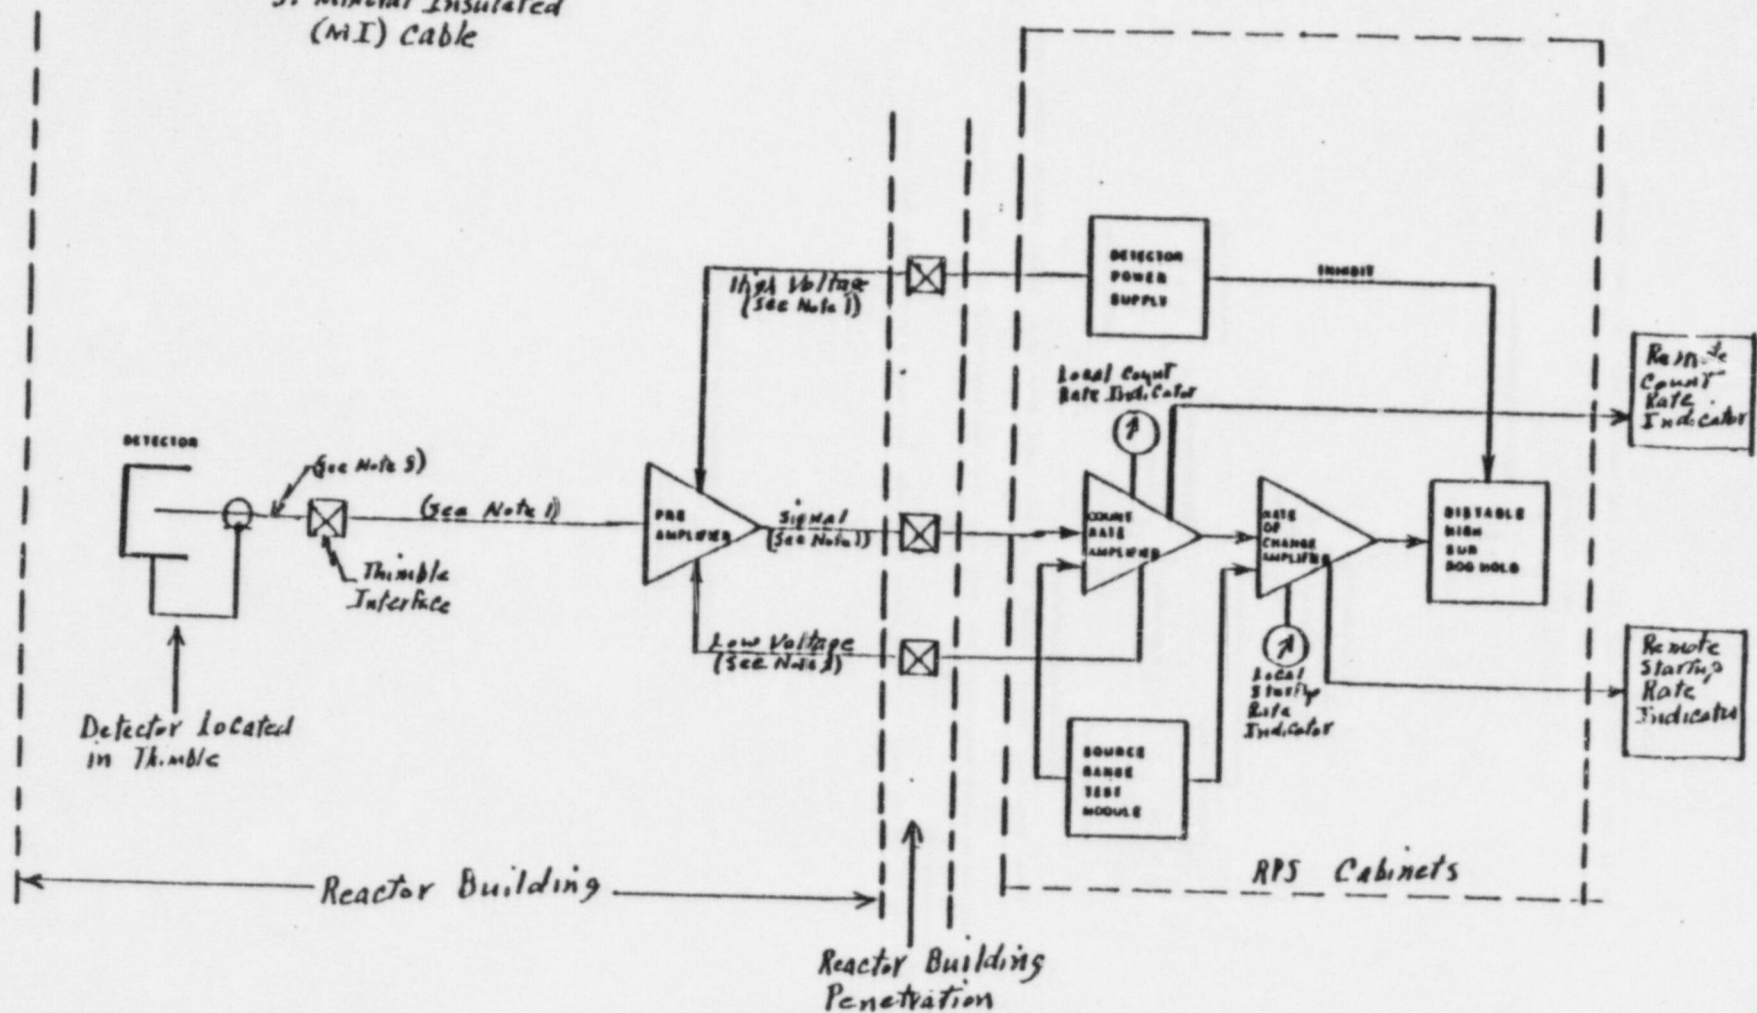
Fig 1

The subject of this report is the NI-2 source range instrument string as shown by Fig. 1. NI-2 is located in the Nuclear Instrumentation/Reactor Protection system channel 1.

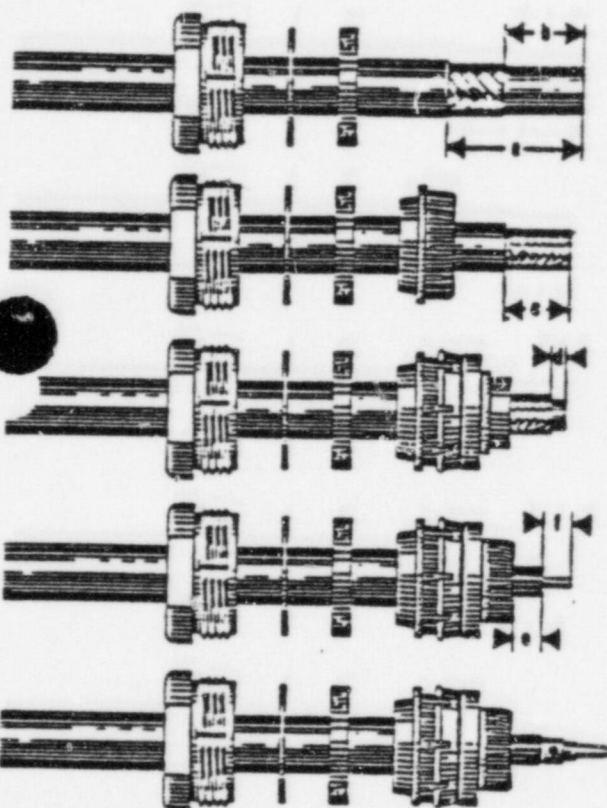
Fig. 2

2. The high voltage cable connector on the back of the power supply in RPS cabinet #1 is missing the "O" ring. Figure 2 shows a typical connector assembly. This connector has been replaced. | 2

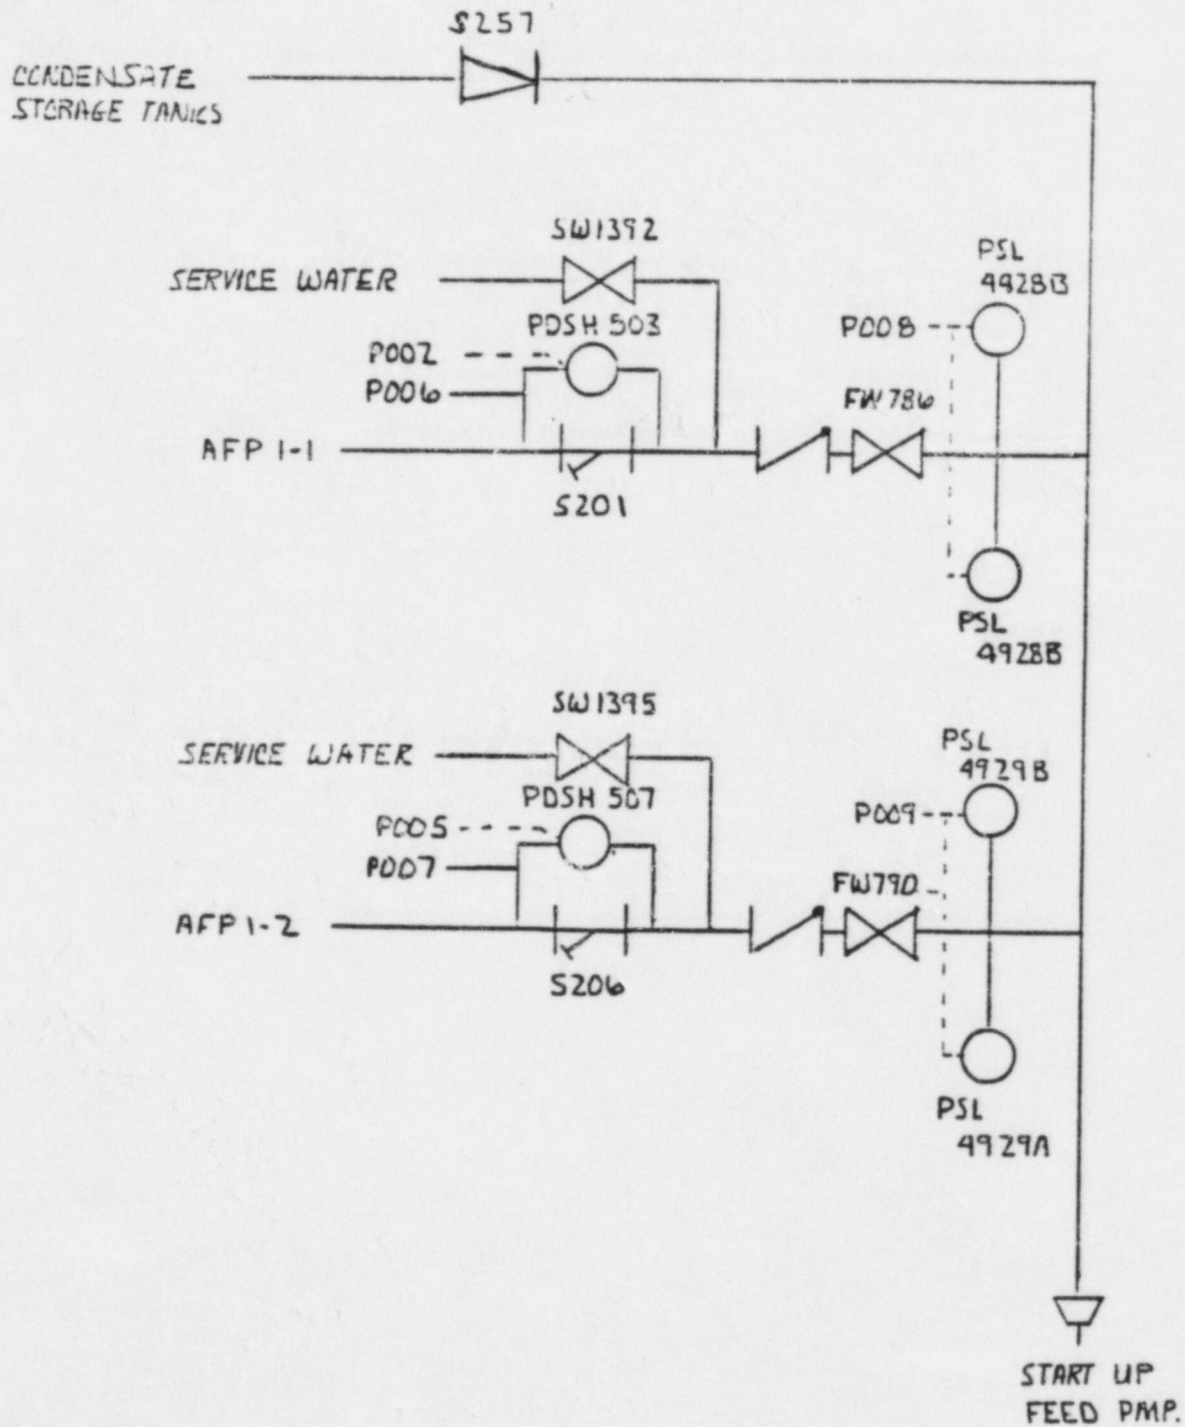
FIGURE 1

In the event of loss of the water supply from the condensate storage tanks, an automatic backup is provided from the service water system. Two independent low pressure switches provided on the auxiliary feedwater pump suction line, upon both sensing low pressure, will automatically close the valve from the condensate storage tanks and open the valve from the service water system. Each auxiliary feedwater pump has an independent set of pressure switches, supply valve from the condensate storage tank, and supply valve from the service water system. These components function independently with their respective auxiliary feed pumps. See Figure 1.

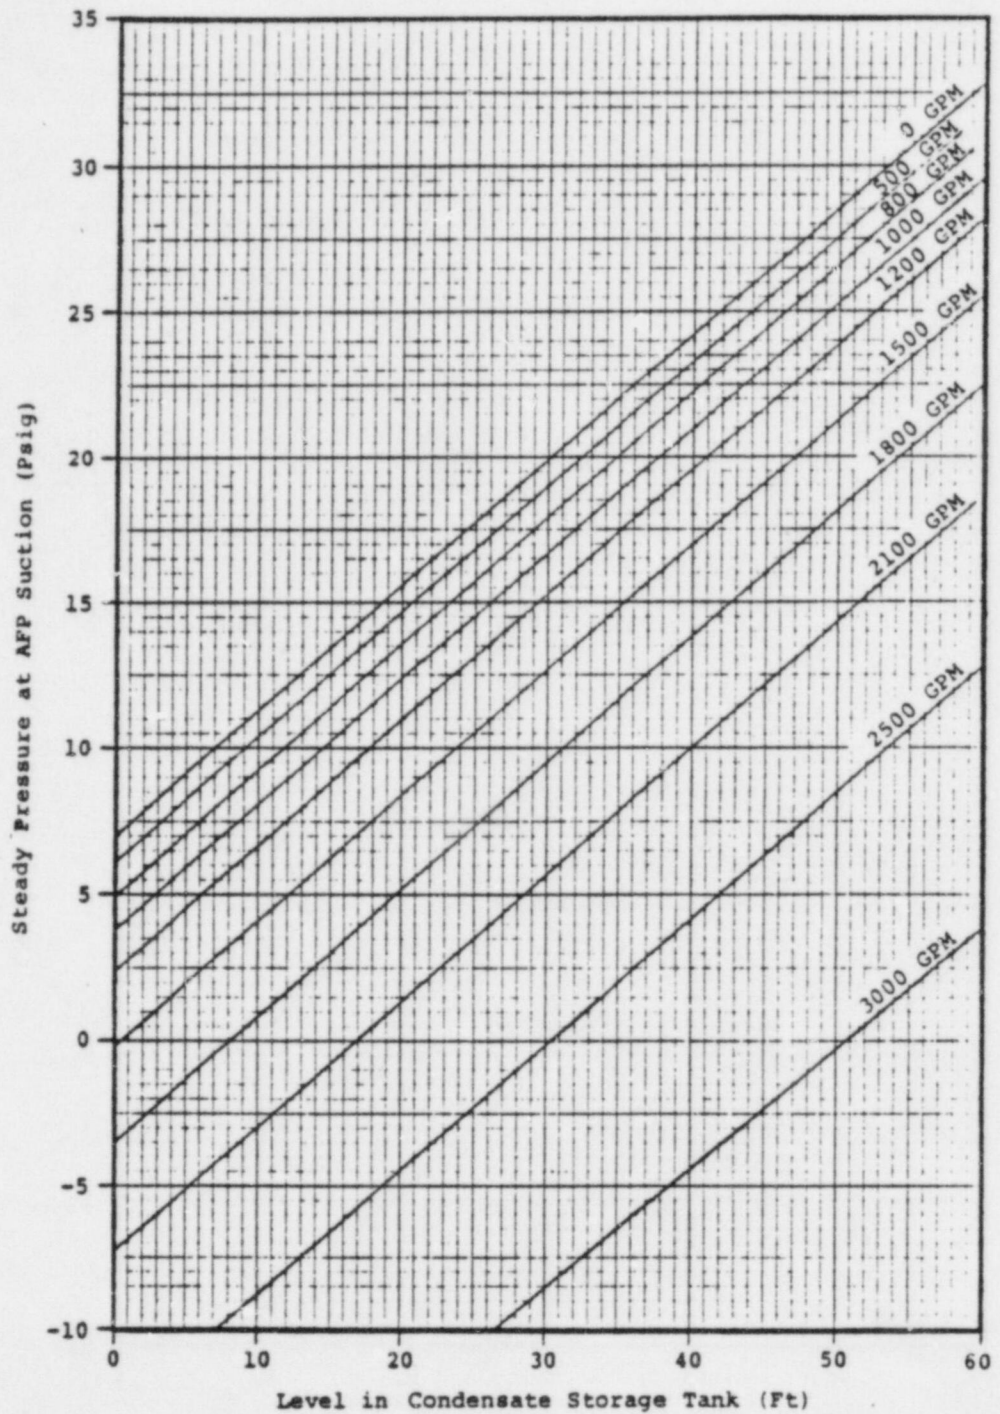
AUXILIARY FEED PUMP SUCTION PRESSURE
FIGURE 2

Test procedure ST 5071.01 (T-mod 9544) (performed on September 6, 1985) determined the steady pressure losses in the line from the auxiliary feed pumps to the condensate storage tank. This was done with AFPT 1-2 operating on auxiliary steam and recirculating through a large recirculation line as well as the normal recirculation path. Based on these data the pressure at the pressure switch location can be calculated for other flow rates and other levels in the condensate storage tank. These results are shown in Figure 2.

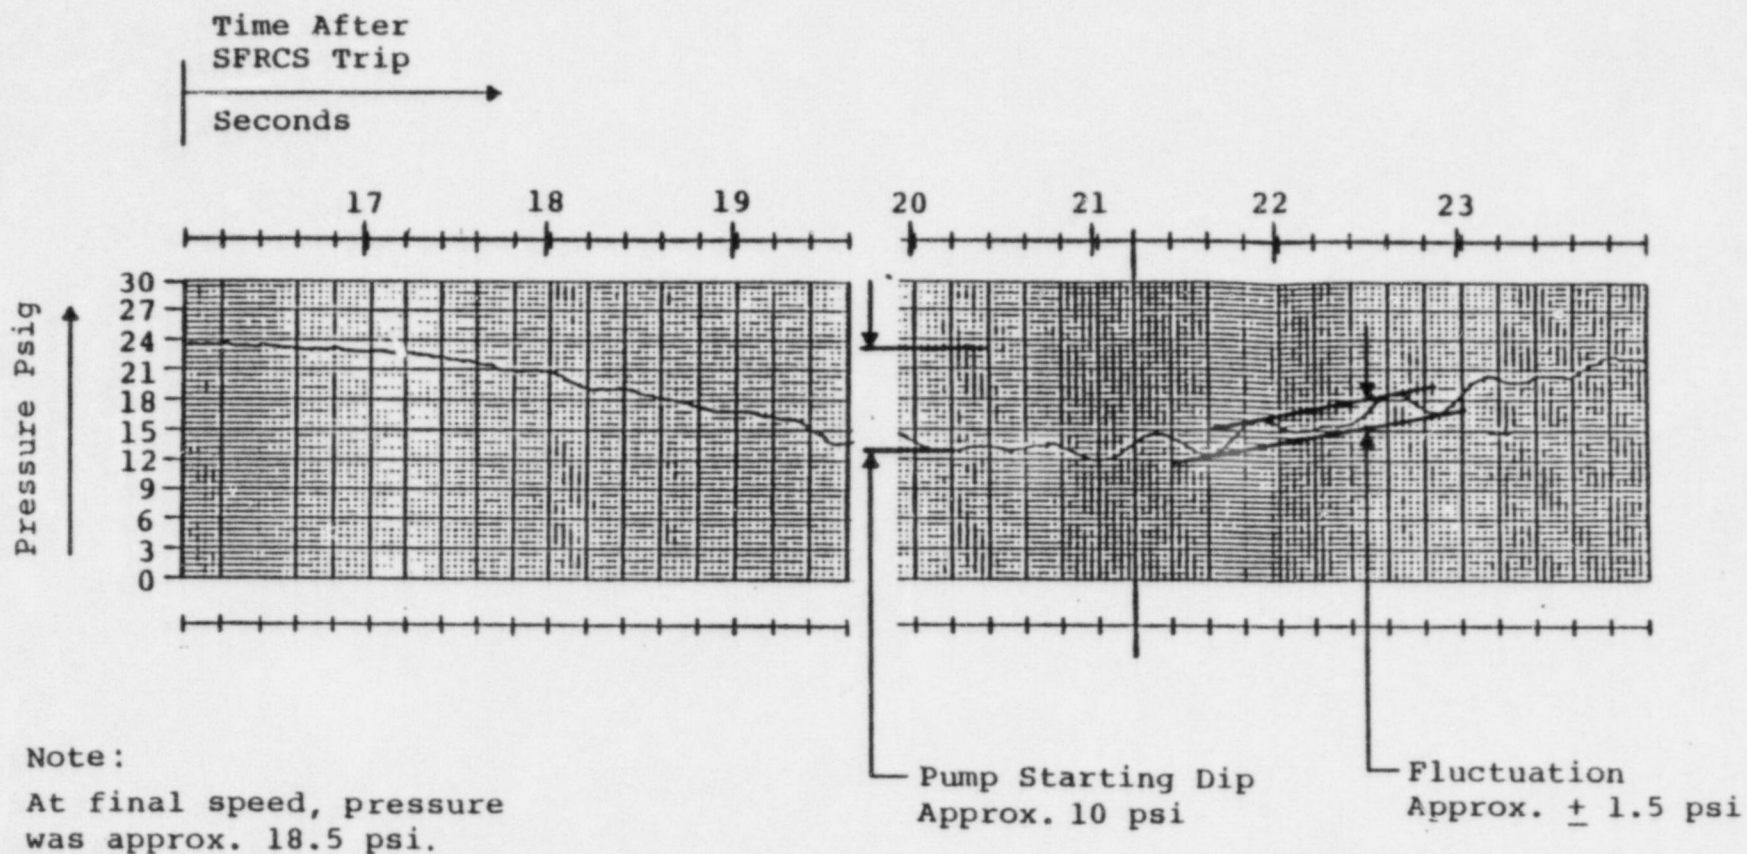
AUXILIARY FEED PUMP SUCTION PRESSURE
AUGUST 21, 1982, TESTING
FIGURE 3

Observations of transient pressures during startup of AFPT 1-2 were made in August 21, 1982 using test procedure TP 520.48. In this test a pressure transducer was placed in the pump suction and the pressure was recorded as the SFRCS was tripped and auxiliary feed pump 1-2 started. Figure 3 shows the dip in suction pressure which resulted as the pump accelerated. This trace also shows other fluctuations in pressure which are evidently related to flow through the system, but are not the result of acceleration of the turbine.
