B. AHLUWALIA, PH.D.
RADIOLOGICAL PHYSICIST

REPORT OF TELETHERAPY TESTS AND SURVEYS

Licensee St. Joseph Regional Medical Center of North Oklahoma, Inc.
Address 14th and Hartford, P. O. Box 1270, Ponca City, Oklahoma 74602
License # 35-14046-01

FIVE YEAR INSPECTION & PREVENTATIVE MAINTENANCE REPORT

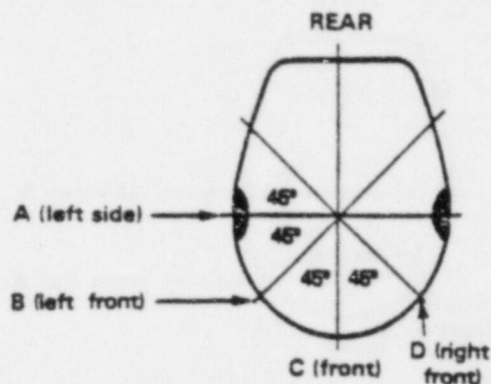
View A-Vertical
from left side

Position No.	Radiation Level (mr/hr)
View A	1 <u>2.8</u>
	2 <u>0.4</u>
	3 <u>6.8</u>
	4 <u>1.4</u>
View B	5 <u>1.2</u>
	6 <u>1.6</u>
	7 <u>2.2</u>
	8 <u>1.3</u>
View C	9 <u>0.5</u>
	10 <u>0.5</u>
View D	11 <u>1.2</u>
	12 <u>1.8</u>
	13 <u>1.2</u>
	14 <u>1.3</u>
Average value	<u>1.73</u>
Maximum value	<u>6.8</u>
