Accident Sequence Precursor Program Event Analysis

LER No: 455/88-008
 Event Description: Loss of feedwater and one train of auxiliary feedwater tripped
 Date of Event: July 14, 1988
 Plant: Byron Unit 2

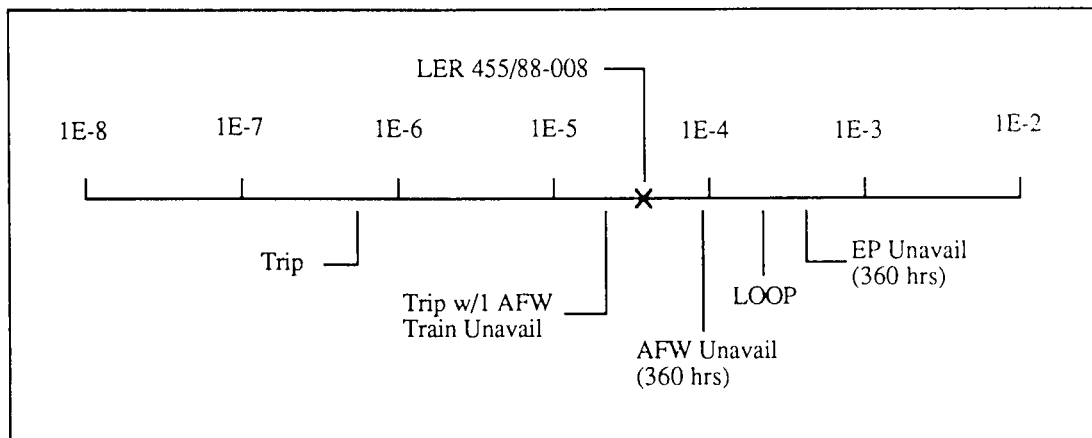
An operator inadvertently caused a loss of feedwater while operating at 95% power. During the recovery from the reactor trip, one train of auxiliary feedwater tripped and was restored approximately 4 min later. The core damage probability estimated for the event is 4.0×10^{-5} . The relative significance of this event compared with other potential events at Byron 2 is shown below.
