FUEL & PLANT MATERIALS TECHNOLOGY
FINAL REPORT

LABORATORY EXAMINATION OF RECIRCULATION LINE
DECONTAMINATION FLANGE FROM
MONTICELLO NUCLEAR POWER STATION
(WORK PERFORMED FOR NORTHERN STATES POWER)

January 15, 1988

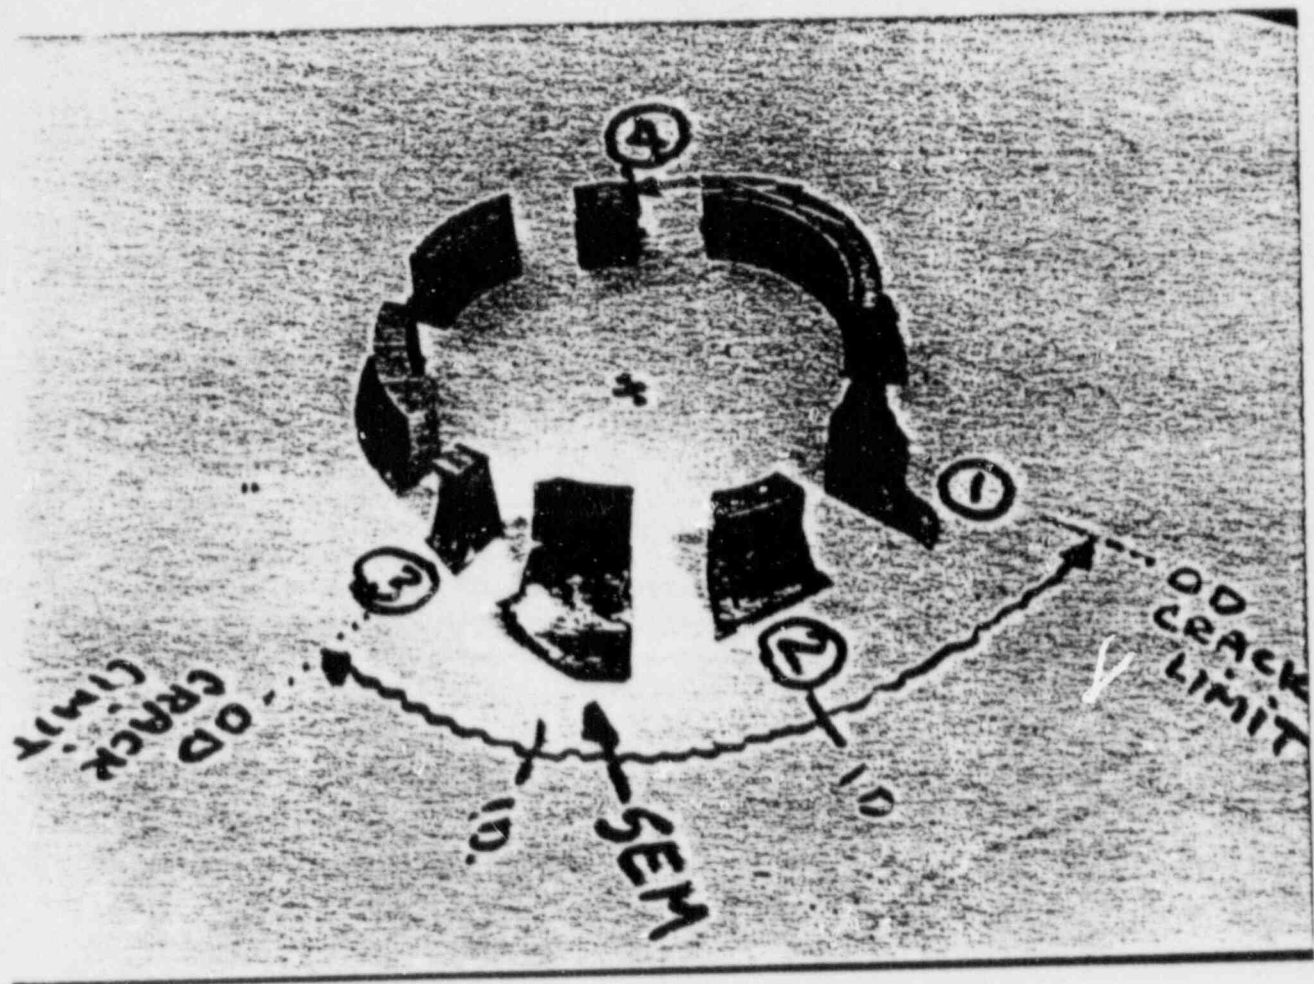
The sectioning plan is illustrated in Figure 5. Specimens 1 and 3 represent the ends of the crack and specimen 2 is representative of the through-wall portion of the crack at a location equidistant from the crack ends. A fourth specimen for optical metallography was sectioned 180° from the crack center. The SEM specimen was pried slightly open before the photograph of Figure 5 was taken. Figures 7 through 13 show the optical metallography results. The crack originated at the OD closely following the fusion line and then propagating into the base metal. The crack mechanism is clearly transgranular and the base metal microstructure is typical of annealed 316L thin walled piping. There is no evidence of grain boundary sensitization and the grain structure was revealed only after heavy etching. A "banding" effect resulting from the extrusion process prior to annealing and repeated preferential etching was visible, but the annealed structure showed no evidence of grain deformation due to cold work, nor was there any visible damage to the base material (i.e. burn through) as a result of a reported weld repair. No cracking was detected in specimen #4, 180° from the through wall crack.

Figure 5. Sectioning plan for optical and SEM metallographic evaluation.
