Subject: Reportable Occurrence 50-29/77-30/01T
Errors in Accident Analysis

(LER 77-30/1T)
LICENSEE EVENT REPORT

SUMMARY OF MEETING HELD ON JUNE 17, 1977, FOR BRIEFING ON MATTERS RELATING TO ECCS PERFORMANCE EVALUATION FOR YANKEE-ROWE

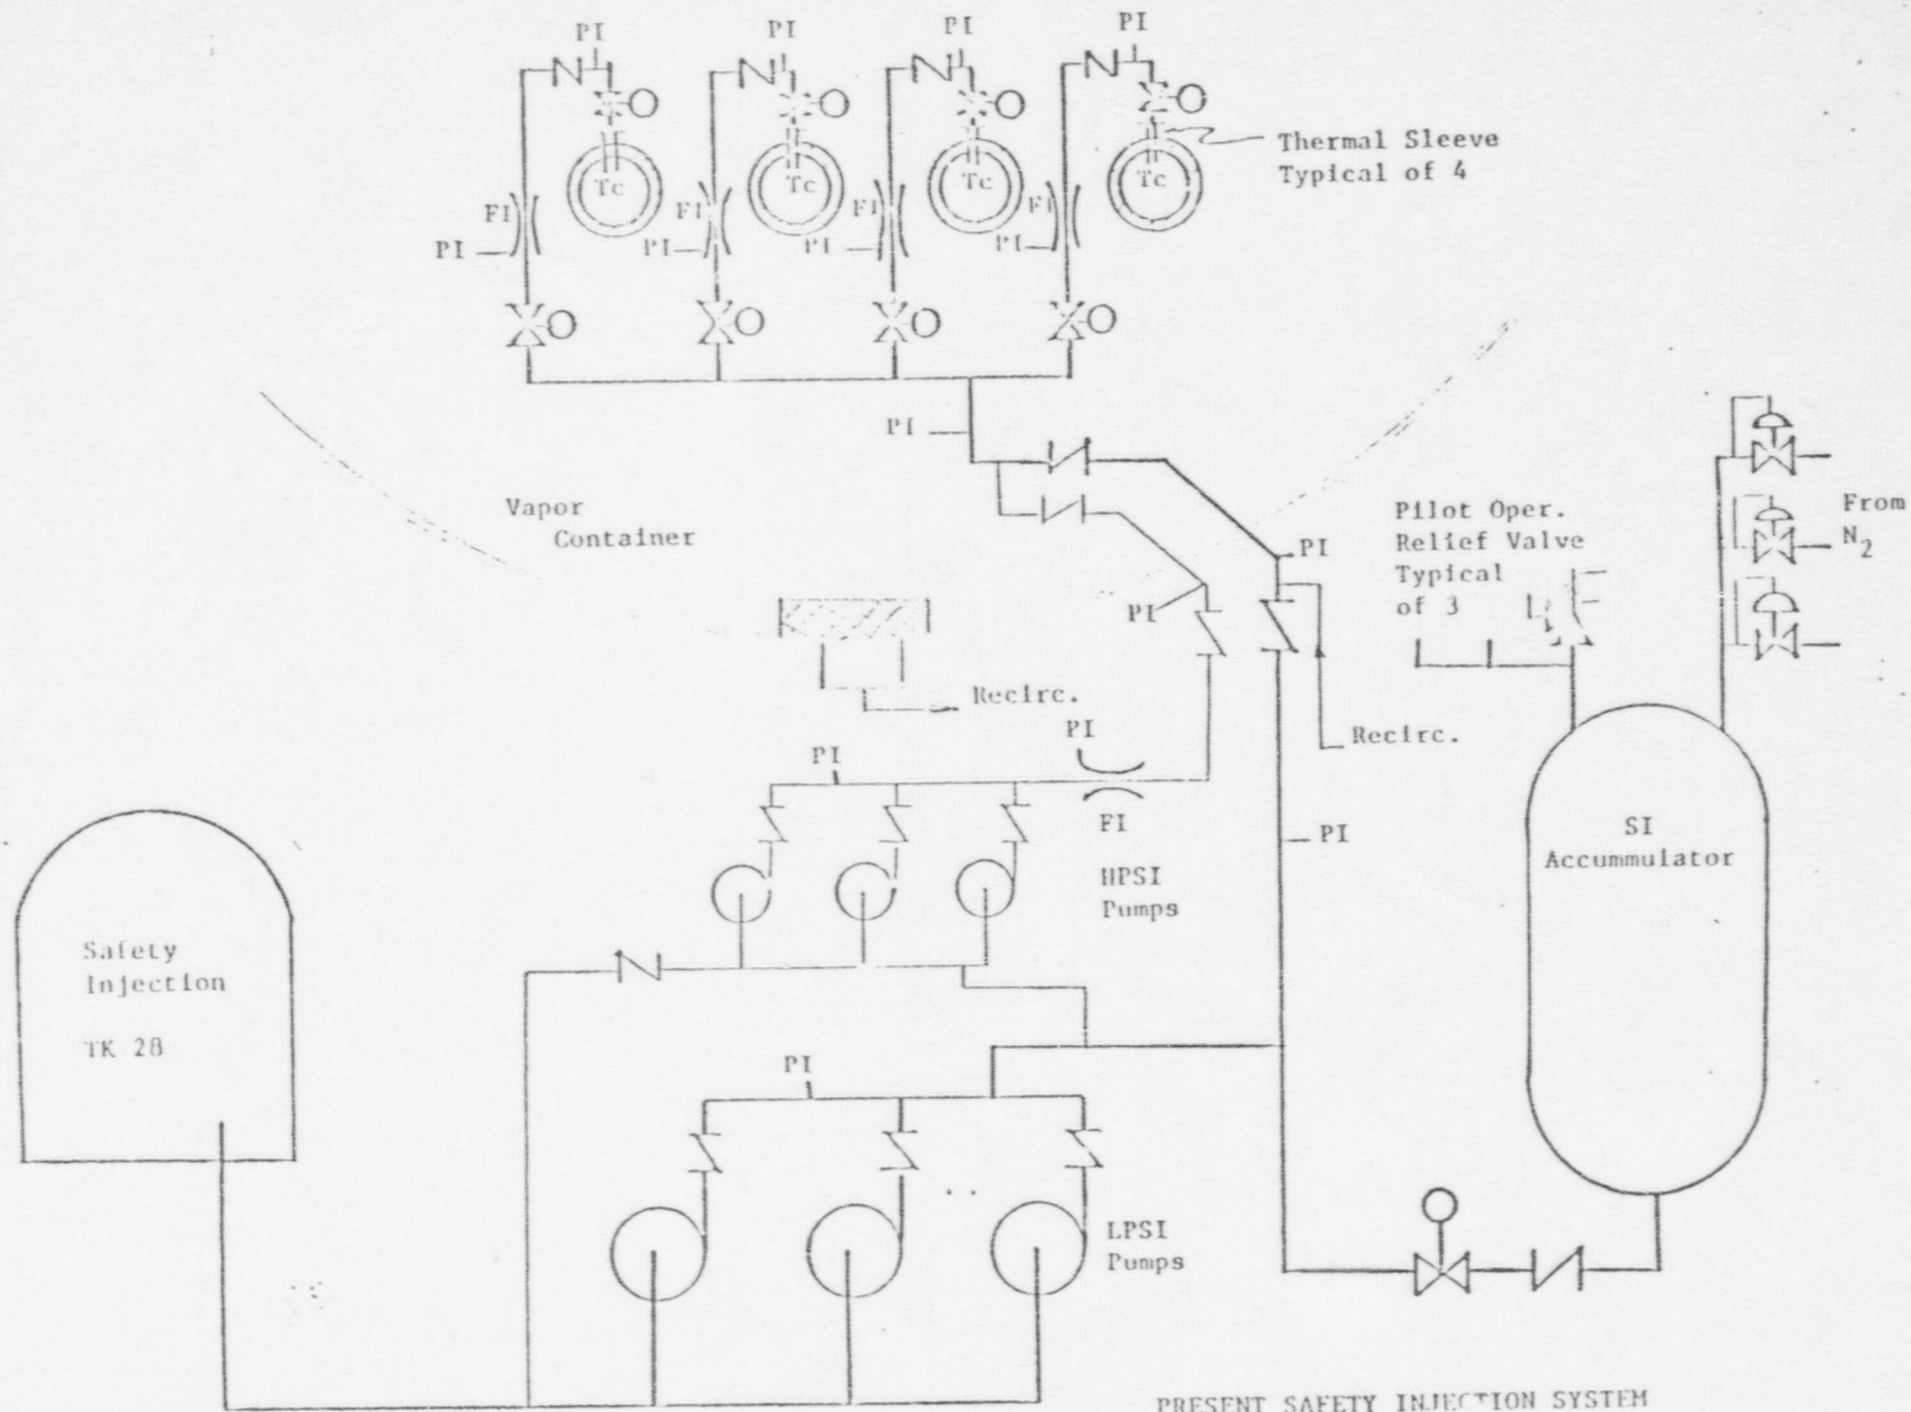
PRESENT SAFETY INJECTION SYSTEM

THE ECCS SYSTEM IN ITS PRESENT CONFIGURATION WAS ORIGINALLY DESIGNED TO PROVIDE THE CAPABILITY TO ISOLATE FLOW TO AN INDIVIDUAL RC LOOP. THIS WAS REQUIRED ONLY IN THE CASE OF A RUPTURE OF THE SI BRANCH LINE DOWNSTREAM OF THE CHECK VALVE.

THE CORE XII ECCS ANALYSIS DID NOT ASSUME ISOLATION OF FLOW TO THE BREAK. BASED ON THE ASSUMPTION THAT ISOLATION WAS NOT ESSENTIAL, YANKEE PROPOSED TO PROTECT AGAINST OPERATOR ERROR AND SPURIOUS FAILURE BY REMOVING POWER FROM THE BRANCH LINE MOTOR OPERATED VALVES.

YANKEE PROPOSES TO RESTORE POWER TO CS-MOV-536, 537, 538, 539 AND SI-MOV-22, 23, 24, 25 WHICH WILL PROVIDE REDUNDANT CAPABILITY TO ISOLATE THE BROKEN BRANCH LINE, FROM THE CONTROL ROOM. RESTORATION OF POWER WILL PROVIDE PROTECTION AGAINST

IN ADDITION YANKEE PROPOSES TO PROVIDE IMPROVED RELIABILITY OF THIS ISOLATION CAPABILITY BY EITHER OF THE FOLLOWING:

1. RELOCATE THE DOWNSTREAM VALVES OUTSIDE THE LOOP, I.E. REMOTE FROM LOCA IMPACT, OR
2. INSTALL NEW REPLACEMENT VALVES OUTSIDE THE LOOP.
