Safety Evaluation Report

related to the restart of
Rancho Seco Nuclear Generating Station, Unit 1,
following the event of December 26, 1985

Docket No. 50-312

Sacramento Municipal Utility District

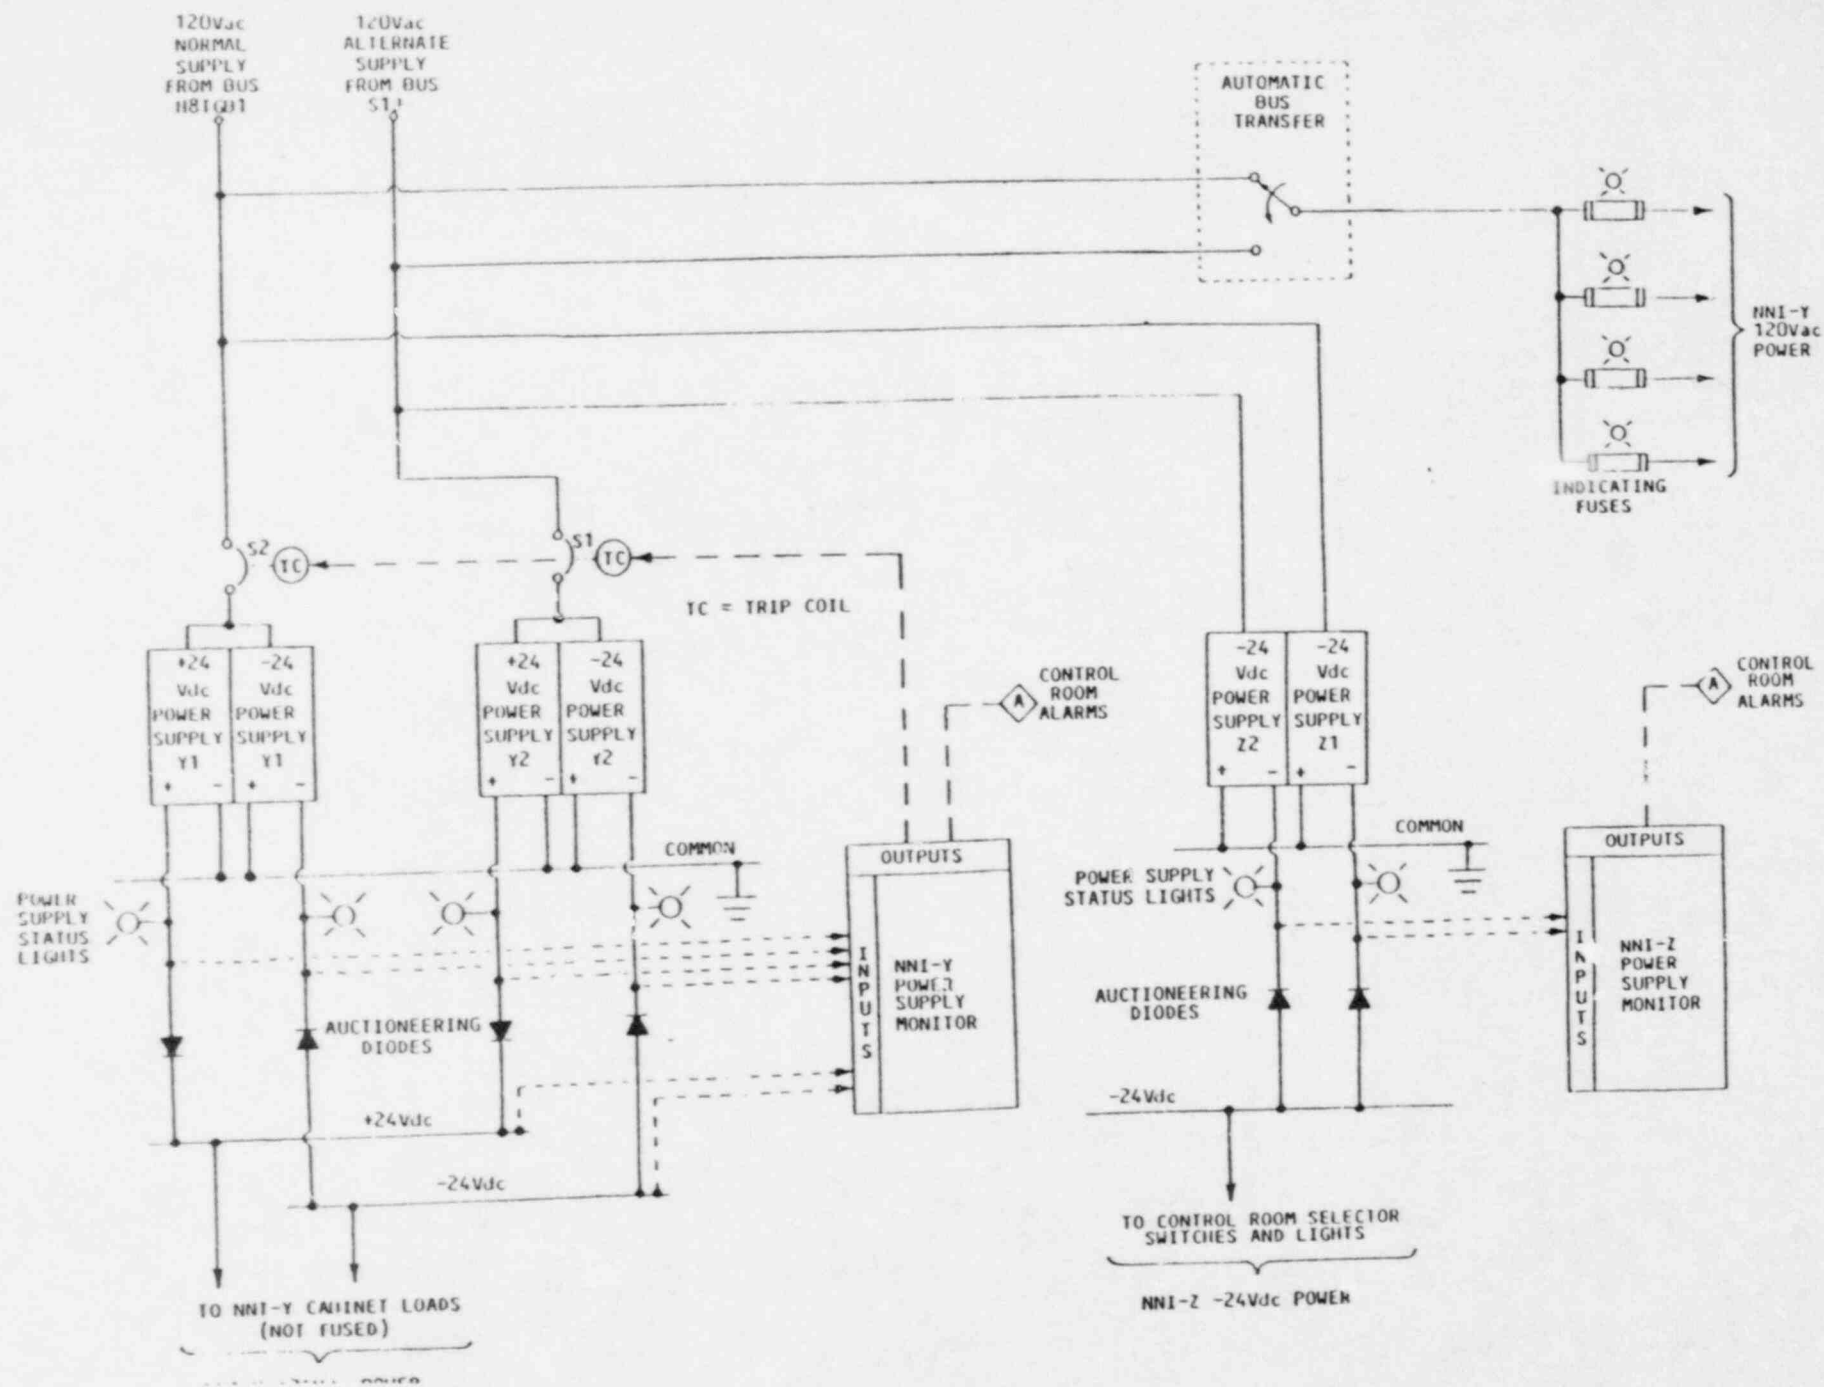
Figure 3.19 NNI-Y and NNI-Z dc power distribution

The dc power system design includes overvoltage and undervoltage protection features to preclude system operation when the ± 24 -V dc supply voltage is outside of the specified $\pm 10\%$ band. Different methods are used for overvoltage and undervoltage protection, but in both cases, final protection is provided by a power supply monitor (PSM) module which is designed to transform a degraded voltage condition on either the positive or negative 24-V dc bus (a condition where the ICS/NNI system modules are subject to malfunctioning) into a complete loss of voltage condition for both the positive and negative 24-V dc buses (an easily detected condition where the module and plant response is more predictable, and from which better defined corrective actions can be initiated). If voltage on either the positive or negative 24-V dc bus is lost (e.g., because of multiple power supply failures or because of fault conditions within the dc power distribution system), but the other bus continues to supply its loads, operation of many system modules will become unbalanced, leading to potentially abnormal/erratic control system behavior and false control room indications (meters and recorders).

Overvoltage protection is provided within the ± 24 -V dc power supplies themselves. Each supply contains circuitry that automatically short-circuits its output terminals (causing an excessive overcurrent condition) whenever an overvoltage condition in excess of a predetermined setpoint value is detected. This circuit is referred to as a "crowbar" circuit. Overcurrent protection circuits internal to the power supply will turn the supply off upon sensing the excessive current caused by the crowbar circuit. The loss of voltage, or more accurately, an undervoltage condition of less than the setpoint value of 22.0-V dc, is then detected by the PSM, similar to an actual undervoltage condition. The PSM module is basically a set of undervoltage detection circuits and associated output relays mounted on a single, printed, circuit board. Upon sensing undervoltage, the PSM is designed to interrupt the ac power feeds to both pairs of ± 24 -V dc supplies (after a time delay of approximately 0.5 second) by automatically opening shunt trip switches S1 and S2.

The licensee's investigation to determine the root cause for the loss of ICS dc power revealed that power was interrupted because of the automatic opening (tripping) of S1 and S2 by the PSM upon sensing an undervoltage condition associated with the +24-V dc bus. The root causes for the undervoltage condition have been attributed primarily to a bad wiring connection within the ICS dc power distribution system (the poor connection introduced a series resistance, and hence a voltage drop across the resistance, causing the PSM to sense a voltage less than the actual bus voltage), and secondarily to unstable operation of the PSM itself. The effects of the bad wiring connection and unstable PSM operation are discussed in Section 3.1.2.8, "Power Monitor Design," of this report.

The ICS and NNI-X ± 24 -V dc power supplies have been replaced with new, larger capacity supplies. The new supplies provide additional margin between the actual power supply load and the load capacity limit. A review of the NNI-Y and NNI-Z power supplies showed that sufficient margin existed, and that replacement was not necessary. Both the new and existing ± 24 -V dc power supplies are manufactured by the NJE Corporation. The power supply overcurrent and overvoltage protection setpoints (120% of rated current and 28.8 V dc, respectively) have been selected so that the power supplies are less susceptible to spurious trips, while still maintaining adequate protection.

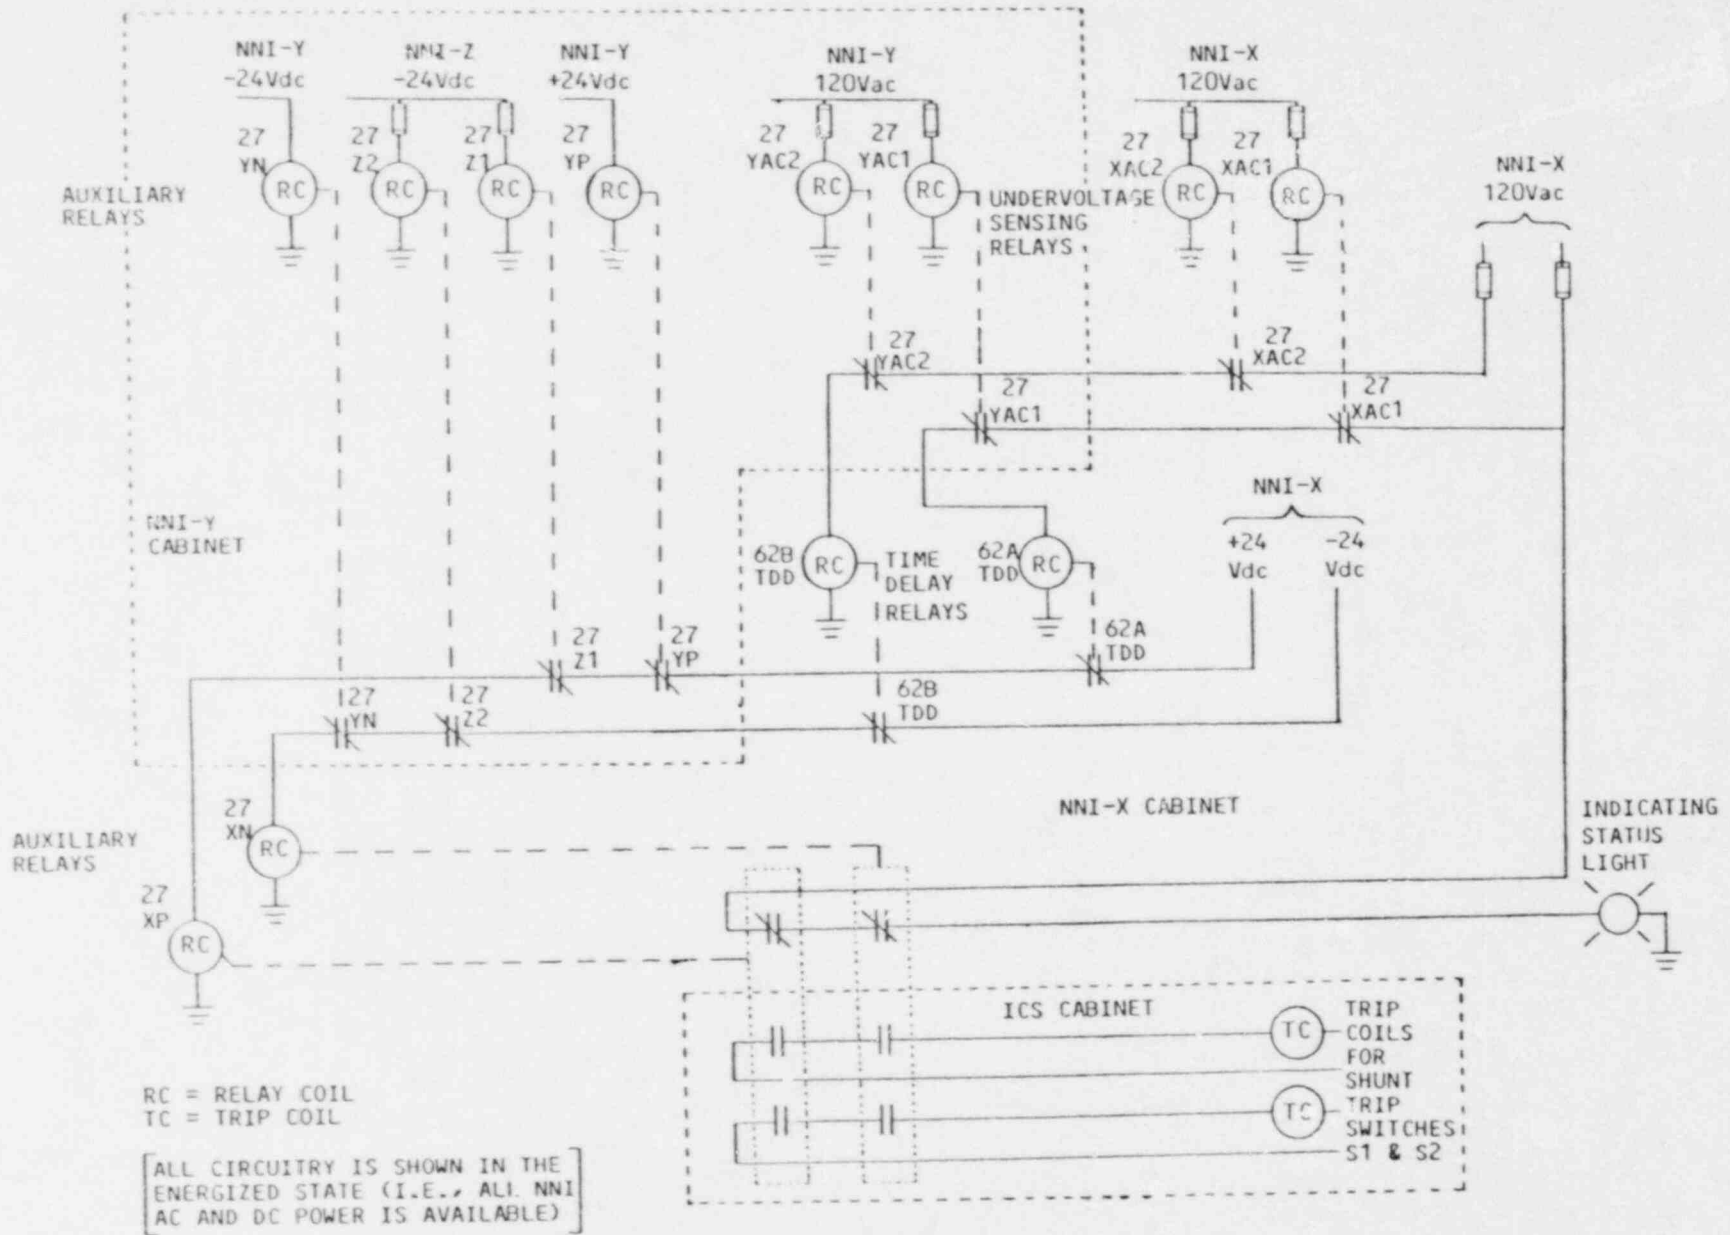
Figure 3.20 Automatic trip of ICS dc power on loss of NNI system ac or dc power

supplies are lost within the ICS/NNI ac or dc distribution systems, a forced loss of ICS dc power condition results. The circuitry added to trip the ICS dc power supplies consists primarily of undervoltage relays used to sense the loss of NNI-X and NNI-Y 120-V ac power, and auxiliary relays used to sense the loss of NNI-X, NNI-Y, and NNI-Z ± 24 -V dc power. The relay contacts are then used to energize the existing trip coils for shunt trip switches S1 and S2 in the ac supply lines to the ICS ± 24 -V dc supplies. The same trip coils are actuated separately by the ICS PSM. NNI system 120-V ac power is sensed downstream of the automatic bus transfer (ABT) devices. Time delay on dropout (TDD) relays are provided to delay trip of the ICS dc power supplies for 1 second following loss of NNI system 120-V ac power to allow time for the automatic transfer to occur (the transfer should occur within 0.5 second). The added circuitry is shown in Figure 3.20. Both S1 and S2 must open to cause a complete loss of ICS dc power. The trip logic is arranged in a 2-out-of-2 configuration to minimize the probability of spurious losses of ICS dc power from a single failure. A status light has been mounted on the front of the NNI-X cabinet to indicate a half-trip condition such as could be caused by failures within the added circuitry. The light is on only when all relays are in the untripped/energized state (i.e., when all NNI system ac and dc power is available). Periodic observation of the indicating light will permit early detection of a half-trip condition.

The basis for tripping ICS dc power upon losses of NNI system power is that the ICS controls main feedwater flow, main steam header pressure (turbine pressure regulation), and reactor control rod movement (to make changes in reactor power level and maintain a constant reactor coolant average temperature, Tavg) based on more than 20 input signals it receives from the NNI system. Losses of NNI system ac or dc power can result in degraded/erroneous signal information being provided to the ICS, in turn causing undesirable ICS control actions for the actual plant conditions. The licensee has made modifications to ensure that the response of ICS-controlled equipment to a loss of ICS dc power are well defined and will not result in severe plant upsets. Therefore, instead of a number of potentially different transient scenarios with varying consequences (i.e., the effects of a loss of NNI-X ac power would differ from the effects of a loss of NNI-Y dc power, etc.), the effects will always be those associated with a loss of ICS dc power where the plant has been modified to ensure that a known safe condition is reached, and where the operators can respond to all ICS/NNI system power failures using a single procedure on which they have been trained. In general, a known safe state is ensured by causing an automatic trip of the main feedwater pumps upon loss of ICS dc power. This results in a reactor trip on high reactor coolant system pressure, and subsequent automatic initiation and control of auxiliary feedwater flow by the safety-related emergency feedwater initiation and control (EFIC) system to ensure adequate heat removal. In addition, the turbine bypass valves are designed to fail closed, as are the atmospheric dump valves (which have been removed from the ICS and are now controlled by the EFIC system) to prevent subsequent excessive steam flow from the steam generators and potential overcooling conditions. The EFIC system is discussed in detail in Section 3.1.3 of this report.

During initial plant startup, a one-time integrated loss of ICS/NNI system power test will be performed to verify: (1) that main feedwater pumps trip on loss of ICS dc power and (2) that the ICS ± 24 -V dc supplies will trip on loss of NNI system power as designed. Following this initial startup test, the

circuits will be functionally tested every refueling outage as part of the ICS and NNI system functional test programs. ICS/NNI system surveillance testing is discussed in Section 3.1.2.9 of this report, "ICS/NNI System Maintenance, Surveillance, and Testing."

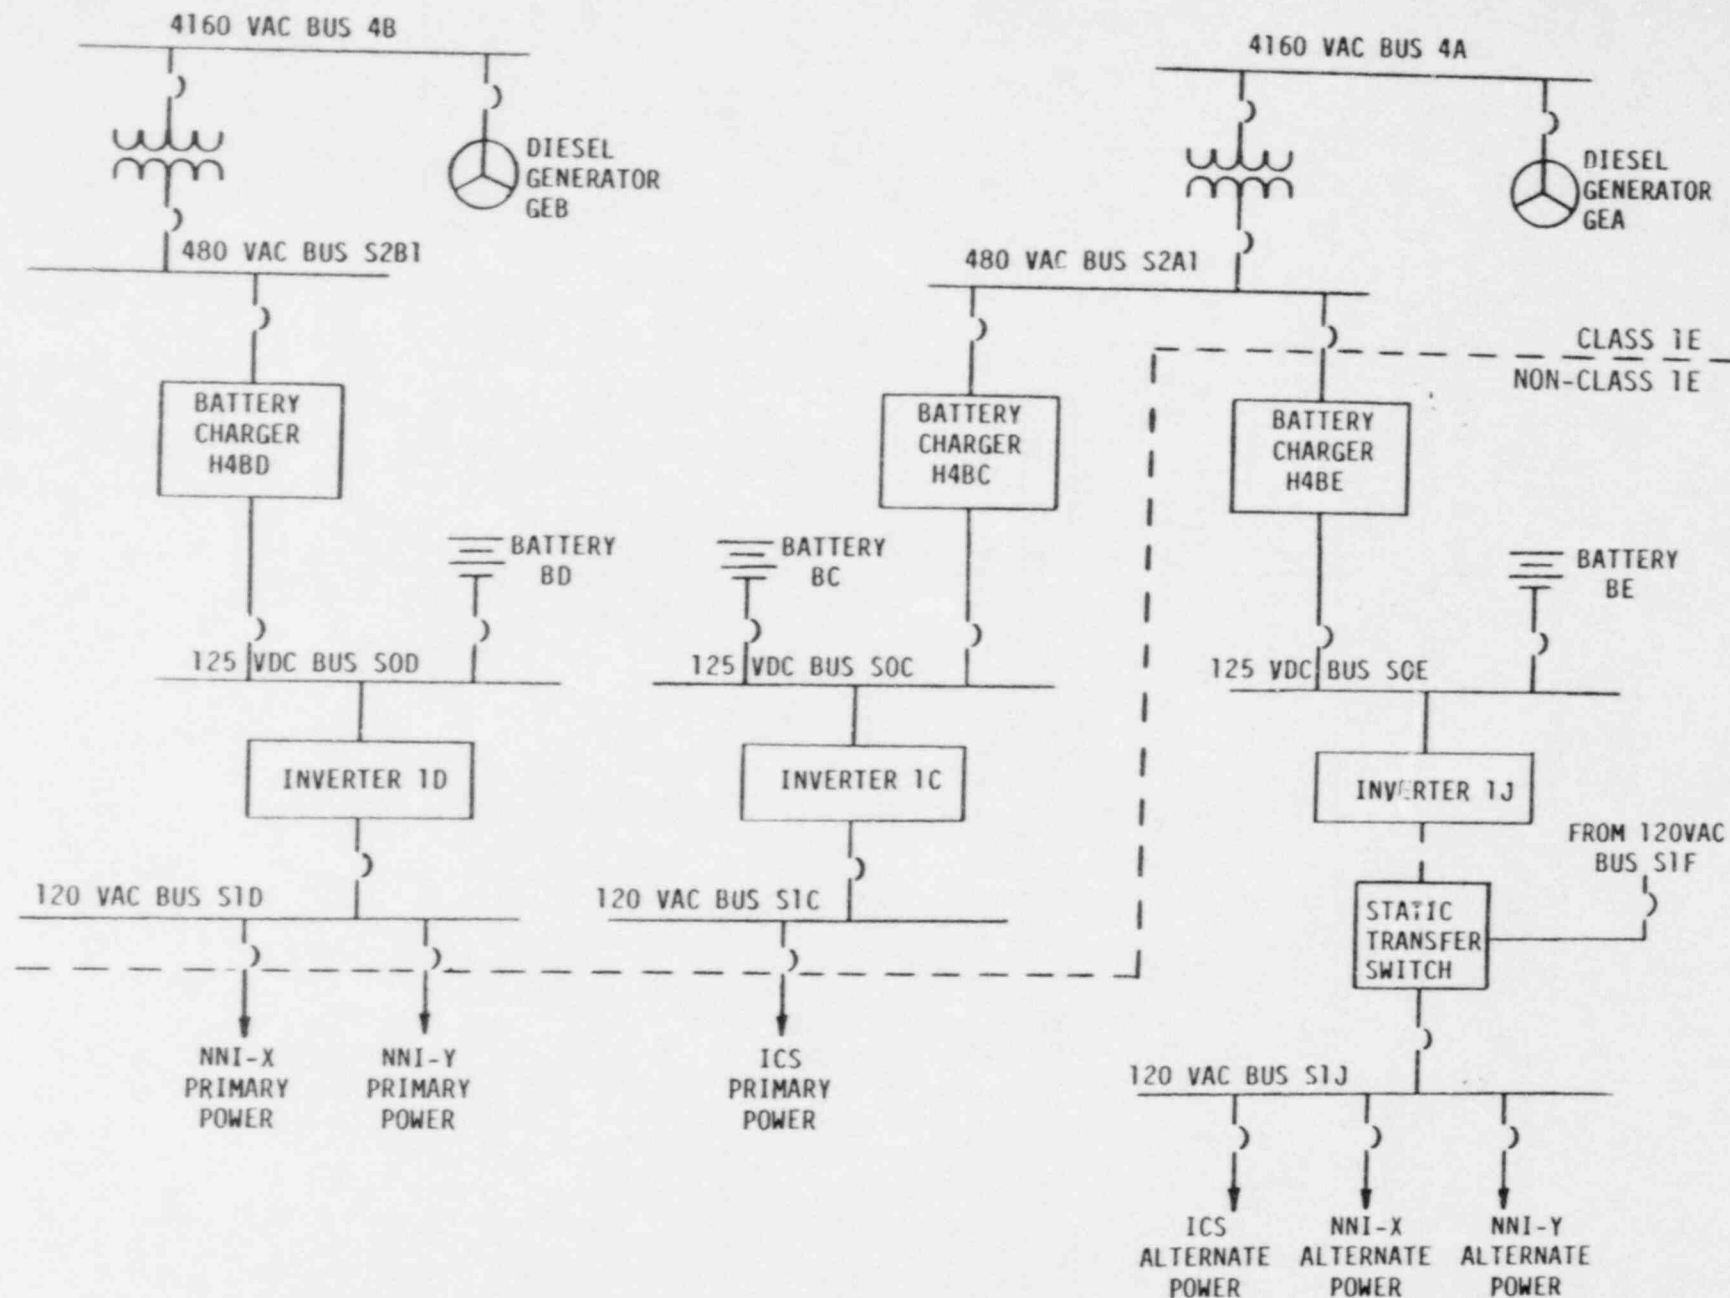
Figure 3.21 A simplified diagram of ac power distribution to the ICS and NNI system at Rancho Seco before the December 26, 1985 event

Distribution of ac power to the ICS and NNI system at the time of the December 26, 1985 event is illustrated in Figure 3.21. As discussed in SER Section 3.1.1.2, the Rancho Seco ICS/NNI system designs include provisions for two redundant ac input power feeds; a primary (normal) supply and a secondary (backup) supply. At the time of the event, the primary source of ac power for the ICS was one of the plant's four safety-related Class 1E 120-V ac vital instrumentation buses (bus S1C). The primary source for the NNI system was also one of the vital instrument buses (bus S1D). Vital instrument buses S1C and S1D are powered by Class 1E battery-backed inverters that convert dc power to highly regulated ac power suitable for instrumentation applications. During normal plant operations, the inverters are energized by their associated battery chargers. The battery chargers were, in turn, powered from 480-V ac sources that could be energized by the associated divisional emergency diesel generators (EDGs) upon a loss of offsite power. Power was provided to ICS bus S1C by the Division A EDG (GEA) via battery charger H4BC and inverter 1C, and power was provided to NNI system bus S1D by the Division B EDG (GEB) via battery charger H4BD and inverter 1D. During momentary interruptions of power from the battery charger, such as between losing offsite power and obtaining power from the EDG, the inverter would continue to operate by drawing power from the battery. The circuit breakers between the vital instrument buses and the ICS/NNI system served as the isolation devices between the safety-related portion and the non-safety-related portion of the design.

At the time of the December 26, 1985 event, the backup (alternate) power feeds for the ICS and for both NNI system sets of instrumentation (i.e., NNI-X and NNI-Y) were provided from one non-safety-related plant instrument bus (bus S1J). Bus S1J was also powered from a battery-backed inverter. Although bus S1J is a non-safety-related bus, the battery charger associated with the inverter could be powered from the Division A EDG upon loss of offsite power. It should be noted that a transfer switch was provided to allow the use of a standby source of ac power (non-Class 1E, non-battery-backed instrument bus S1F) to bus S1J when the normal battery-backed inverter was not available. At the time of the December 26, 1985 event, the power to the backup ICS/NNI system bus (S1J) originated from bus S1F.

The primary sources of incoming ac power to the ICS and NNI system remained available throughout the December 26, 1985 event. This was determined by the observation that the automatic bus transfer (ABT) devices within the ICS and NNI system did not transfer to the backup power sources. The behavior of plant equipment also confirmed that ac power was not lost. Therefore, ac power to the ICS/NNI system was not a factor in the event.
