Vicinity Property Completion Report

Vicinity Property No. **DUR 003**

DU-003

12TH STREET - 13TH STREET

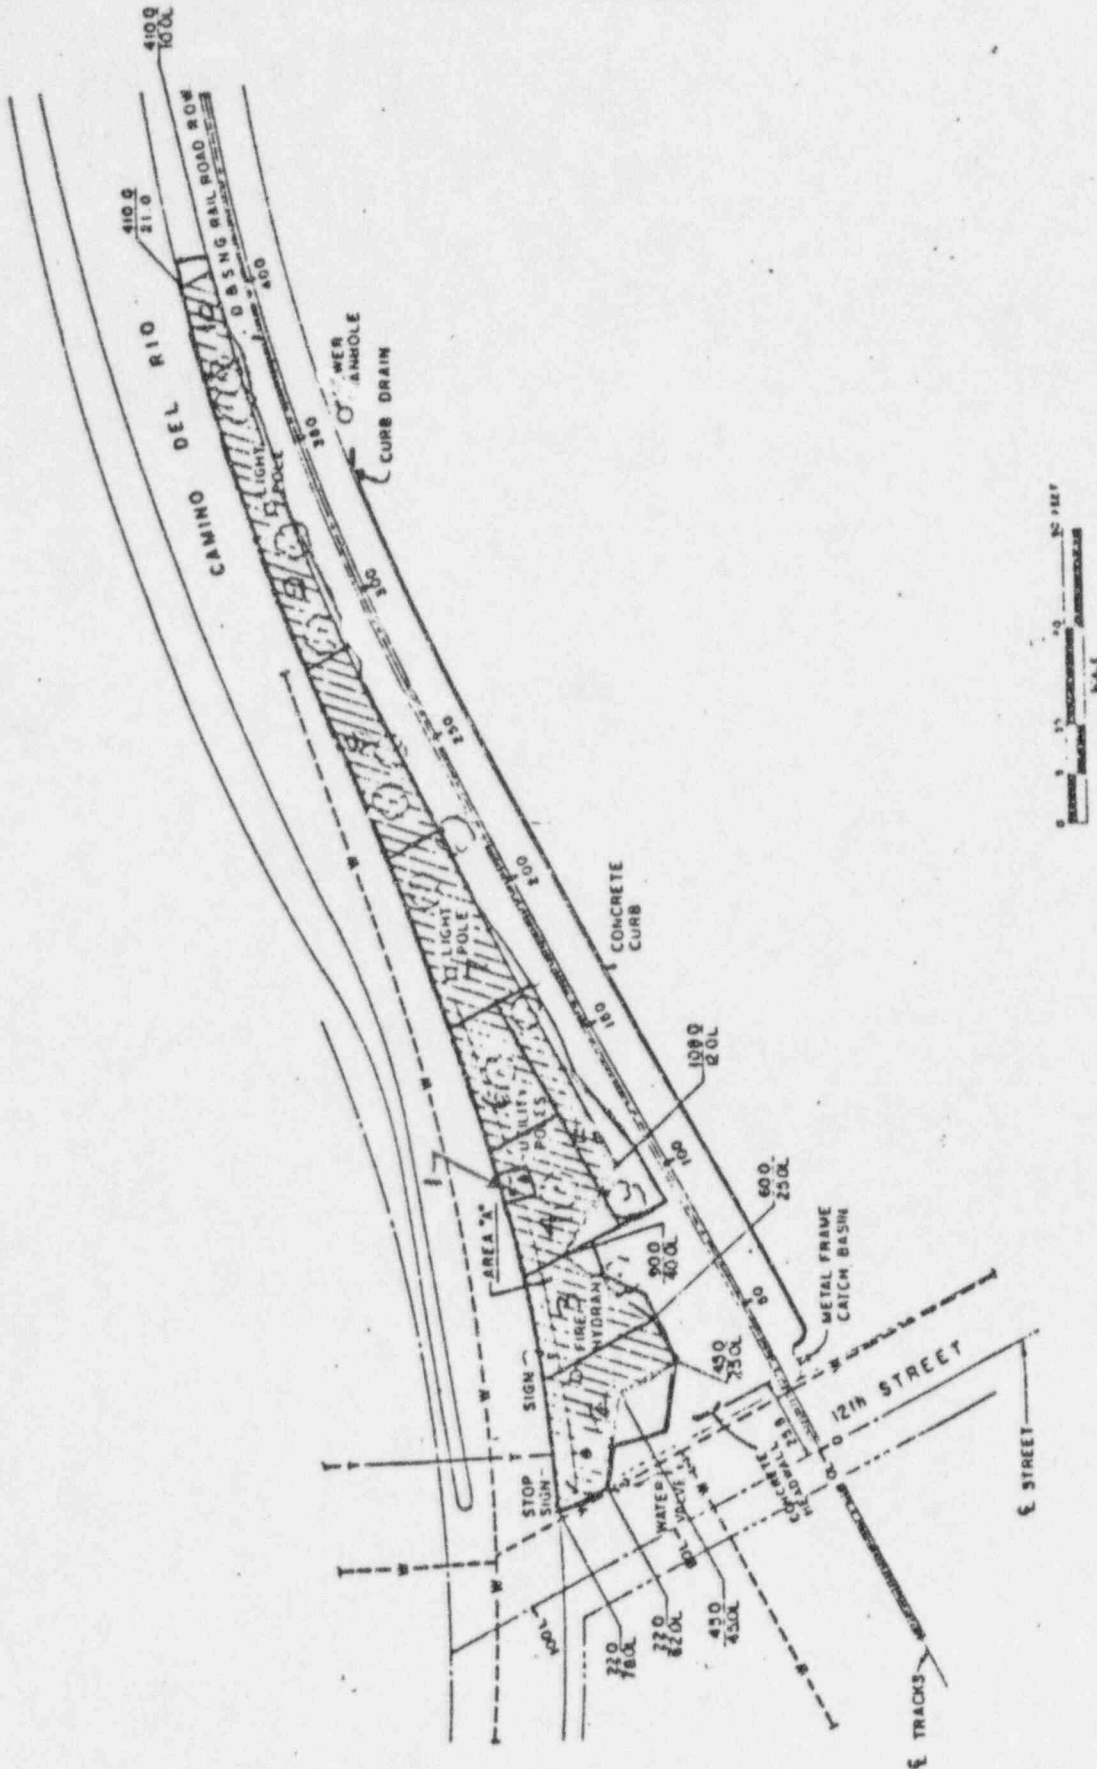
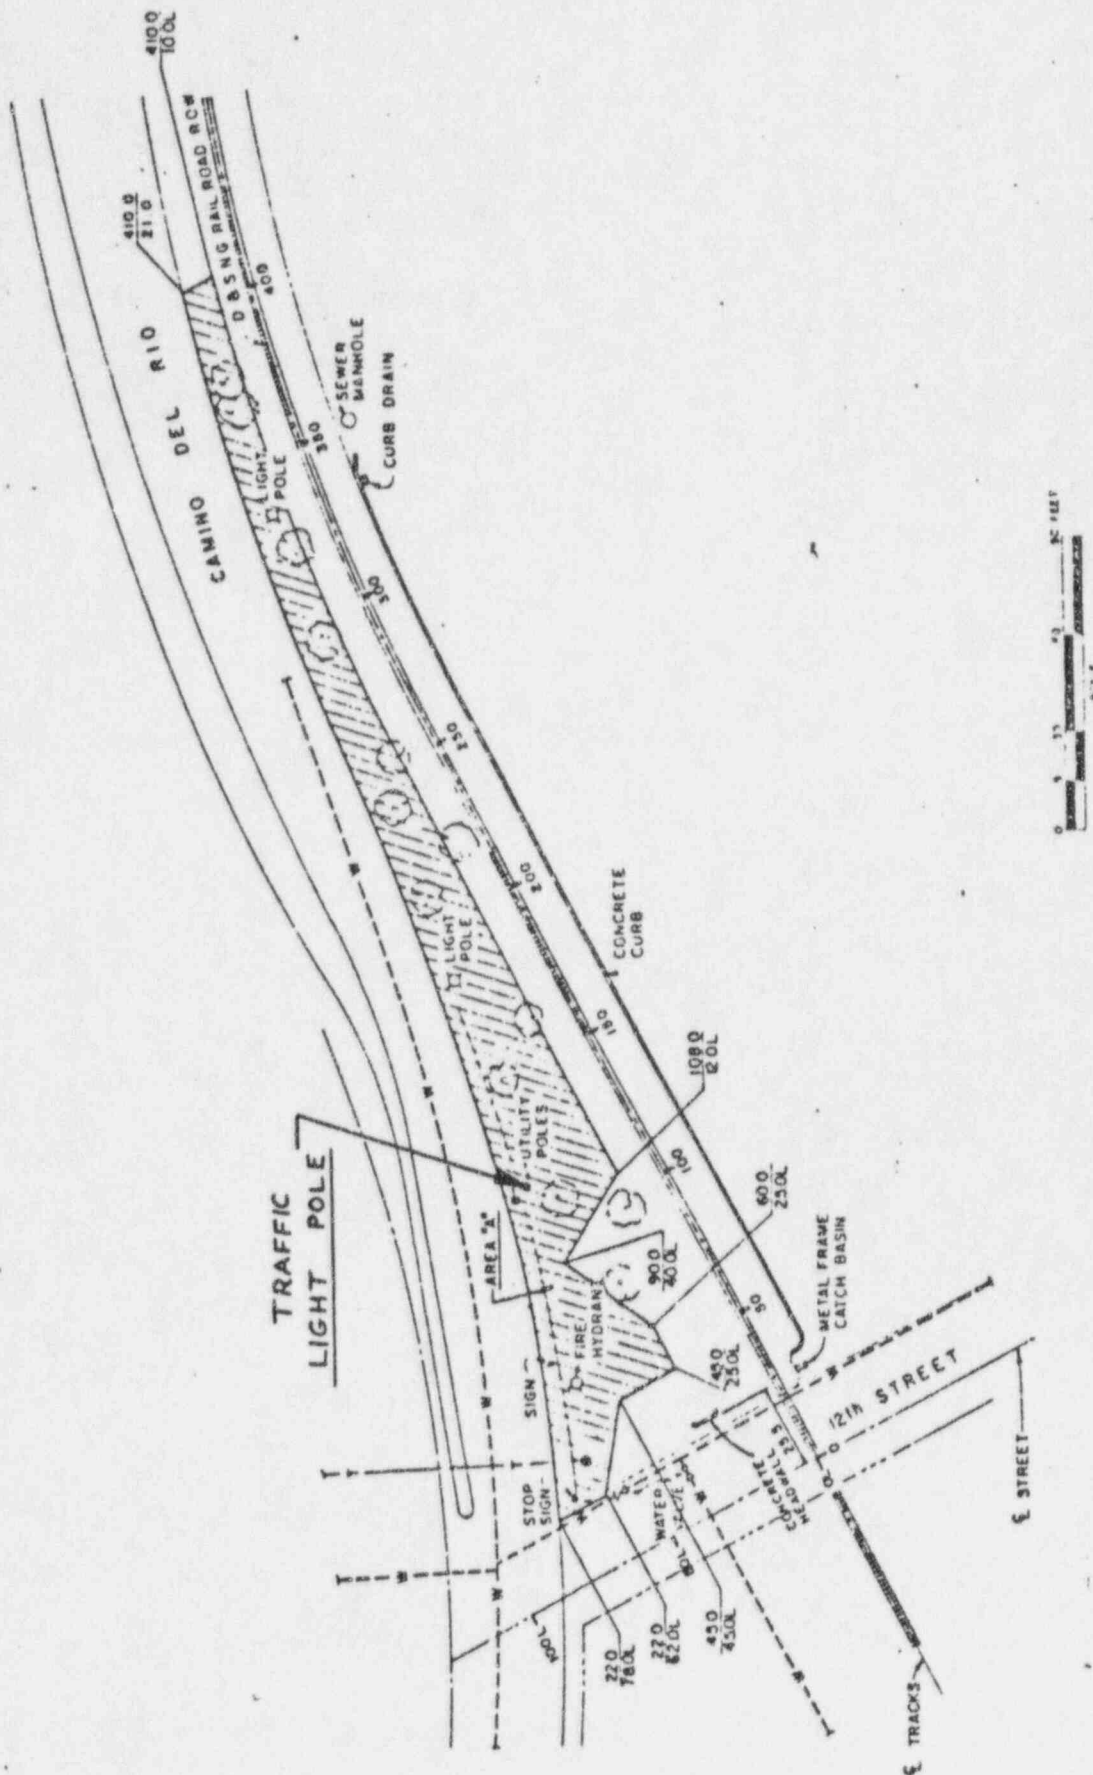
VERIFICATION LAYOUT

G... ID	Coordinates	Sample #	Approx. Depth	Ra-226 (pCi/g) Concentration		Comments
				Initial	- Final	
1	1+08,47L; 1+13,45.5L 1+13,42.5L; 1+08,44L	D-SV-3780	5'2"	1.2	1.1	
2	0+23,78L; 0+60,63L 0+60,24L; 0+46,24L 0+28,38L; 0+31,55L 0+22,62L; 0+20,69L	D-SV-3783	2'6"	3.2	4.1	
3	0+60,63L; 0+60,24L 0+67,24L; 0+80,32L 0+90,30L; 0+90,52L	D-SV-3784	3'3"	3.2	3.9	
4	0+90,52L; 0+90,19L 1+30,19L; 1+30,41.5L 1+13,45.5L; 1+13,42.5L 1+08,44L; 1+08,47L	D-SV-3803	4'7"	2.5	2.9	
5	0+90,19L; 0+90,4L 1+10,04L; 1+20,06L 1+30,7.5L; 1+40,09L 1+50,08L; 1+70,08L 1+70,19L	D-SV-3804	1'3"	1.7	2.4	
6	1+70,19L; 1+70,34L 1+30,41.5L; 1+30,19L	D-SV-3805	2'5"	1.8	3.3	
7	1+70,08L; 1+80,09L 1+90,10L; 2+00,11L 2+25,12L; 2+25,26.5L 2+00,27L; 1+70,34L	D-SV-3806	1'10"	1.6	2.2	
8	2+25,26.5L; 2+25,12L 2+30,13L; 2+60,13L 2+70,12L; 2+80,08L 2+87,8.5L; 2+87,20L 2+50,23.5L	D-SV-3813	1'4"	2.6	3.6	
9	2+87,8.5L; 2+90,8.5L 3+00,08L; 3+10,8L 3+20,09L; 3+40,10L 3+40,08L; 3+70,08L 3+80,07L; 3+80,19L 3+50,19L; 3+00,20L 2+87,20L	D-SV-3814	1'6"	2.4	4.0

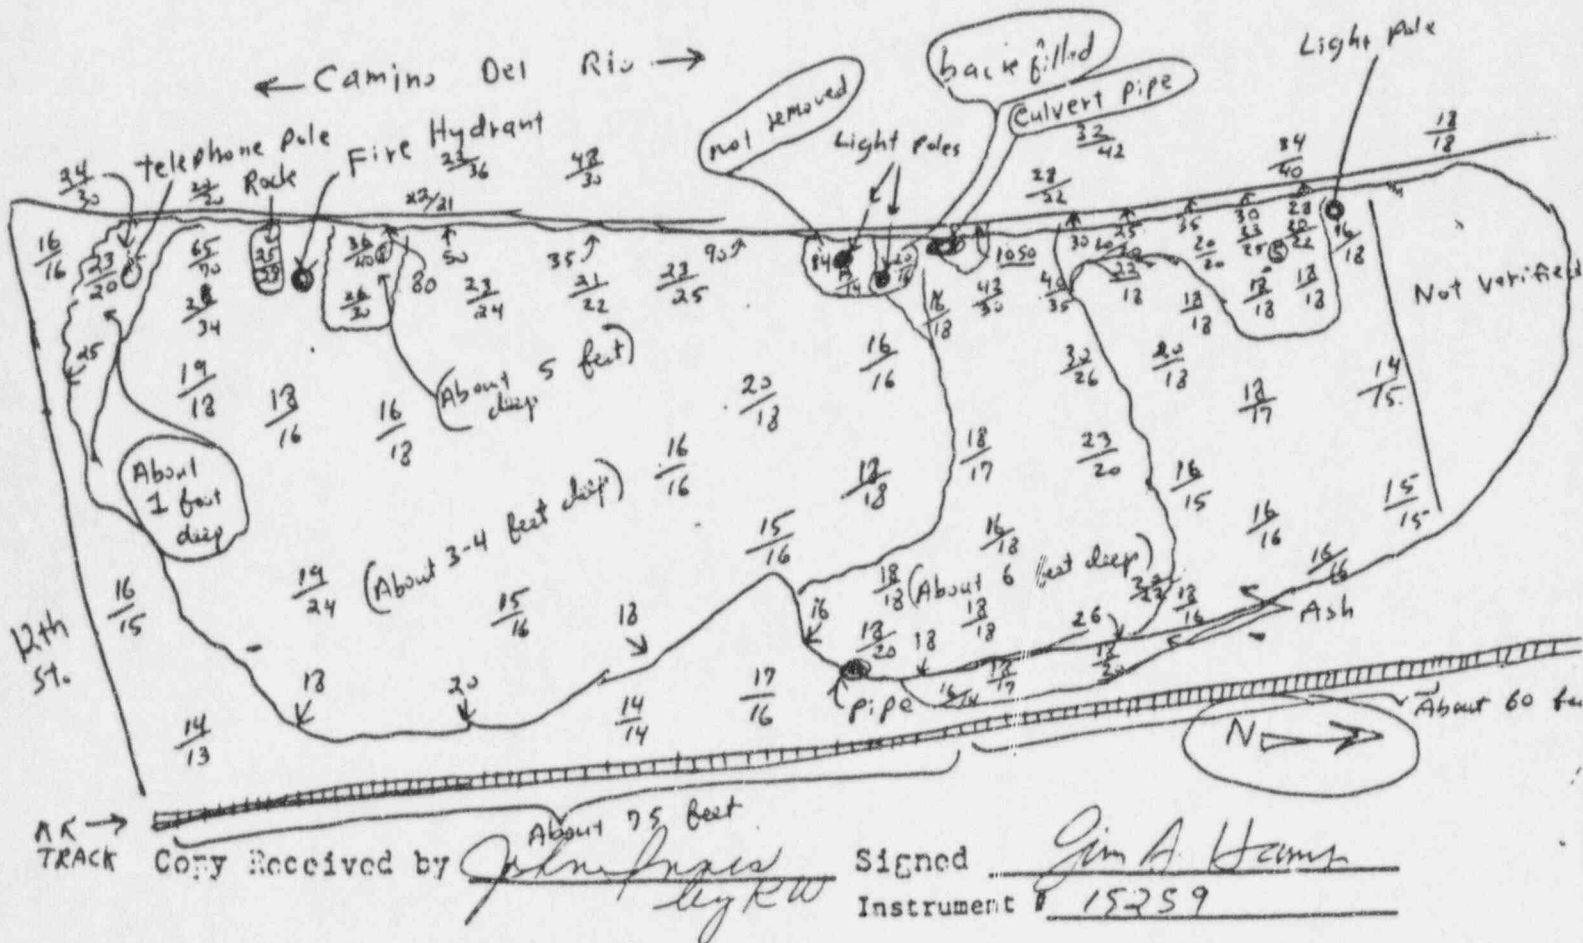
COLORADO DEPARTMENT OF HEALTH
ULTRAP
FIELD INSPECTION

- ☒ 1. All detectable contamination removed.
- ☐ 2. Most of the detectable contamination removed with the exception of: (see sketch)
- ☒ 3. All contamination defined in the REA has been removed.
- ☐ 4. Most of the contamination defined in the REA has been removed with the following exceptions:
