Vicinity Property Completion Report

VICINITY PROPERTY COMPLETION REPORT

DU-144A S
TRUCK BY-PASS (CAMINO DEL RIO)
DURANGO, COLORADO

May 16, 1991

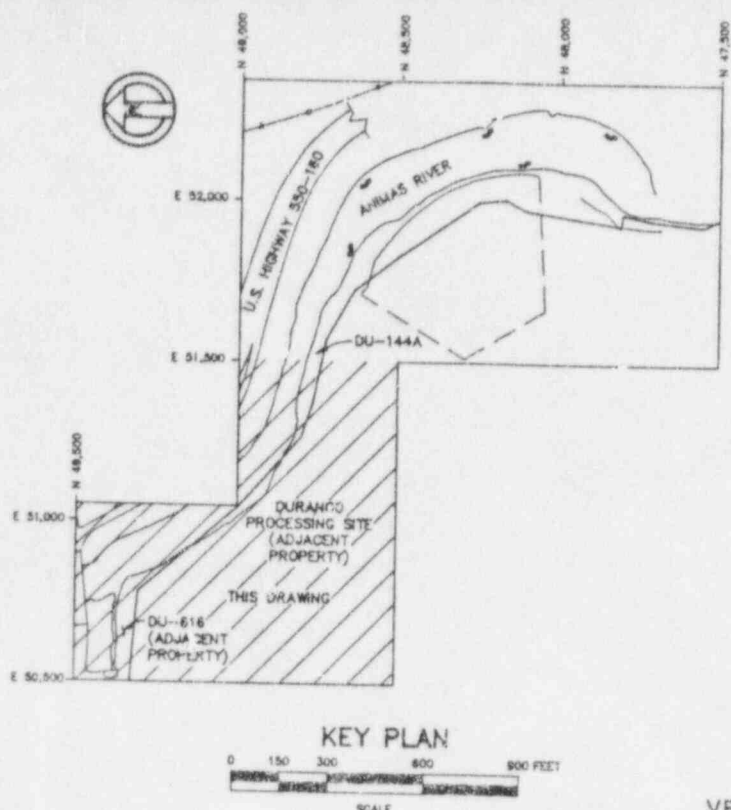
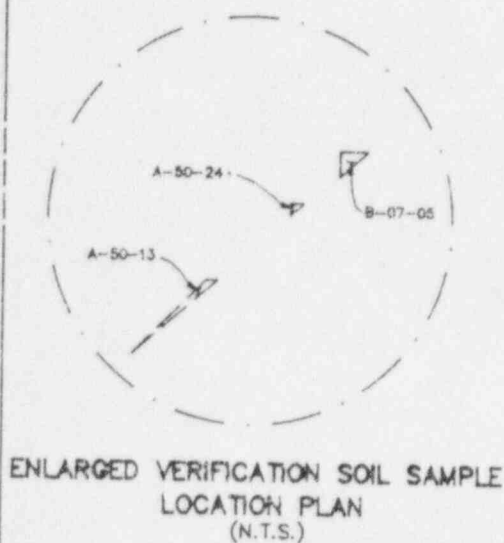
- SEE DRAWINGS DU-144A-017 AND DU-144A-018 FOR VERIFICATION SOIL SAMPLES (PERTAINING TO OTHER PORTIONS OF THIS PROPERTY) NOT SHOWN THIS DRAWING.
- SUPPLEMENTAL STANDARDS IN ACCORDANCE WITH 40 CFR SECTION 192.22 (C) SHALL APPLY TO LOW LEVEL RADIOACTIVELY CONTAMINATED MATERIAL. APPROXIMATELY 517 CUBIC YARDS REMAIN IN PLACE.
- ALL VERIFICATION SOIL SAMPLES CONTAIN THE PREFIX DUR-SV.
