PRECURSOR DESCRIPTION AND DATA

NSIC Accession Number: 135079

Title: All Safety Injection Pumps Inoperable During Heatup at Robinson 2

NSIC 135079 — Sequence of Interest for Inoperable Safety Injection Pumps at Robinson 2

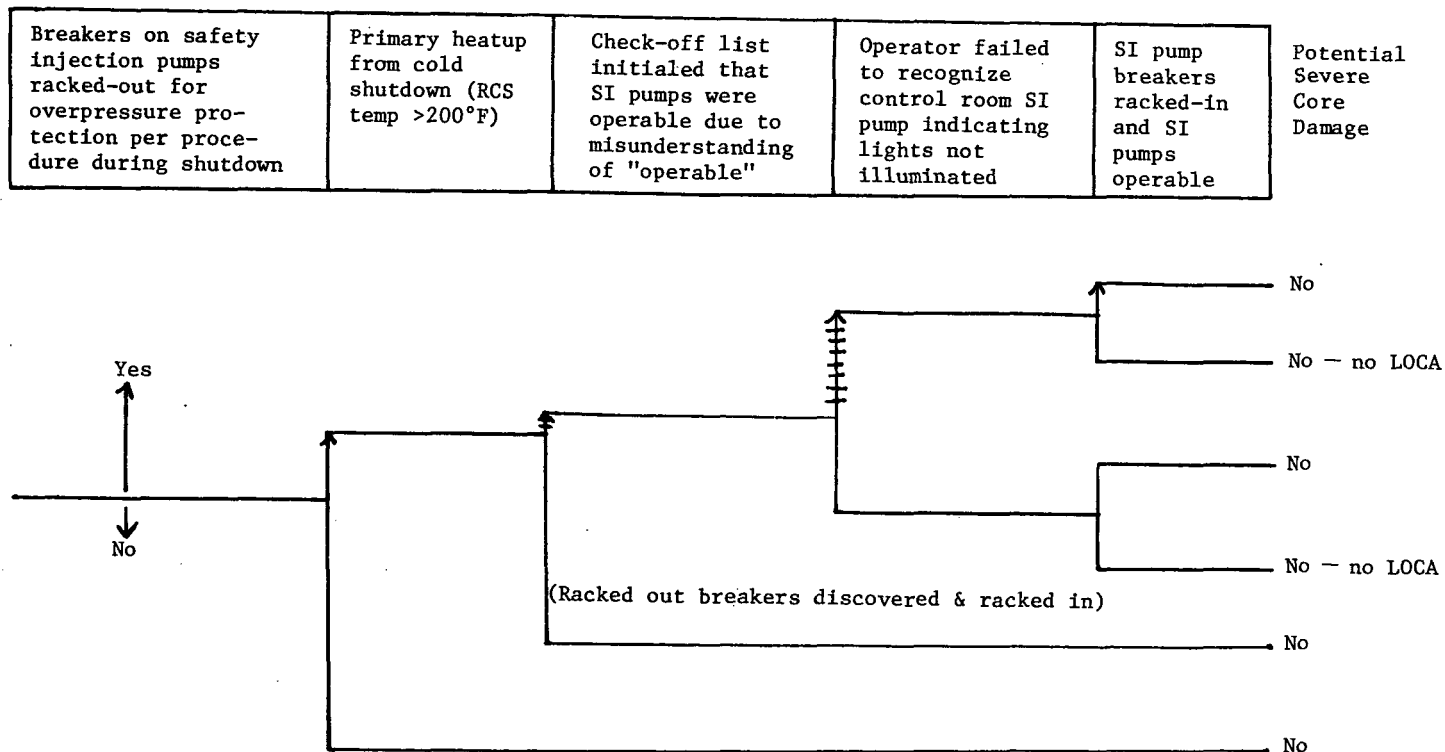
1. While the reactor was shut down, the SI pumps were tested and determined to be **operable**. The pump breakers were then racked out as required for over-pressure protection during cold shutdown.
2. During heatup (~4 hrs later) the pump breakers were not racked in, as required before going above 200°F due to a misunderstanding of the procedures.
3. This fact was discovered while completing a minimum equipment list and the breakers were racked in (five hours after they were required to be racked in).

CAUSE: Breakers incorrectly racked out, human error

1. The breakers were racked in.
2. Operating procedures were revised as necessary to require the pumps to be in service before exceeding 200°F.
