# Loss of an Iridium-192 Source and Therapy Misadministration at Indiana Regional Cancer Center Indiana, Pennsylvania, on November 16, 1992

**U.S. Nuclear Regulatory Commission**

Manuscript Completed: February 1993  
Date Published: February 1993

On December 1, 1992, the Indiana Regional Cancer Center reported to the U.S. Nuclear Regulatory Commission's (NRC) Region I that they believed a  $1.37 \text{ E}+11$  becquerel (3.7-curie) iridium-192 source from their Omnitron 2000 high dose rate remote brachytherapy afterloader had been found at a biohazard waste transfer station in Carnegie, Pennsylvania. After notifying the NRC, this cancer center, one of several operated by the licensee, Oncology Services Corporation, retrieved the source, and Region I dispatched an inspector and a supervisor to investigate the event. The source was first detected when it triggered radiation alarms at a waste incinerator facility in Warren, Ohio. The licensee informed the NRC that the source wire had apparently broken during treatment of a patient on November 16, 1992, leaving the source in the patient. On the basis of the seriousness of the incident, the NRC elevated its response to an Incident In

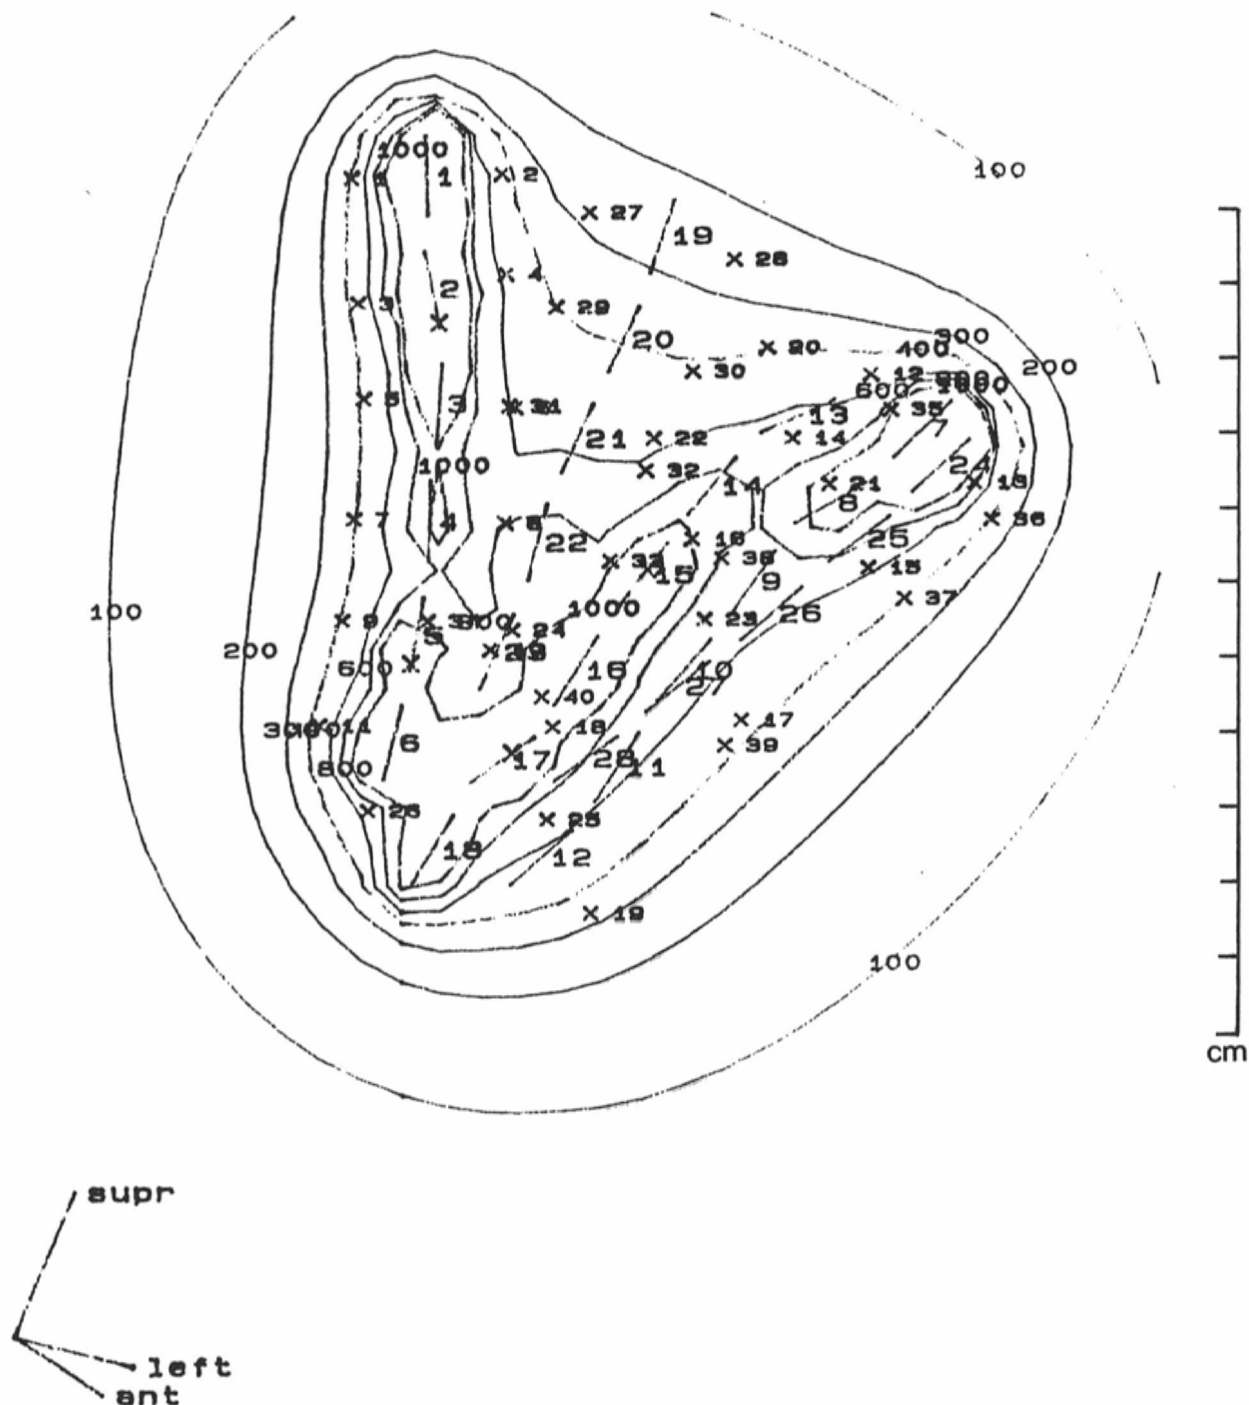
Figure 2.1 Isodose Graph for Initial High Dose Rate Patient Treatment Plan

On November 16, 1992, before the patient was treated, Medical Physicist A generated an Omnitron HDR dosimetry drawing with 40 dosimetric points (Figure 2.1). The calculated source strength upon initiating the treatment was  $1.56 \text{ E}+11 \text{ Bq}$  (4.219 Ci). The dwell time calculations for the five implanted catheters were generated by computer (Figure 2.2). On November 16, 1992, at 9:35 a.m., the implanted catheters were connected to the HDR afterloader connecting catheters\* and patient treatment was initiated. Difficulties were encountered during the source wire insertion into implanted Catheter 5, and Physician A directed termination of treatment without treating the patient through implanted Catheter 5. The patient was disconnected from the HDR afterloader (Figures 2.3 and 2.4). After the patient was removed from the treatment room, one loose catheter was removed, and the other four catheters were left in the patient for subsequent treatments.

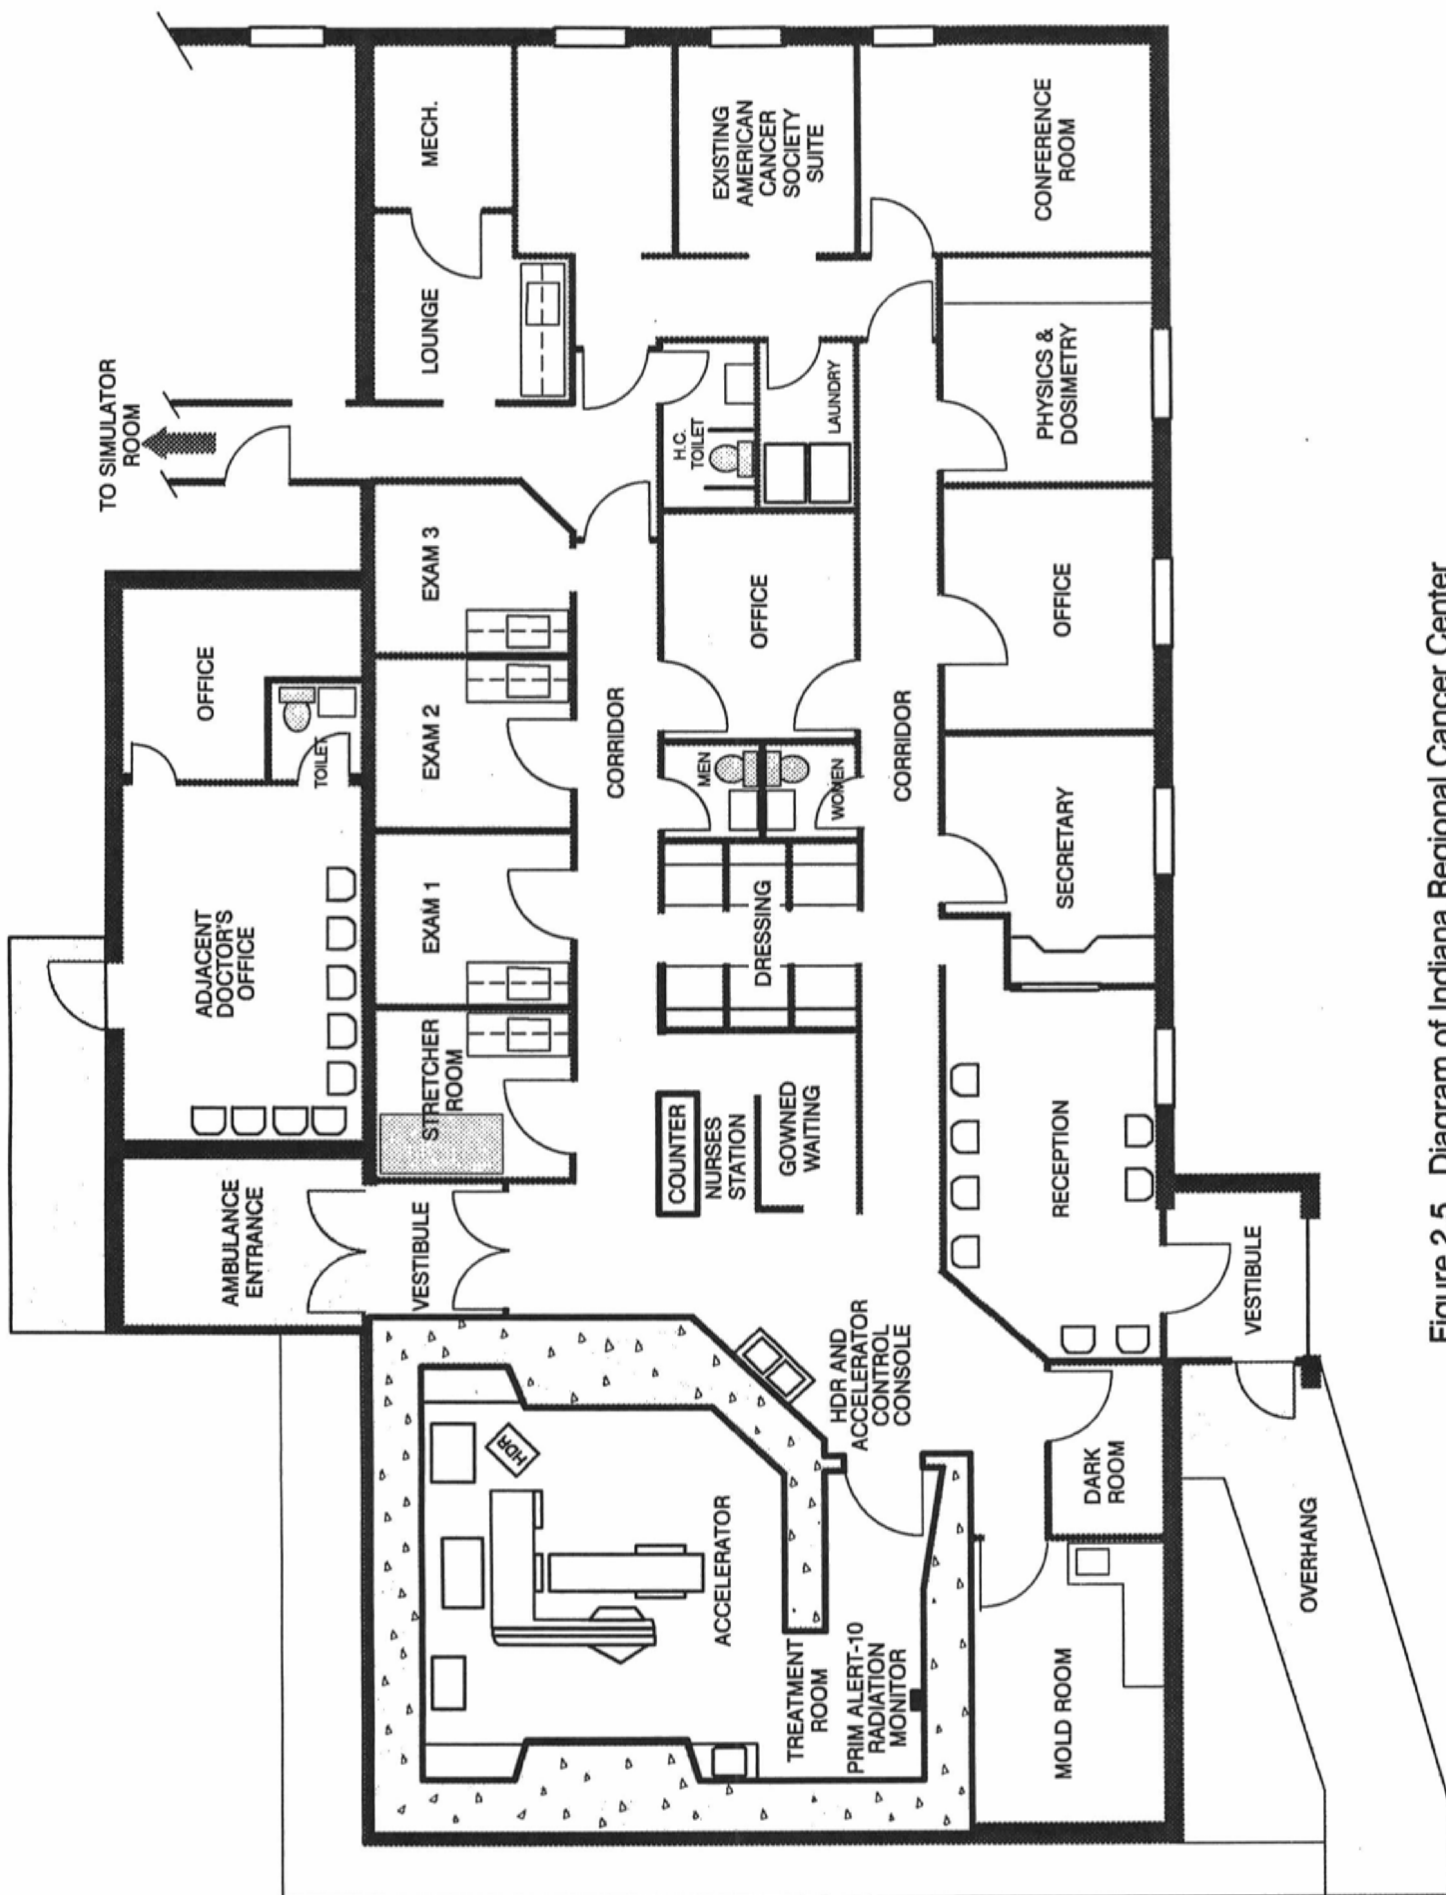
Figure 2.5 Diagram of Indiana Regional Cancer Center

7:12 a.m.	The patient departed the nursing home in a local Citizens Ambulance Service ambulance to be transported to the IRCC.
7:30 a.m.	The patient arrived at the IRCC (Figure 2.5).

- 10:20 a.m. RTT-A disconnected the patient's implanted catheters from the HDR afterloader. RTT-A removed the patient from the HDR treatment room, and the patient was taken to the stretcher room (see Figure 2.5).

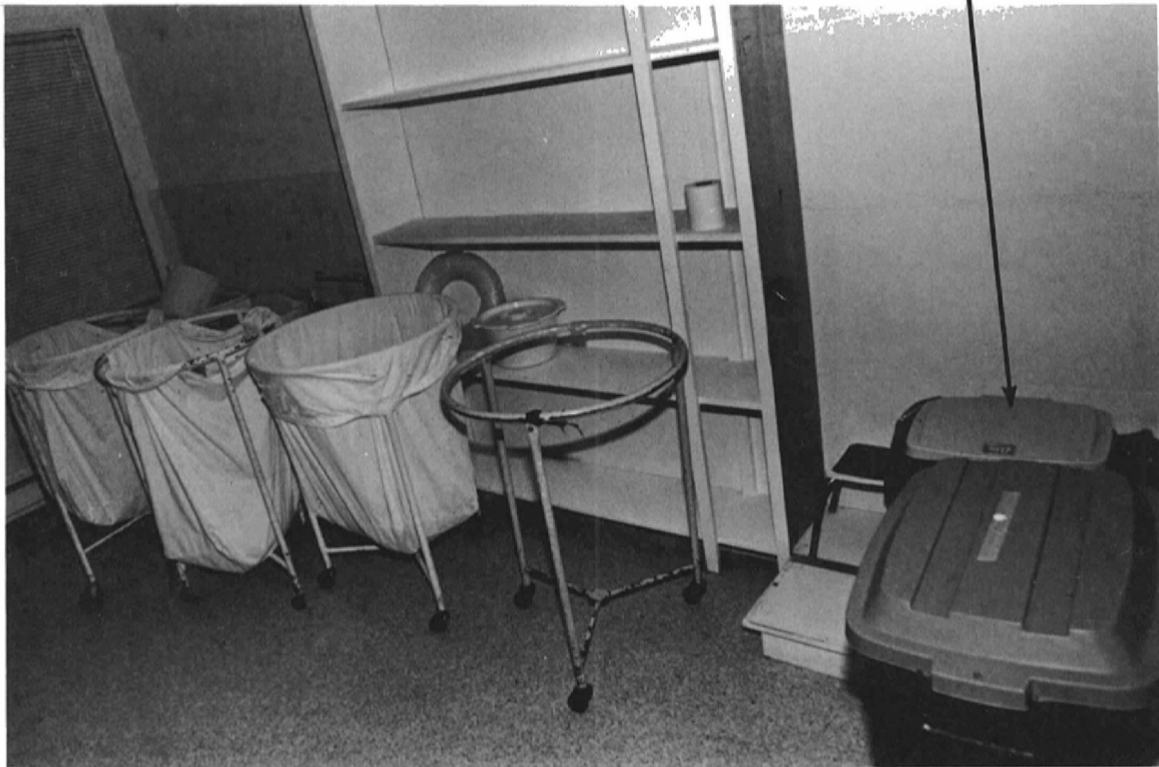
Figure 2.7 Soiled Utility Room with Biohazard Waste Container

LPN-B picked up the catheter containing the source, placed it in a red bag, which the nursing home uses for medical and biohazardous waste (typically referred to as "red-bag" waste), and transferred this small, red bag to a larger container for medical waste in the soiled utility room where red-bag waste is stored daily (Figure 2.7). LPN-B was unaware the catheter contained the iridium-192 source.

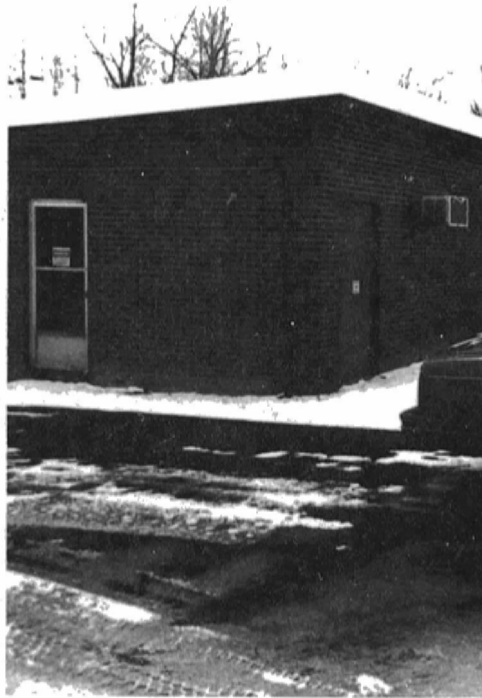
Figure 2.8 Waste Storage Room at Scenery Hill Manor Nursing Home

After discussing the situation with the IRCC, RN-D instructed Maintenance Man A to remove the large red bag of waste from the soiled utility room, which he normally does at 7:30 a.m., and transfer it to the outside waste storage room (see Figure 2.8).

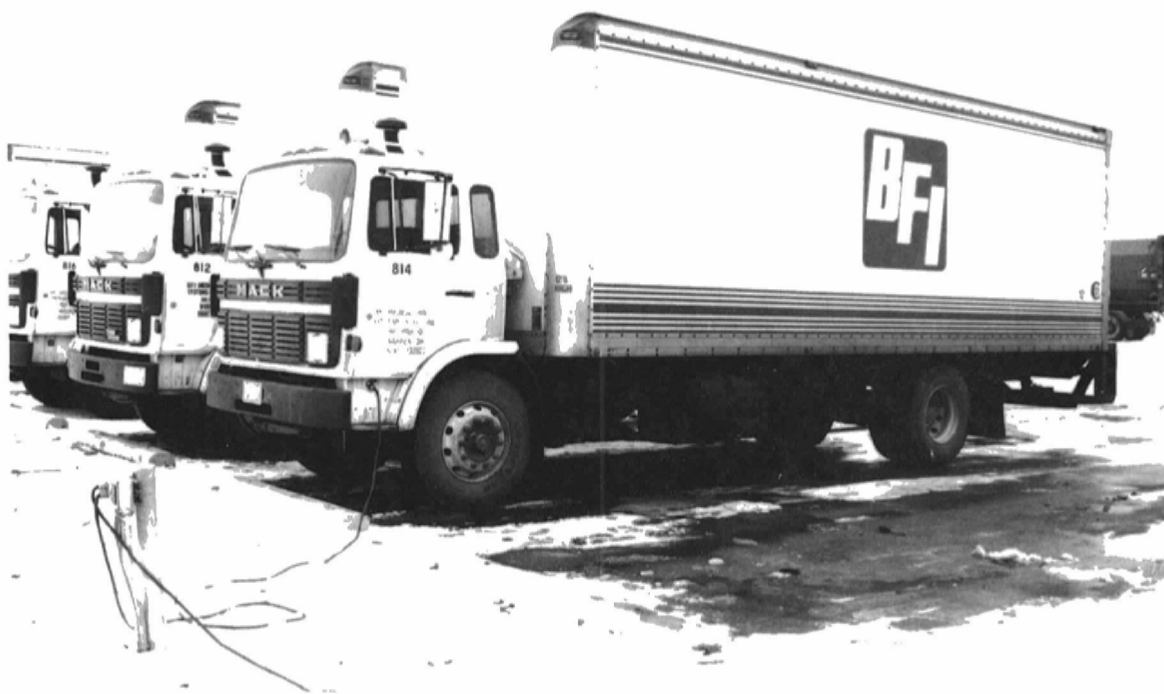
**Figure 2.9** Browning – Ferris Industries Straight Truck Used to Collect Waste from Scenery Hill Manor Nursing Home

9:25 a.m. BFI Driver A arrived at his 12th stop, SHM Nursing home; picked up three boxes of red-bag waste from this facility; and placed it in a straight truck (Figure 2.9). Although BFI Driver A had a portable survey meter in the truck, he stated that he did not use it at the SHM nursing home. He continued with his regularly scheduled stops throughout the day, stopping at an additional 10 facilities before returning to BFI-Carnegie (Figure 2.10).

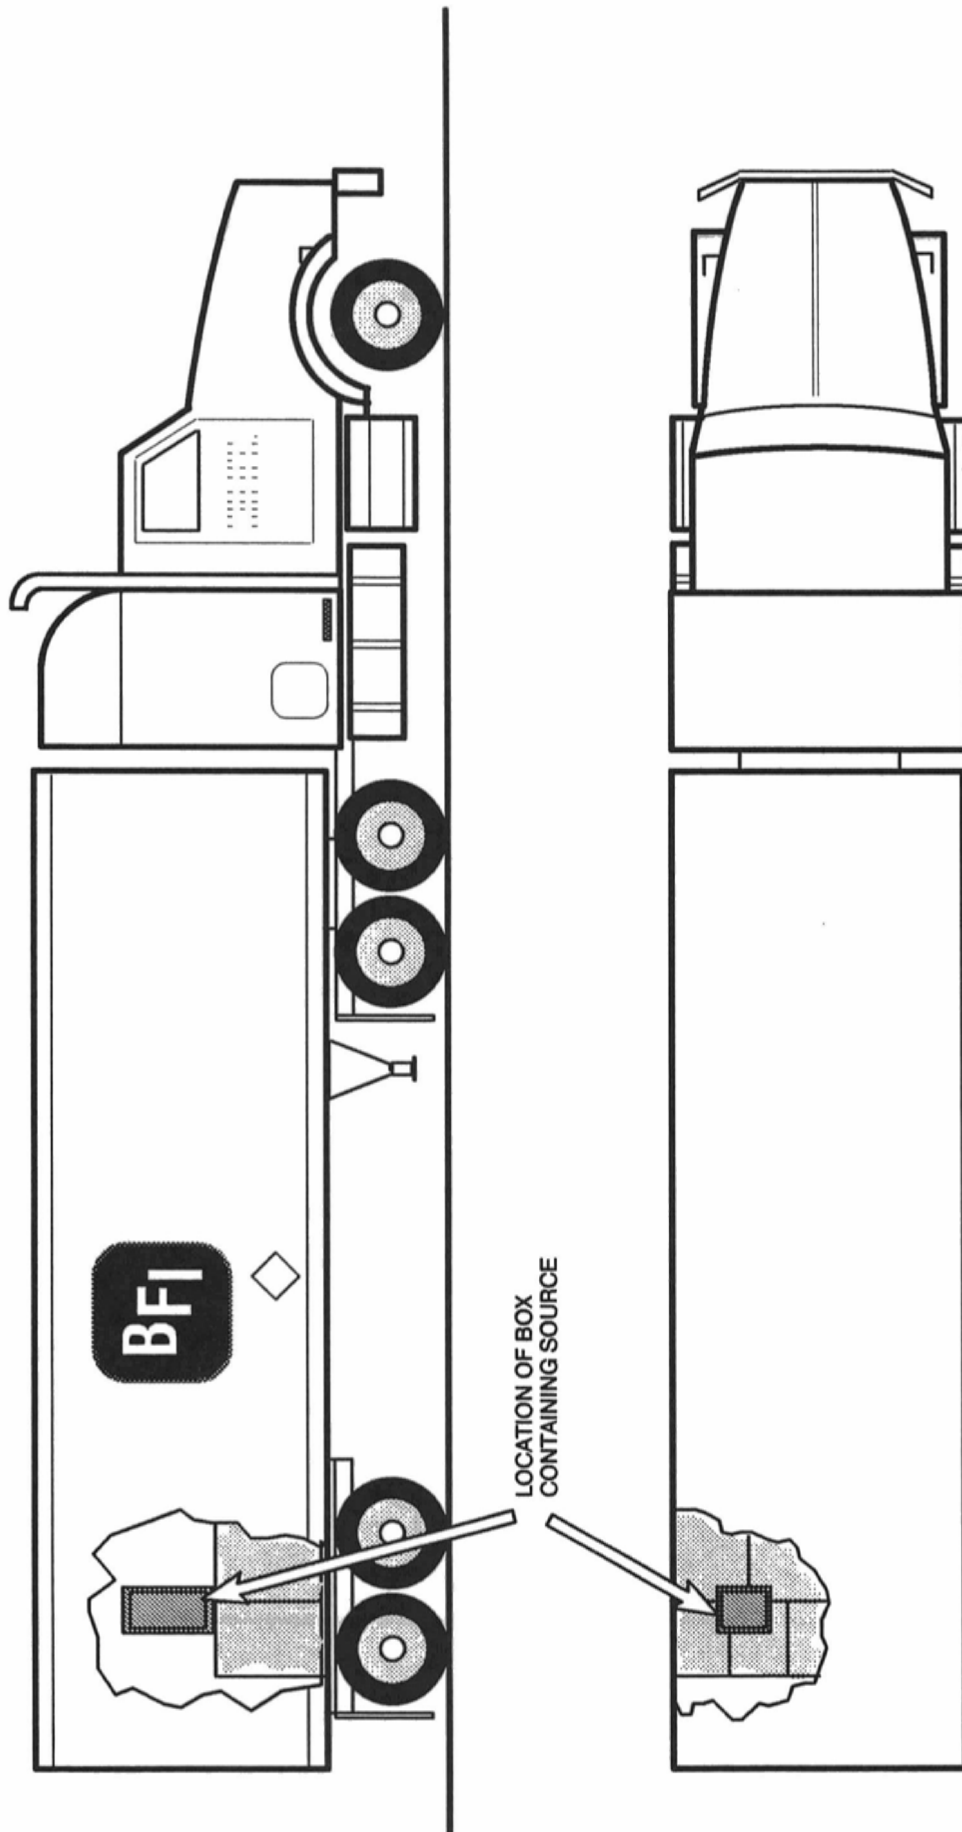
Fig. 2.11 BFI Tractor Trailer 14.63 m (48') Long Showing Location of Source Container in the Trailer.

- 2:30 p.m. BFI Driver A arrived at BFI-Carnegie.
- 3:30 p.m. BFI Driver A unloaded all the boxes by himself from the straight truck onto BFI Trailer 808, which is a 14.6-meter (48-foot) trailer and left for the day. The box containing the source was one of the last ones to be loaded. The box was positioned in the rear left-hand corner of the trailer, approximately 1.8 meters (6 feet) off the floor (Figure 2.11).

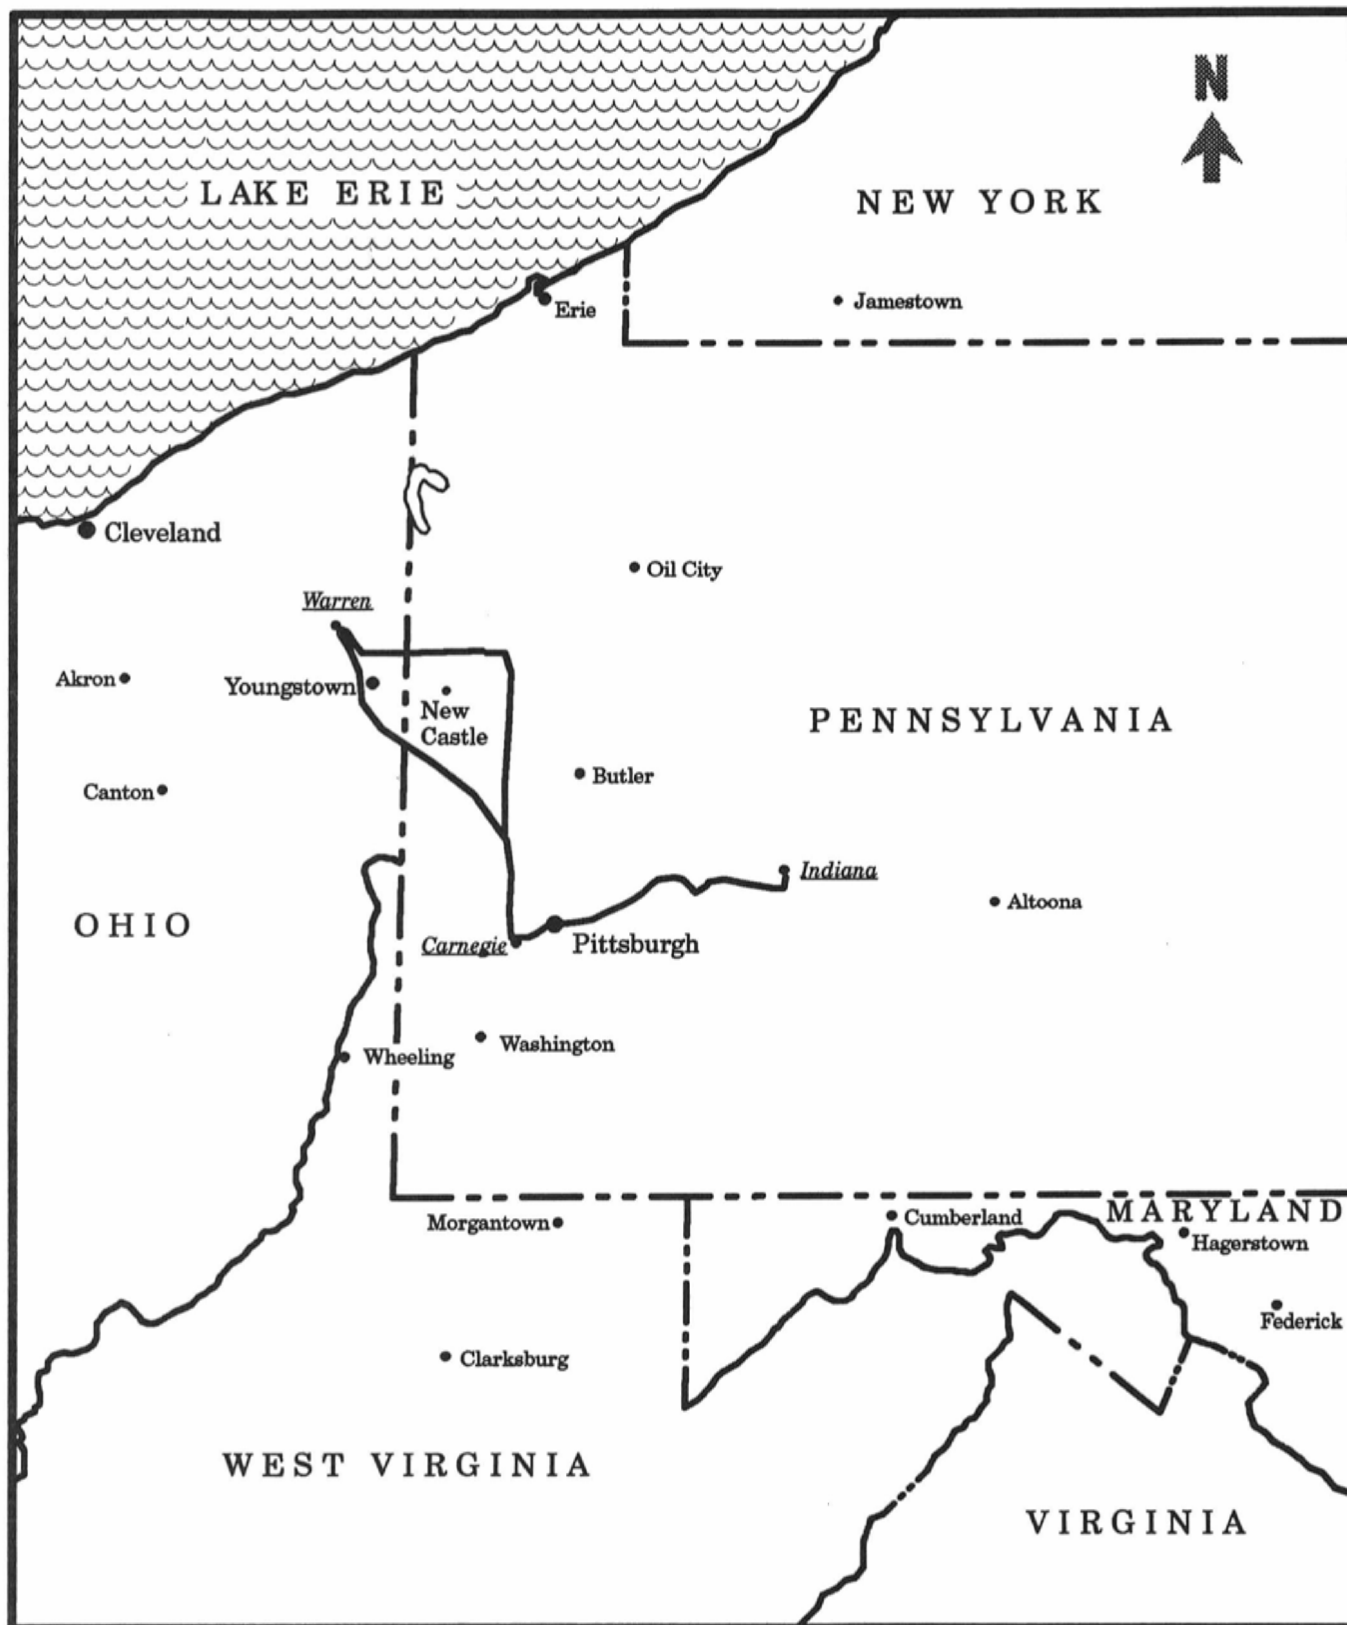
Figure 2.12 Route of Browning - Ferris Industries Semitruck 808 on November 25, 1992

- 6:30 a.m. BFI Driver B left BFI Carnegie via I-79, to I-680N, to I-80W to Hwy-46N, and on to Hwy-169N (Figure 2.12). He made no stops between Carnegie and Warren.

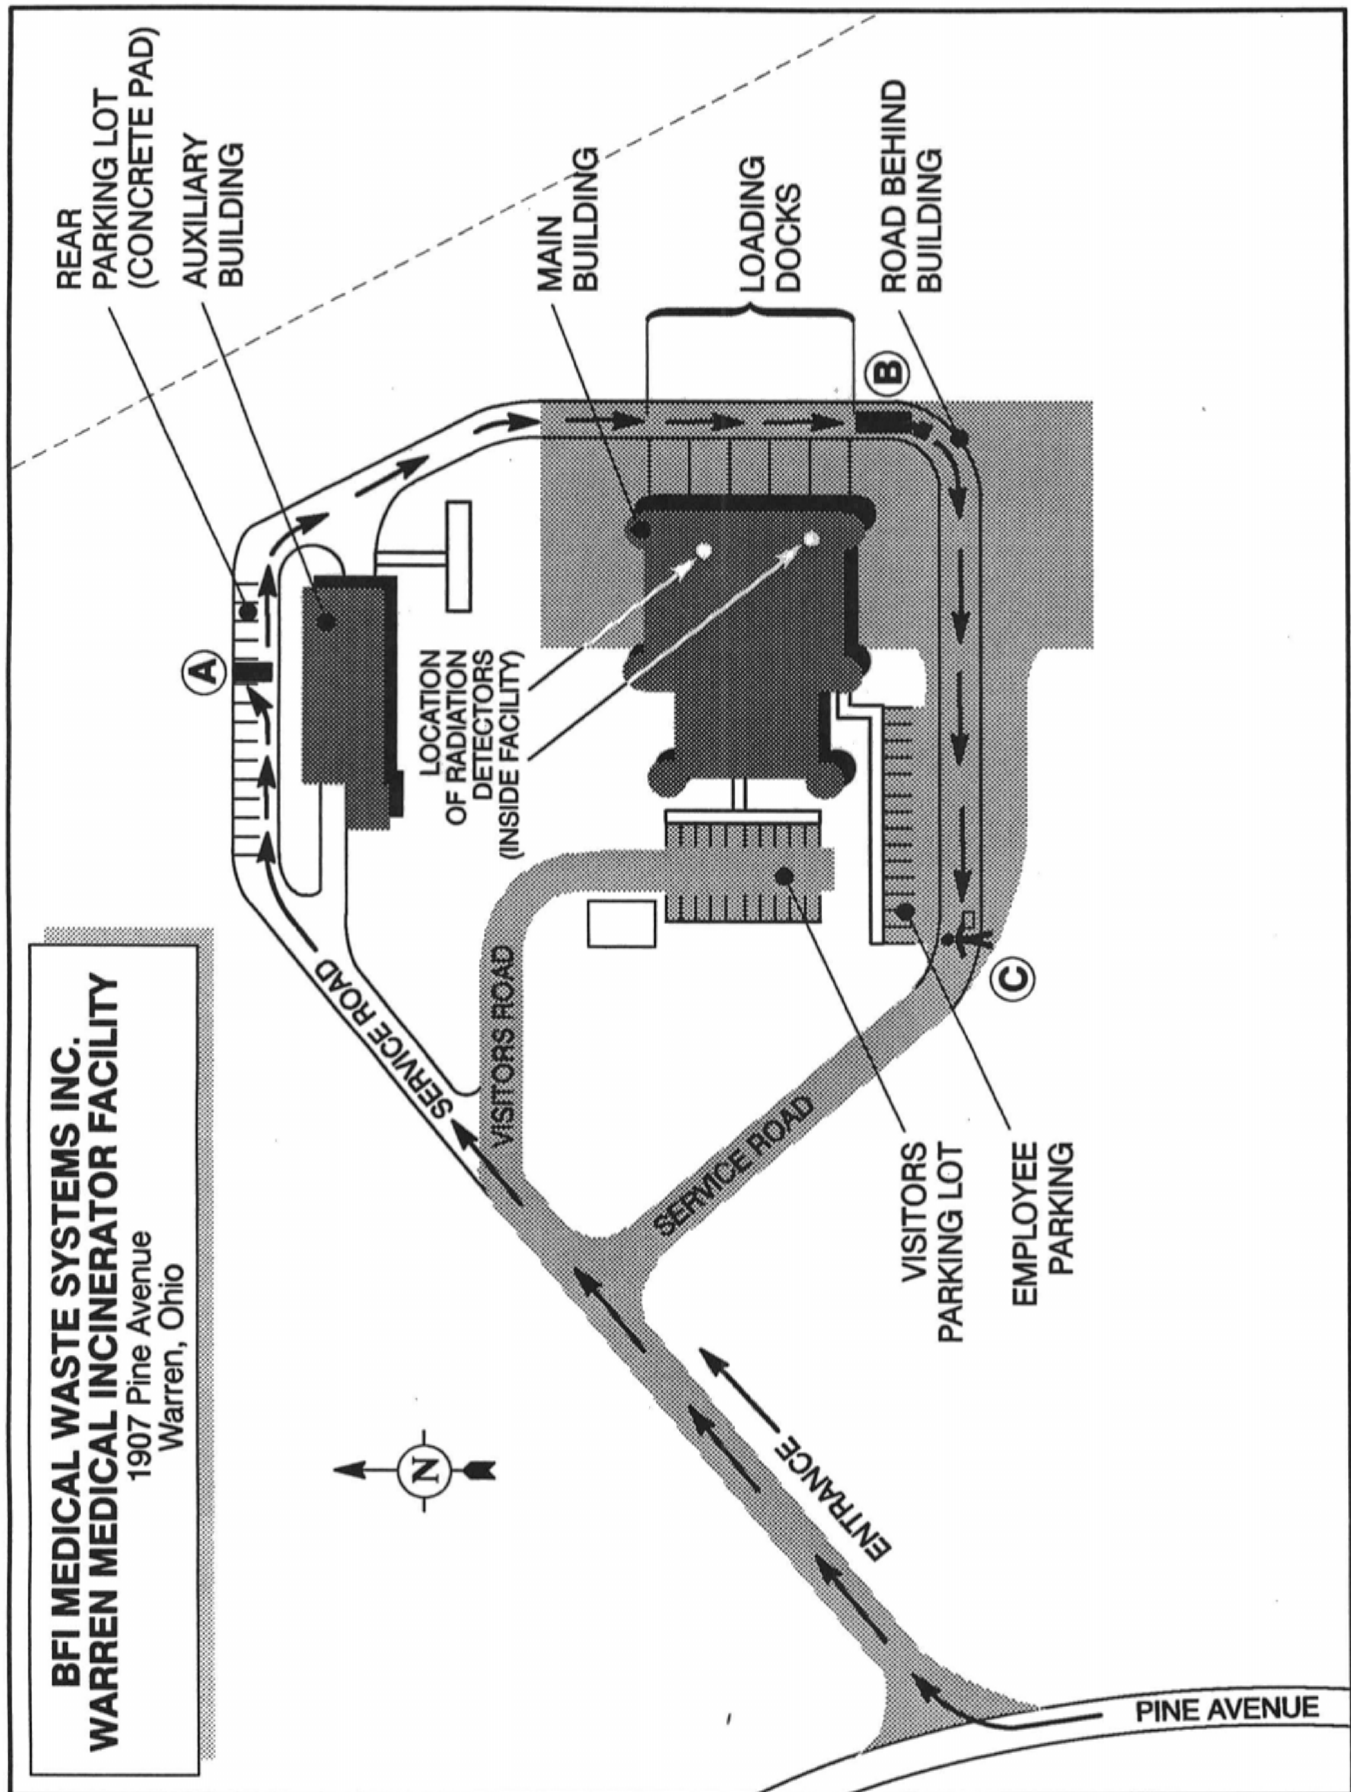
Figure 2.13 Diagram of Tractor-Trailer Route Carrying Iridium-192 Source at BFI-Warren on November 25, 1992

- 8:30 a.m. Driver B arrived at BFI-Warren, drove over to the unloading area (see Position A, Figure 2.13), disconnected Trailer 808, hooked up his cab to an empty trailer, drove to the front office, completed the paperwork for this shipment, and left BFI-Warren. Two fixed radiation monitors inside the facility alarmed, reading above their normal limits of 0.2  $\mu\text{Sv}$  (20  $\mu\text{rem}$ ) per hour. Employees working that shift began trying to locate the cause of the radiation alarms.

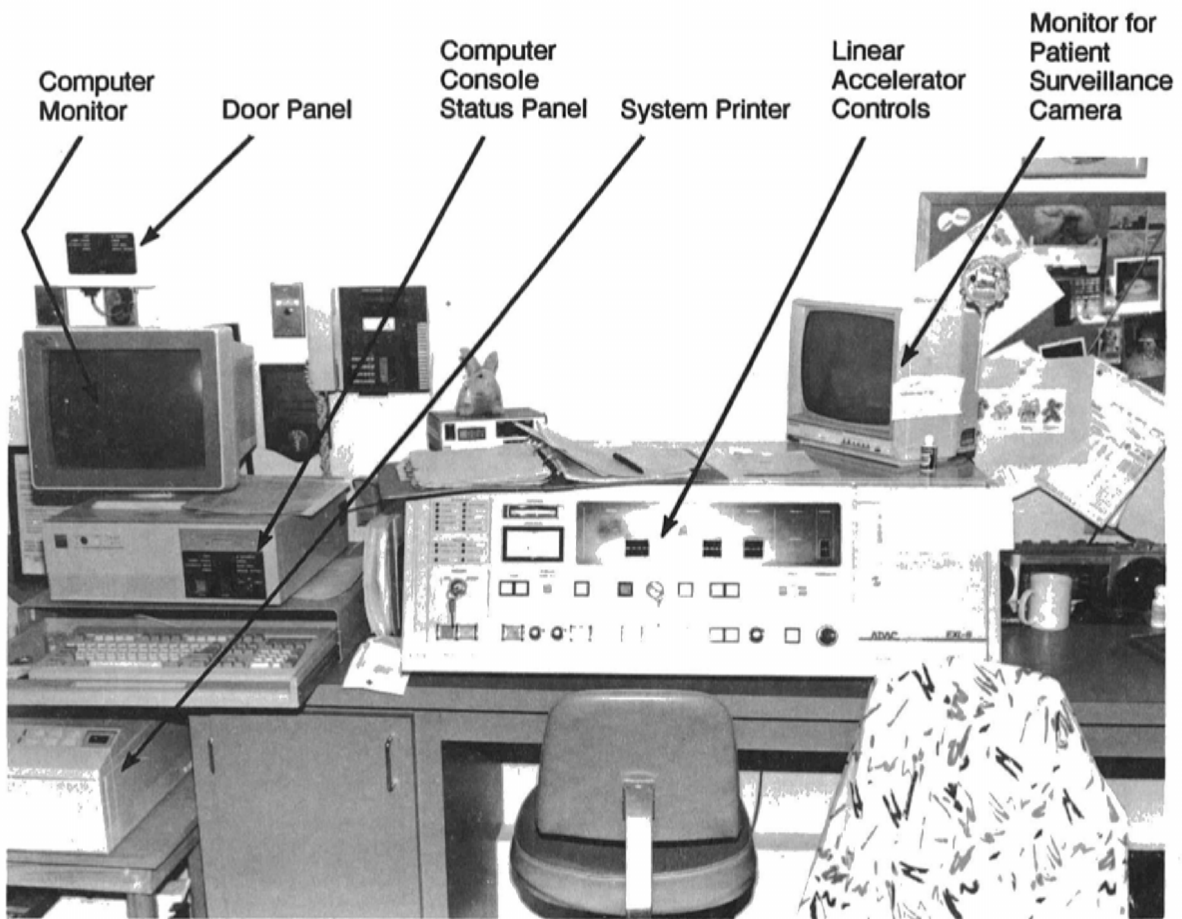
Figure 3.5 Arrangement of the Computer Console Status Panel, Door Panel System Printer, Linear Accelerator Controls, Computer Monitor, and Monitor for Patient Surveillance Camera

Owing to the placement of the computer console and the patient surveillance camera monitor (Figure 3.5), it was difficult for one operator to watch both simultaneously. Additionally, the PrimAlert-10 was located inside the treatment room and was visible through a window in the treatment room door. Therefore, the operator would have to look away from the console and monitor to observe any alarm on the PrimAlert-10. Physician A was not present at the computer console during the treatment, and Medical Physicist A was off the site. In contrast, at the GPCC, Medical Physicist B was watching the computer console and Physician E was watching the patient surveillance camera monitor.

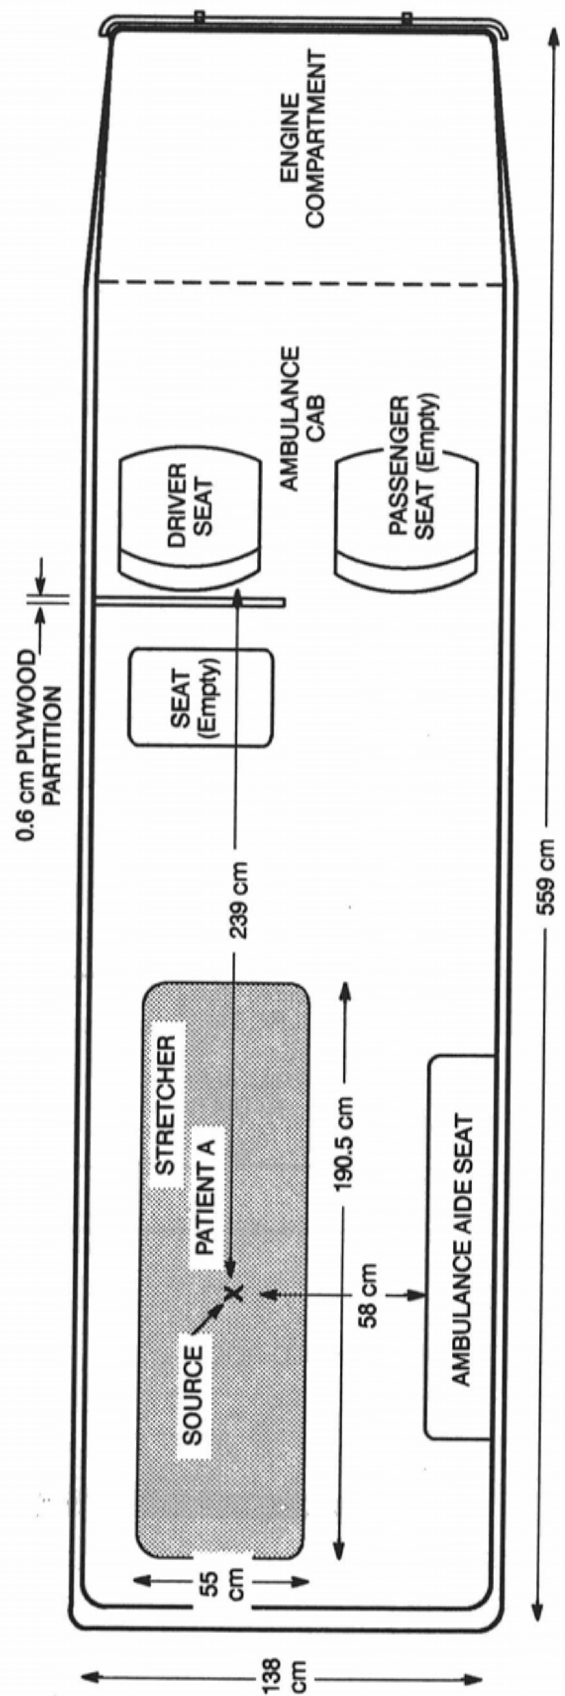
Figure 6.2 Location of Ambulance Staff and Patient A in Citizen's Ambulance

Two ambulance service employees were exposed to the iridium-192 source during transport of Patient A after Patient A received HDR treatment on November 16, 1992. The team measured probable distances that the ambulance service employees maintained from the source in Patient A and estimated the time spent at each distance based on the ambulance service's dispatch log. The team estimates that the ambulance aide received a dose in the range of 13.3 mSv (1.3 rem) to 25.7 mSv (2.6 rem), while the ambulance driver received from 4.8 mSv (0.48 rem) to 8.4 mSv (0.84 rem) (Table 6.6). The estimated dose range for the ambulance aide is higher because he spent the time in transit to SHM nursing home sitting across from Patient A approximately 58 cm (22.8 inches) away (Figure 6.2).

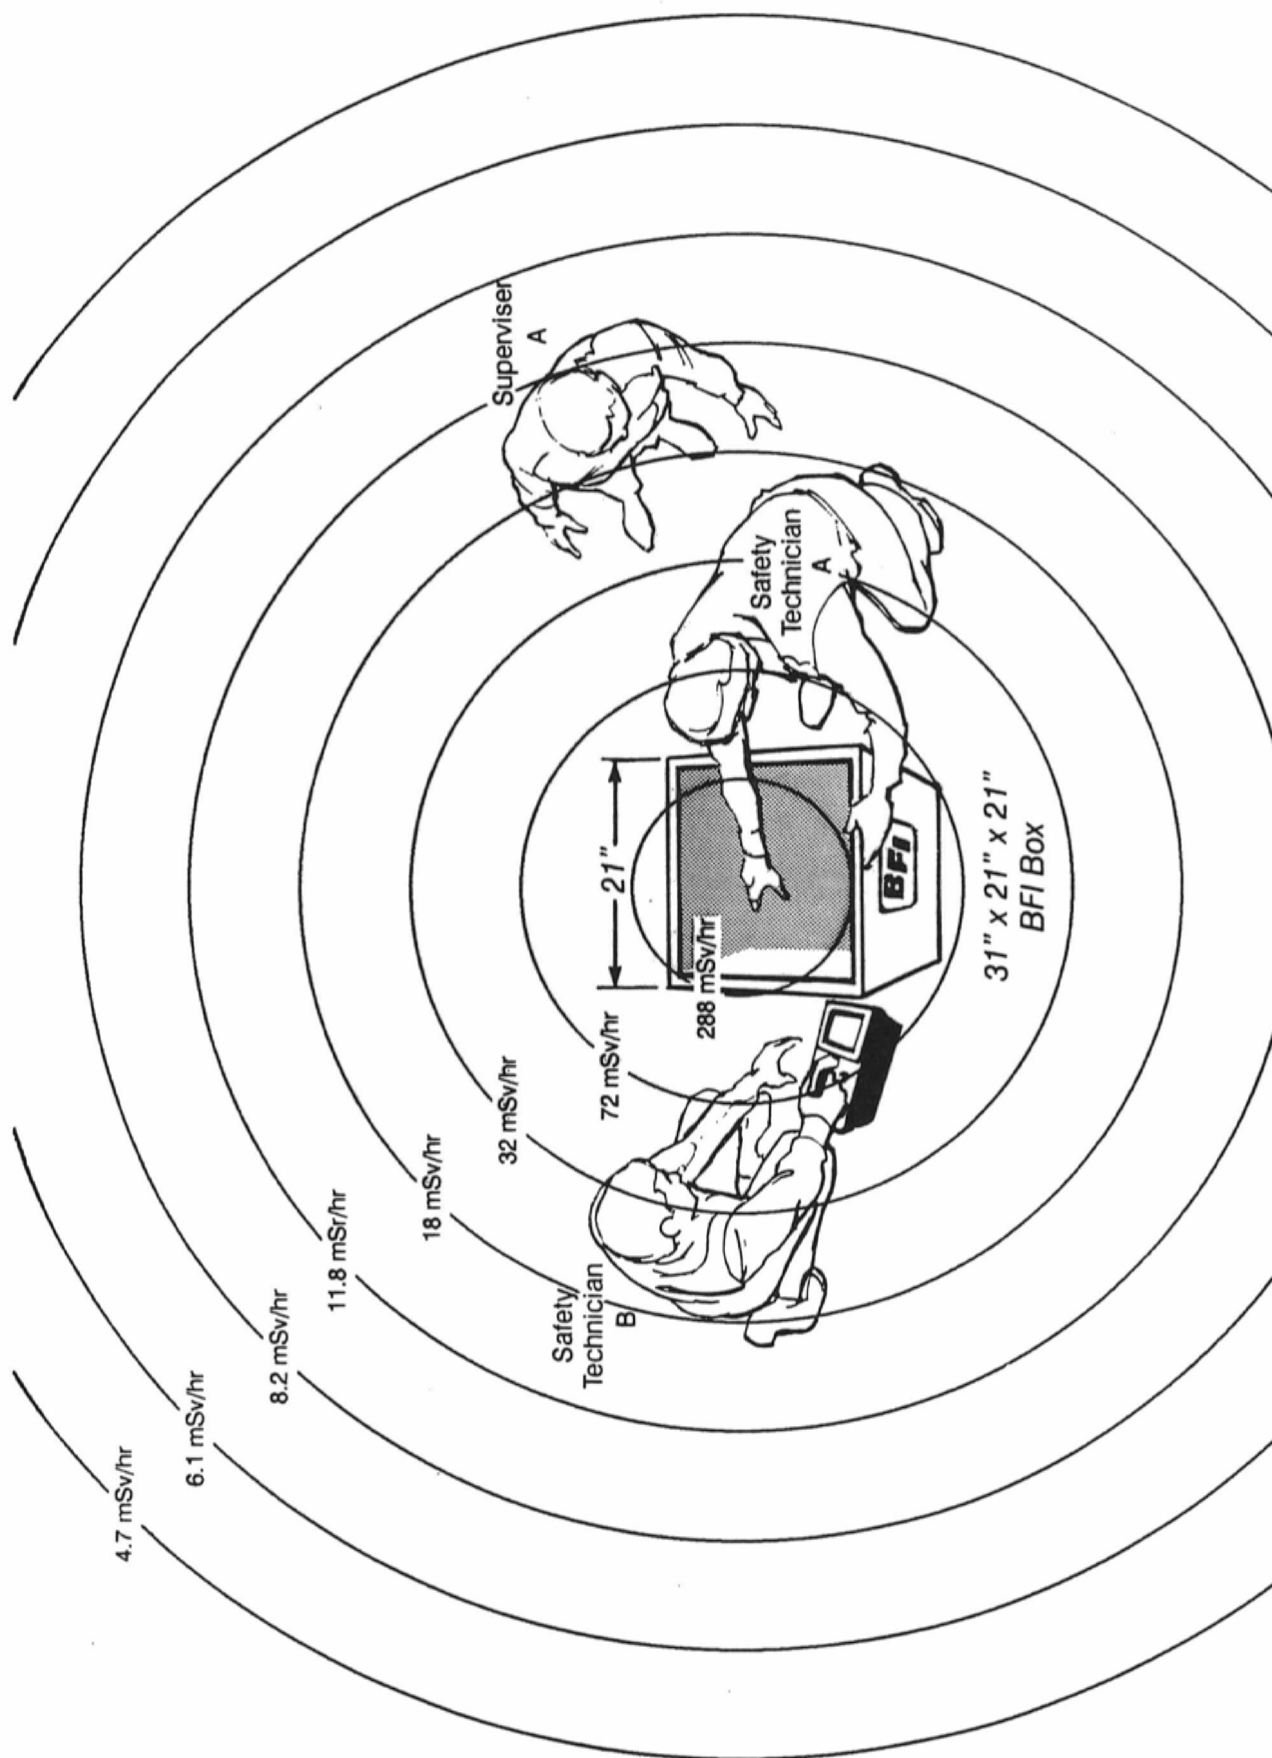
Figure 6.8 shows the position of Supervisor A, Safety Technician A, and Safety Technician B around the box [78.7 cm by 53.3 cm by 53.3 cm (31 inches by 21 inches by 21 inches)] showing isodose curves in mSv per hour.

Figure 6.8 Aerial View of the Positions of Supervisor A, Safety Technician A, and Safety Technician B Around the Box Containing the Iridium-192 Source on December 1, 1992, Showing Isodose Curves in mSv per Hour
