U.S. DEPARTMENT OF
ENERGY

Legacy
Management

2020 Annual Site Inspection and Monitoring Report for Uranium Mill Tailings Radiation Control Act Title II Disposal Sites

December 2020

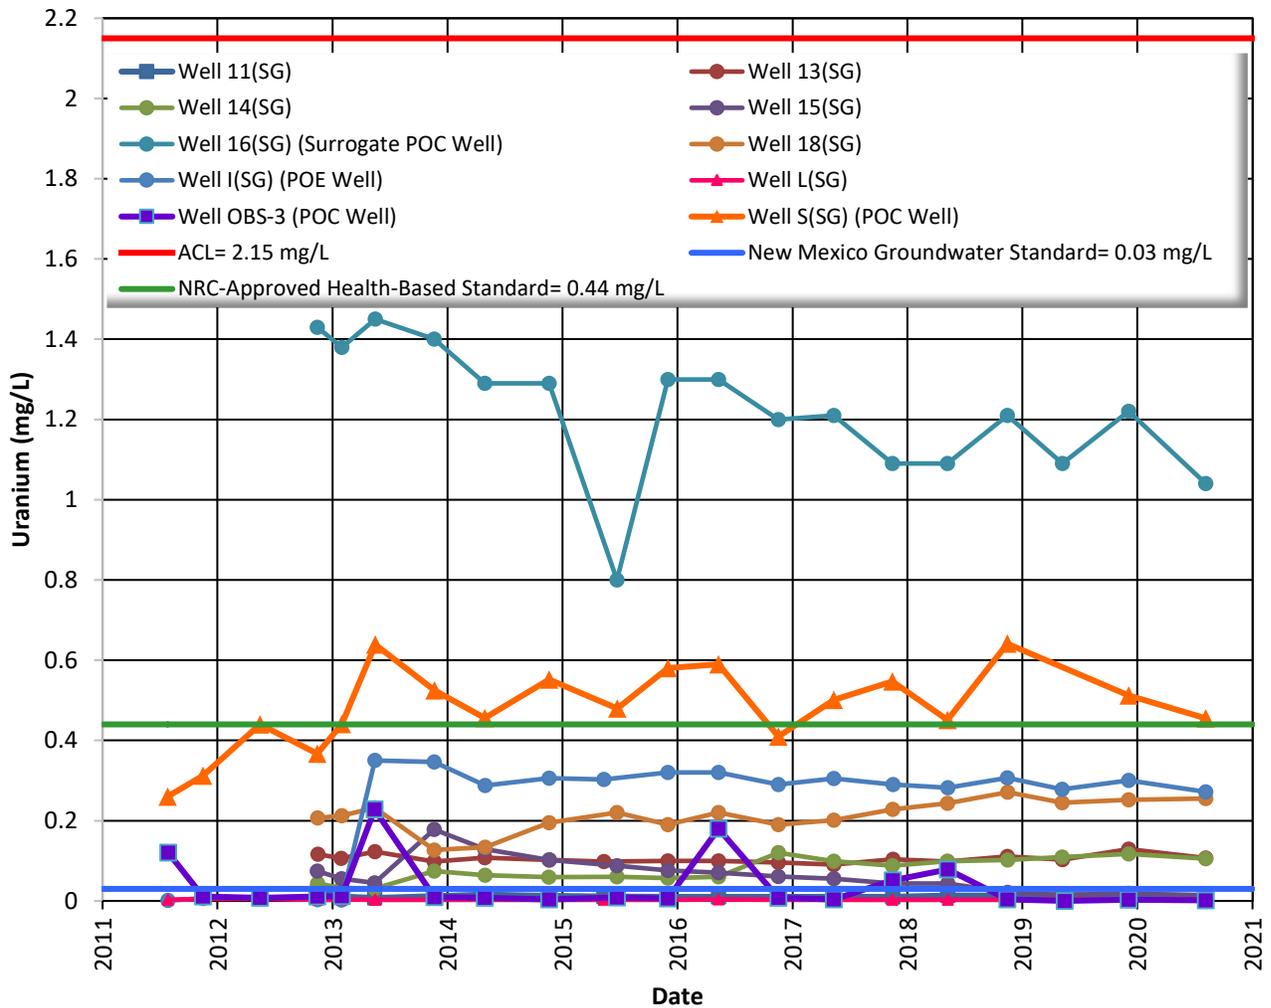
Figure 1-5. Uranium Concentrations in the San Andres/Glorieta Aquifer at the Bluewater, New Mexico, Disposal Site

Figure 1-5 shows uranium concentrations in the SAG aquifer. Uranium concentrations in well I(SG) before 2013 are not shown because an incorrect sampling depth in the well led to erroneously low results. Uranium concentrations at POC wells OBS-3 and S(SG) are not shown in Figure 1-5 because the well screens are encrusted with iron scale that has resulted in erroneously low uranium concentrations since LM began sampling the wells.

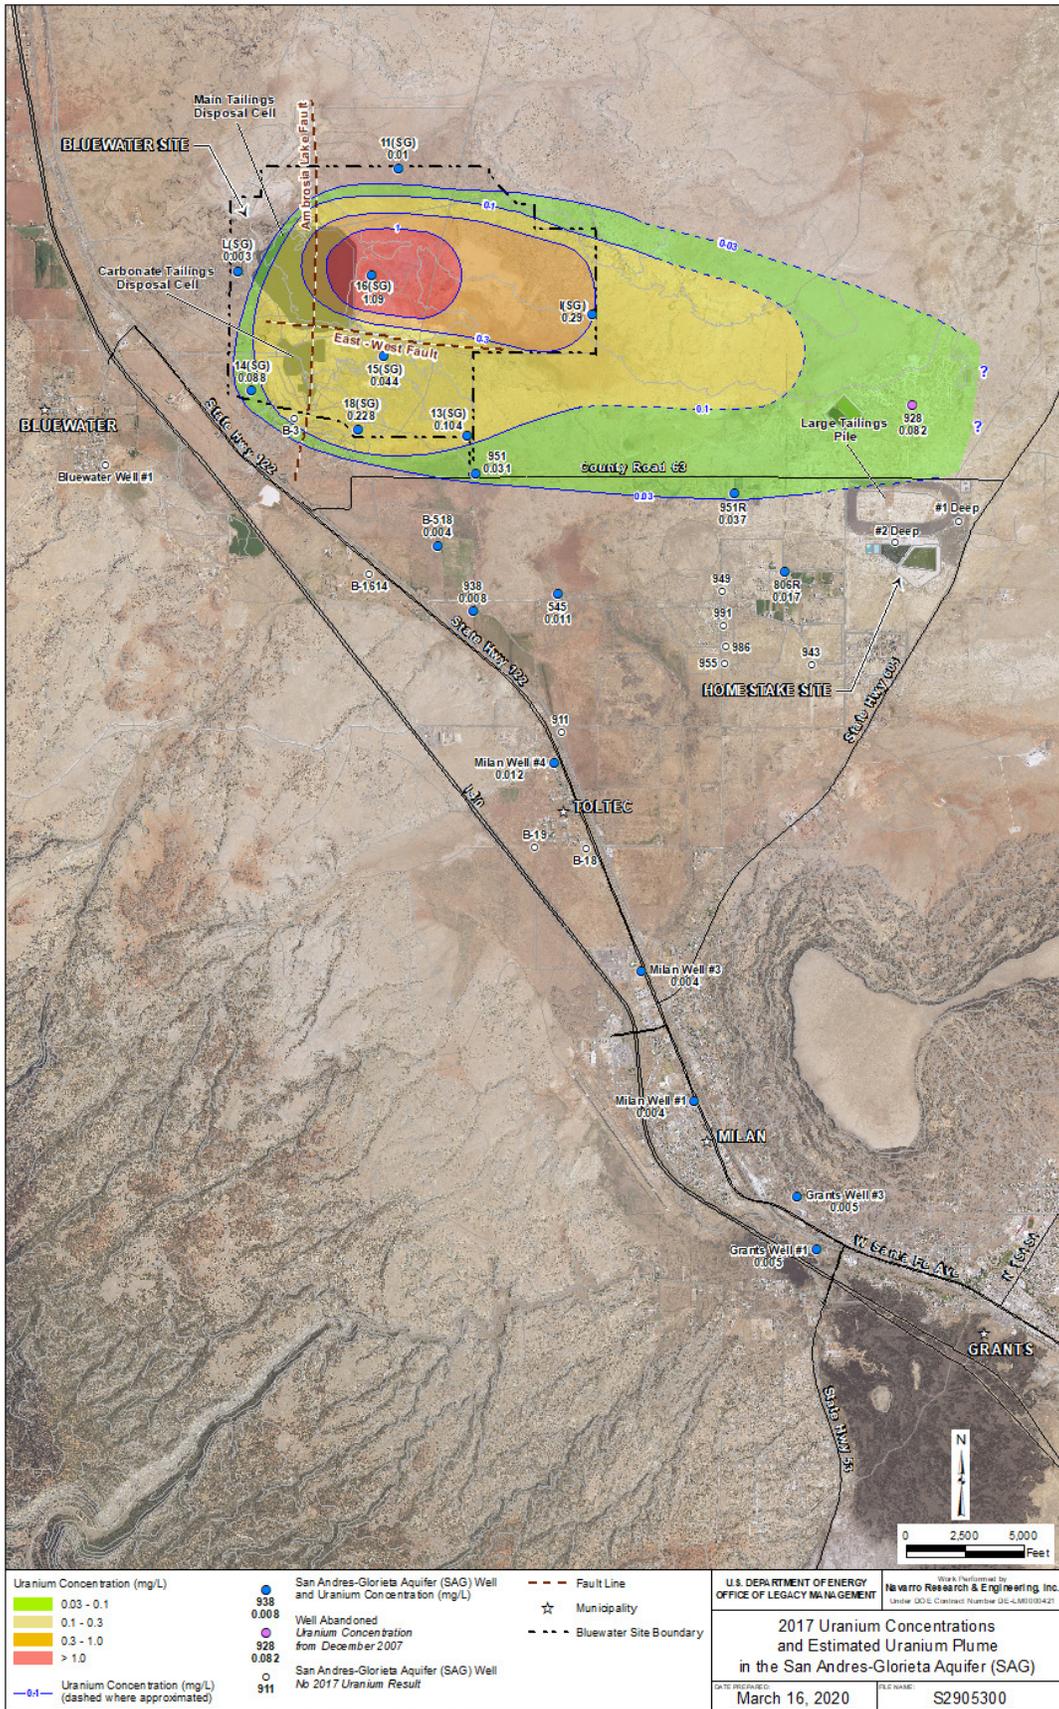
Figure 1-7. 2017 Estimated Uranium Plume in the San Andres/Glorieta Aquifer (DOE 2019)

The estimated extent of the uranium plume based on data collected primarily in 2017, described in the updated groundwater model (DOE 2019), is shown in Figure 1-7. The uranium plume follows the groundwater flow path, and the leading portion is near the Homestake site. Groundwater monitoring results obtained by various entities over the last several decades indicate that uranium contamination from Bluewater mill operations reached the Homestake site by 1980 and that the plume has essentially stabilized (i.e., it is not continuing to migrate to the east). Uranium concentrations attenuate with distance from the site primarily through dispersion instead of chemical reduction because of the absence of a reducing environment in the aquifer formations (DOE 2014). No known drinking water wells are completed within the uranium plume, and site-derived uranium contamination in the SAG aquifer is not expected to impact the Milan or Grants municipal water supplies that are pumped from SAG aquifer wells (DOE 2014; DOE 2019).

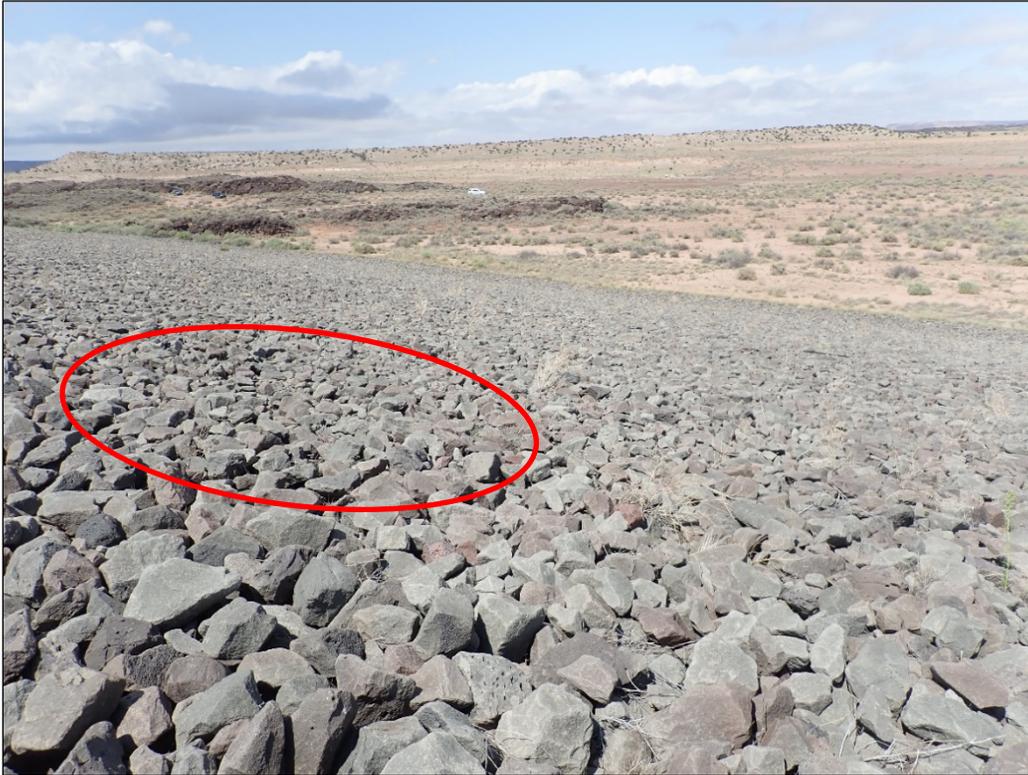
The Bluewater, New Mexico, Uranium Mill Tailings Radiation Control Act (UMTRCA) Title II Disposal Site (site) was inspected on September 10 and September 11, 2020. Possible settlement was observed on the north side slope of the main tailings disposal cell. Depressions continue to be observed on the north portion of the top slope of the main tailings disposal cell. A siphon is operated to remove the runoff water that accumulates in the depressions. The U.S. Department of Energy (DOE) Office of Legacy Management (LM) entered into an interagency agreement with the U.S. Army Corps of Engineers (USACE) in October 2019 to design a repair to the depressions and ensure continued positive drainage from the main tailings disposal cell. The U.S. Nuclear Regulatory Commission (NRC) will be involved in reviewing designs as they are developed and will concur on the final design before construction. Inspectors identified several routine maintenance needs but found no cause for a follow-up or contingency inspection.

PL-11. Potential Settlement on the North Side Slope of the Main Tailings Disposal Cell

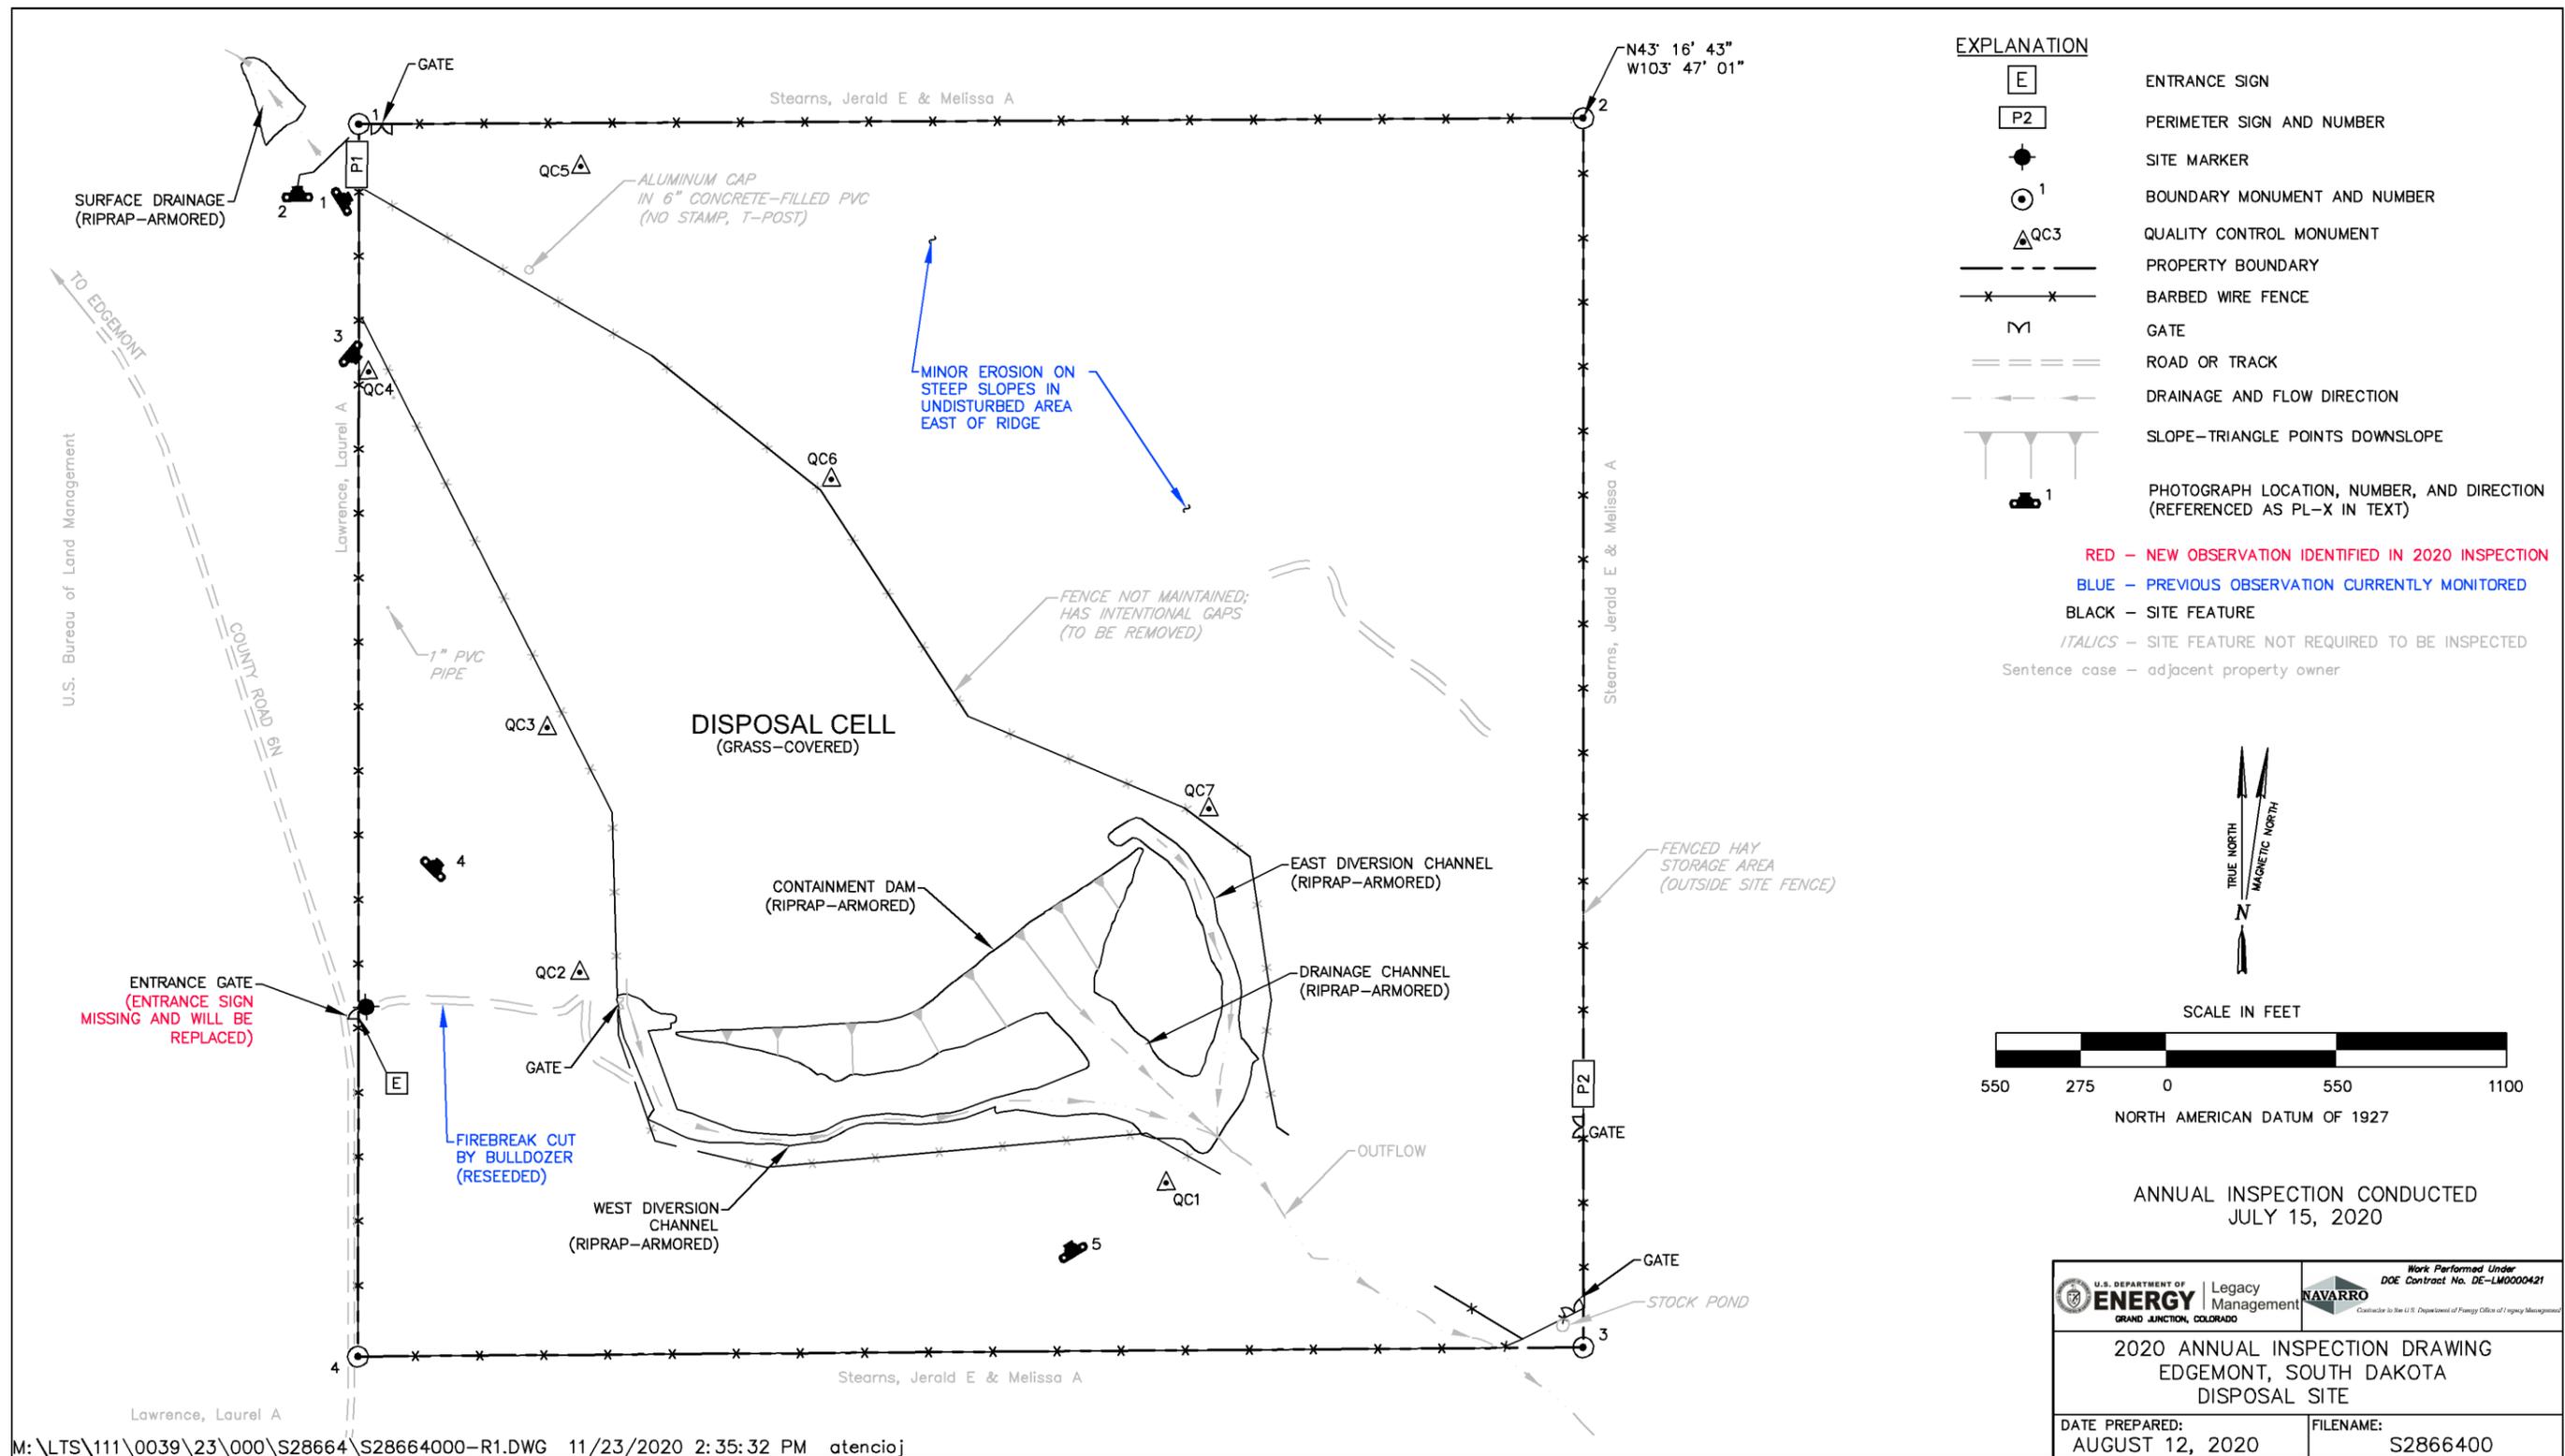
Figure 2-1. 2020 Annual Inspection Drawing for the Edgemont, South Dakota, Disposal Site

Boundary monuments are present at each of the property's four corners (PL-2). All boundary monuments were inspected, and no maintenance needs were identified.

Seven aerial survey quality control monuments, installed in 2019, were inspected during the 2020 annual inspection (Figure 2-1, PL-3). No maintenance needs were identified.

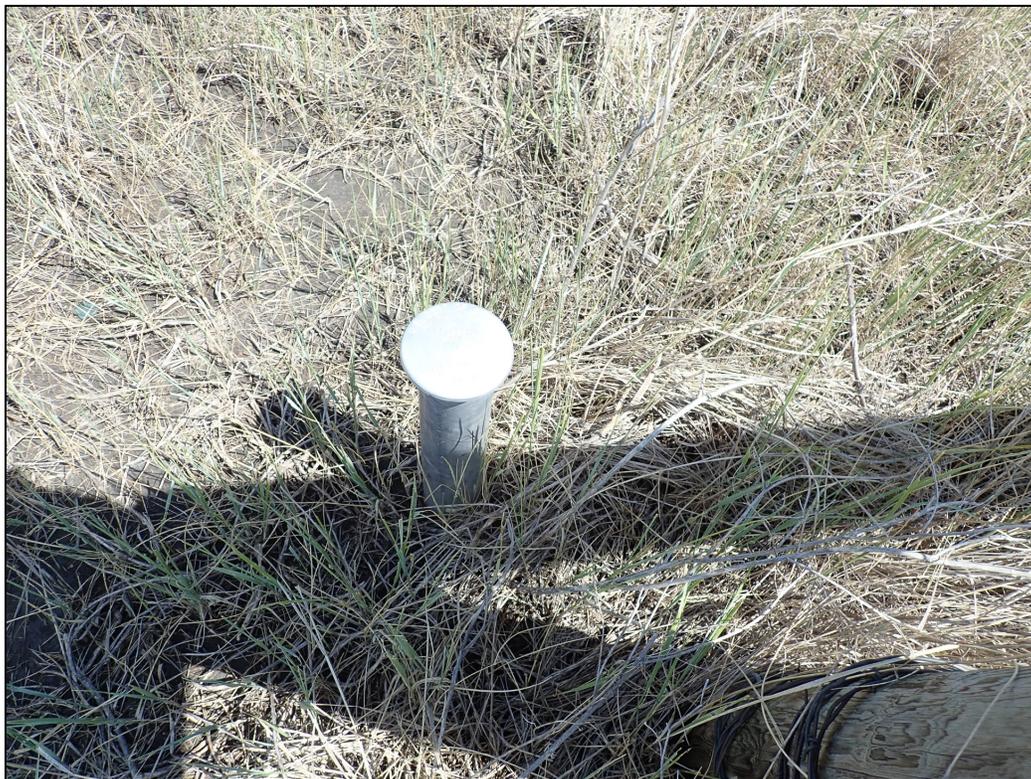
PL-2. Boundary Monument BM-1

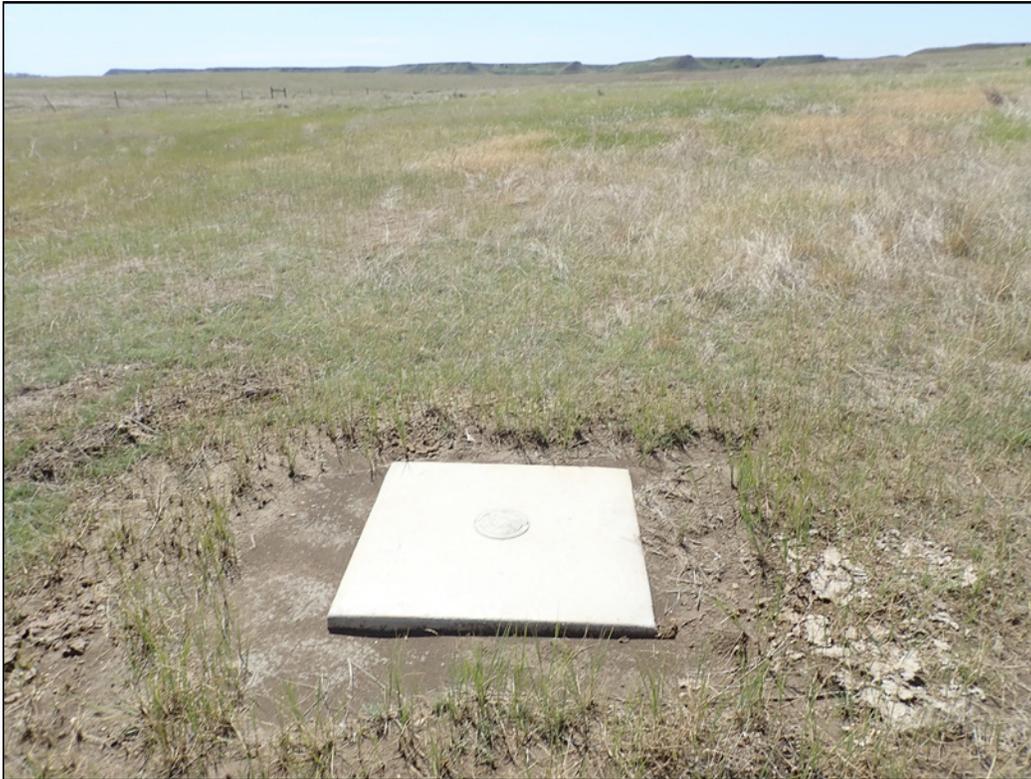
PL-3. Quality Control Monument QC4

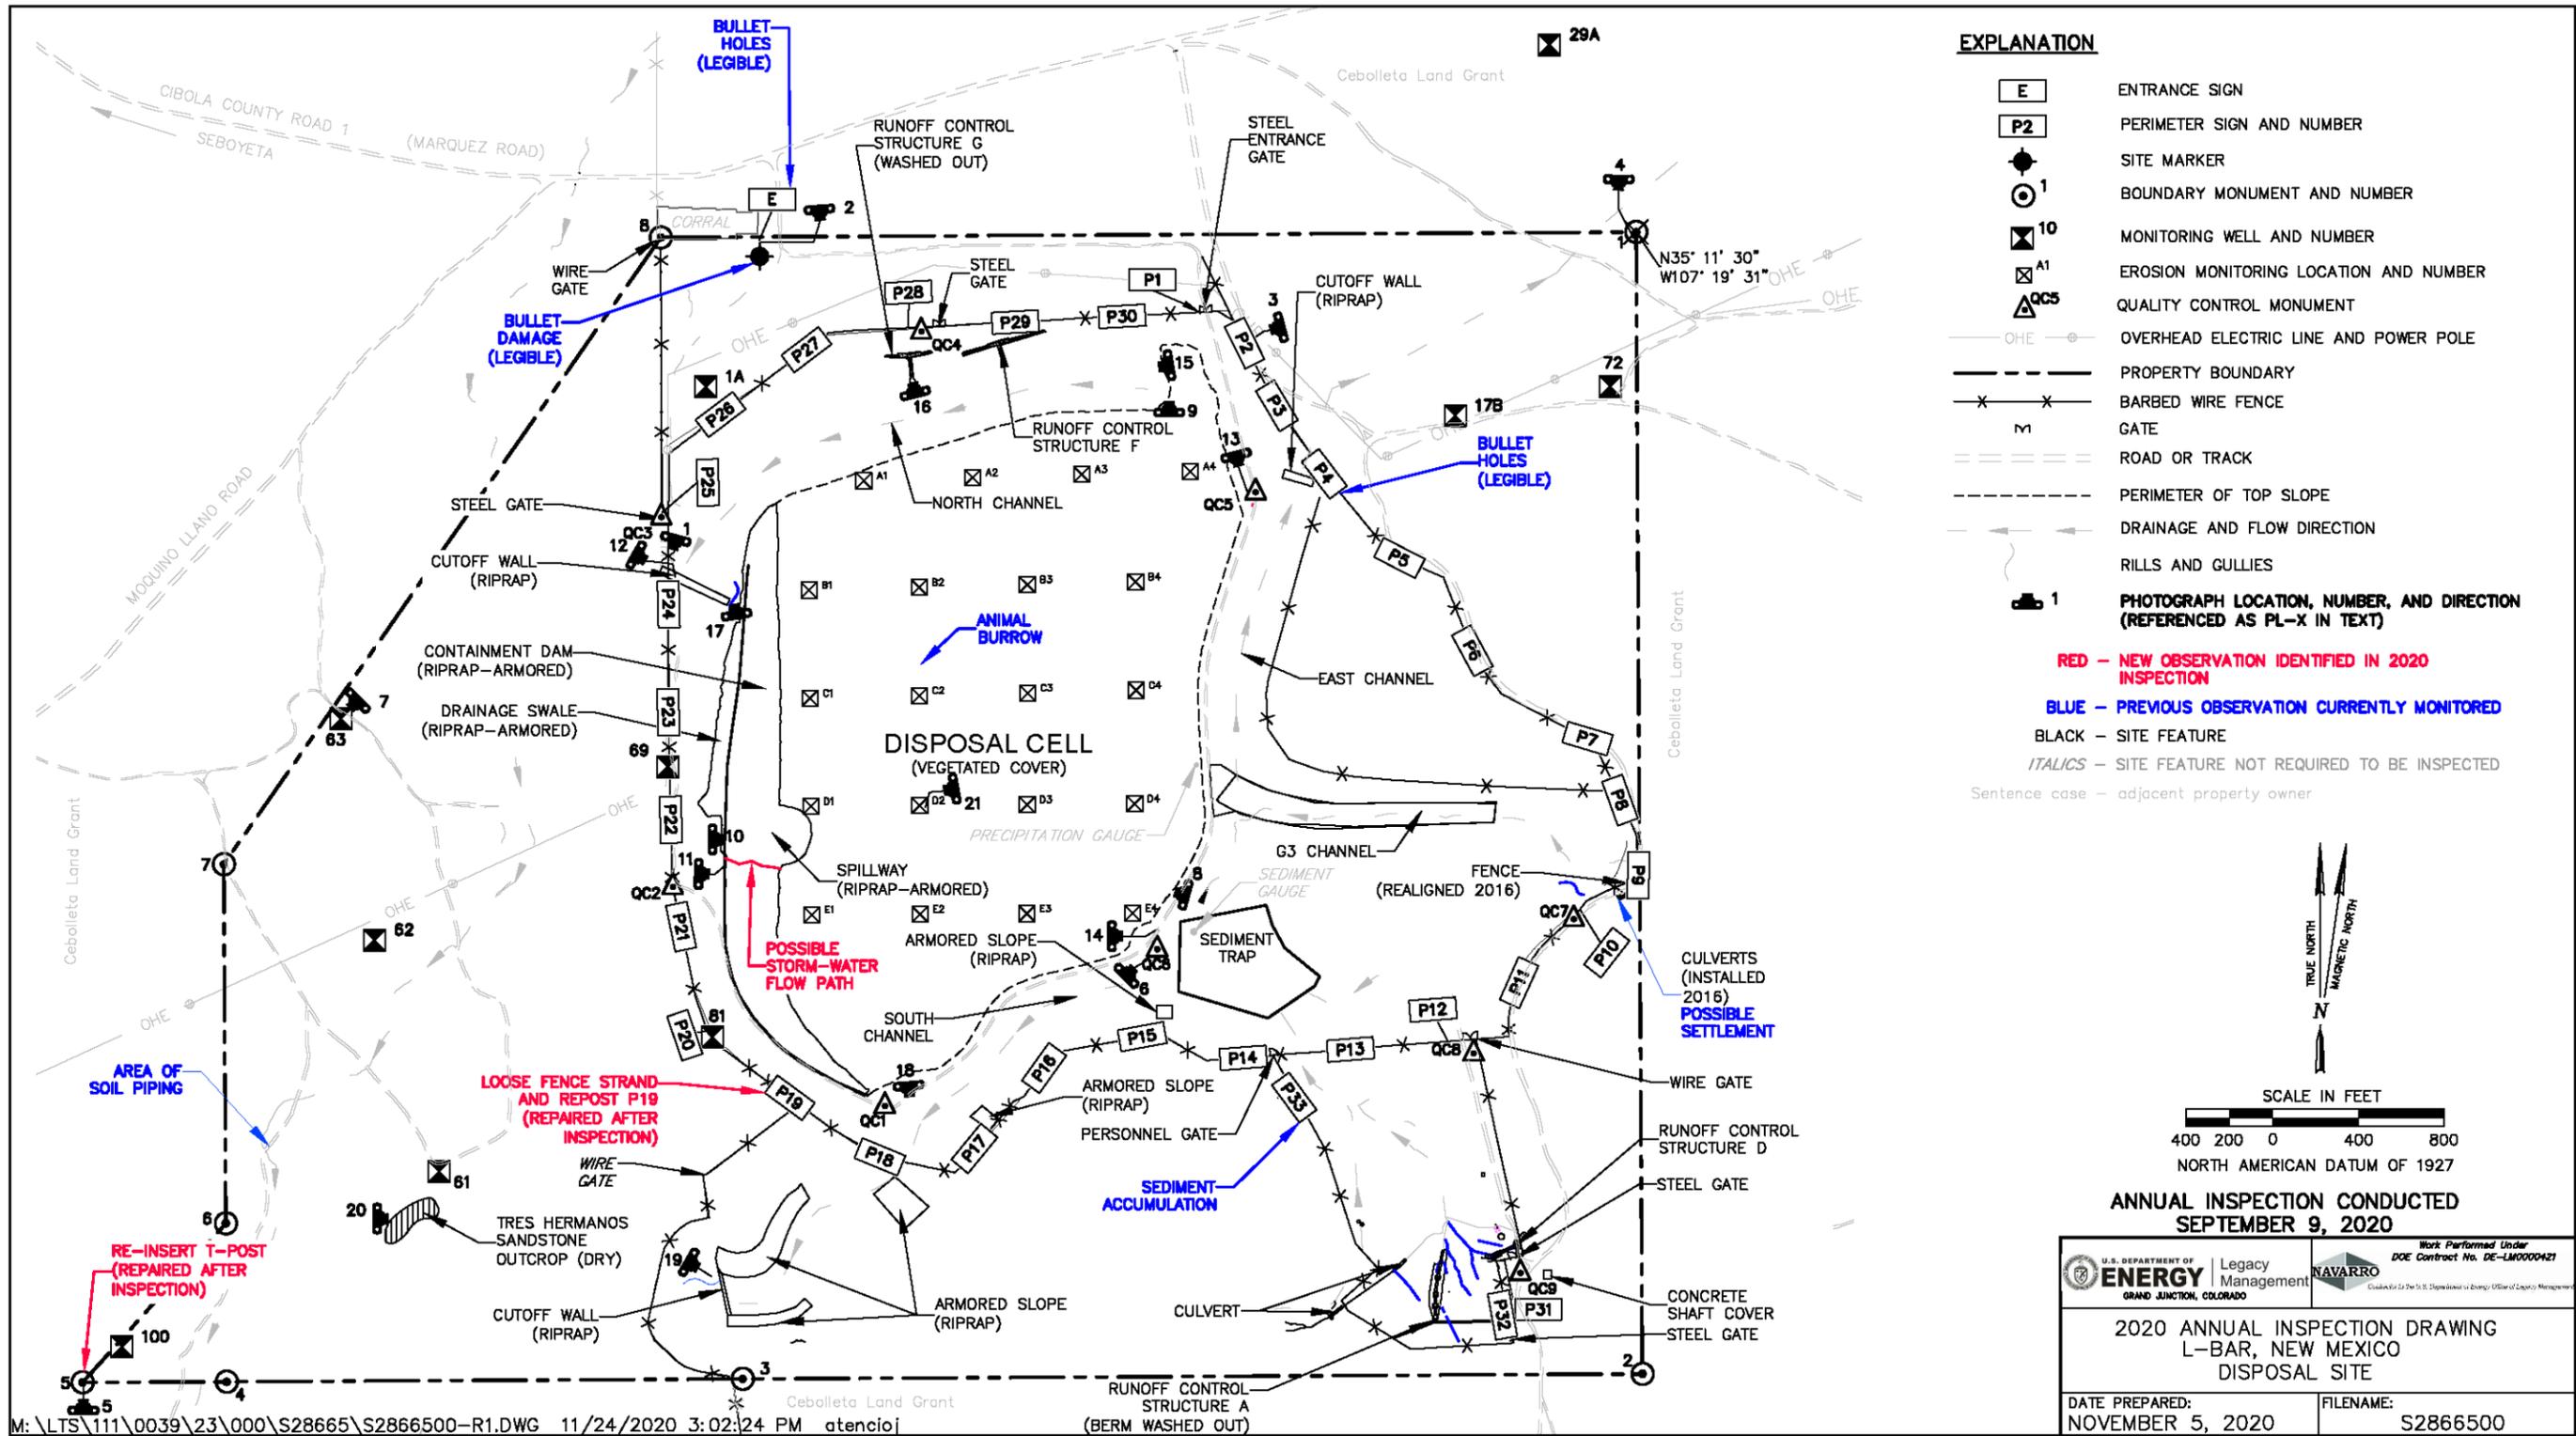
Figure 3-1. 2020 Annual Inspection Drawing for the L-Bar, New Mexico, Disposal Site

A barbed-wire fence (PL-1) encloses the disposal cell and associated drainage structures and is intended to prohibit trespassing and livestock intrusion on the disposal cell structures (because livestock trails would initiate gully erosion). The fence is about 3300 ft inside the property boundary, and the area between the fence and the boundary is grazed in accordance with an LM grazing license with the Cebolleta Land Grant stakeholders who collectively own and manage the surrounding property. Sediment is accumulating along the fence line near perimeter sign P33, but it is not impacting the function of the fence. A loose fence strand near perimeter sign P19 was observed during the inspection and repaired during a subsequent maintenance trip on September 30, 2020.

The entrance sign is on the main site access road near the site marker. It has several bullet holes but was legible (PL-2). Thirty-three warning or perimeter signs (PL-3) are attached to the barbed-wire fence that surrounds the disposal site structures and an area of excessive gully erosion in the southeast portion of the site. Perimeter sign P19 was found on the ground and was reattached to the perimeter fence during the September 30, 2020, maintenance activities.

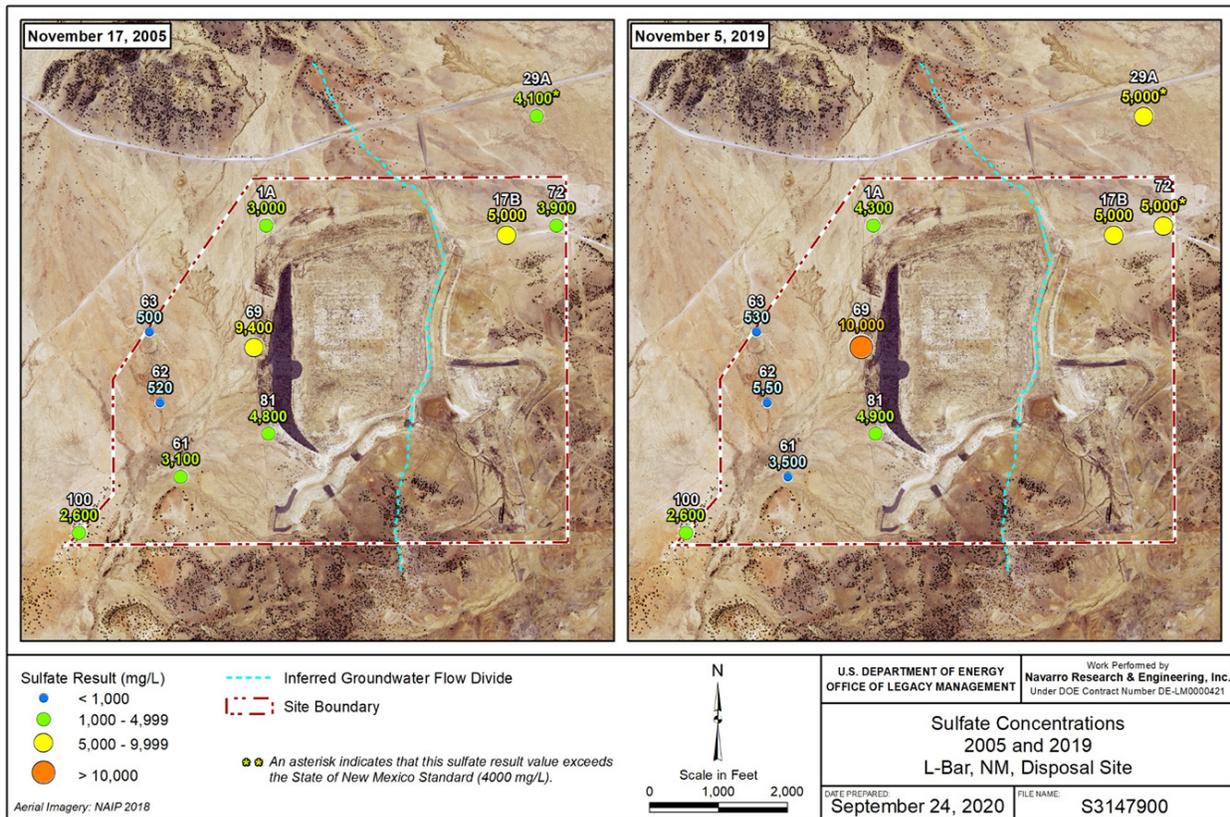
Figure 3-12. Sulfate Concentrations in 2005 and 2019

As stated in the LTSP, a groundwater contour map and a sulfate isoconcentration map for the years that sampling has been conducted is to be provided with the groundwater monitoring results and are presented below (Figure 3-11 and Figure 3-12, respectively). Concentration location bubble maps were generated in lieu of isoconcentration maps because of the limited number of well locations where water quality was measured at the site. No water quality measurements were taken directly beneath the tailings impoundment, so interpolated isoconcentrations would likely not be representative of site conditions. Each monitoring well sample was taken within the First Tres Hermanos (FTH) sandstone unit and do not represent contaminant levels in porous media above or below this stratigraphic unit.

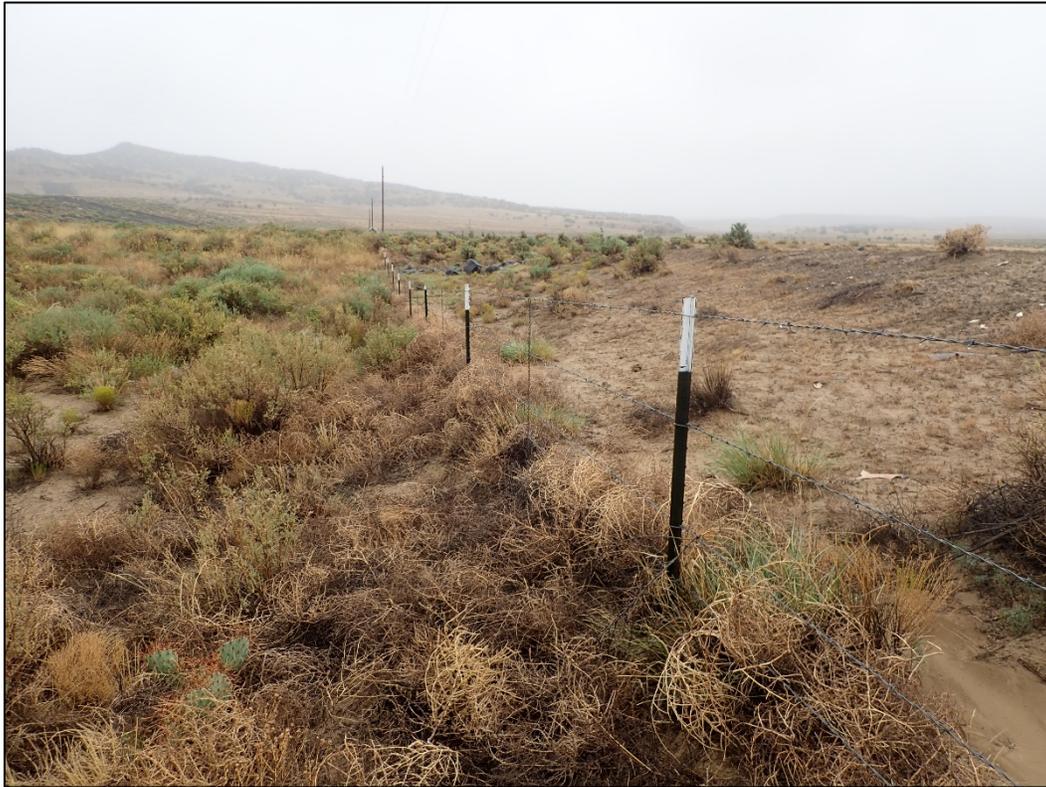
PL-1. Western Perimeter Fence

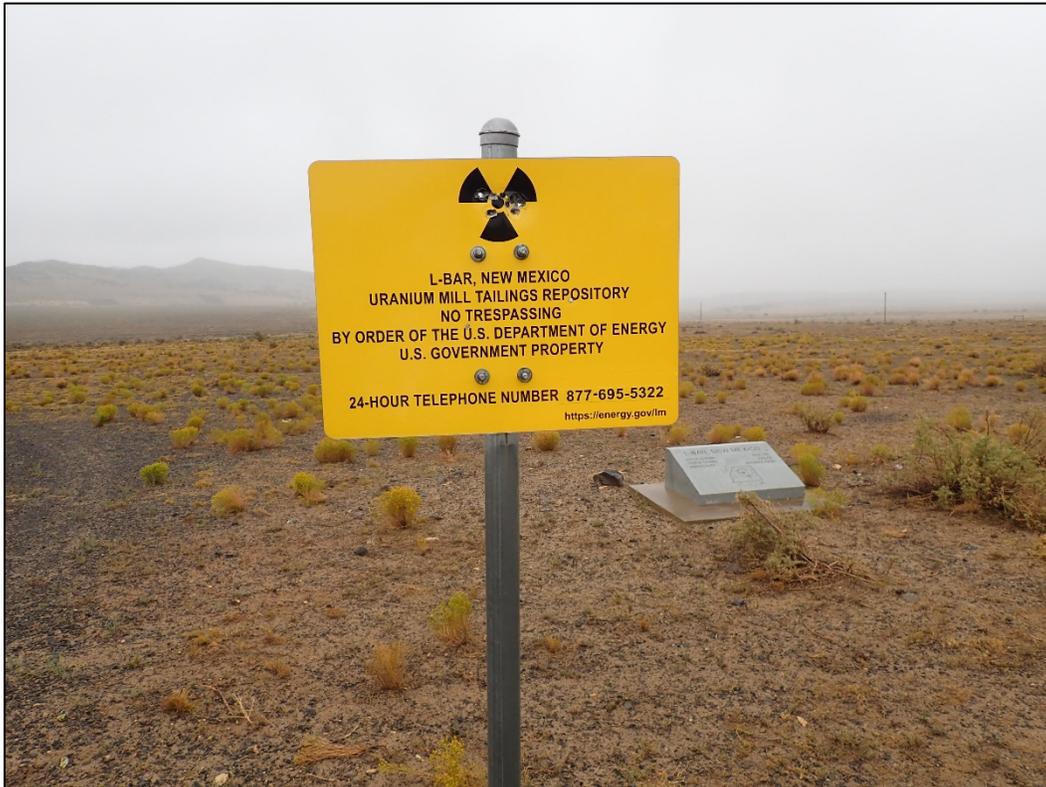
PL-2. Entrance Sign

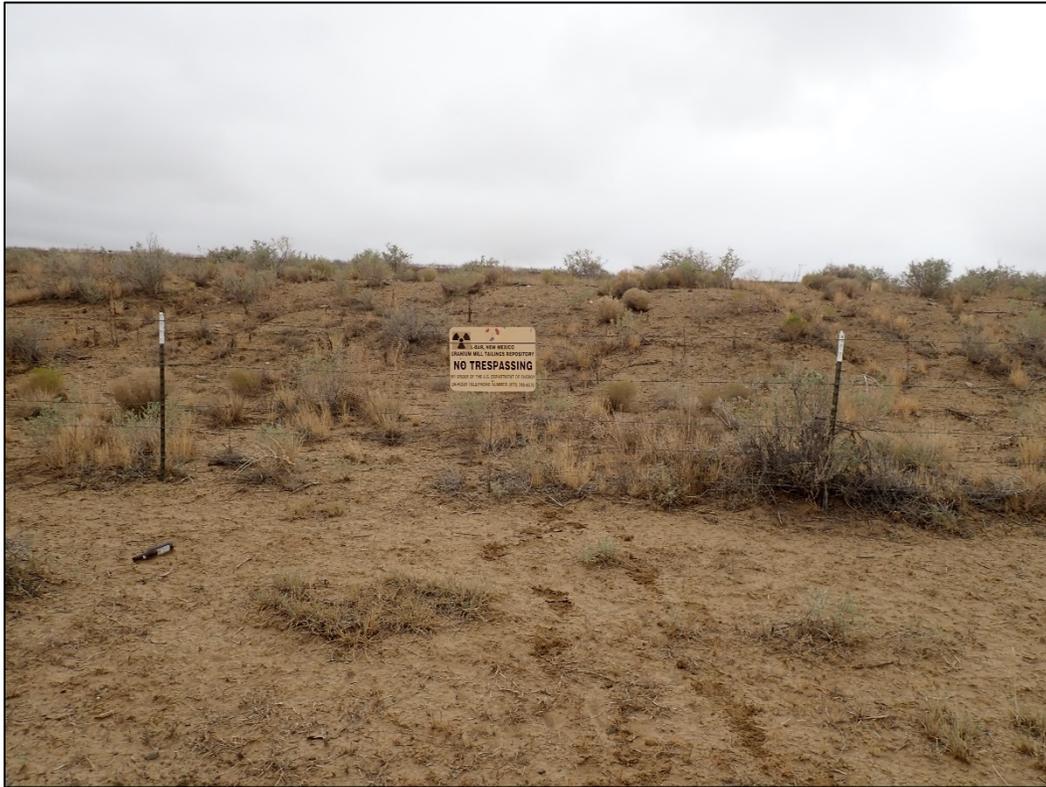
PL-3. Perimeter Sign P2

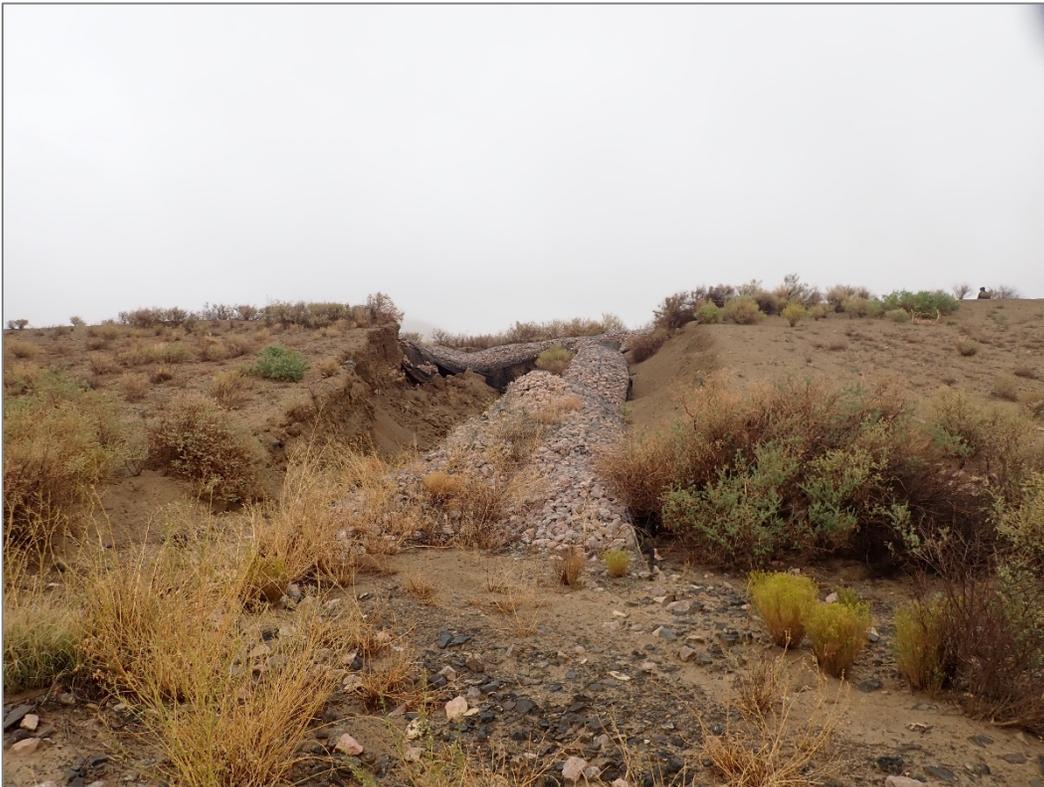
PL-16. Runoff Control Structure G

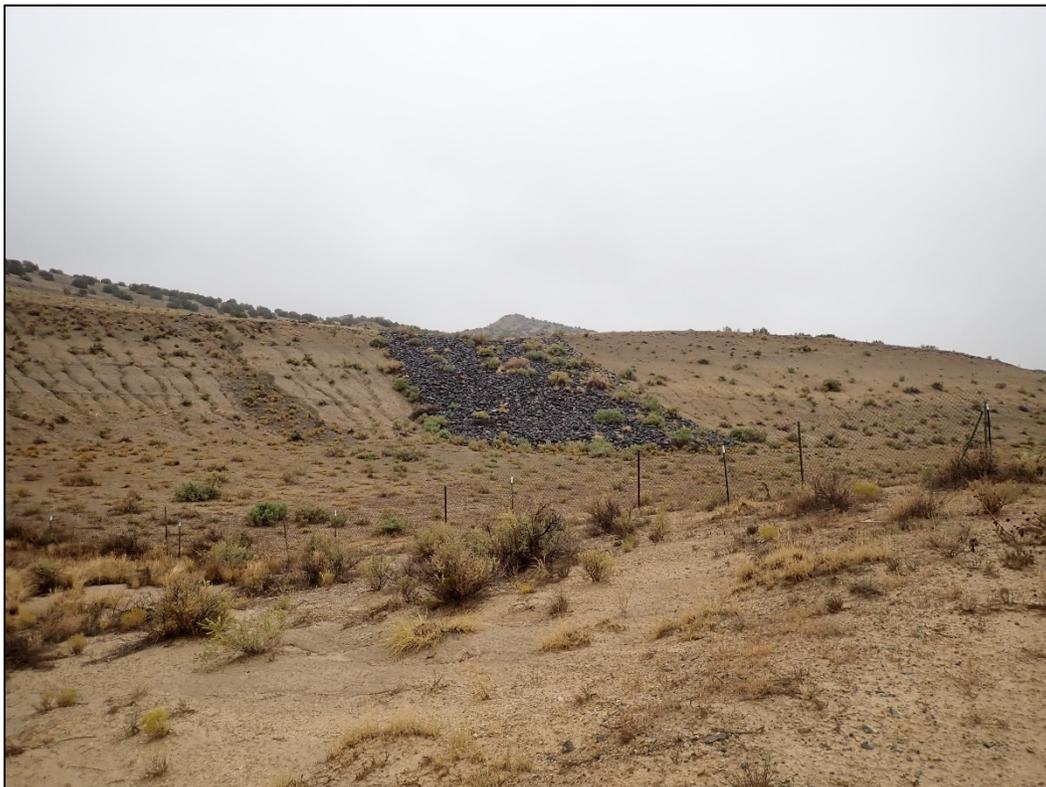
PL-18. Armored Side Slope Near South Channel

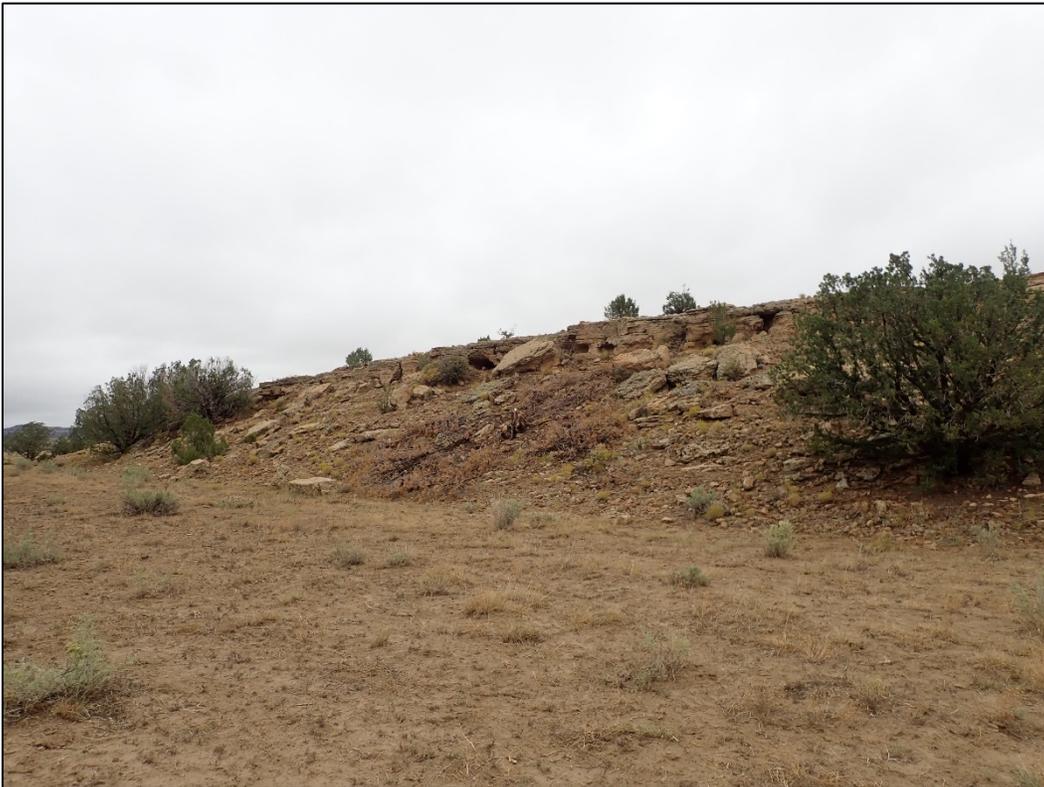
PL-20. Tres Hermanos Sandstone Outcrop

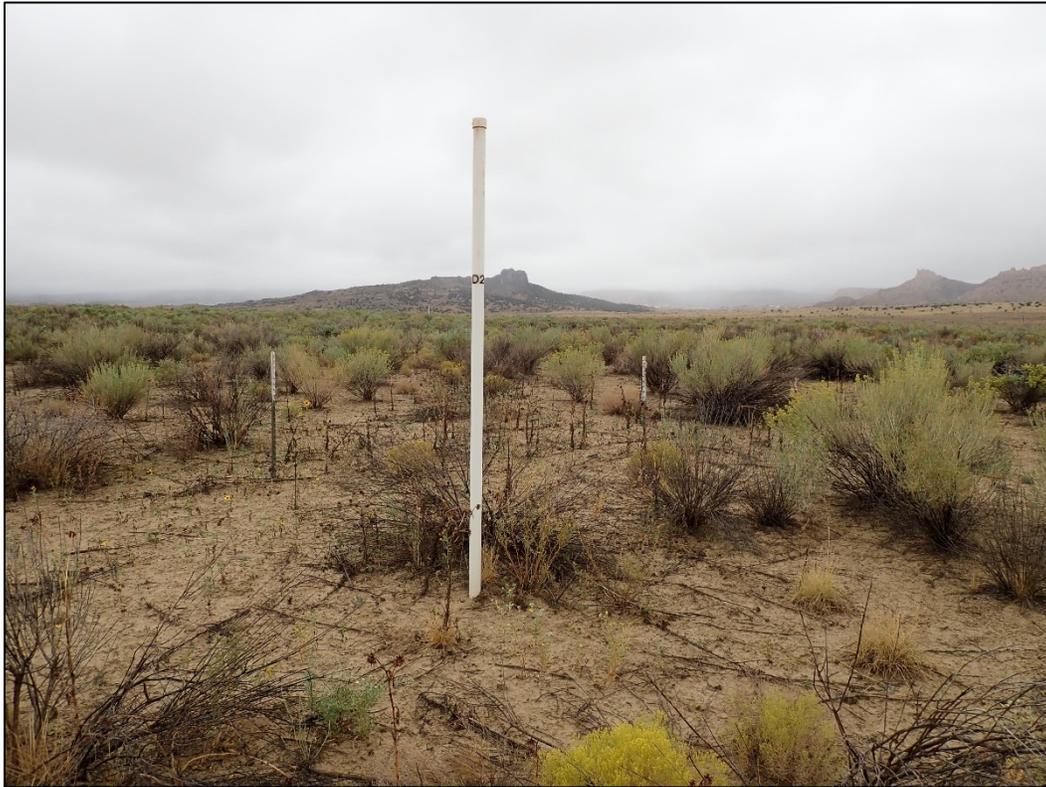
PL-21. Erosion Monitoring Location D2

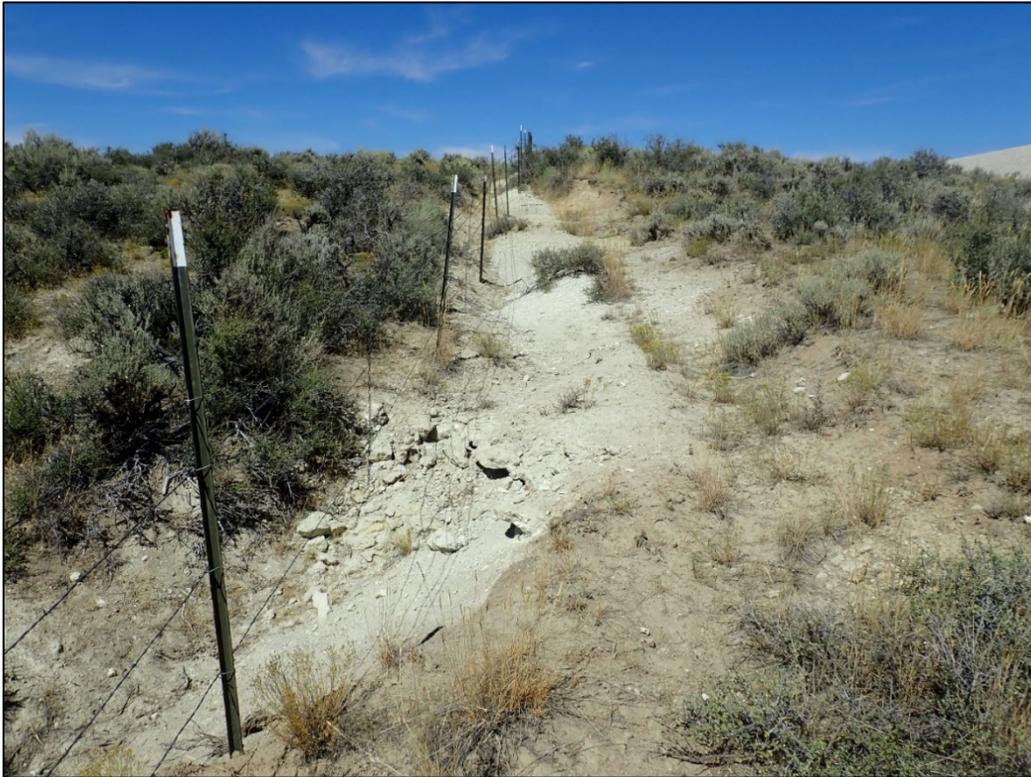
Gullies were observed west of Diversion Channel No. 2, and slight rilling under the northern and southwestern perimeter fence was also observed. None of this erosion currently threatens the integrity of the main disposal cell, ancillary cell, or associated surface water diversion structures; monitoring of this erosion will continue. Minor maintenance needs associated with the perimeter fence, a boundary monument, and perimeter signs were identified. Inspectors identified no cause for a follow-up inspection. Groundwater monitoring is not required at the site.

PL-1. Erosion Along Western Perimeter Fence South of Perimeter Sign P7

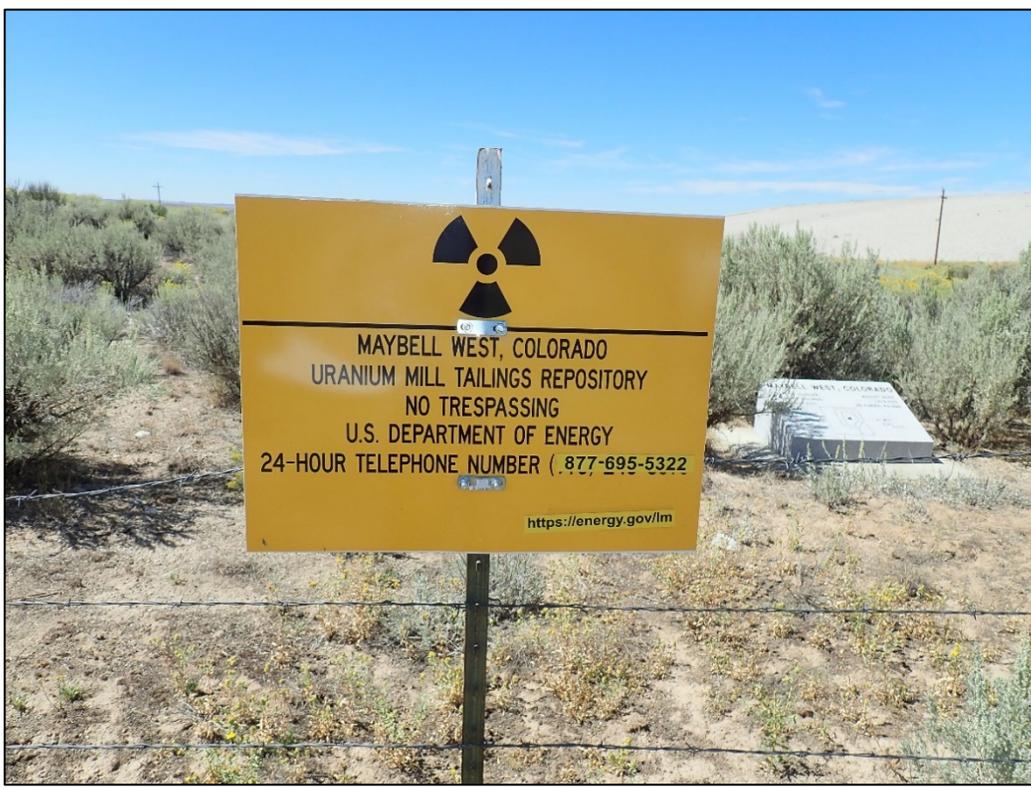
The entrance sign is mounted on a metal T-post directly south of the entrance gate (PL-2). Ten warning or perimeter signs are mounted on metal T-posts around the site (PL-3). Perimeter sign P2 was found to be missing at the time of the inspection and was replaced during a routine maintenance trip on September 23, 2020. No other maintenance needs were identified.

PL-2. Entrance Sign
