U.S. DEPARTMENT OF
ENERGY

Legacy
Management

2020 Annual Site Inspection and Monitoring Report for Uranium Mill Tailings Radiation Control Act Title II Disposal Sites

December 2020

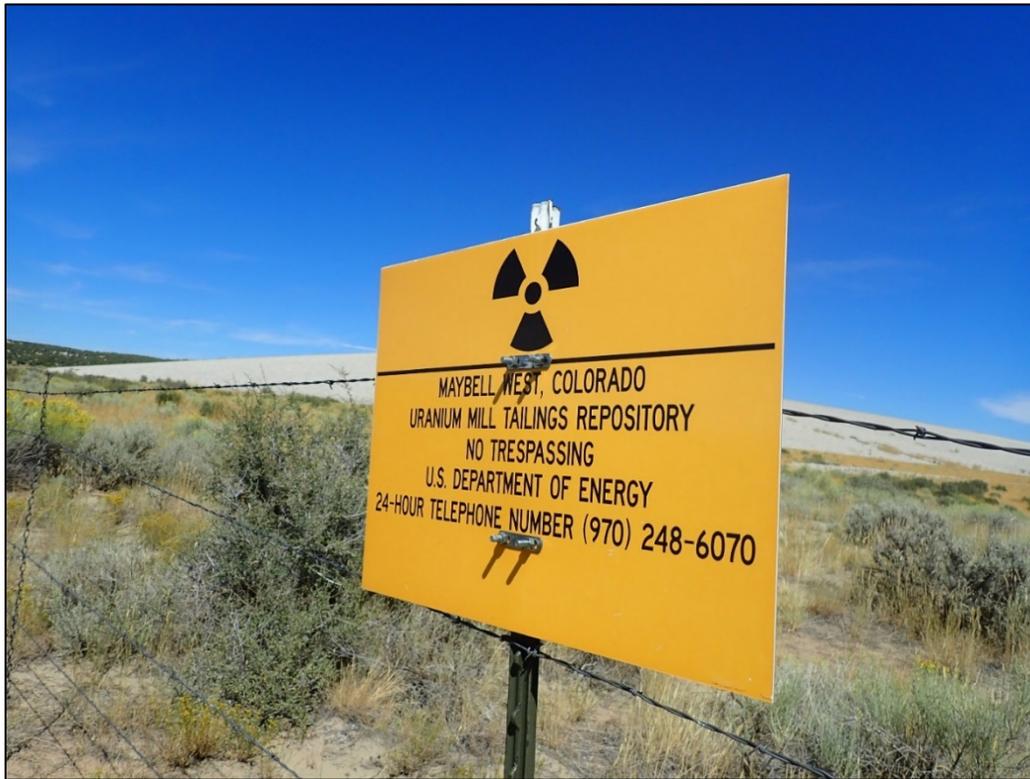
The entrance sign is mounted on a metal T-post directly south of the entrance gate (PL-2). Ten warning or perimeter signs are mounted on metal T-posts around the site (PL-3). Perimeter sign P2 was found to be missing at the time of the inspection and was replaced during a routine maintenance trip on September 23, 2020. No other maintenance needs were identified.

PL-3. Perimeter Sign P7

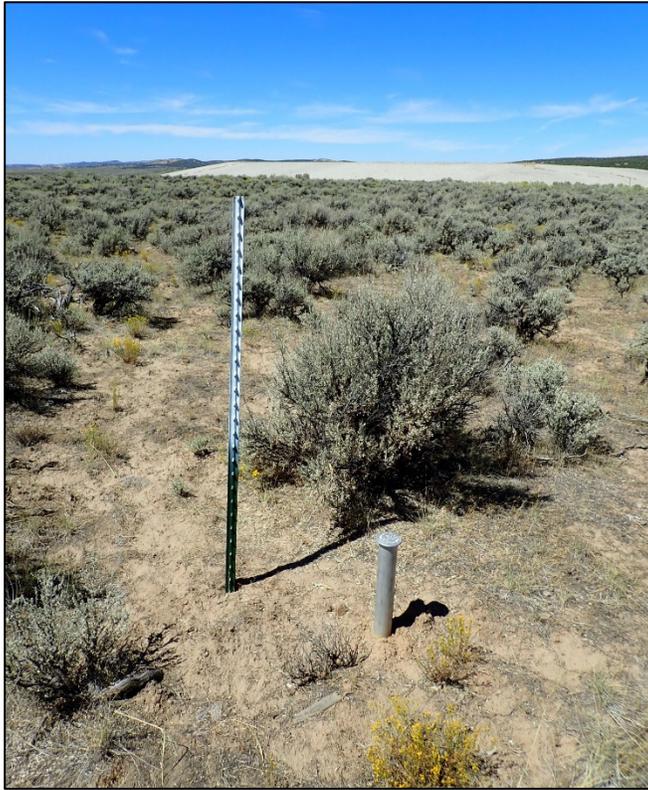
Eight boundary monuments are on the site boundary outside the fenced area (PL-5). Four of the monuments are at the property corners, and the other four define an approximate 20-foot offset along the north and south boundaries where the private land that LM acquired in fee adjoins the BLM withdrawal area on the western portion of the site. Boundary monuments BM-3 and BM-6 (capped pieces of rebar) define the two 20-foot offsets. Boundary monument BM-3 (PL-6) was first observed to be bent during the 2017 annual inspection; since then attempts to straighten the monument were not successful; however the monument is still in place. A plastic rebar cap covering boundary monument BM-6 was observed to be broken at the time of the inspection and replaced during the September 23, 2020, routine maintenance trip.

PL-5. Boundary Monument BM-8

- Noxious weeds treated with herbicide
- Repaired three areas of the perimeter fence
- Replaced missing P2 perimeter sign
- Replaced plastic rebar cap covering boundary monument BM-6

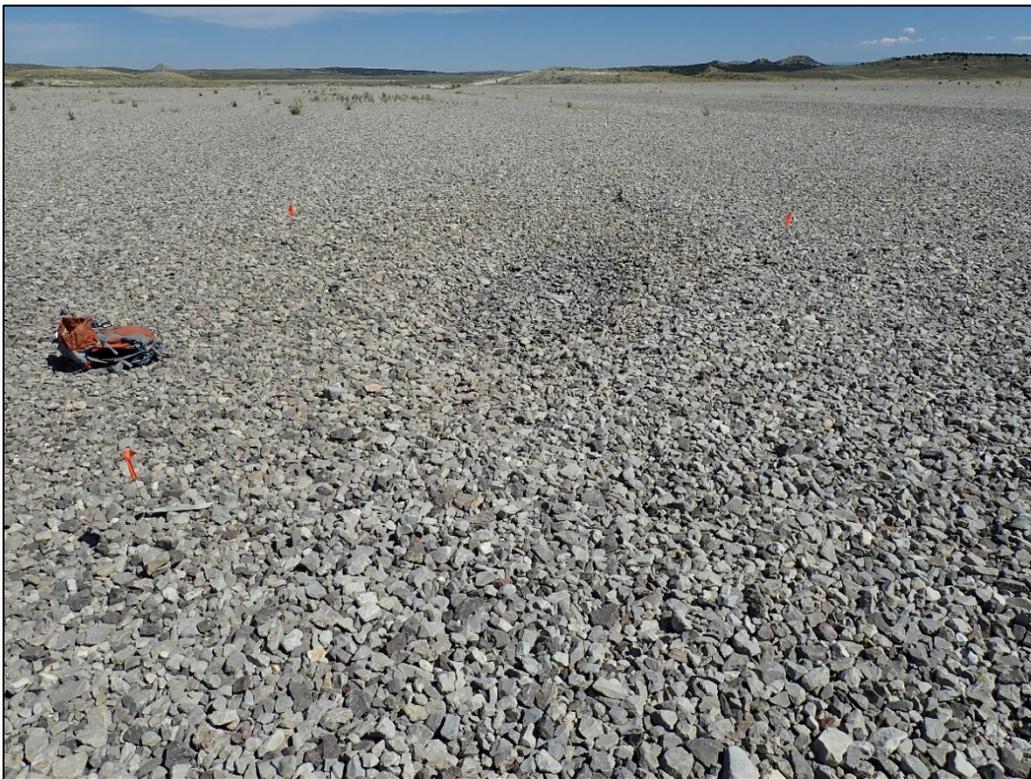
No standing water was observed in any of the depressions during the inspection. These depressions currently do not threaten the integrity or performance of the disposal cell. No maintenance needs were identified.

PL-8. Shallow Depression No. 1 on Disposal Cell Top Slope

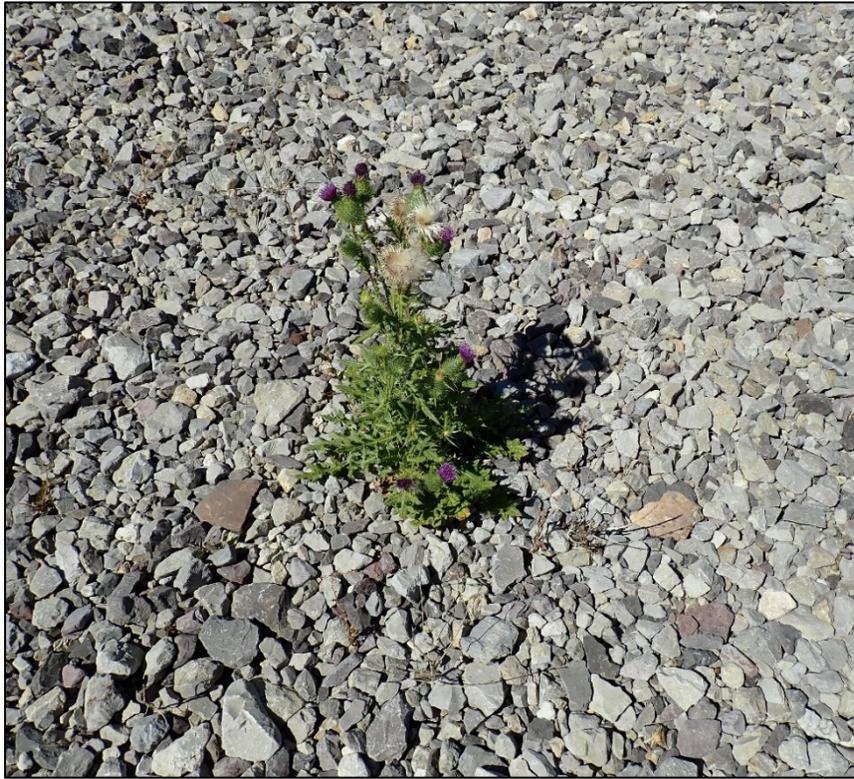
PL-11. Noxious Weed Growth on the Disposal Cell Surface

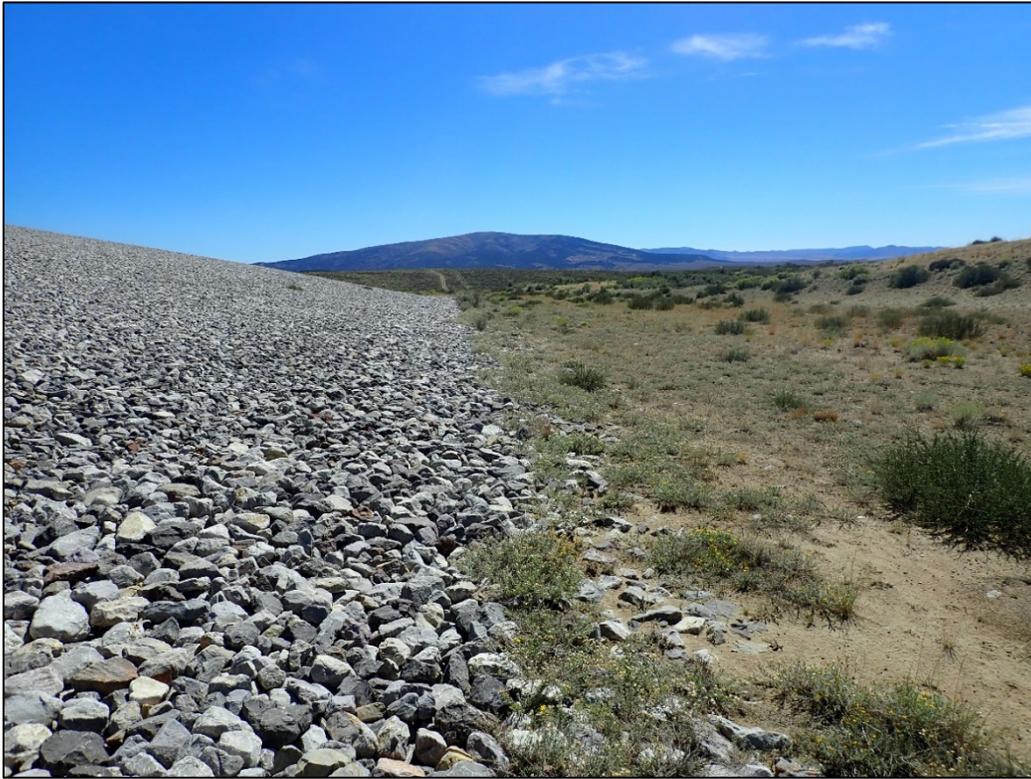
PL-13. Windblown Sediment Accumulating at Toe of Disposal Cell West Side Slope

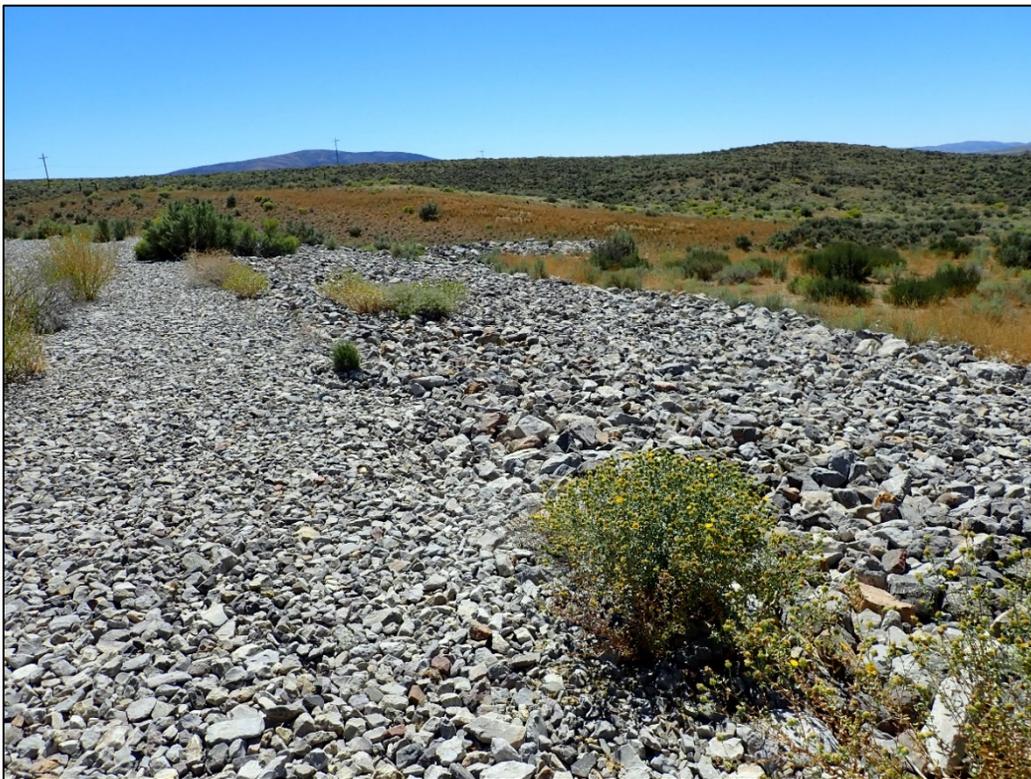
PL-16. Ancillary Cell West Side Slope with Small Depression on Cell Top Slope in Foreground

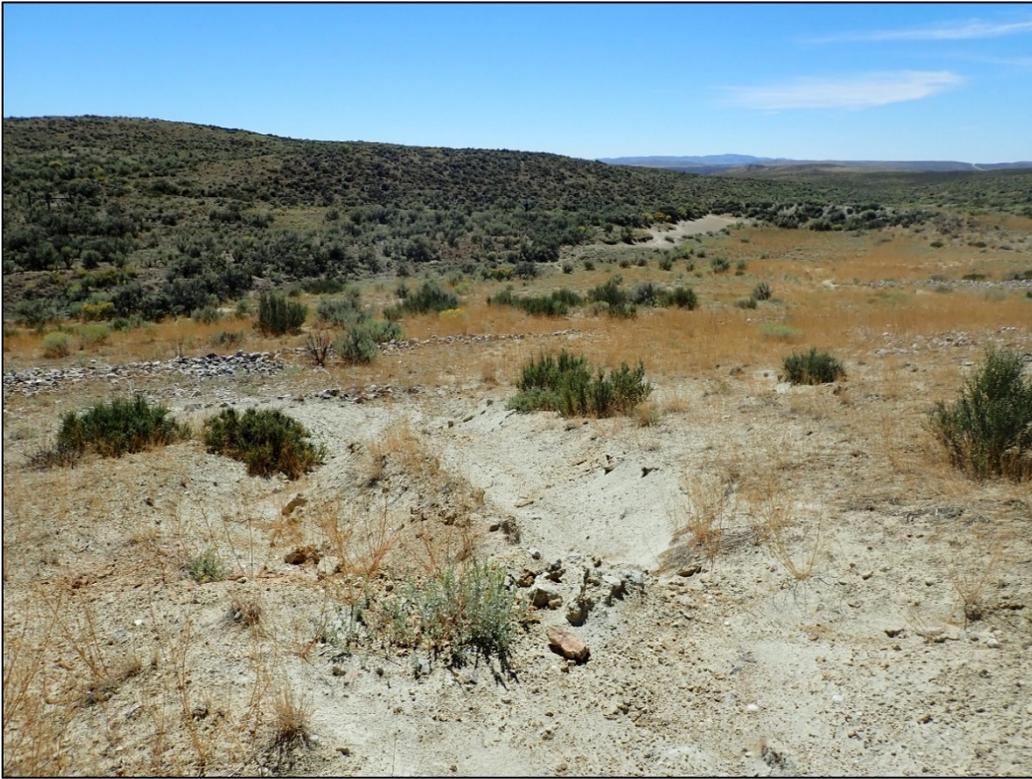
Gullies were observed west of Diversion Channel No. 2, and slight rilling under the northern and southwestern perimeter fence was also observed. None of this erosion currently threatens the integrity of the main disposal cell, ancillary cell, or associated surface water diversion structures; monitoring of this erosion will continue. Minor maintenance needs associated with the perimeter fence, a boundary monument, and perimeter signs were identified. Inspectors identified no cause for a follow-up inspection. Groundwater monitoring is not required at the site.

PL-21. Erosion Between Rock Berms West of Ancillary Cell

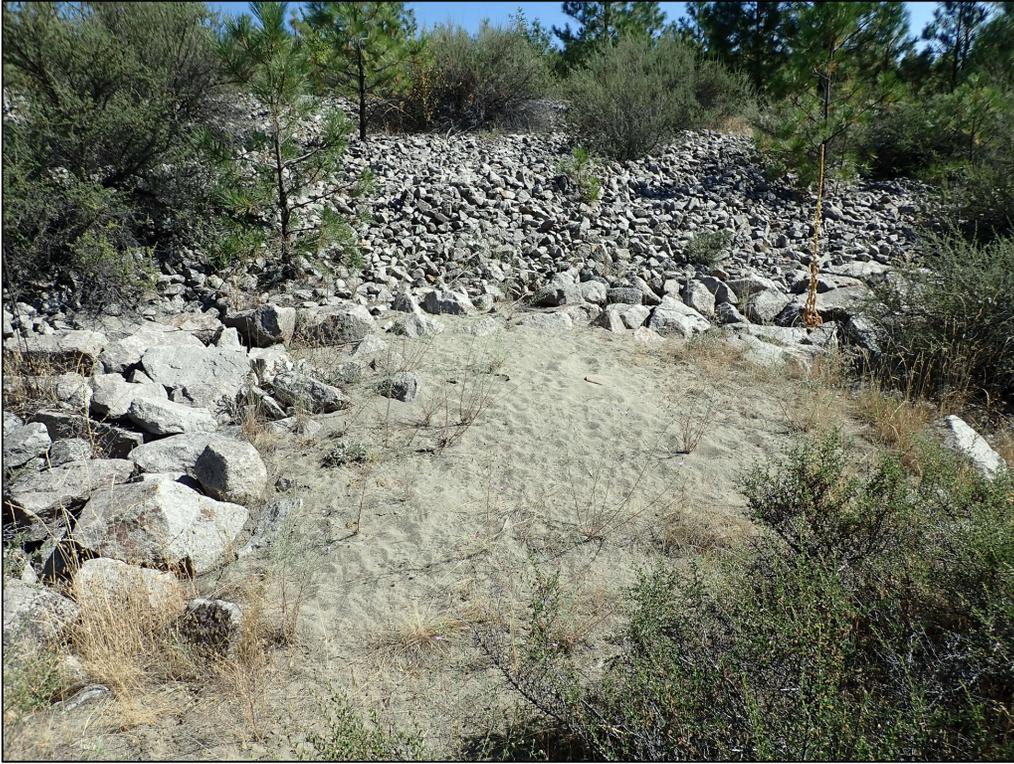
During the 2016 annual inspection, one location at the base of the rock-covered containment dam face was found to have a deposit of sand that had washed out from underneath the rock cover, as evidenced by a shallow rock-filled erosion feature upgradient of the deposit (Figure 5-1). A subsequent follow-up inspection and evaluation identified that the sandy material was the same as natural undisturbed material nearby. During reclamation, this area of the site was used as a source for fill material used to contour the area below the toe of the containment dam. Review of

PL-9. Sand Deposit at Toe of Containment Dam Outslope

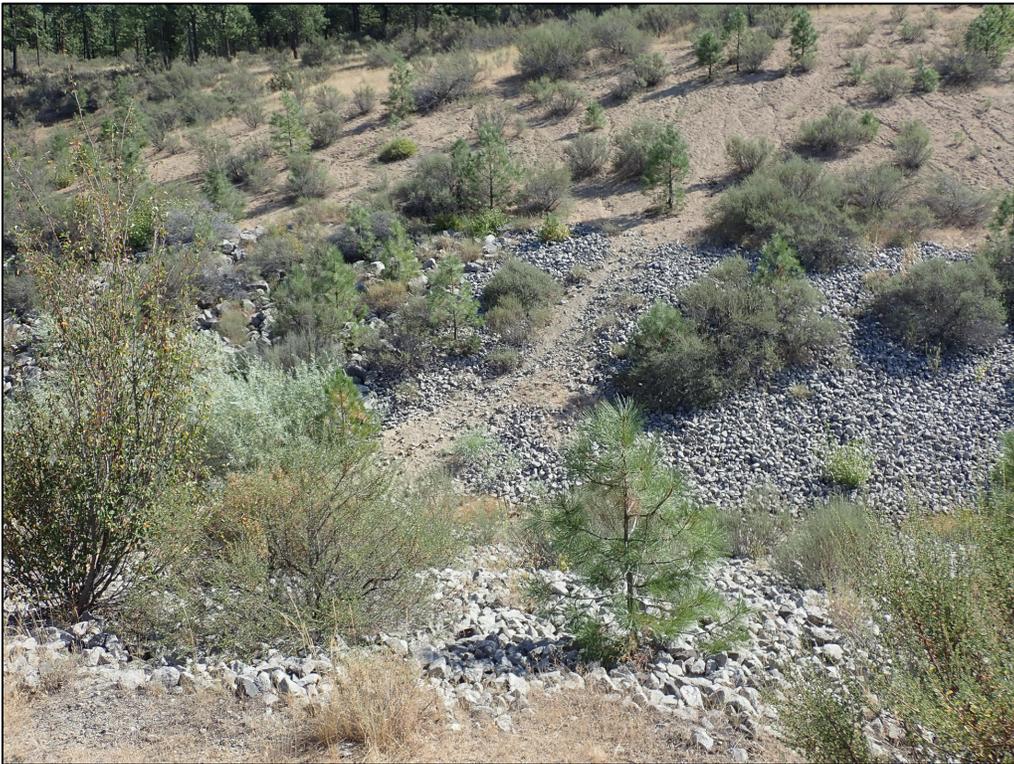
PL-10. Diversion Channel with Wildlife Trail

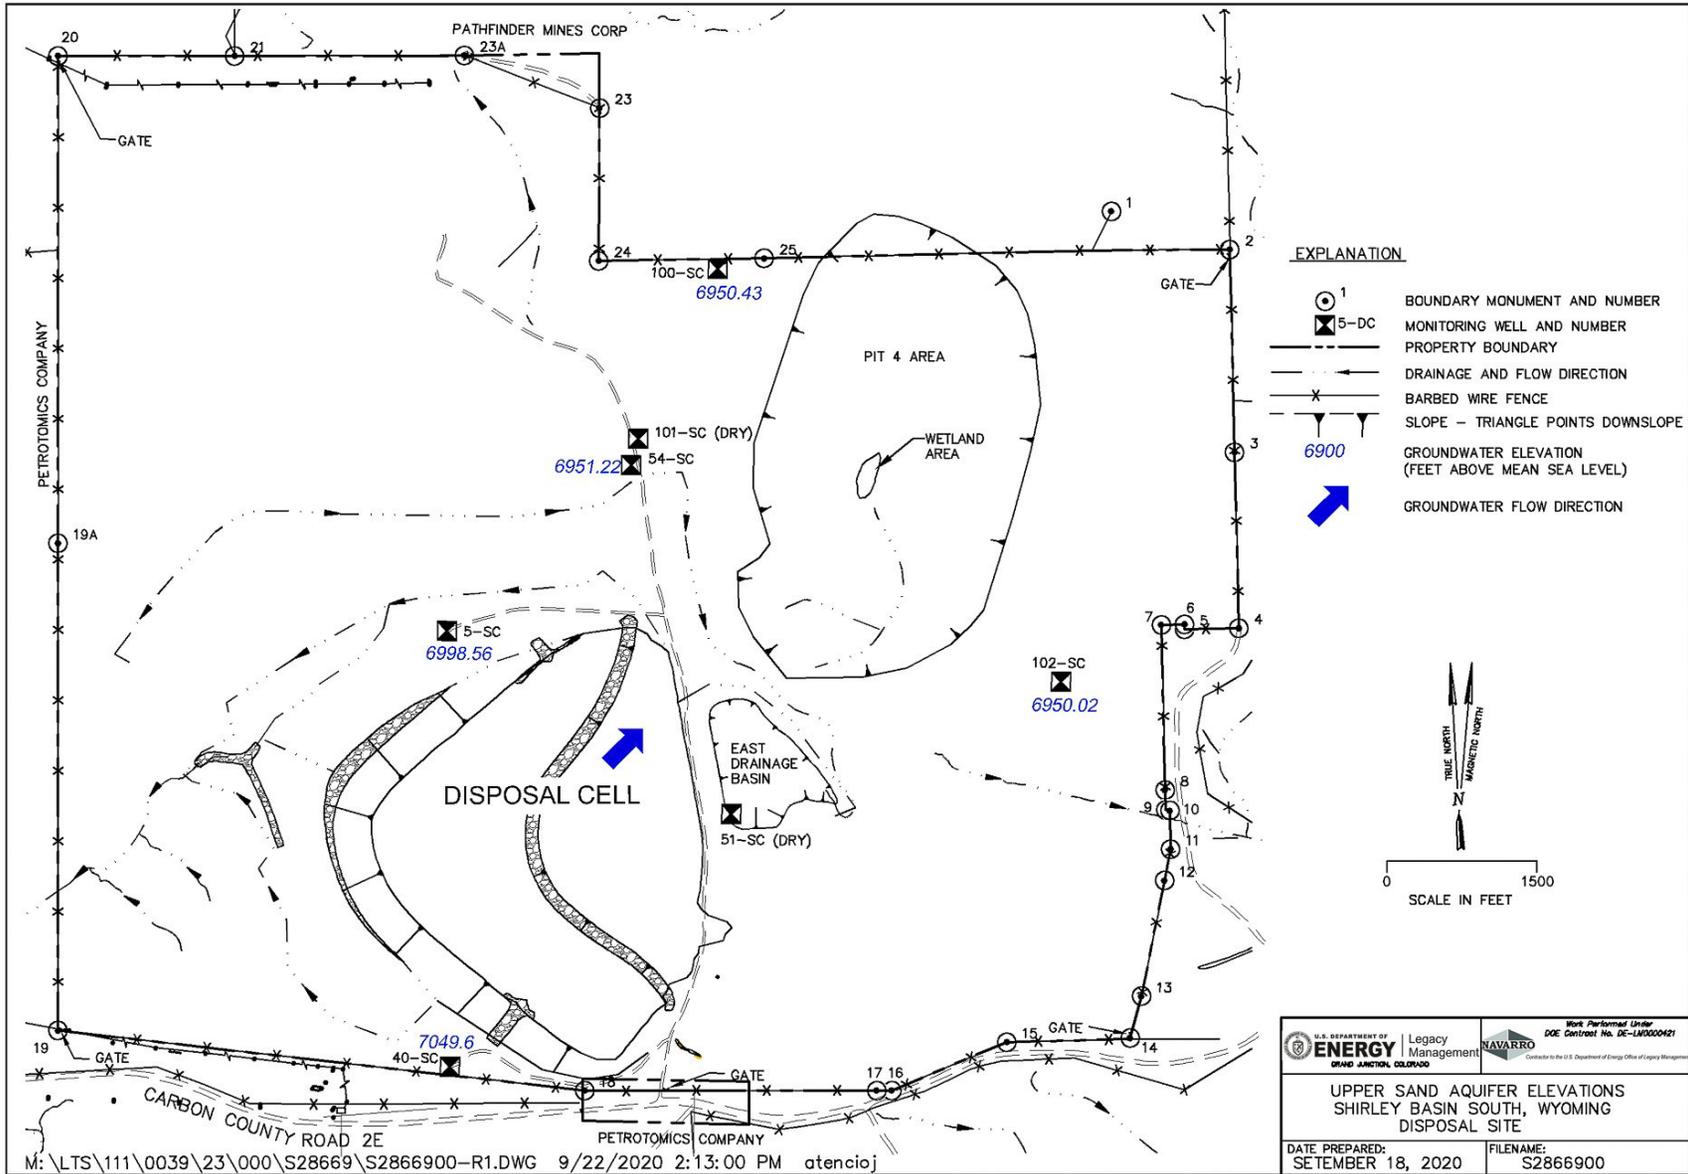
Figure 6-3. July 2020 Groundwater Elevations in the Upper Sand Aquifer at the Shirley Basin South, Wyoming, Disposal Site

The site map showing 2020 water level elevations for the Upper Sand Aquifer are shown in Figure 6-3, and water elevations over time are plotted in Figure 6-4. The LTSP specifies the inclusion of groundwater contour maps with the annual inspection report; however, as indicated in annual reports since 2005, the well network does not provide a spatial distribution of data points necessary to generate contours without significant uncertainty. Apparent groundwater flow direction within the Upper Sand Aquifer at the site is in the direction of structural dip and

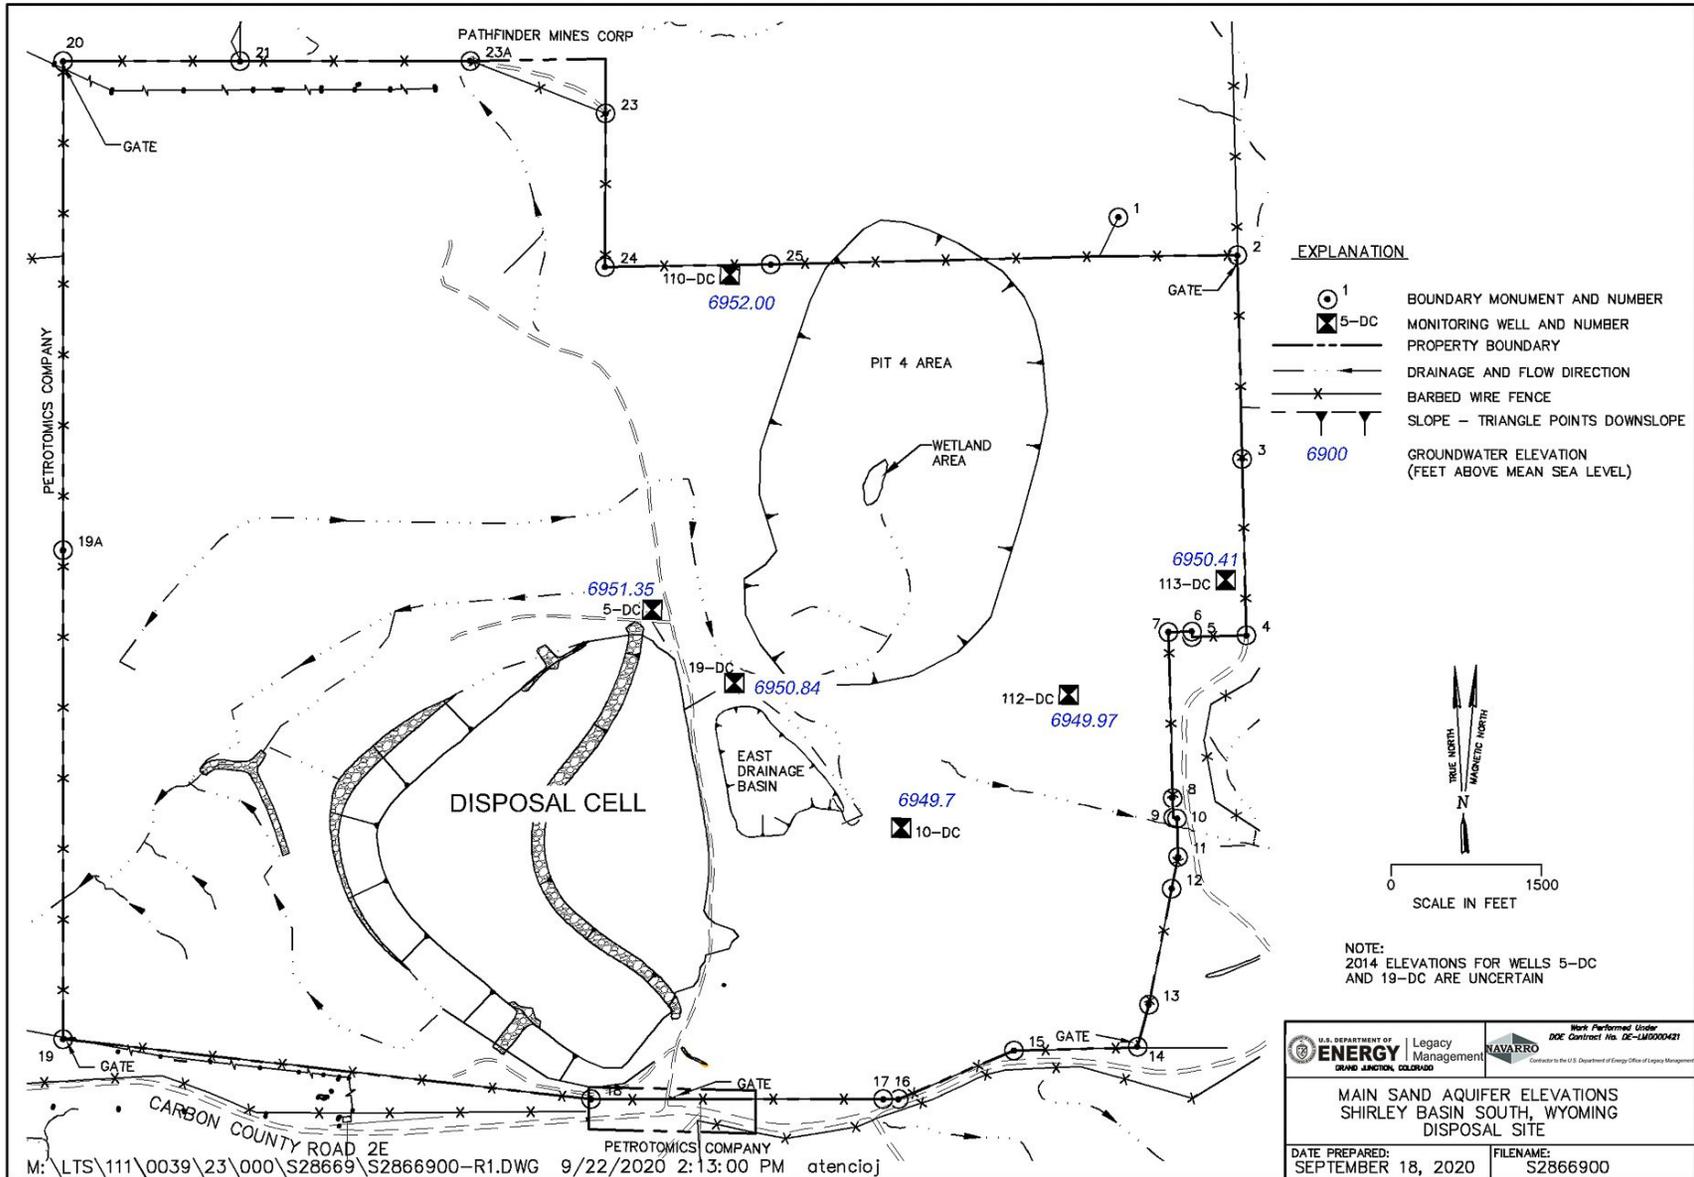
Figure 6-5. July 2020 Groundwater Elevations in the Main Sand Aquifer at the Shirley Basin South, Wyoming, Disposal Site

Figure 6-5 shows piezometric head measured in wells screened in the Main Sand Aquifer, and Figure 6-6 shows these water level trends over time. According to the water levels in the Main Sand Aquifer, the apparent flow direction in the aquifer is to the south-southeast. The apparent flow direction from 2020 head data is different than the generally west flow direction reported in 2010 (DOE 2013) and the flow direction predicted for 2020 by the former licensee's model (Petrotonics 1996).

Well 110-DC was considered a downgradient well at the time of installation, when groundwater flow direction in the Main Sand Aquifer was generally to the north-northeast. However, due to the recent changes in flow direction, well 110-DC is hydraulically upgradient from the disposal cell (Figure 6-5). Well 54-SC is near the Pit 4 area where the Upper Sand and Main Sand units coalesce. Both the Upper Sand and Main Sand Aquifers at the site were dewatered during mining and remediation and are recovering. Consequently, periodic increases in some constituent concentrations, such as ^{228}Ra , in the groundwater may represent a reestablishment of equilibrium of groundwater with naturally occurring constituents in the sand units (DOE 2011).

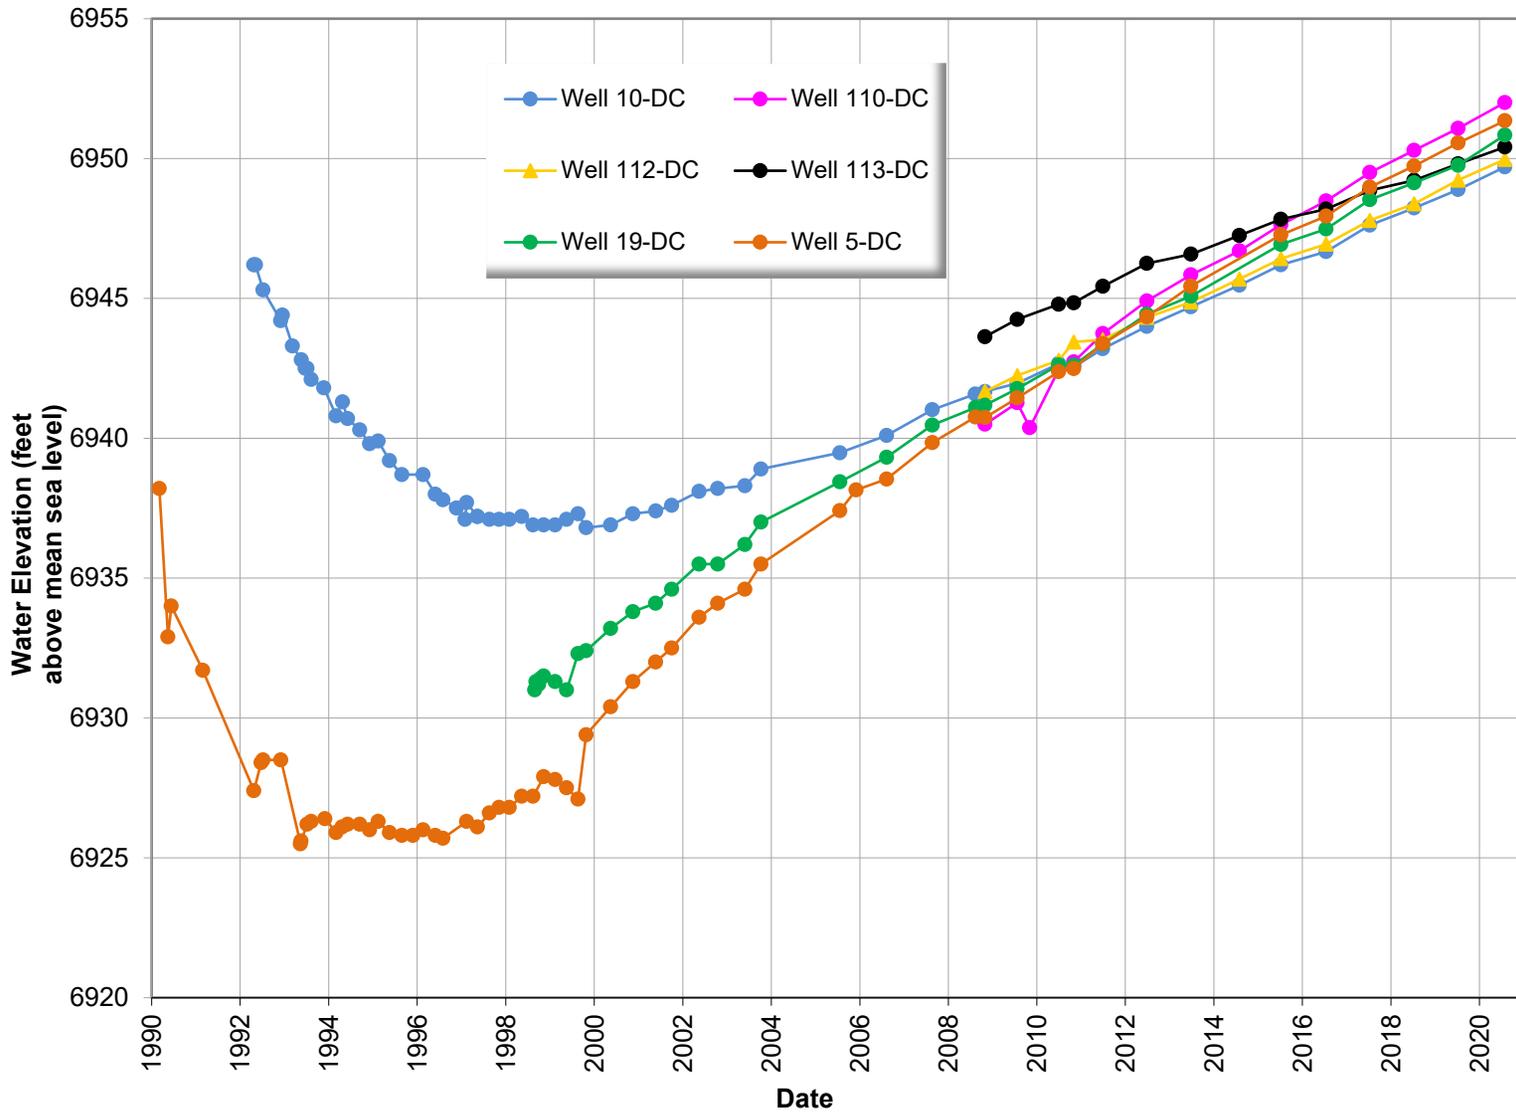
Figure 6-6. Hydrographs for Main Sand Aquifer Wells at the Shirley Basin South, Wyoming, Disposal Site

Piezometric heads have been gradually rising at all wells since 2000, with an average rate of increase of approximately 0.9 foot per year since LM began monitoring water levels in 2005 (Figure 6-6). The rising levels indicate a gradual recovery of the aquifer. However, the altered conditions at Pit 4 might prevent a return to premining elevations of the water table because the Upper Sand and Main Sand units now coalesce. Ongoing hydrologic analysis will further elucidate possible influences on aquifer recharge at the site, as well as changes in regional flow direction over time.

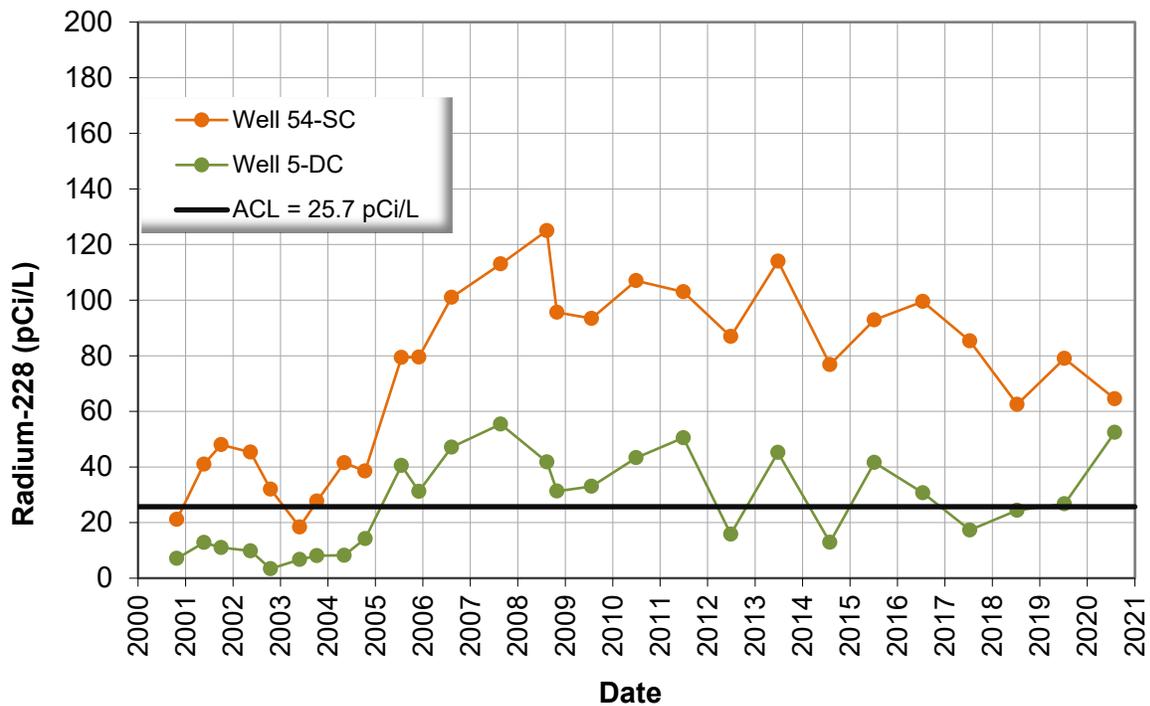
Figure 6-7. Radium-228 Concentrations in Wells 5-DC and 54-SC Since Completion of the Disposal Cell at the Shirley Basin South, Wyoming, Disposal Site

Time-concentration plots of ^{228}Ra are shown for wells 5-DC and 54-SC in Figure 6-7. Well 5-DC first exceeded the ACL for ^{228}Ra in 2005, after which concentrations have fluctuated above and below the ACL since 2012. As stipulated by the LTSP, NRC and WDEQ were notified of any exceedances in constituent ACLs. Although the ^{228}Ra concentration was elevated in well 54-SC, it is lower than the highest concentration measured in this well in the early 1990s (greater than 180 pCi/L) during site groundwater remediation activities (Petrotonics 1996). Radium-228 is a decay product of thorium-232 (^{232}Th), which is highly immobile. Because the half-life of ^{228}Ra is relatively short, ^{232}Th sources must be near monitoring wells 5-DC and 54-SC. Additionally, ^{226}Ra concentrations over time have been consistently above the ACL in well 110-DC since 2009 (Figure 6-8). Both elevated ^{226}Ra and ^{228}Ra in these site wells indicate continuous sources nearby.

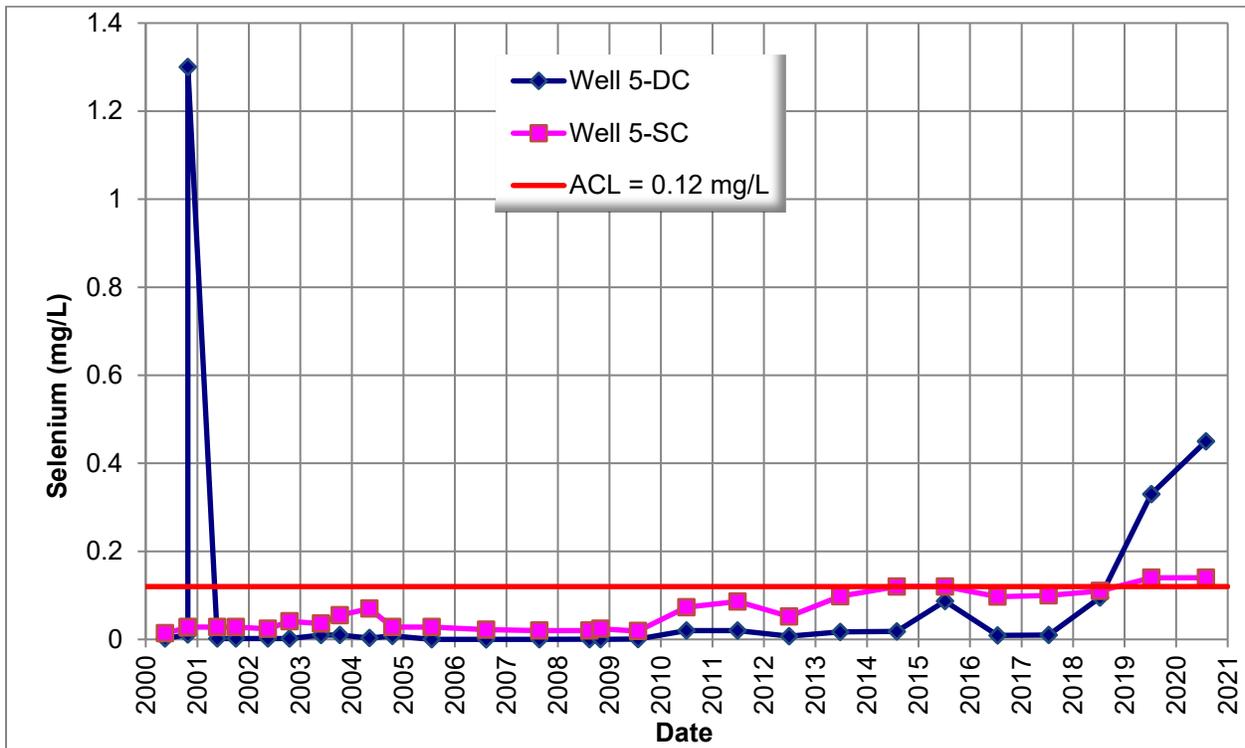
Figure 6-9. Selenium Concentrations at the Shirley Basin South, Wyoming, Disposal Site

In 2020, the ACL for selenium was exceeded in POC and Upper Sand Aquifer well 5-SC and Main Sand Aquifer well 5-DC (Table 6-5 and Figure 6-9). Selenium concentrations were measured at the ACL of 0.12 milligrams per liter (mg/L) in well 5-SC in 2014 and 2015, and then they increased to exceed the ACL in 2019. Aside from an anomalously high selenium concentration of 1.3 mg/L in 2000, well 5-DC did not exceed the ACL until 2019 and further increased to 0.45 mg/L in 2020. Although the water levels in wells screened in the Main Sand Aquifer suggest the regional flow direction within the aquifer is oriented toward the south-southeast, it is unknown whether groundwater high in selenium from beneath the disposal cell is flowing in the direction of well 5-DC in the Main Sand Aquifer.

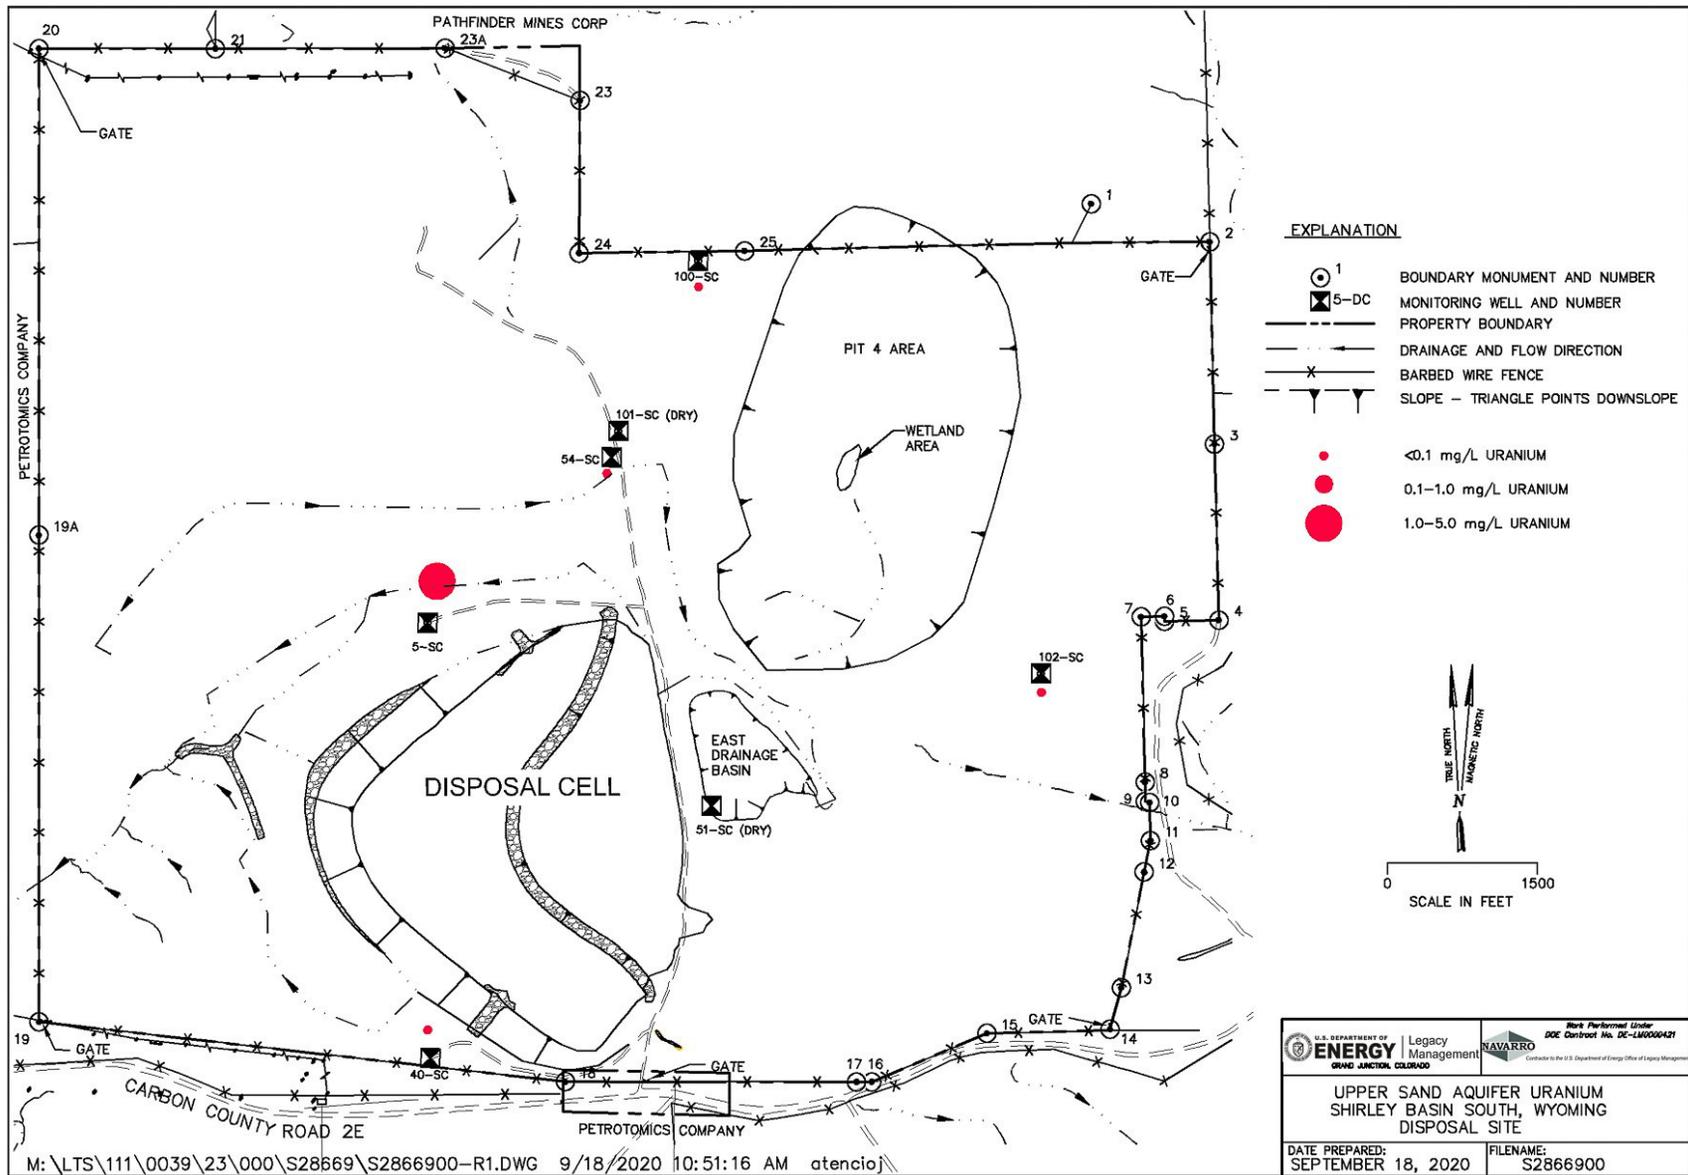
Figure 6-10. July 2020 Uranium Concentrations in the Upper Sand Aquifer at the Shirley Basin South, Wyoming, Disposal Site

The LTSP specifies that this report will include isoconcentration maps for uranium and sulfate in each aquifer; however, the monitoring well network does not provide sufficient data points to interpolate a statistically defensible interpolated contaminant plume for either aquifer. Uranium concentrations are shown in Figure 6-10 and Figure 6-11 for the Upper Sand and Main Sand Aquifers, respectively. Figure 6-12 and Figure 6-13 show sulfate concentrations for the 2020 sampling event. Uranium concentrations remain below the ACL; however, as stated above, sulfate concentrations exceeded the State of Wyoming groundwater protection standard of 3000 mg/L in Upper Sand Aquifer wells 5-SC and 54-SC and Main Sand Aquifer well 5-DC.
