**Subject:** [External\_Sender] Salem Generating Station - Incidental Take Reports: Atlantic  
Sturgeon 04/06/2021  
**Sent Date:** 4/7/2021 9:25:54 AM  
**Received Date:** 4/7/2021 9:26:39 AM  
**From:** Cary, Richard H.

### Appendix C, Part 2A (Sturgeon)

# STURGEON DATA COLLECTION FORM

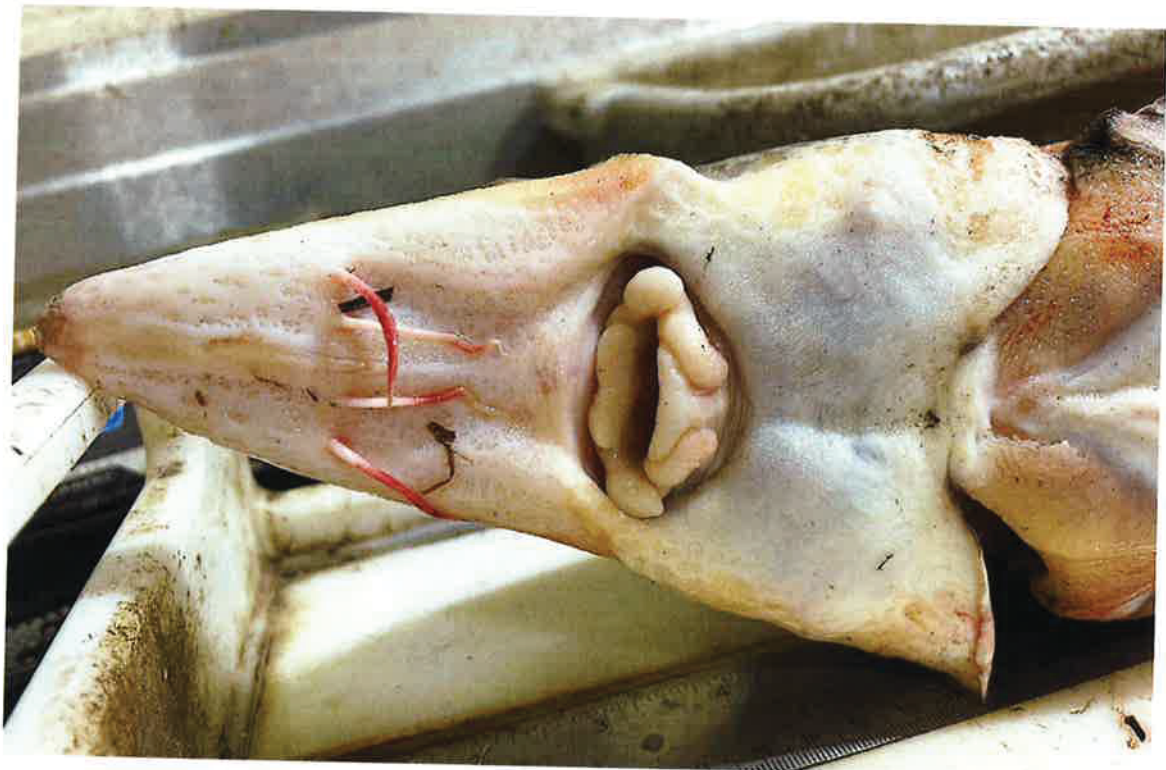
A ventral view of the specimen showing the characteristic long rostrum and small mouth (04/06/2021).

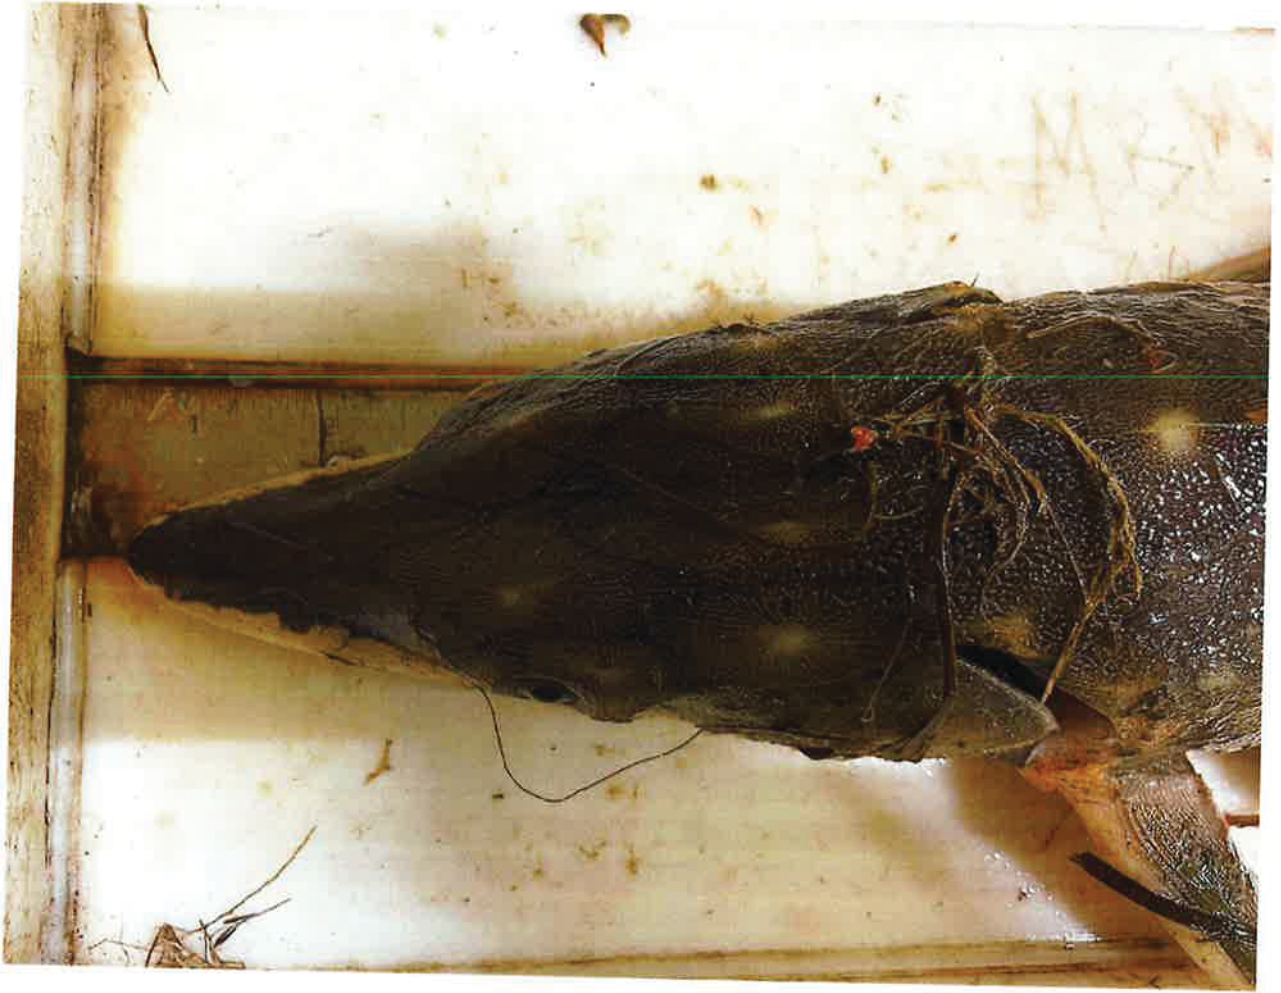
Describe any wounds / abnormalities (note tar or oil, gear or debris entanglement, propeller damage, etc.). **Please note if no wounds / abnormalities are found. Specimen was deceased at the time of collection due to an existing severe laceration, located dorsally and mid torso, which exposed damaged tissue, cartilage, and internal organs (refer to diagram above).**

A dorsal view of the specimen showing the characteristic elongated rostrum (04/06/2021).

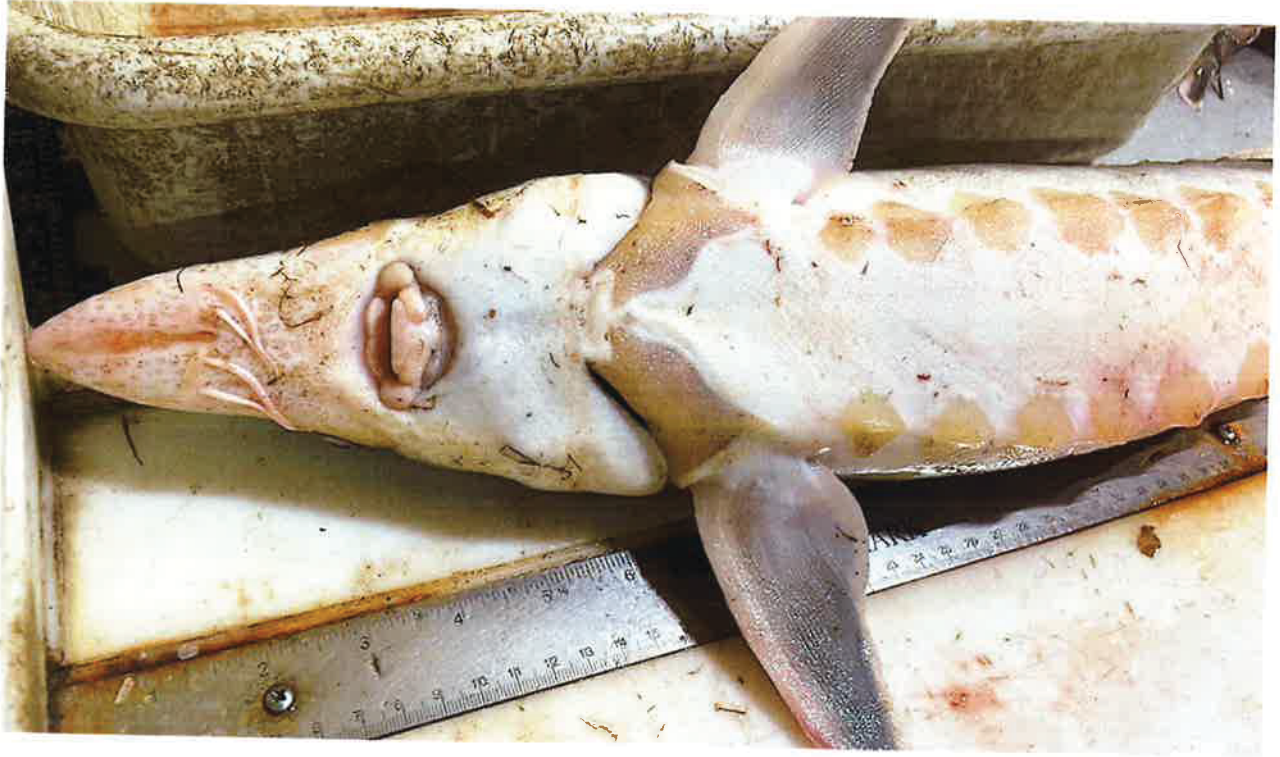
A ventral view of the specimen showing the characteristic elongated rostrum and small mouth (04/06/2021).

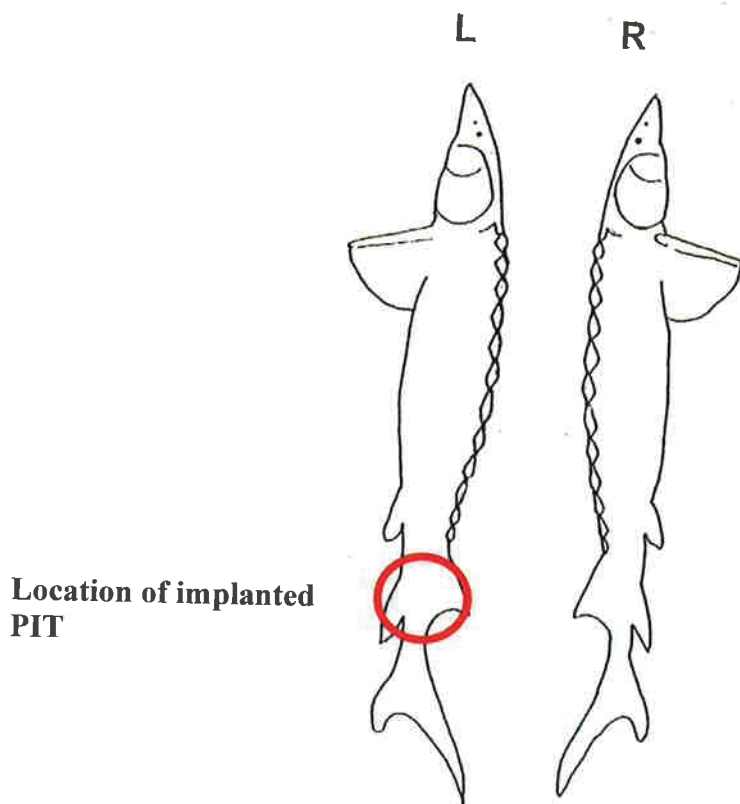
Describe any wounds / abnormalities (note tar or oil, gear or debris entanglement, propeller damage, etc.). Please note if no wounds / abnormalities are found. Specimen was alive at the time of collection, with no injuries observed. No PIT was indicated, so tagging procedures were implemented. Specimen received a PIT (#933000320184002), implanted below the dorsal fin on the left side (refer to diagram above).

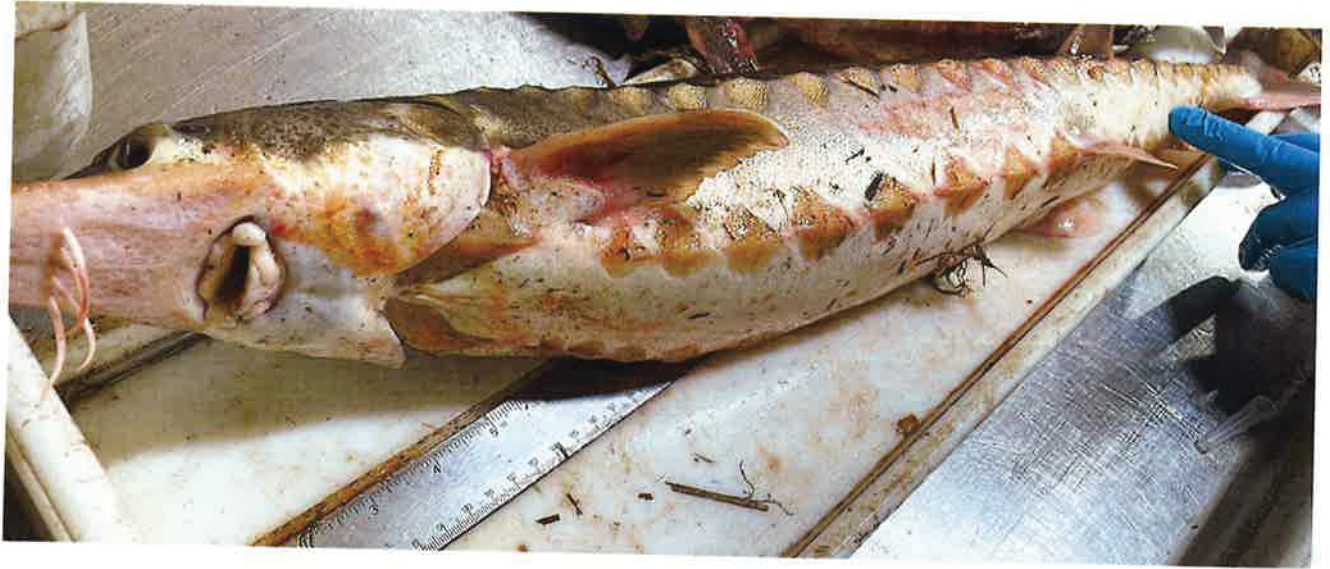
A ventral view showing the size and condition of a fourth Atlantic sturgeon (*Acipenser oxyrinchus*), retrieved alive at approximately 10:12AM on 04/06/2021 from the Salem Circulating Water Intake by Salem Yard Crew personnel during routine trash rack cleaning at Salem Nuclear Generating Station. Specimen exhibits the characteristic small mouth and elongated rostrum (04/06/2021).
