**Technical Letter Report
TLR-RES/DE/CIB-2021-06**

**Technical Assistance to Review American Society of
Mechanical Engineer's Boiler and Pressure Vessel Code
Case and Licensee Relief Requests for Carbon Fiber Repairs
Task-3: Mockup Testing and Physical Evaluation of Proposed
Carbon Fiber Reinforced Polymer Repair
Technical Letter Report**

Engineering Mechanics Corporation of Columbus (Emc²)
3518 Riverside Drive - Suite 202
Columbus, OH 43221-1735

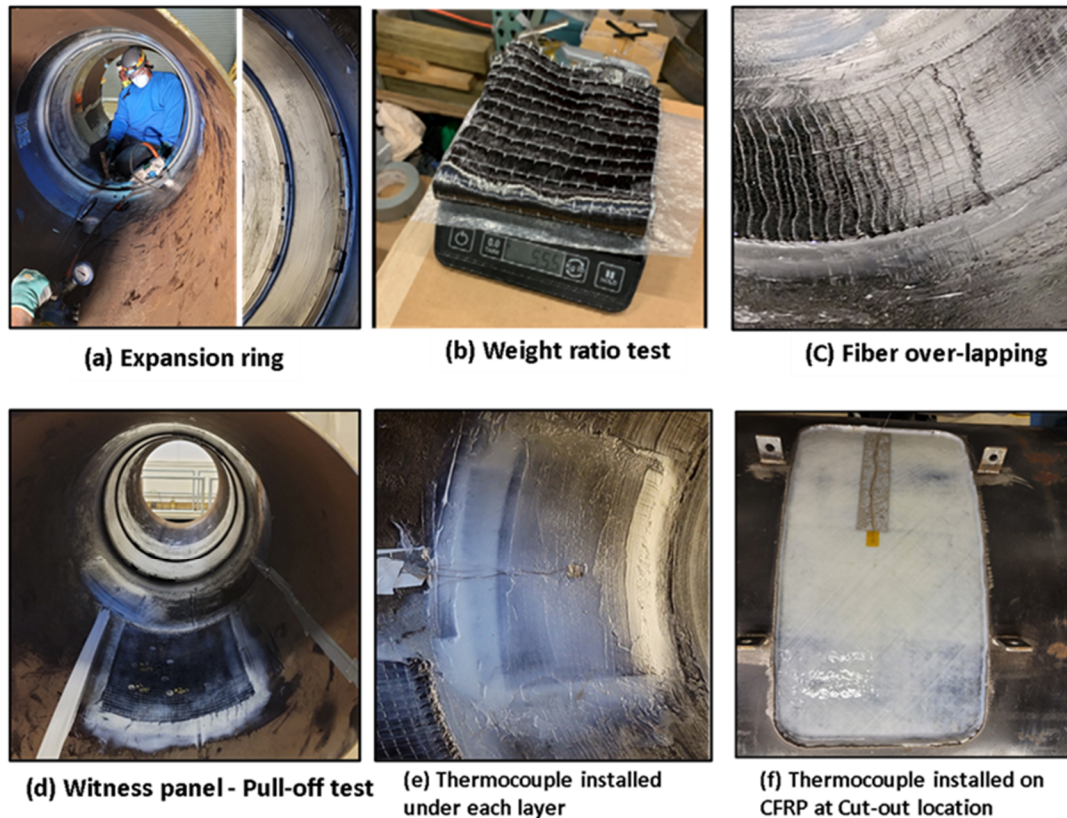
Figure 21 Some other steps in CFRP repair installation process

- Figure 21e shows the location of witness panel that was installed per Emc² guidance (not required by CC N-871). This witness panel was installed to monitor the curing temperature during installation. Emc² personnel installed one thermocouple on top of each layer (total of five layers) including one on the pipe, one on the top coat. These thermocouples were installed to investigate how the curing temperature varies for each composite layer as the curing progressed over 7 days.

- Figure 21f shows another thermocouple installed at the center of the cut-out on the inner-most epoxy layer.

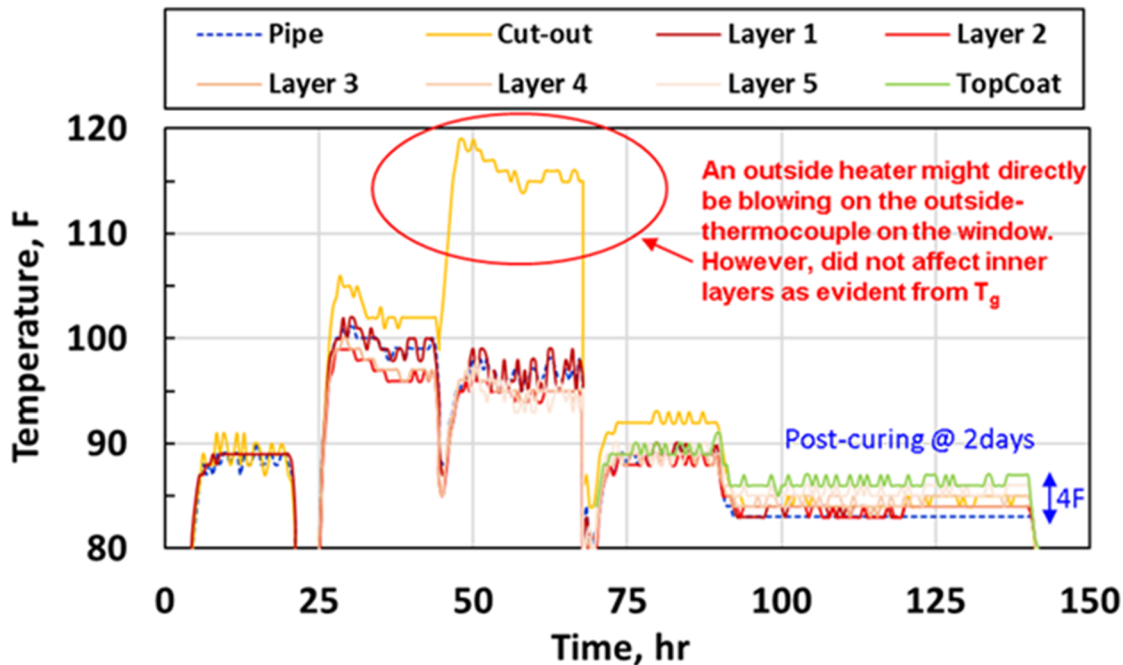
Figure 24 Temperature data from thermocouples installed under each layer of CFRP repair system over entire period of curing and post-curing

To monitor how the curing and post-curing temperatures vary for each composite layer over the entire period of curing and post-curing process, thermocouples were installed under each layer of composite layer by Emc² personnel (Figure 22b). Thermocouples were also installed on the pipe surface, top coat and cut-out window on the outside surface. Figure 24 shows the temperature data from all eight thermocouples installed under each layer of CFRP repair. *The main take away*

from this figure is that the range of curing temperatures among all composite layers are quite close to each other for any particular day suggesting that heat had been transferred reasonably through all composite layers and hence, all layers should experience similar curing condition. However, it should be also noted that the length of the test pipe (13-ft) and CFRP repair (2-ft) were relatively short as compared to long pipe and a repair installed under field conditions. During post-curing for 2 days, the temperature range on all composite layers, host steel pipe and top coat was within 4 F (between 83 F to 87 F). As may be noted in Figure 23, the thermocouple installed on the cut-out window outside the pipe on the inner-most layer of epoxy showed relatively high temperature (~120 F) on the 3rd day of curing as compared to other layers. After discussion with the installer, it was believed that a space heater placed outside the pipe may have been blowing directly on that particular thermocouple causing this anomaly. However, this did not affect the curing of the remaining layers as evident from the DSC results discussed in a later section.

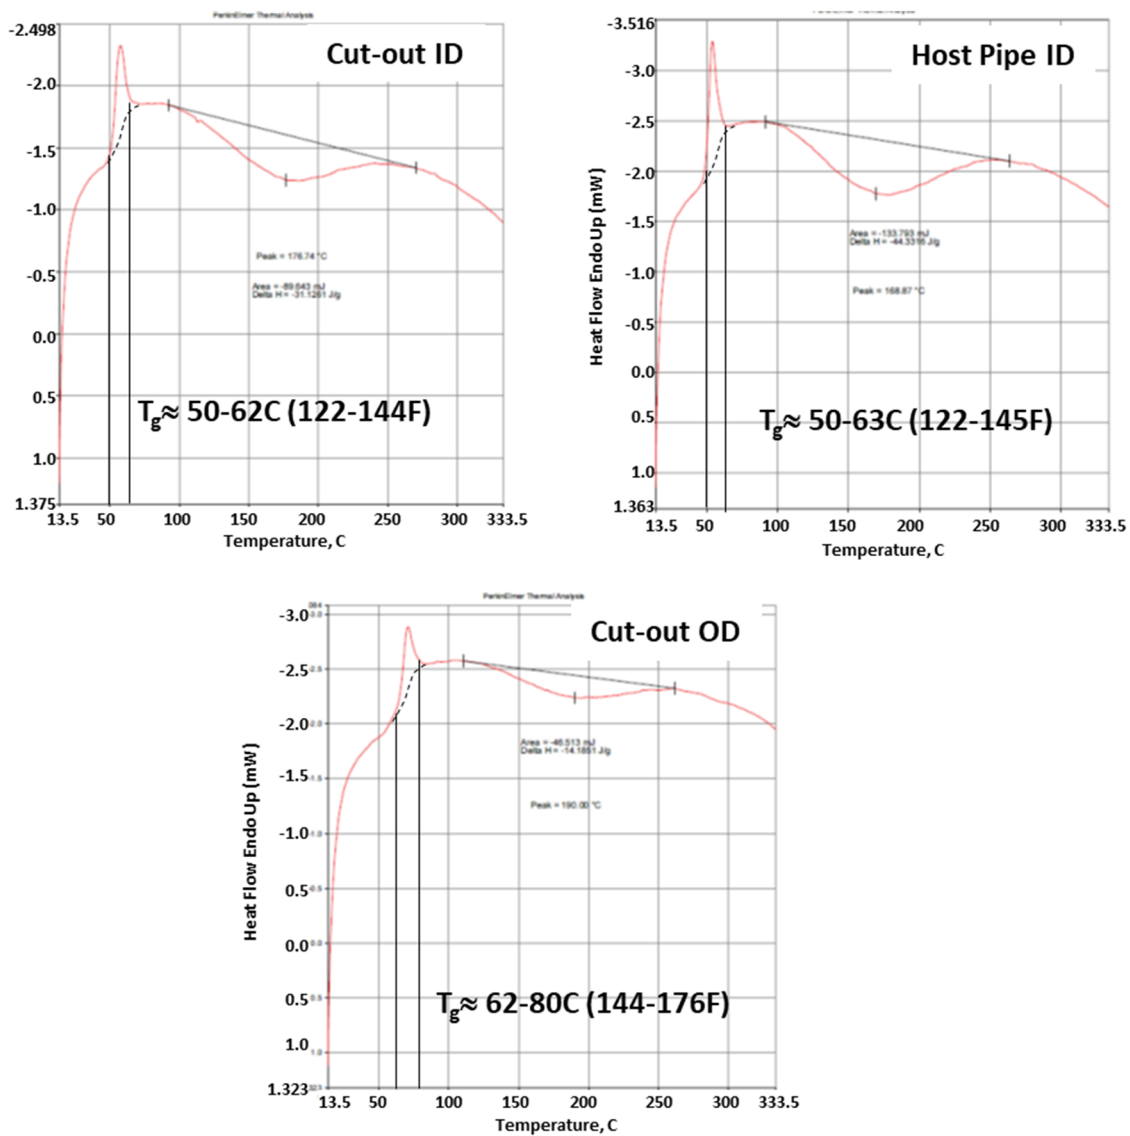
Figure 25 DSC results for three samples collected from CFRP repair system of the test

After post-curing for 2 days at around 85 F, three DSC samples were collected from three locations: Cut-out ID, Host Pipe ID from terminal end, and Cut-out OD. Samples were sent to SGH to run DSC on these samples as part of their installation procedure. DSC tests were conducted according to ASTM E2160-04(2018) using a PerkinElmer Sapphire Differential Scanning Calorimeter (DSC) which heated one sample at a time from an initial temperature of 20 C to a final temperature of 350 C at a rate of 20 C/min. Nitrogen purge gas was used at a flow rate of 200 mL/min. SGH reported that all three samples achieved more than 89% of curing meeting the CC N-871 requirement of achieving a minimum of 85% curing (see Table 11). The heat flow versus temperature curves from DSC tests for three samples are given in Figure 25 (high resolution figures are given in Appendix D, Attachment D1, page 144-146) which were used to determine heat of cure to evaluate the degree of cure by comparing against a calibrated heat of cure. As a part of the installation procedure per CC N-871 recommendation, the user only needs to evaluate the degree of curing. However, as discussed previously, the glass transition temperature (T_g) of epoxy also needs to be evaluated to ensure that the T_g is higher than the maximum design temperature by a minimum specified value amount (CC N-871 currently suggests this value to be 40 F; confirmatory tests are ongoing on the related NRC project to verify this value). Emc² conducted an independent analysis of DSC results shown in Figure 25 to estimate the T_g for these three samples. As seen in this figure, T_g for specimens collected from “Cut-out ID” and “Host pipe ID” are very similar (122 F-145 F) and within the range of 140 F for 85 F curing temperature. Whereas T_g for specimen from “Cut-out ID” was higher (144 F-176 F) which may be attributed to the higher curing temperature (120 F on Day 3 curing as shown Figure 24). Note that each DSC results showed a peak around the T_g area which may be attributed to heat relaxation. However, the presence of these peaks made the determination of T_g difficult.

Samples	Heat of Cure, (J/g)	Degree of Cure (%)	T_g (C)	T_g (F)
Cut-out ID	-31	92	50-62	122-144
Host Pipe ID	-44	89	50-63	122-145
Cut-out OD	-14	97	62-80	144-176

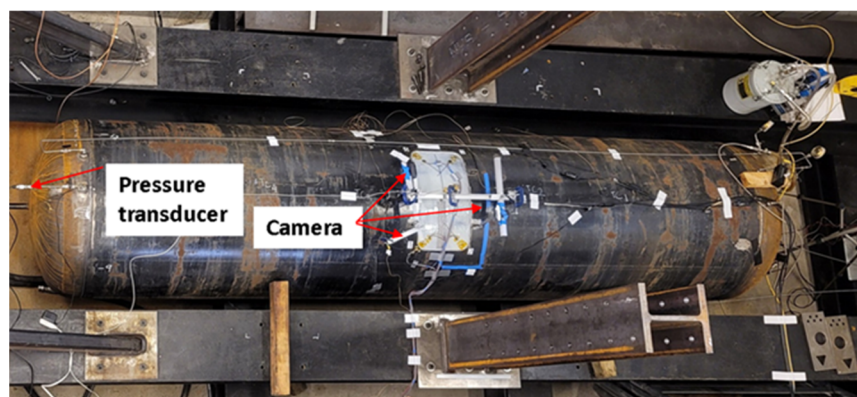
Figure 28 Instrumentation for the full-scale hydrostatic test

Figure 28 shows the detailed instrumentation installed on the host steel pipe and CFRP repair system. There was one pressure transducer, one LVDT on the CFRP at the center of the cut-out measuring the bulging of CFRP system and one thermocouple at the cut-out location measuring the test temperature. There were 15 strain gages mounted on CFRP – 3 strain gages forming a triaxial set on each of four corners of the cut-out and another triaxial set at the center of the cut-out on CFRP. Each triaxial set was placed to measure hoop, longitudinal and 45° strains on CFRP. The 3 strain gages forming a triaxial set were mounted on the steel host pipe at one of the corners of the cut-out. The strain values from these strain gages were monitored live during the test to ensure the strain on the pipe material would not exceed the yield strain. Four cameras and LED light strips were installed underneath the shield to record the video covering the whole area of the cut-out and instrumentation. Several NRC staff were originally planning to visit Emc² to witness the full-scale hydrostatic test. Due to COVID-19 pandemic and travel restrictions, the entire full-scale hydrostatic test was live streamed to NRC staff via multiple cameras.

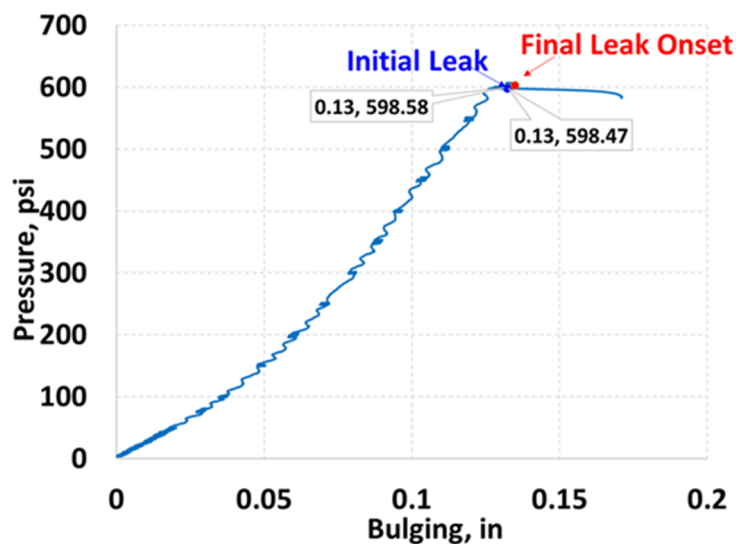
Figure 31 Pressure versus bulging during the hydrostatic test

Figure 31 shows the pressure versus bulging data and Figure 32 shows the temperature data during the hydrostatic test. As seen in Figure 31, maximum bulging of the CFRP repair system at the center of the cut-out was 0.13 inch at 600 psi failure (leak) pressure. The test temperature was 72 F for the entire period of the hydrostatic test.
