Regulatory Conference Related to Davis-Besse EDG FFSS Finding

February 1, 2022

Summary of EDG#1 FFSS Failure

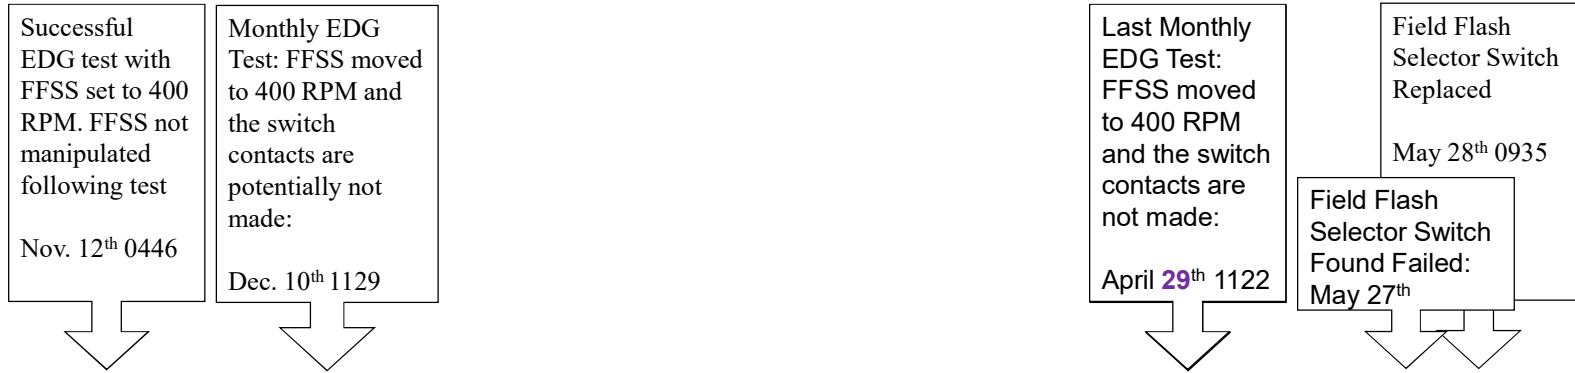
Exposure Time – EDG#1 FFSS Failure

Standard T/2:
T/2=98.6

T/2 Analysis would be Nov. 12 2020 0446 to May 28th 0935 2021: 197.2 days, T/2=98.6

TIME UNKNOWN IF FFSS WAS FAILED
NRC USING T/2 Nov. 12th to April 27th
NRC using 166 days or T/2= 83.

TIME KNOWN FFSS WAS FAILED
Full T for April 27th 2021 to May 28 2021 17:30.
NRC is using 31 days .

TIME UNKNOWN IF FFSS WAS FAILED
November 12th should be December 10th
April 27th Date should be April 29th
T=140, T/2=70

TIME KNOWN FFSS WAS FAILED
April 27th should be April 29th. T=29
EDG was available at 0935 not 17:30

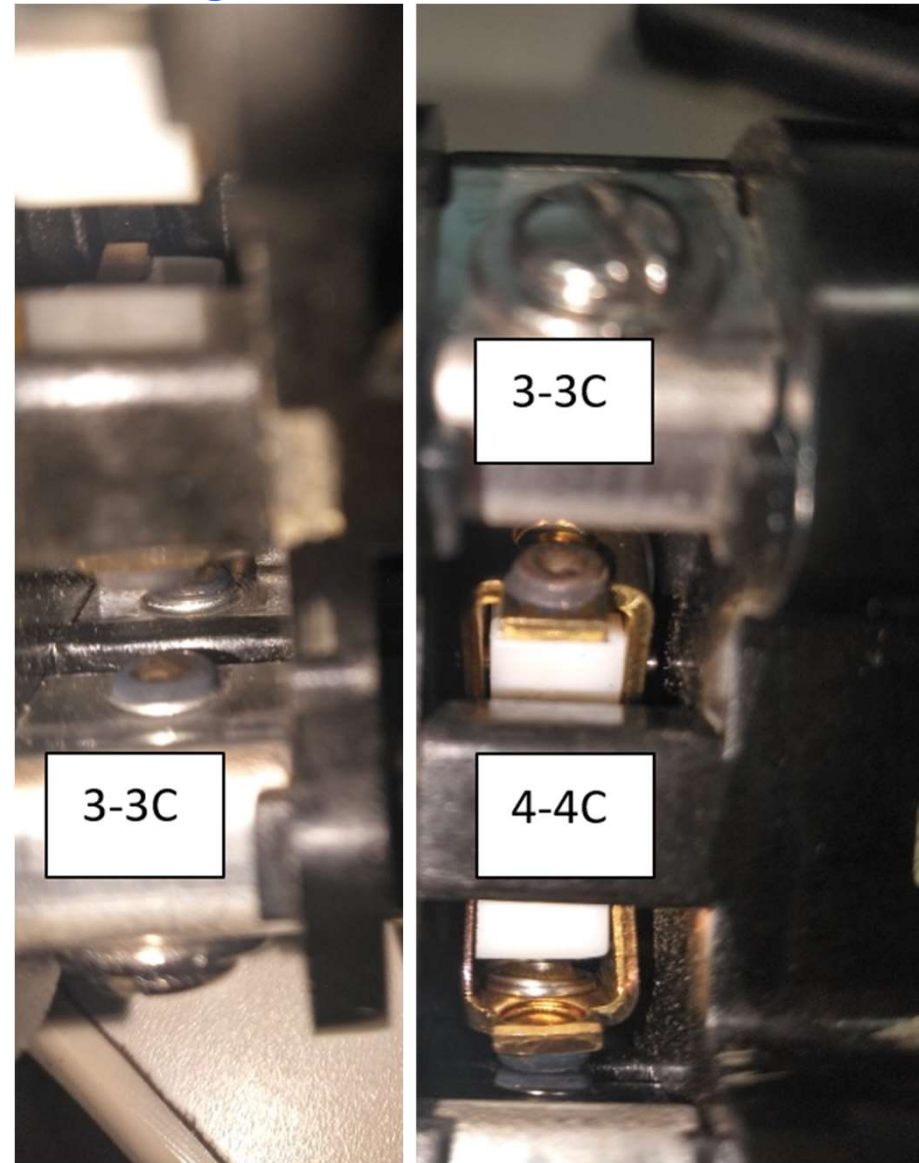
Manipulation of the FFSS during initial troubleshooting

- Initial FFSS contact 3-3C (400 RPM) checks following EDG Shutdown showed continuity across contact.
- With the switch still installed additional troubleshooting operated the FFSS 5 times.
- Following removal, the switch was delivered to the PSDM team and then to the system engineer.
- The switch was manipulated for visual inspection between removal and delivery to the system engineer.
- Pictures of 3-3C contact surfaces were taken on 6/3/21.
- After these pictures were taken the following was performed on the switch between 6/3/21 and 9/9/21
 - FFSS cycled for visual inspections of contacts.
 - Plate on front end of switch was removed for visual inspection Switch operator Mechanism and re-installed.
 - Main bolts loosened slightly ($\sim 1/4$ "") to attempt better visual inspection of contact surfaces and bolts were re-snugged.
- On 9/9/21 switch is prepared for shipment.
