February 3, 2021 Alert at the NIST Center for Neutron Research

Tom Newton
Deputy Director
Chief of Reactor Operations and Engineering
NCNR

Root Cause Investigation of
February 2021 Fuel Failure

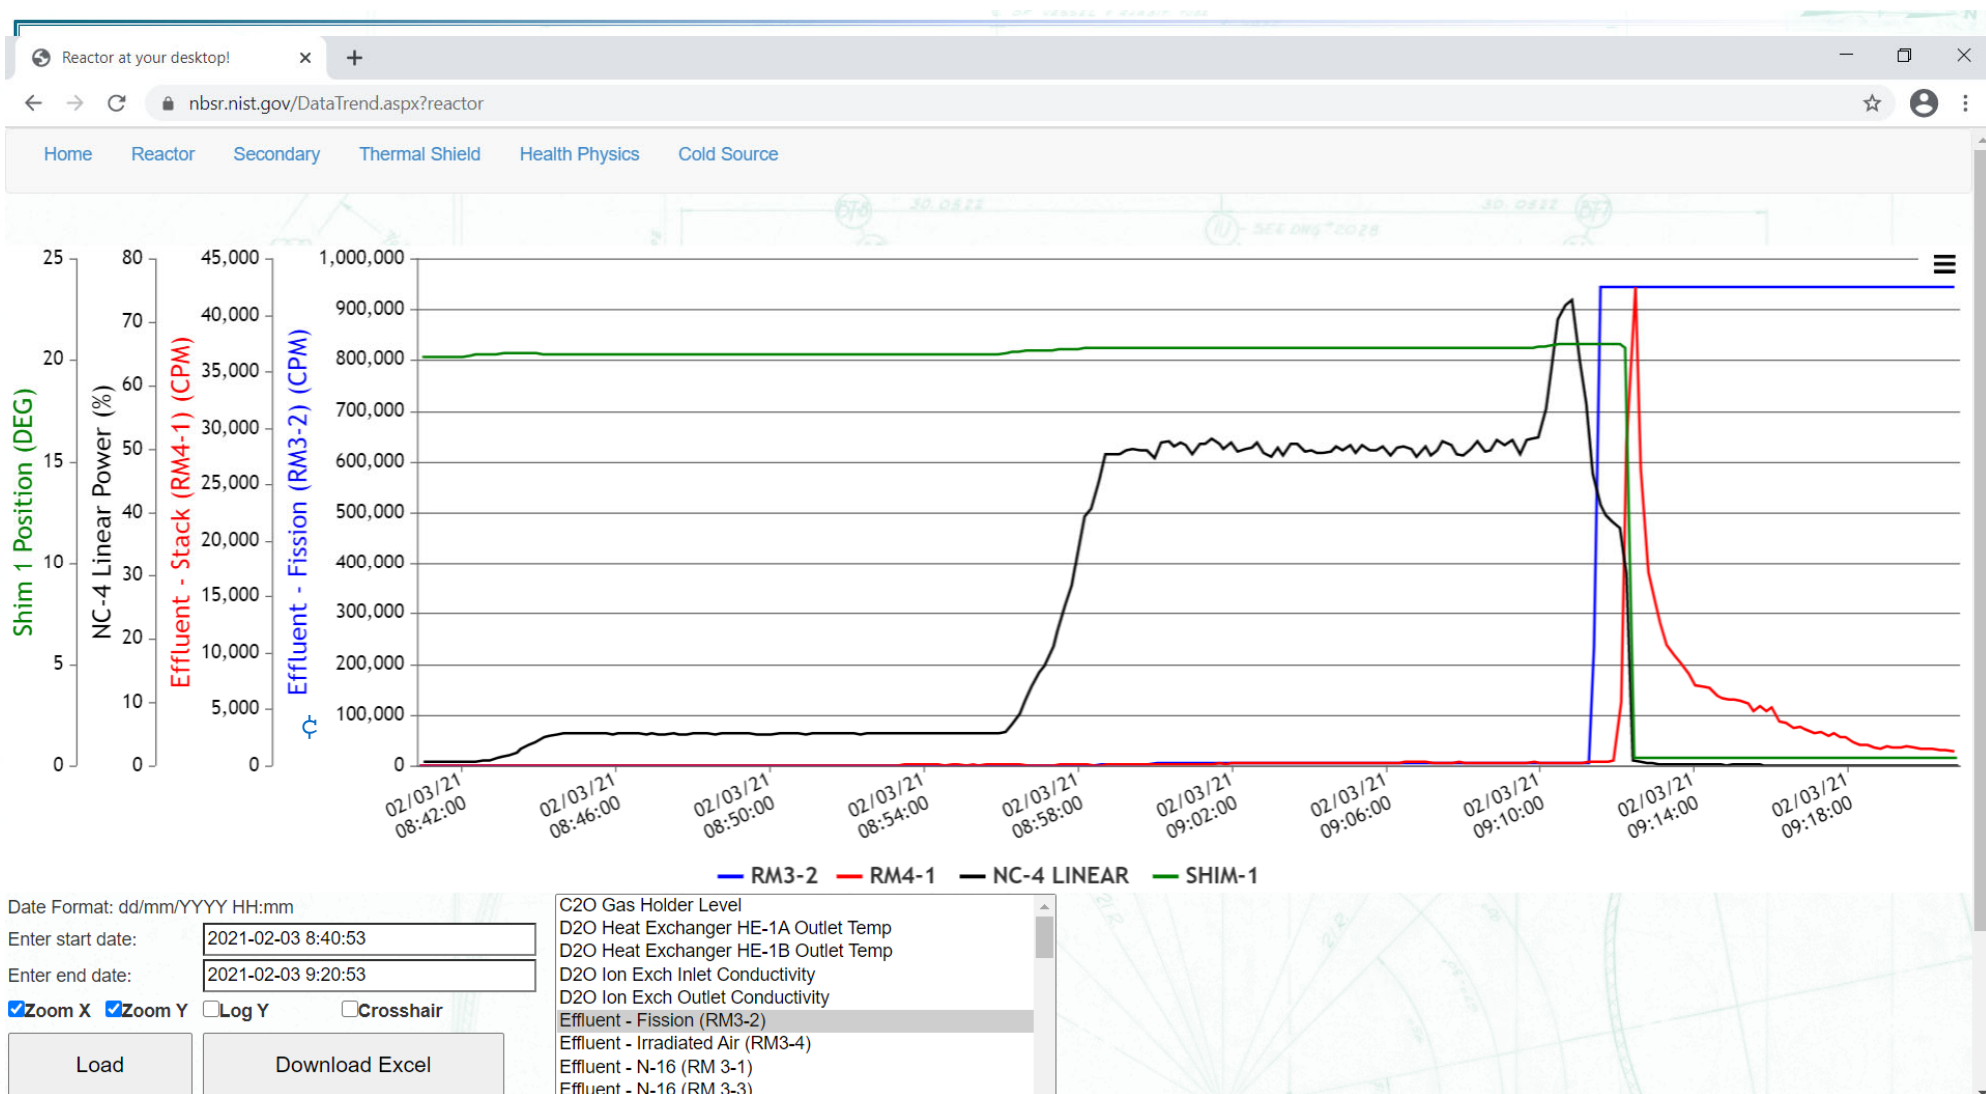
February 3 event

- ☛ 9:00 Normal startup to 10 MW
- ☛ 9:06 begin ascension to full power
- ☛ 9:07 sudden drop to about 7 MW
- ☛ 9:08 release of fission products
- ☛ 9:09 major scram via stack monitor reaching 50,000 cpm
- ☛ 9:16 alert declared
- ☛ 9:21 evacuation of control room due to high radiation levels
- ☛ 9:29 NRC notified
