Davis Besse EDG Failure Field Flash Selector Switch May 2021

Kevin Barclay
U.S. Nuclear Regulatory Commission
2022

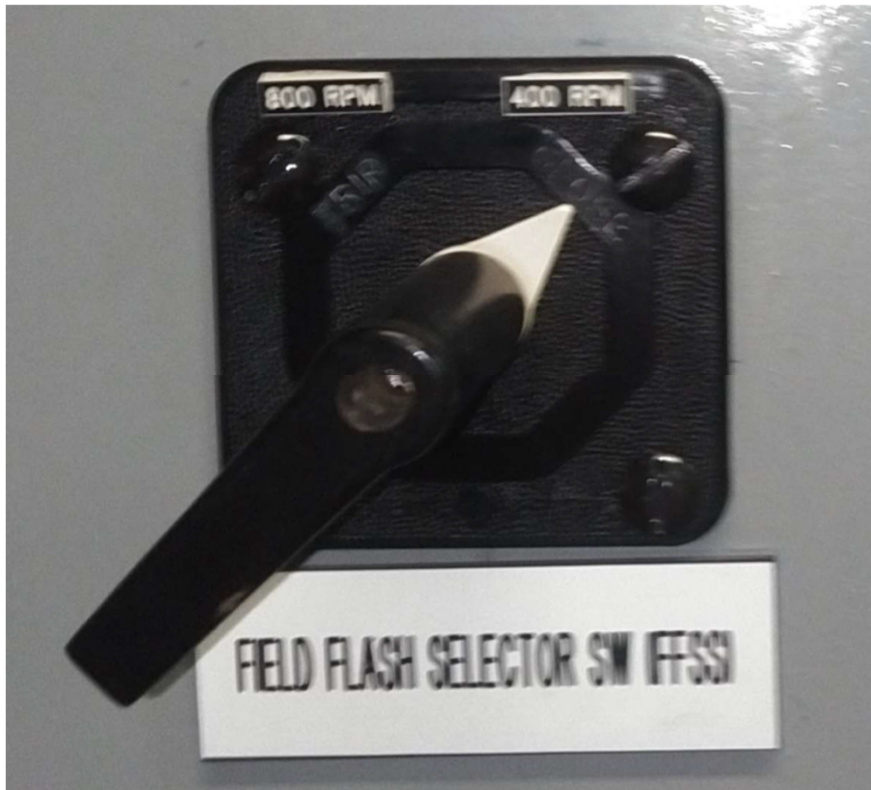
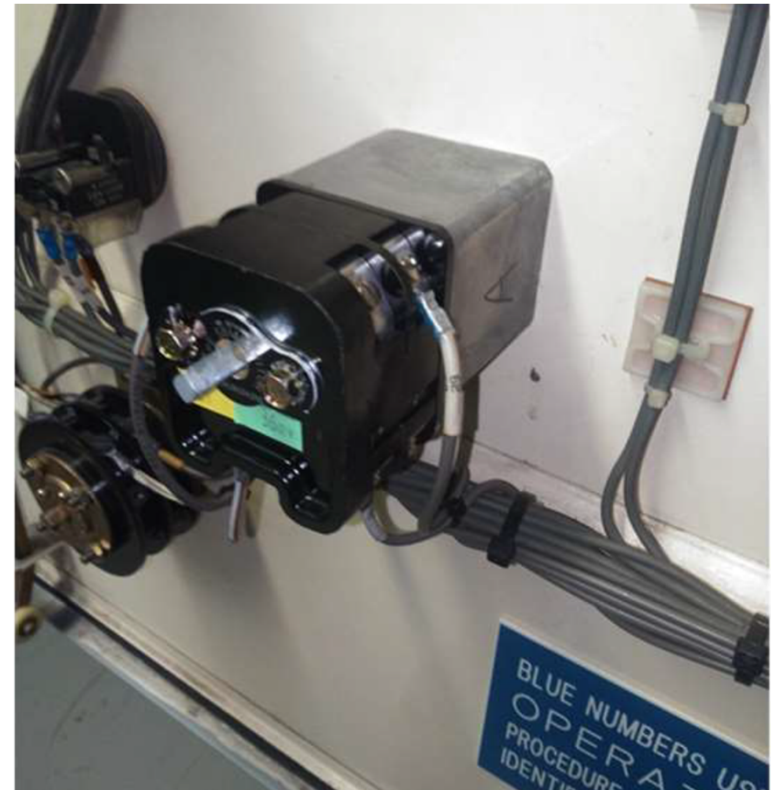
EDG Field Flash Selector Switch

- GE SBM Control and Transfer Switch
- Panel Mounted
- Rotary Cam Operated Switch

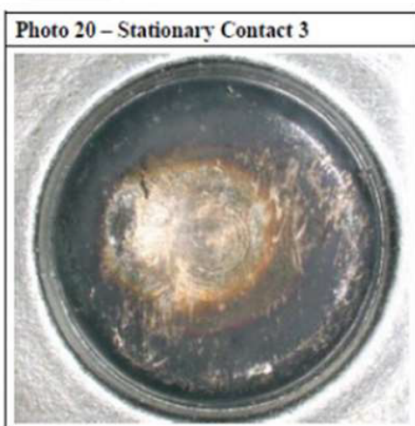
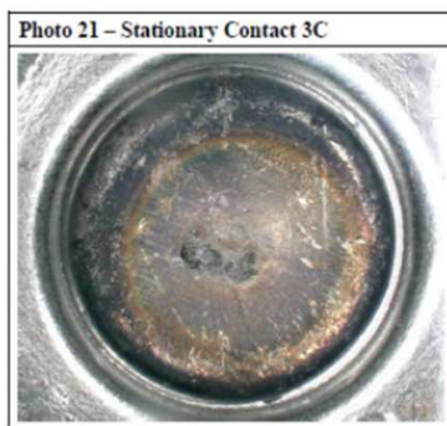
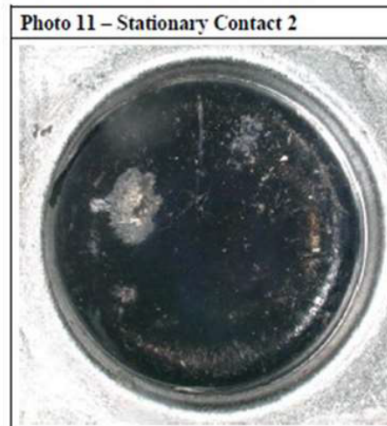
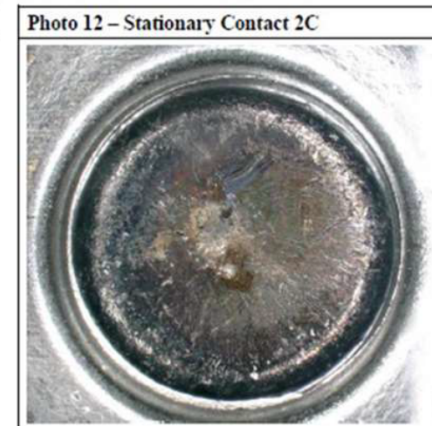
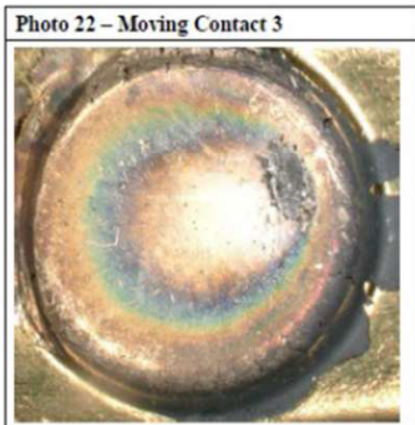
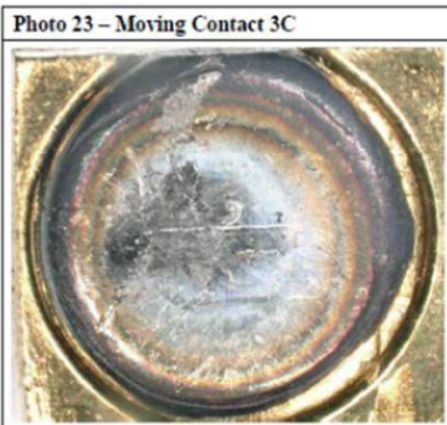
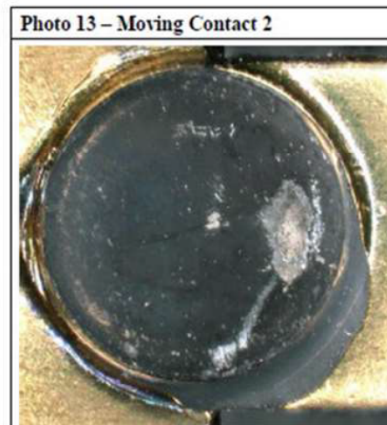
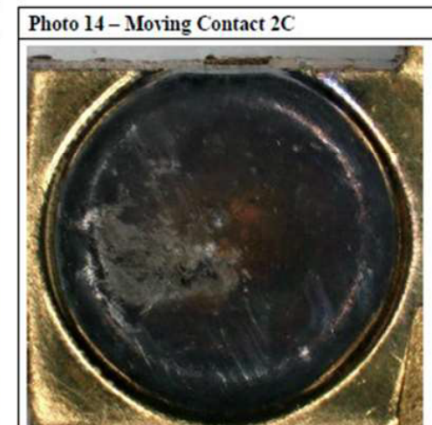
- Switch Failure Was Not Contact Fouling From Lack of PM
- Found Nickel Contamination on Contact
- Postulated FME From Upper Terminal Screw Location
- PM Performance Deficiency Did Not Cause May 27th Event
